# Tree Survey for Abbots Ann Parish Council

Health and Safety Tree Survey September 2023

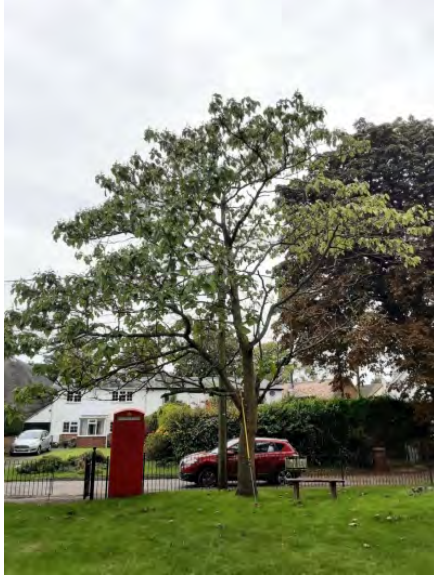
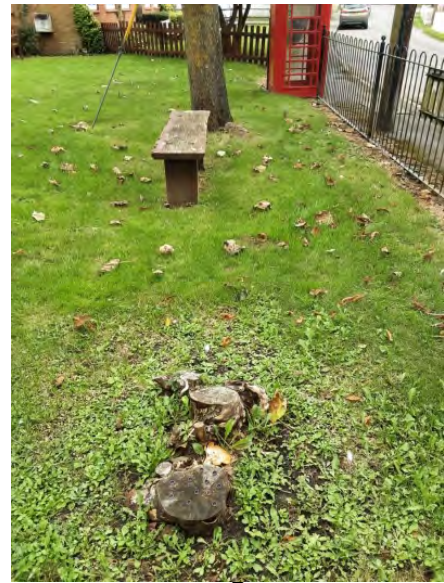
**Seq No:** 1

- Bark damage - to branches rubbing on the overhead cables
- Bleeding canker - on lower trunk to West with black new exudate
- Die back - around 30% - 40% of the crown has died back and is dead with limited live growth
- Epicormic growth - upright epicormic growth rafting along the branches on the Southern side of the crown
- Major dead wood >50mm
- Minor dead wood <50mm
- Roots strimmer damaged - root to the North West bark damaged and potential for infection

**Prune clear of overhead wires** -prune clear of overhead wires, one limb rubbing so sensitive selective branches to be pruned to achieve 0.5m clearance from wires within 3 months to ensure clearance of the overhead power and phone lines and to prevent further bark damage by rubbing on the wires

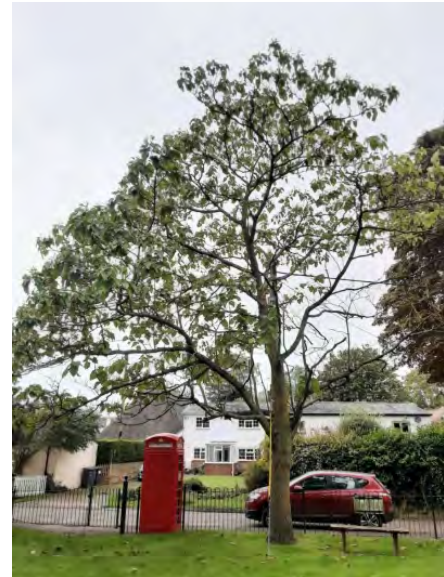
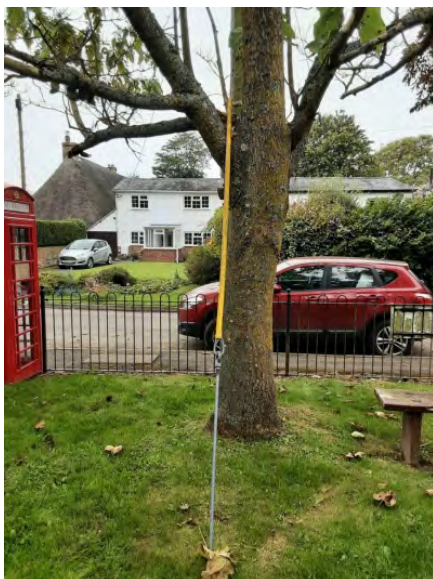
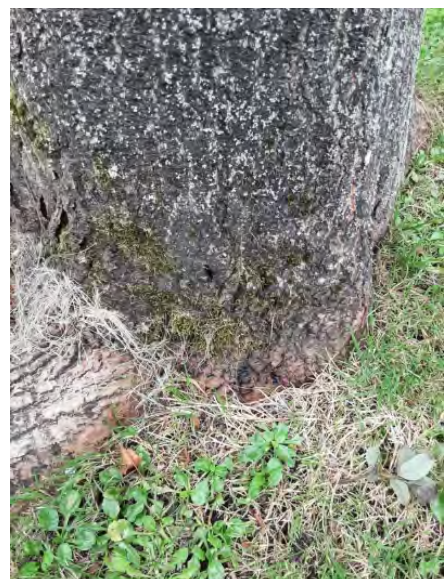
Roots strimmer damaged

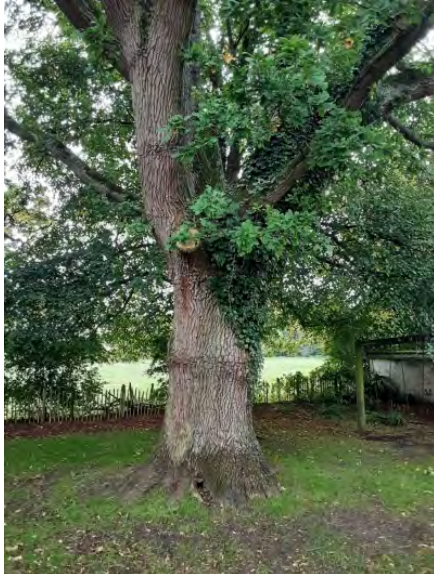
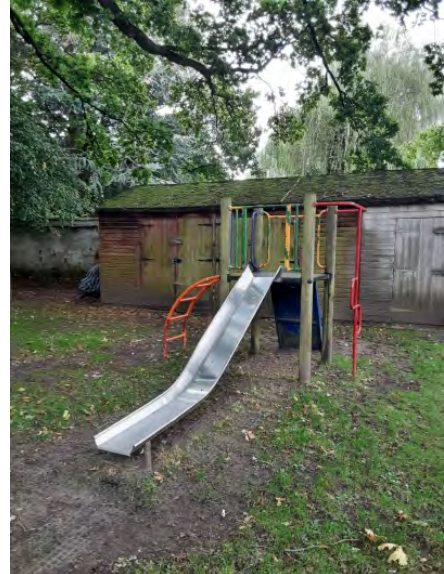
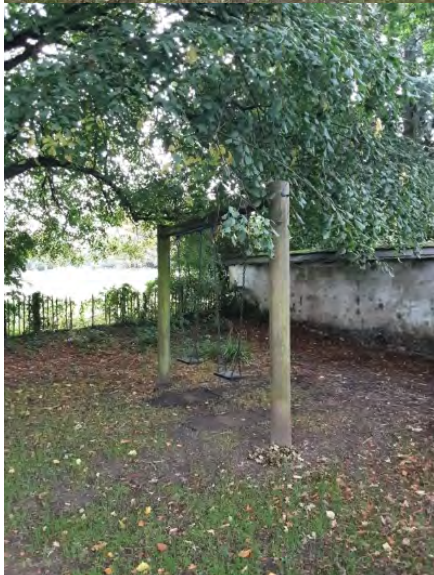
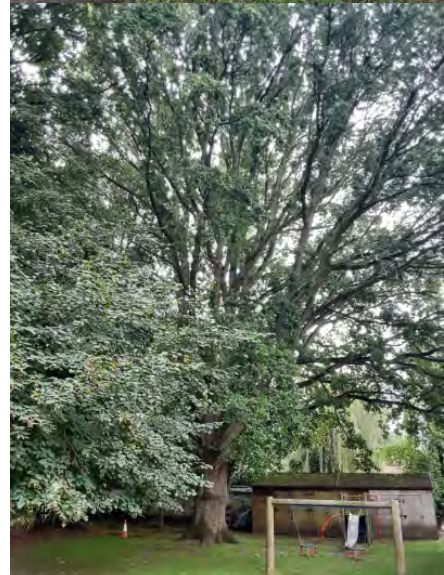
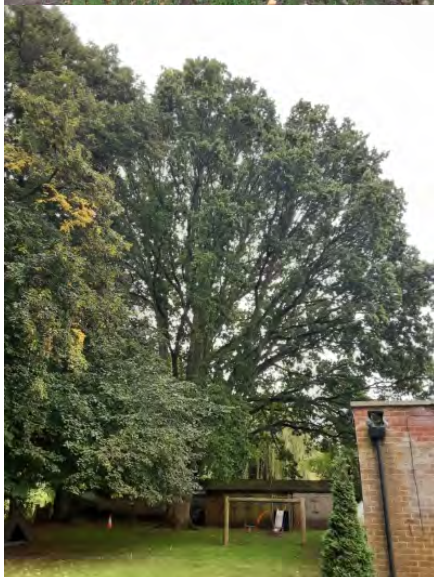
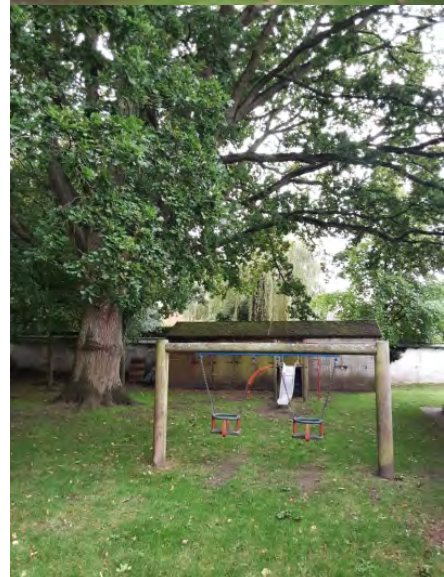
**Seq No:** 2**Position:** War Memorial Hall rear garden  
play area**Species:** Quercus robur ( English Oak)**Grid Ref:** SU 32900 43638**OS X/Y:** 432899.43, 143637.12**Lat Long:** 51.191016, -1.530602**what3words:** ///ledge.suffer.hours

**Notes:** Veteran tree characteristics include a large girth minimum of 25% of species age equating to around 177 - 216 years of age circa 1800's. With potential for internal heartwood decay, large quantities of deadwood, habitat holes and epiphytic plants including Lichens and Ferns. This is an important tree locally as well as historically, culturally, ecologically and environmentally.

**Lift canopy to 2.5m** - Crown lift over flat roof to West to achieve 1.5m clearance over the roof within 3 months to prevent any damage to the roof of the building

**Sever climbing plant** - This will prevent a build-up of ivy obscuring any potential defects in addition to reducing the build-up of ivy on the stem and in the crown adding additional weight.

**Management of the land around the tree** - Over time look to convert the land underneath the crown of the Oak tree from grass over to wood chip mulch and leaf litter. Reduce the grass-cutting regime to avoid damage to surface roots. Add composted bark chips (ideally from an Oak tree) over the area evenly to a depth of 5-7cm in stages starting with the current areas used for the play equipment in year 1, then expand the area out to the second half in year 2. This will aid in providing a natural source of organic matter to the tree over a period of time while it breaks down aiding in maintaining a healthy rooting environment for the tree.

**Monitor (Annually)** - This can be carried out initially by the Parish Council performing a visual check for obvious signs that the tree's condition has changed from that set out within this tree survey and taking photographs throughout the year to document any changes in the tree's condition in each season. They can check for fungi, large volumes of deadwood, any branch damage etc. If they then have any concerns then it would be worth getting it reinspected by a qualified Arboriculturist. This will aid in monitoring for any health changes over time.

**Target management** - If possible seek to move the targets from underneath the canopy of the Oak tree. This would include the two sets of swings and the slide. If possible do not disturb the ground when moving the play equipment to avoid any further root damage and move them to a more suitable location away from underneath the canopy of the trees. This will reduce the risk as the fixed targets beneath the tree will be moved.

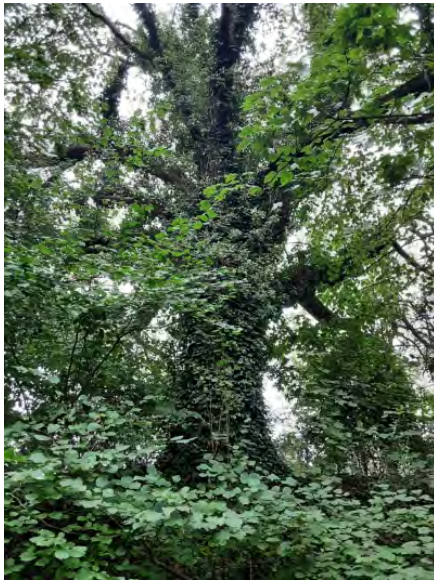
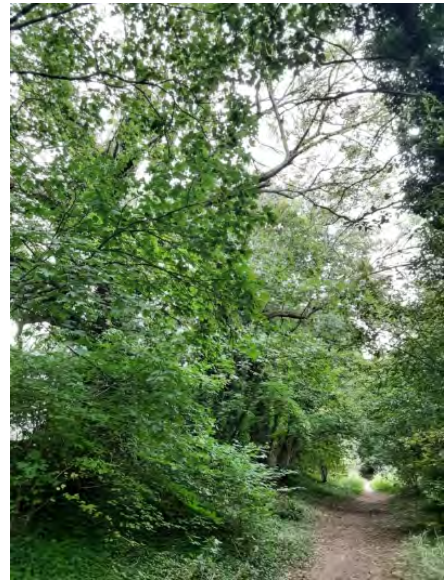
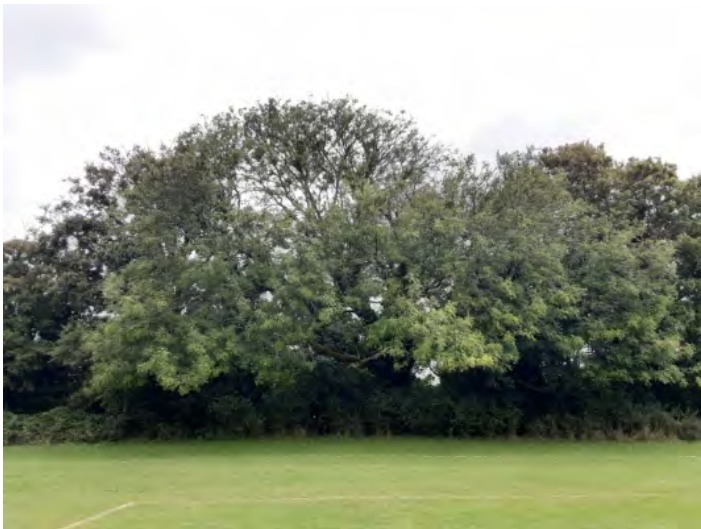
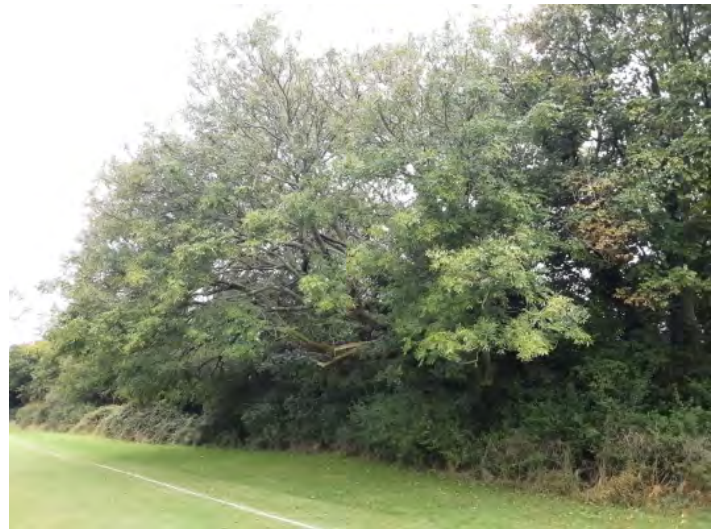
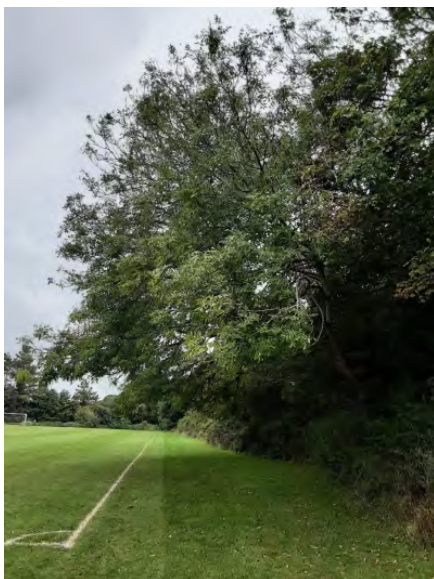
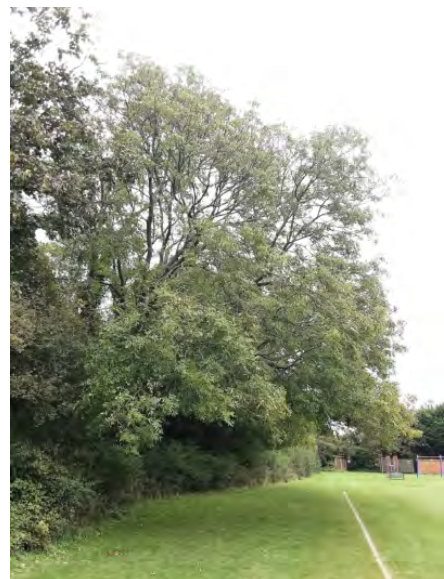
**Seq No:** 3

Ash dieback  
Ash stage 1 = 76-100% canopy remaining  
Ash stage 2 = 51-75% canopy remaining - In the upper crown Bat potential Branch stubs present  
Crown issues or observations -lapsed historic pollard  
Compacted roots - bare earth for the route of the footpath with compacted ground to the North and exposed bark-damaged surface roots visible  
End weighted branches  
Epiphytic plants (Lichens)  
Epicormic growth  
Historical branch loss  
Ivy or climbing plants  
Ivy covered tree  
Live epicormic growth rafting  
Low hanging branches  
Major dead wood >50mm  
Minor dead wood <50mm  
Multiple old pruning wounds Occluded pruning wounds Occluding pruning wounds  
Surface roots  
Thinning crown  
Veteran tree  
Wildlife habitat

- Lateral reduction of 2 - 3m to prune canopy back to edge of the football pitch to the South leaving 11 metre crown spread to the South.
- 2m end weight reduction of over-extended lower limbs to the East and West leaving 10 to 11 m crown spread in each direction.
- 1m height reduction to prune out dying tips down to around 18 metres.
- 2m reduction of lower limbs over the footpath to the North leaving an 11m spread.
- Works to be carried out during the dormant season and within 3 months.
- Check for bats prior to work.
- Works are to aid with the prevention of end-weighted branch failure and to aid with crown management in light of Ash dieback to aid with the overall retention of the Ash tree as an important wildlife habitat tree.

**Sever climbing plant** - to aid with further assessment at the next inspection of the main stem to assess for decay and fungi as currently limited observations are able to be made with the dense ivy present. Within 3 months allow it to die off naturally.

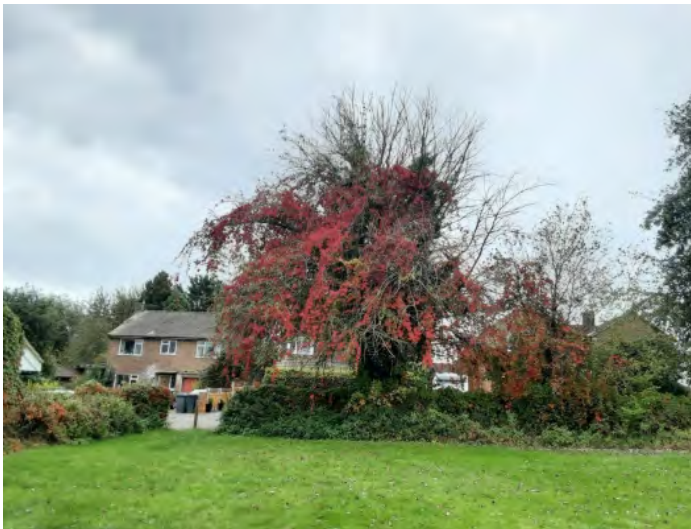
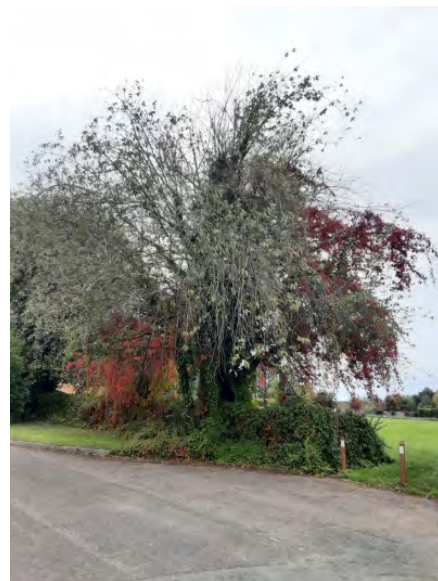
**Seq No:** 4

**Condition:** Very poor

**Fell Broadleaves** - within 3 months for reasons of health and safety as the tree is nearly dead.

**Stump - Grind out stump** - within 3 months to facilitate space for replacement tree planting in this location.

**Plant New Tree** - 8-10 -Recommend a Wild Service tree (*Sorbus torminalis*) as a replacement or a Whitebeam (*Sorbus majestica*) planted in Winter 2023/ 2024) to aid with maintaining the existing tree stock and canopy cover for the site.

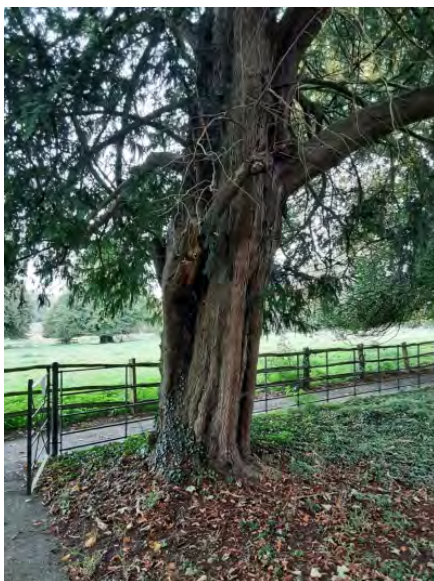
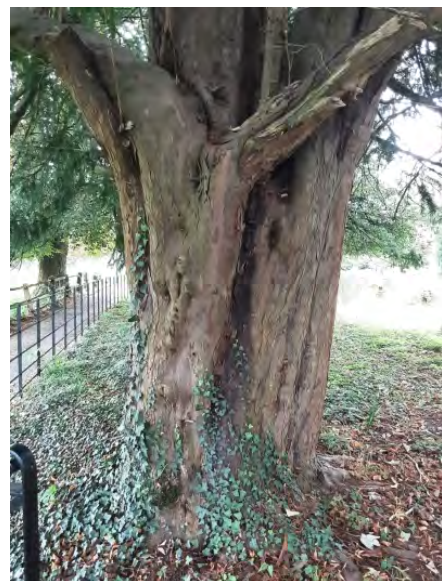
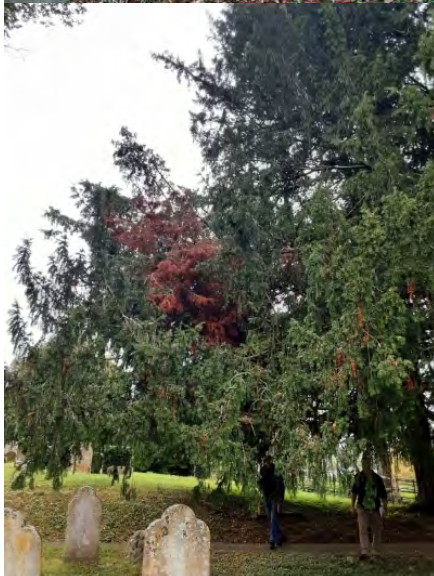
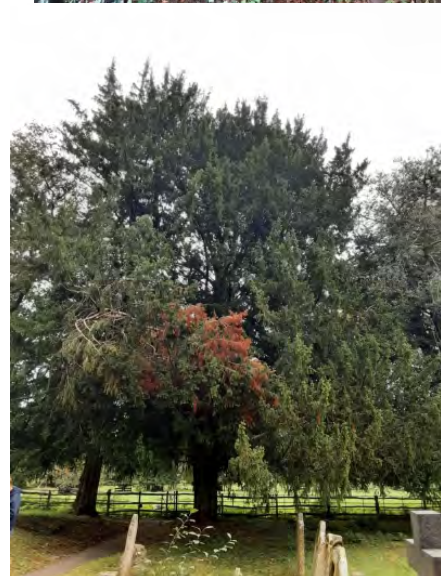
- Branch stubs present
- Crown shape distorted due to group pressure
- Epicormic growth
- Hanging broken branches - failed hazard beam
- Ivy or climbing plants
- Low hanging branches
- Major dead wood >50mm
- Minor dead wood <50mm

**Remove hanging/broken limb** -over footpath within the churchyard, snapped out hazard beam, browning foliage within 1 month for reasons of health and safety

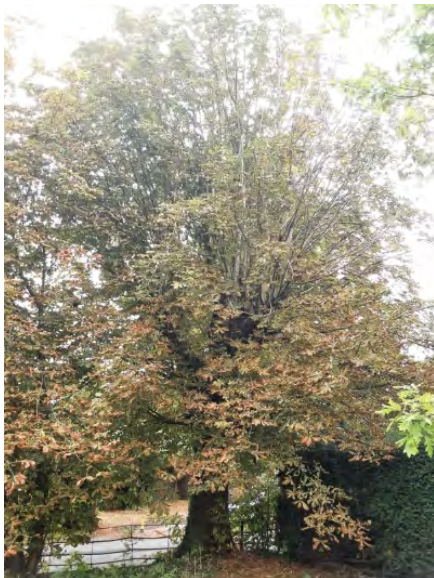
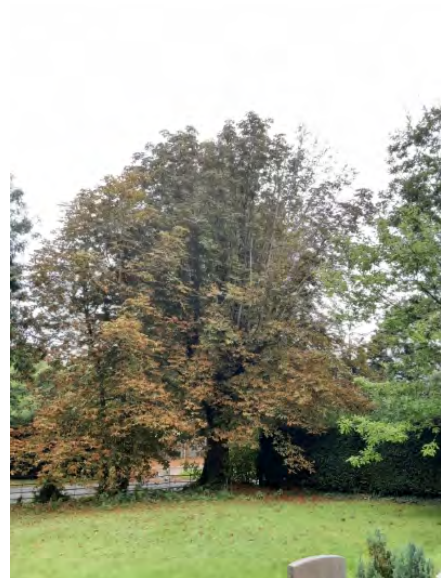
Basal decay - decayed heartwood visible at bark wounds on lower trunk  
 Bird box - plus natural bird nest on trunk in ivy  
 Bleeding canker  
 Bat potential  
 Basal suckers  
 Branch stubs present  
 Cankers on branches  
 Cankers on trunk  
 Cavities present - decay present in the old pollard heads  
 Crossing branches  
 Crown issues or observations - Leaf blotch and leaf miner  
 Epicormic growth  
 Fluted buttresses  
 Ivy or climbing plants - around buttresses  
 Minor dead wood <50mm  
 Multiple old pruning wounds Occluded pruning wounds Occluding pruning wounds  
 Pollarded  
 Stem issues or observations -flaking and delamination bark  
 Veteran tree potential  
 Wildlife habitat

**Reduce crown by 4m** - Reduce crown down by 4m but not to the original pollard points.

- Retain a smaller crown above the pollard points.
  - Thin out each pollard head to retain the smaller stems and remove the two largest diameter stems on each pollard head back to the pollard head at around 6m to reduce the weight on the pollard heads.
  - Works to be carried out within 3 months during the dormant season and bat check prior to work.
  - Works to prevent pollard head collapse under the weight of the new regrowth that has lapsed and to retain a smaller managed crown due to the proximity to the roadside.
-

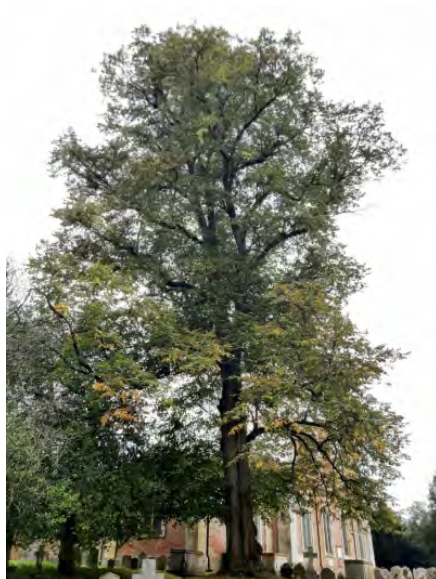
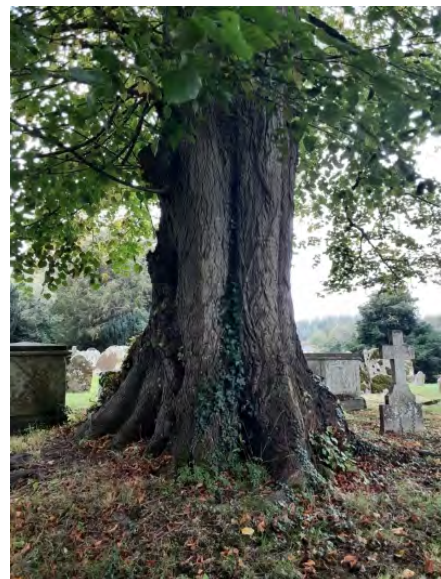
Bat potential  
 Basal suckers  
 Cavities present  
 Epicormic growth  
 Fluted buttresses  
 Ivy or climbing plants - starting up the trunk and around the buttresses  
 Live epicormic growth rafting  
 Major dead wood >50mm  
 Minor dead wood <50mm  
 Multiple old pruning wounds  
 Occluded pruning wounds  
 Occluding pruning wounds  
 Surface roots - lifting tarmac path and visible in the grass bank,  
 bark damage to some exposed roots and decay present

**Risk:** Minimal (64)

**Lift canopy to 3m** - over the footpath within 3 months for reasons of health and safety

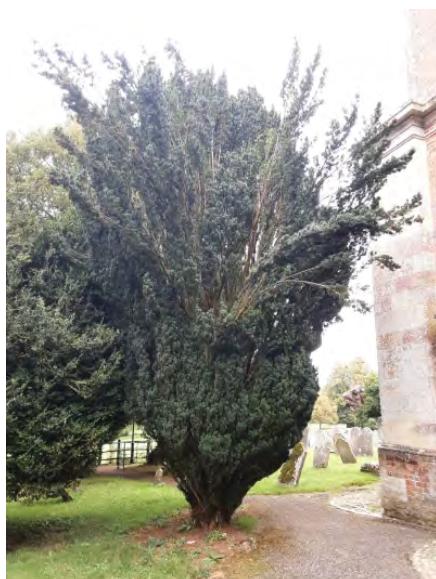
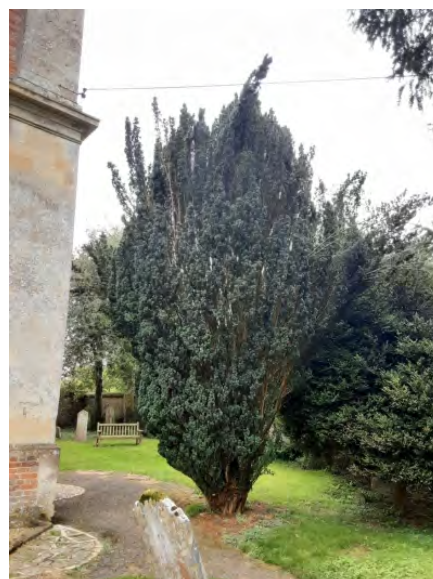
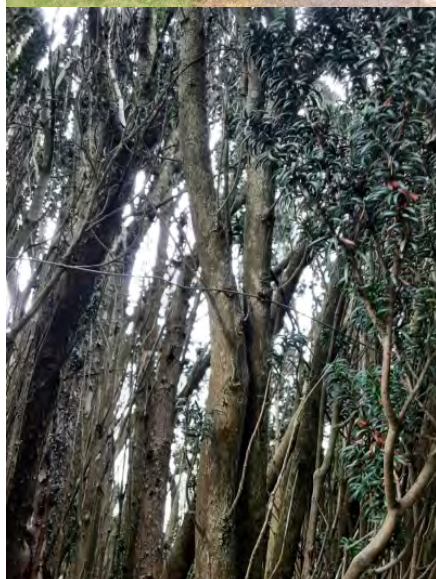
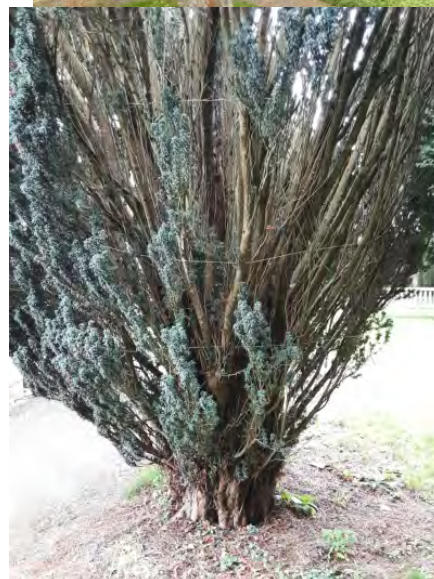
**Seq No:** 9

Bark damage - from wire cutting into branches

Crown issues or observations -Branches collapsed out of the crown and are hanging down. Fastigate form opening up. Previously supported by wire which in places is now imbedded wire cables which are now causing bark and branch damage.

**Risk:** Insignificant (16)

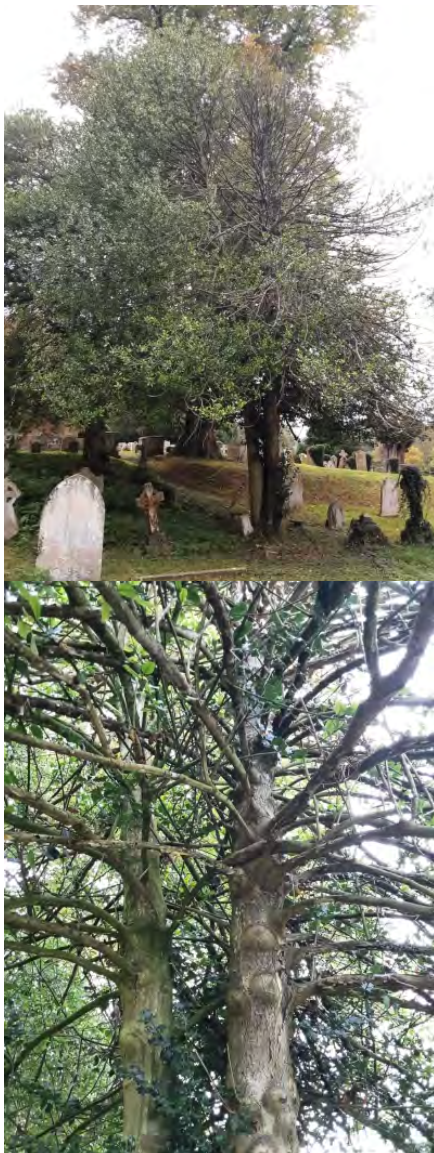
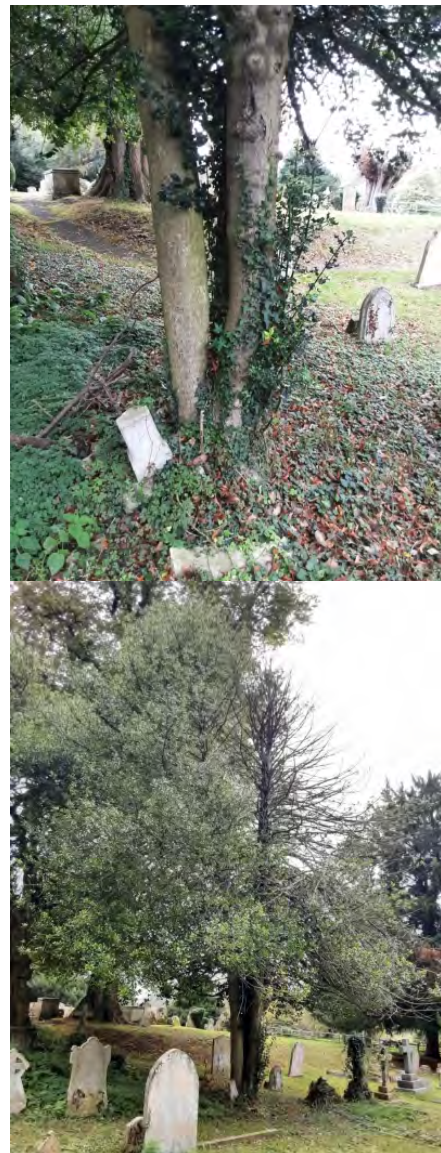
**Risk:** Insignificant (12)

**Reduce crown by 3m** - reduce the two dying stems to the North and East down by 3 metres to reduce the risk of failure but allow the lower stems to regenerate. Within 3 months for reasons of health and safety.
