## **Hamble-le- Rice Parish Council**

**Asset Management Committee of the Parish Council will be held on  
Tuesday 29<sup>th</sup> August 2017 4.00pm at Hamble Village Memorial Hall, High  
Street, Hamble-le-Rice  
AGENDA**

**Tree Survey Report  
Hamble Le Rice Parish Council**

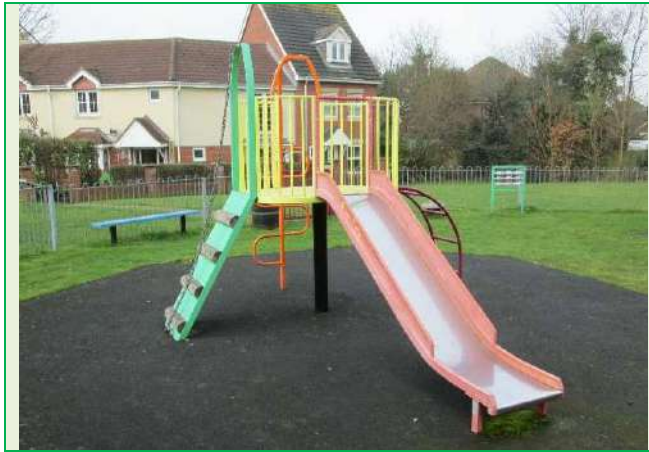
SURFACE PULLING  
APART AT  
JOINTS/EDGES AND  
IS A TRIPPING  
HAZARD AND CAN BE  
LIFTED

RISK  
ASSESSMENT 2  
X 2 LOW RISK

REFIX

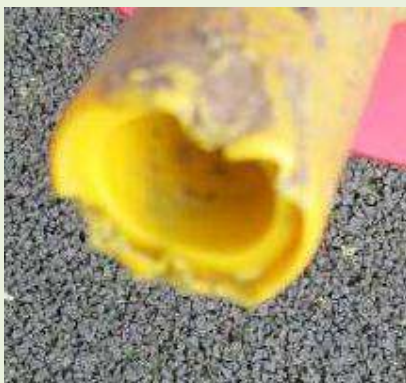
<p>SPRING</p> <p>MANUFACTURER NOT INDICATED</p> <p>WETPOUR</p>		<p>FAULT(S) AND/ OR STANDARD FAILURE(S) FOUND, SEE BELOW</p>
<p>FOOT RESTS</p>	<p>FOOT SUPPORT HAS INSUFFICIENT CROSS SECTIONAL AREA AND HAS SHARP EDGES</p>	<p>RISK ASSESSMENT 1 X 2 LOW RISK</p>	<div>

</div> <p>RENEW PEGS</p>
<p>SURFACE</p>	<p>SURFACE PULLING APART AT JOINTS/EDGES</p>	<p>RISK ASSESSMENT 2 X 2 LOW RISK</p>	<div>   </div> <p>REFIX</p>

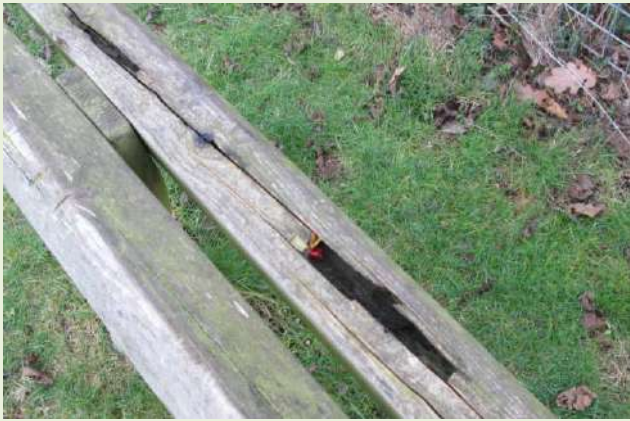
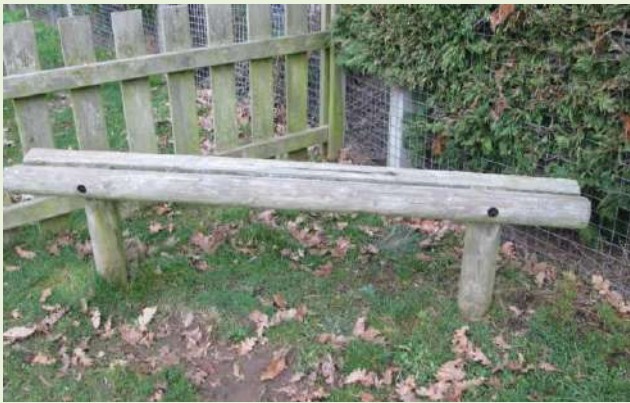
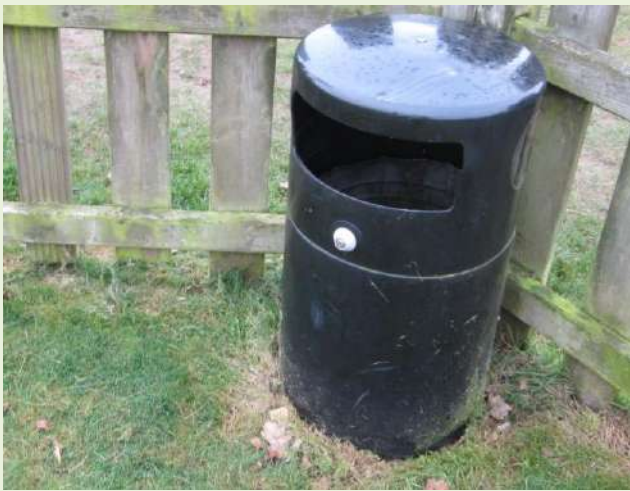
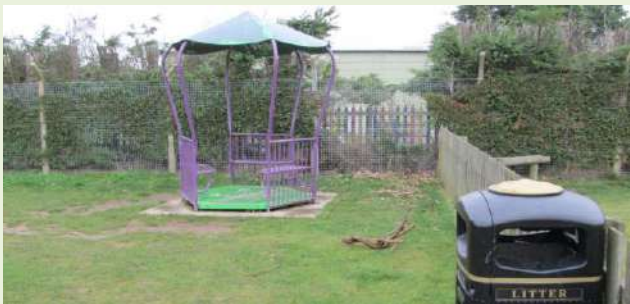
BENCH AT SLIDE	TRIPPING HAZARD DEVELOPING WHERE ROOT PROTRUDES	RISK ASSESSMENT 2 X 2 LOW RISK

ELIMINATE TRIPS
BENCH AT SIDE	ROTTING	RISK ASSESSMENT 2 X 2 LOW RISK

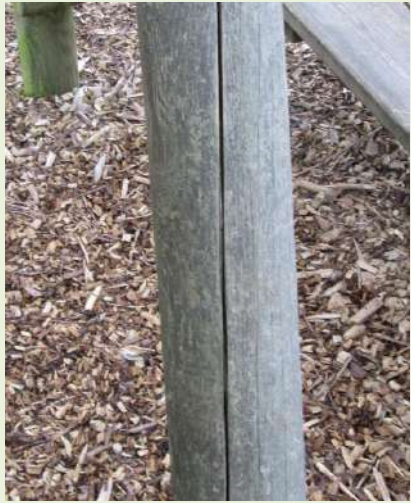
REPAIR
TIMBERS	<p>SPLITS ARE PRESENT IN TIMBERS</p> <p>THESE CAN PERMIT WATER TO REACH THE WOOD INSIDE ITS PRESERVATIVE ENVELOPE AND ROT AND/OR DECAY MAY FOLLOW</p>	NO RISK ASSESSMENT

<p>REGULAR INSPECTIONS, INCLUDING, SHOULD PAY PARTICULAR ATTENTION TO CONDITION AND STABILITY PARTICULARLY CHECKING FOR ROT AND DECAY AT POINTS OF GROUND CONTACT AND IN ALSO IN TIMBER COMPONENTS WHERE FIXINGS AND FITTINGS ARE ATTACHED</p>

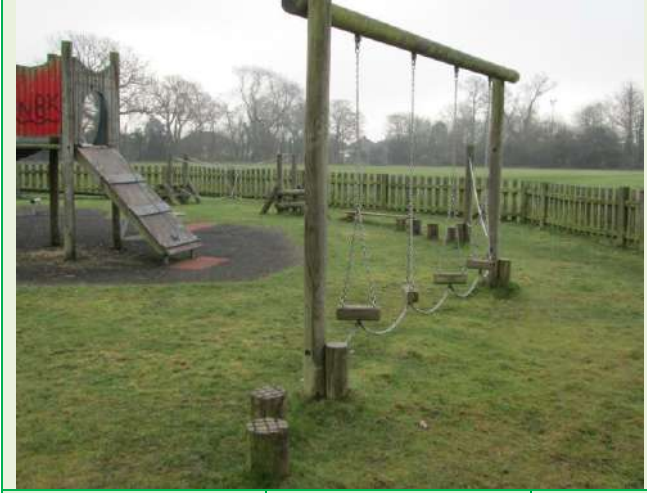
<p>ADVENTURE TRAIL</p> <p>PLAYDALE</p> <p>GRASS</p>		<p>FAULT(S) AND/ OR STANDARD FAILURE(S) FOUND, SEE BELOW</p>
<p>POST AT SWINGING LOGS</p>	<p>POST IS SLIGHTLY LOOSE</p>	<p>RISK ASSESSMENT 1 X 3 LOW RISK</p>

<p>EXCAVATE DOWN TO FOUNDATIONS TO DETERMINE THE CONDITION OF THE POLE</p>	
<p>POSTS</p>	<p>SPLITS ARE PRESENT IN TIMBERS</p> <p>THESE CAN PERMIT WATER TO REACH THE WOOD INSIDE ITS PRESERVATIVE ENVELOPE AND ROT AND/OR DECAY MAY FOLLOW</p>	<p>NO RISK ASSESSMENT</p>	 	<p>REGULAR INSPECTIONS, INCLUDING, SHOULD PAY PARTICULAR ATTENTION TO CONDITION AND STABILITY PARTICULARLY CHECKING FOR ROT AND DECAY AT POINTS OF GROUND CONTACT AND IN ALSO IN TIMBER COMPONENTS WHERE FIXINGS AND FITTINGS ARE ATTACHED</p>

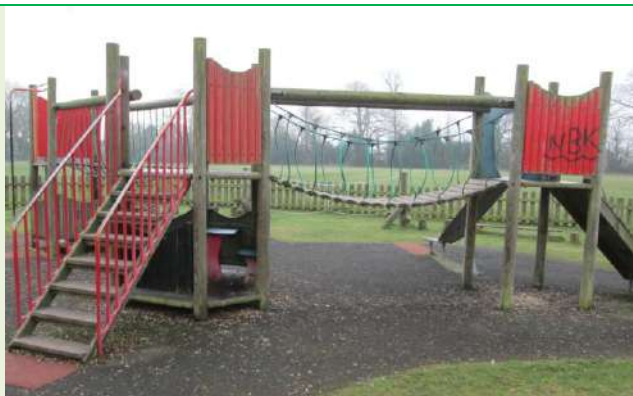
POSTS	SOME POSTS HAVE ROT/ARE DAMAGED	RISK ASSESSMENT 2 X 2 LOW RISK	   	MONITOR FOR FURTHER DETERIORATION
-------	---------------------------------	--------------------------------------	--	---

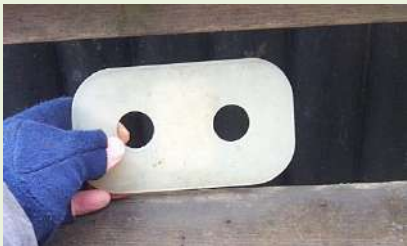
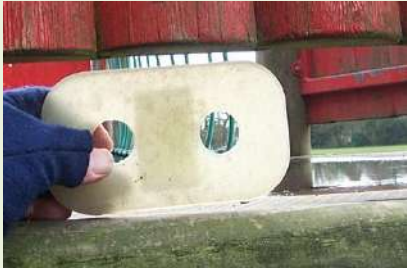
HEAD TRAPS FOUND	HEAD TRAP (S) PRESENT ABOVE A HEIGHT OF 600 MM	RISK ASSESSMENT 1 X 3 LOW RISK

PHOTOS SHOW EXAMPLES

NO REMEDY IS SUGGESTED
------------------	--	--------------------------------------	--	---------------------------

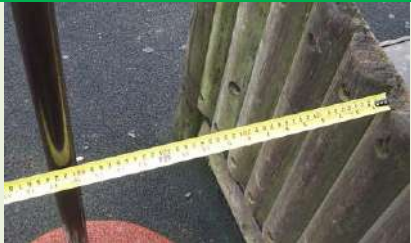
FIRE POLE	BARRIERS ARE IN THE FREE SPACE OF THE FIRE POLE - SHOULD BE AT LEAST 50 CM, CURRENTLY 42 CM	RISK ASSESSMENT 2 X 3 MEDIUM RISK

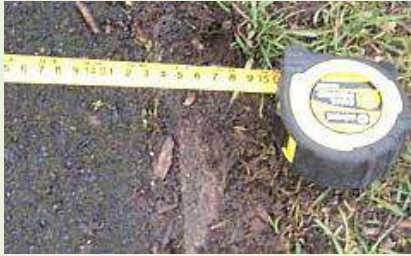
NO REMEDY IS SUGGESTED
FIRE POLE	INSUFFICIENT AREA OF WETPOUR - SHOULD EXTEND 150 CM CURRENTLY 145 RESULTING IN THE CONCRETE EDGE BEING IN THE IMPACT AREA	RISK ASSESSMENT 1 X 4 LOW RISK

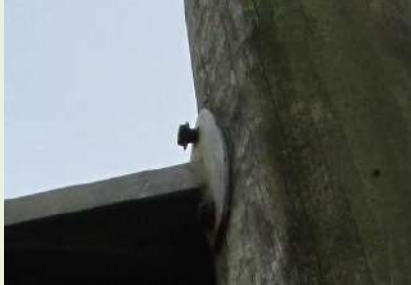
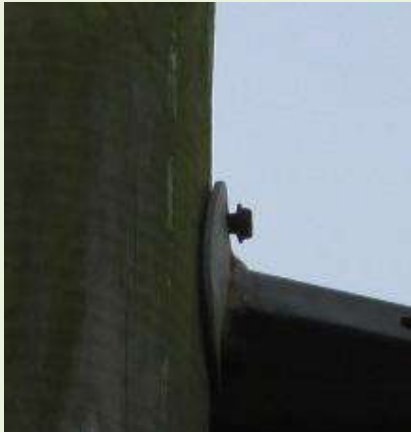
NO REMEDY IS SUGGESTED
FIXINGS	A COUPLE OF FIXINGS PROTRUDE	RISK ASSESSMENT 1 X 3 LOW RISK

TIGHTEN
