Annual Inspection

Battle Town Council - WPS

Telham Recreation Ground

Inspection Ref: 1238930

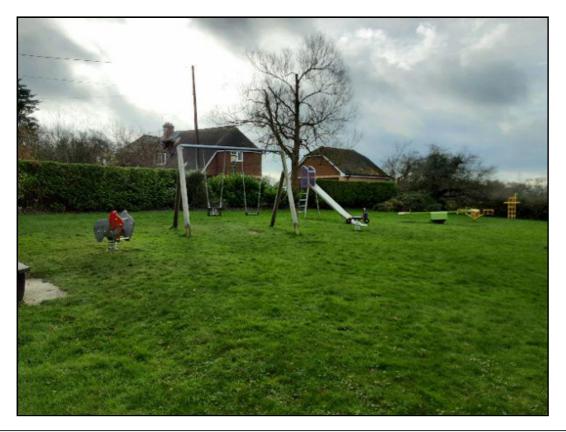
Risk Assessment: 12 Moderate Risk

Location:

The site is located in an area of public open space and is not directly overlooked by any properties in the local community.

areas are treated and repaired
