3.7.3. Site Description

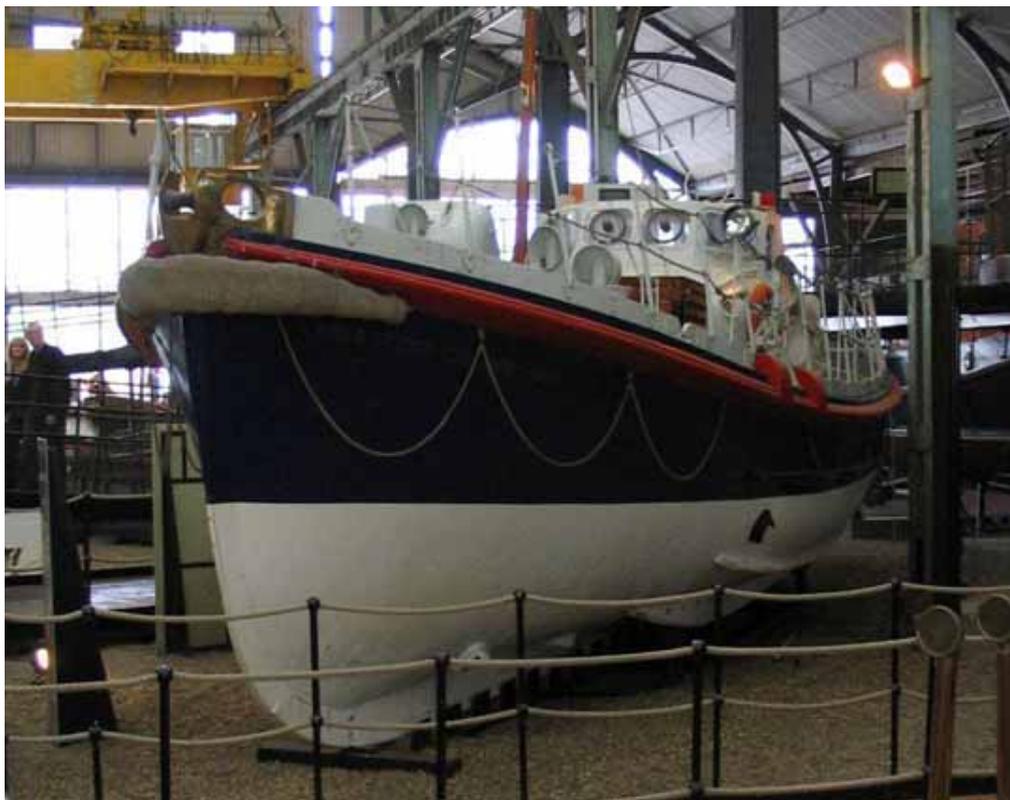
The majority of lifeboats in this collection appear to have four holes in the keel, two astern and two forward. However, one class of lifeboat does indeed have three holes, two astern and one forward. This is a Barnett Class Lifeboat (Figure HAM043-5). The Barnett Class Lifeboats came into service during the 1950s and some were still in service in the 1980s (National Register of Historic Vessels). They were 52ft (15.85m) long and 14ft (4.27m) in the beam (National Maritime Museum).

Figure HAM043- 5 A Barnett Class Lifeboat in the Chatham Historic Dockyard collection

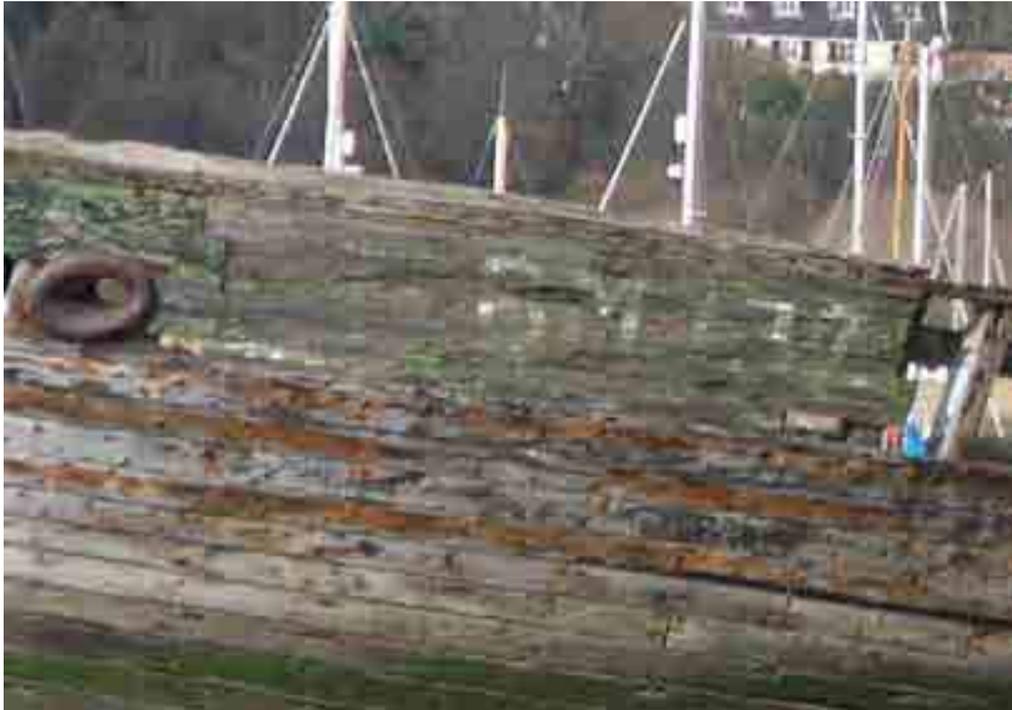
Near the bow there is a large metal hawsehole, which is located above the deck in the bulwark. The bow has a shallow rake and is probably only 15-20° from the vertical. There is a stem post, which appears to be a continuous, flat faced, rebated timber. It is possible that this may be a false stem. On the top of the stem there is a metal fitting, which may have been related to a bowsprit. This appears to be a metal hinge plate with a support stanchion. Judging by the fixture the bowsprit may have been a running bowsprit, but this is only an assumption. The remains of a vessel registration number were observed about 3m from the stem, aft of the hawsehole in the bulwark. This number has faded, but 'BM137' can be identified in white painted characters (Figure HAM044-3).

Figure HAM044-3 A close up of the port bow show the registration 'BM137'

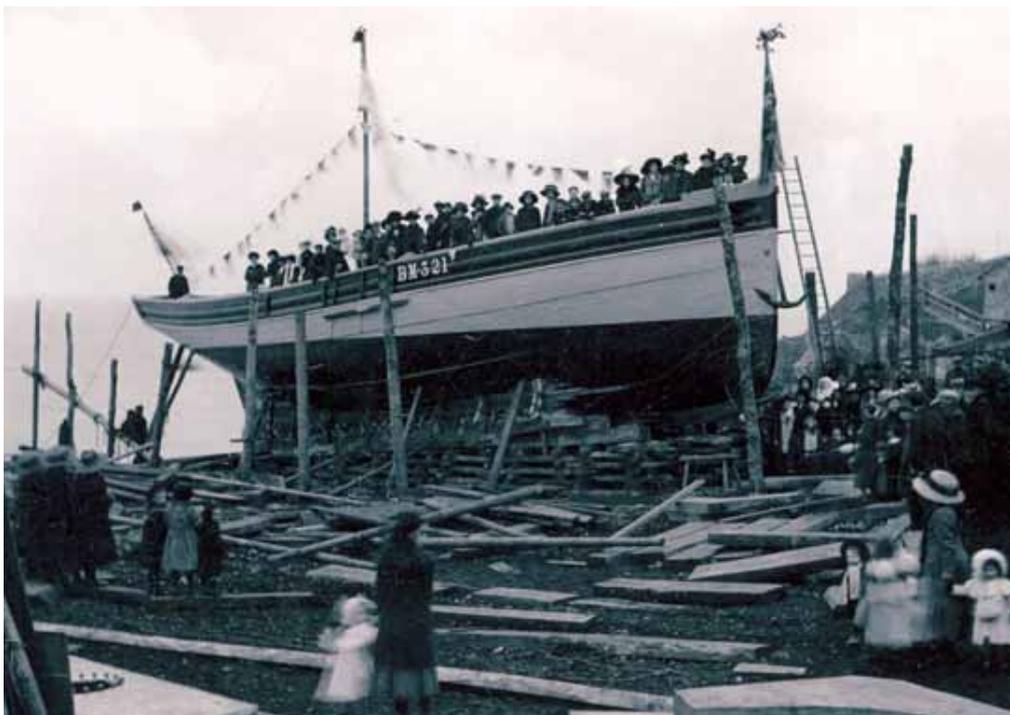
Figure HAM044-4 Photograph of the Terminist taken in 1911 (courtesy of Mike Miller Brixham Heritage Trust)

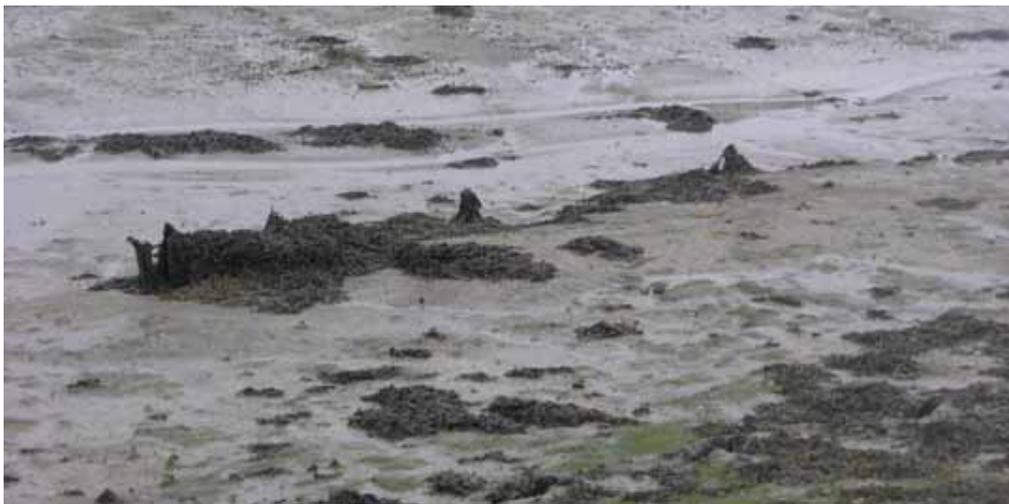
The structure is located on the eastern bank of the river near Bunny Meadows. It lies in an area of tidal sediments and has a covering of weed. The structure of the hulk is heavily eroded, and very little of the original vessel remains (Figure HAM045-1).

Figure HAM045-1 Heavily eroded hulk situated in an area of tidal sediment

This site was visited in 2001 and was described as comprising of only a few timber elements, approximately 12m in length protruding from the tidal sediments. From the most recent visit it was possible to see that the structure has continued to degraded, and even less remains are visible. Only a few components protrude from the sediments and the vessel appears to have been constructed with timber fastened by metal. It was not possible to get closer to the hulk; therefore it was not possible to see if any additional diagnostic elements remain. This vessel lies in a dynamic area of erosion, which means that there is a strong possibility that it has decomposed quickly. Indeed, since the last visit there was a marked level of increased erosion.

Diagnostic information should be collected from these remains, if a way of accessing the hulk safely can be found. Survey, recording and photography would be appropriate to help aid identification. It is also recommended that local people and river users be continued to be approached for information, hopefully this route of enquiry may bear fruit in the future.

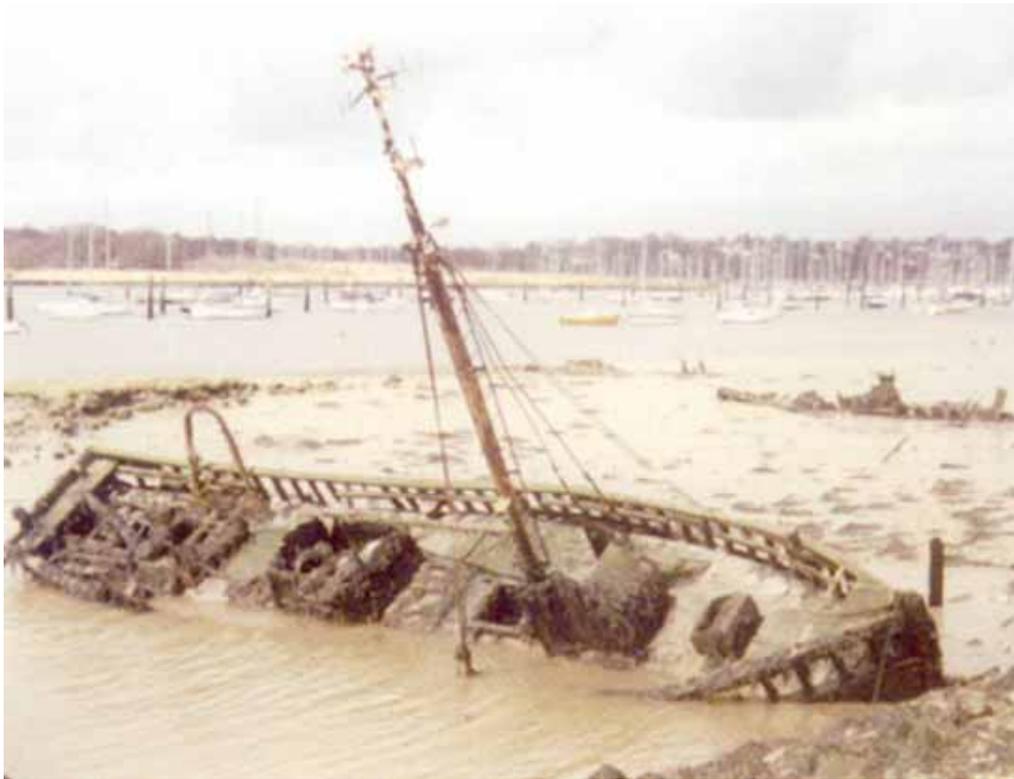
Figure HAM046- 2 A photograph of the vessel taken in 1980 (Peter Holt)

Comparing the photograph taken for this project (Figure HAM046-1) with the 1980 photograph (Figure HAM046-2) shows this vessel has suffered extensively from erosion, and has degraded considerably. This is indicative of a dynamic environment such as tidal area. This site is an excellent example of how quickly vessels can collapse within these environments. Further degradation will occur as erosion continues to affect this hulk. At its current rate of decay it is possible that nothing diagnostic will remain within the next decade or two.

Due to the environmental conditions an archaeological drawn survey may not be possible, however, it is recommended that a regular photographic survey be collected every six months to a year. This will allow monitoring of the condition of the vessel and gauge its rate of decay.

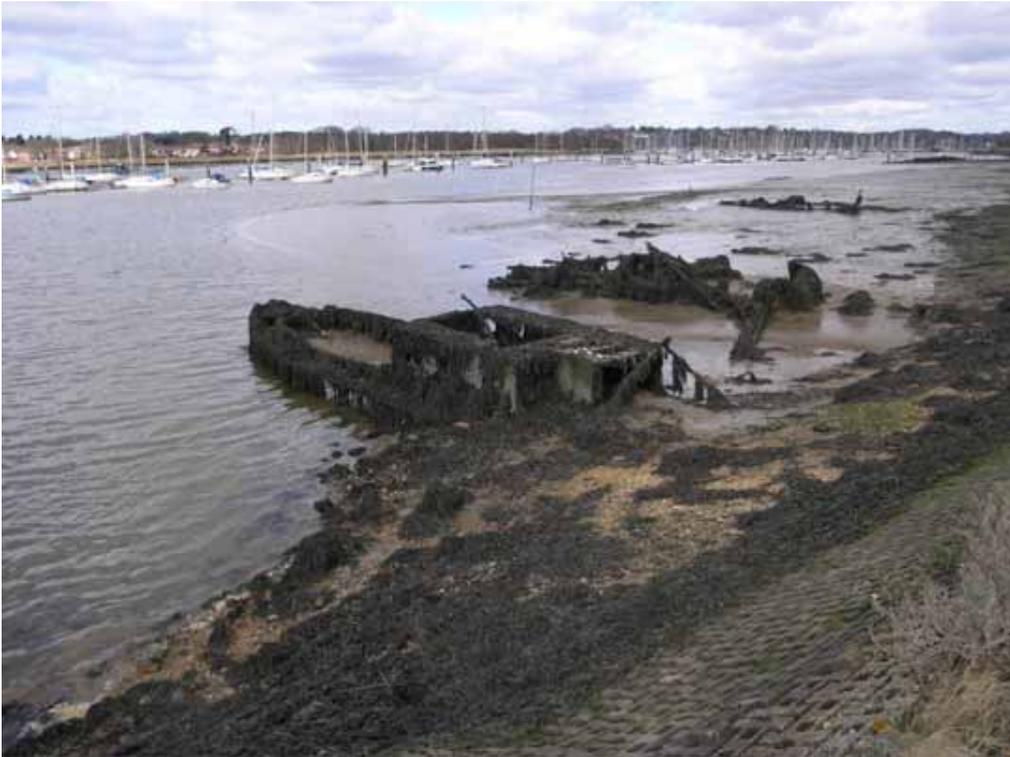
The site is represented by a substantially complete metal wreck of approximately 15m in length, consisting of a large amount of hull structure from the bow to just aft of a raised cabin. The cabin is rectangular in form, approximately 6m long, 3m wide and 1m high. Within the cabin a number of openings can be seen that once would have been windows. Around the forecastle at the sheer there is a 0.50m wide waist, inside of which is located a bay. On the outside of this bay there is a raised metal coaming. It is not certain whether this was an engine bay, a hold or an open deck area. The stern of the vessel is not visible, due to the positioning of the Warsash to Swanwick shore footpath over the vessel (Figure HAM047-2).

Figure HAM047- 2 The stern of the vessel is no longer visible due to its proximity to the shore path

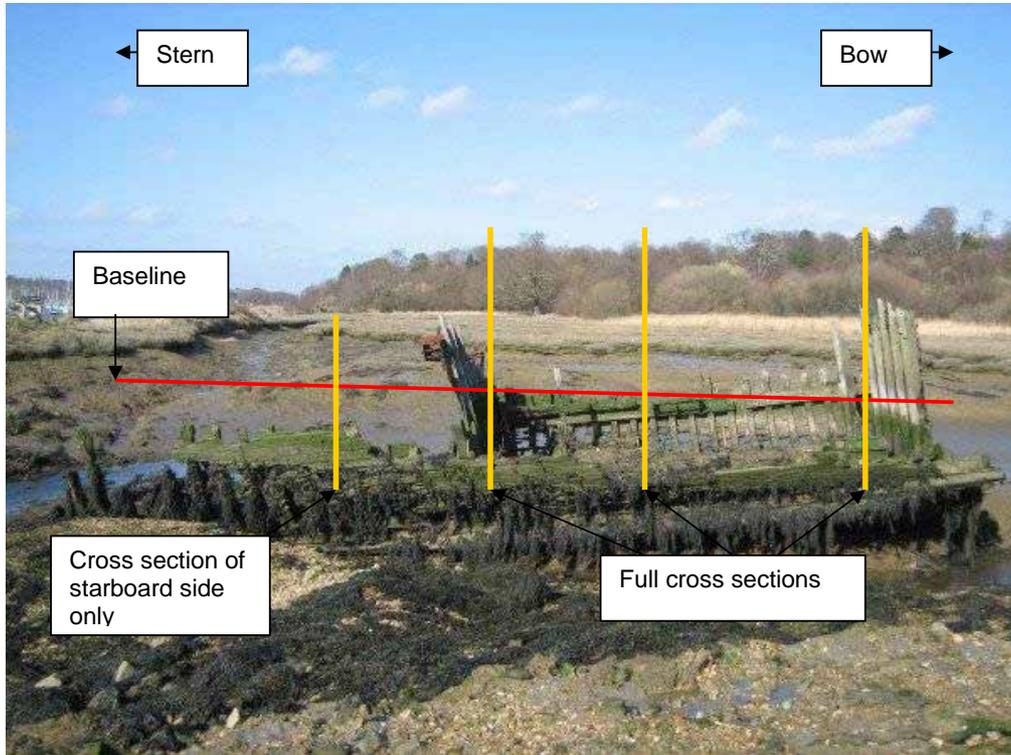
to the aft of the rear bulkhead. Only the port half of this cross-section was drawn due to the depth of sediment and collapse of the port side at this location (Figure HAM050-2).

Figure HAM050- 2 The location of the four cross-section profiles recorded

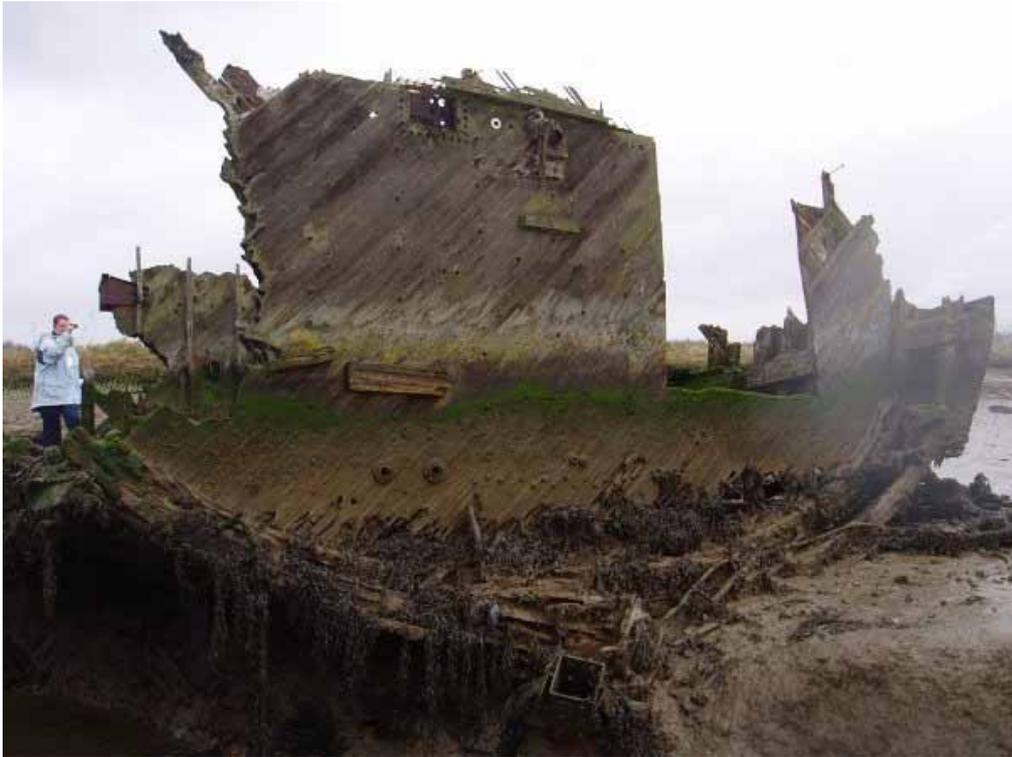
Three bulkheads were identified within the hull remains. Two survive that are relatively complete; both reaching an approximate height of 2.9m at amidships. This is interpreted as approximately the level of the original deck (Figures HAM050- 5 and 6). The distance between these two bulkheads is 6.8m. The third and rearmost bulkhead survives only as a single timber running the breadth of the vessel, with a small amount of *in-situ* diagonally planked timbers to confirm its identity. The distance from this to the middle bulkhead is 5.4m.

Figure HAM050- 5 A view of the forward-most bulkhead, from the east

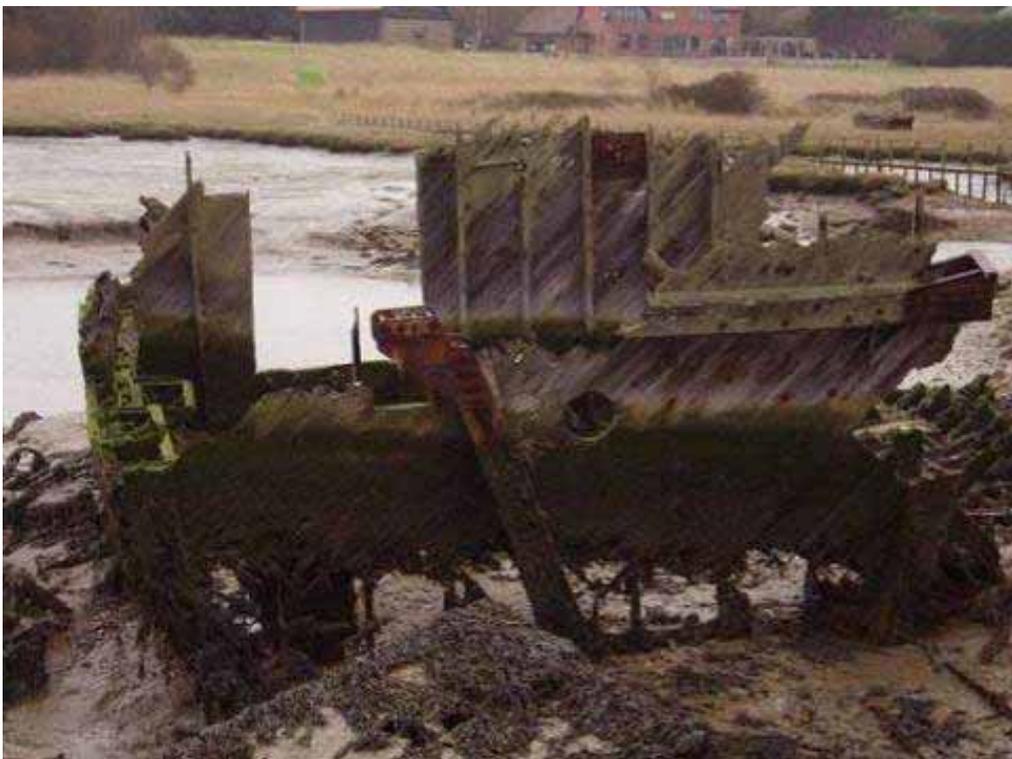
Figure HAM050- 6 The metal deck support can be clearly seen on this photo of the central bulkhead, with the foremost bulkhead in the background

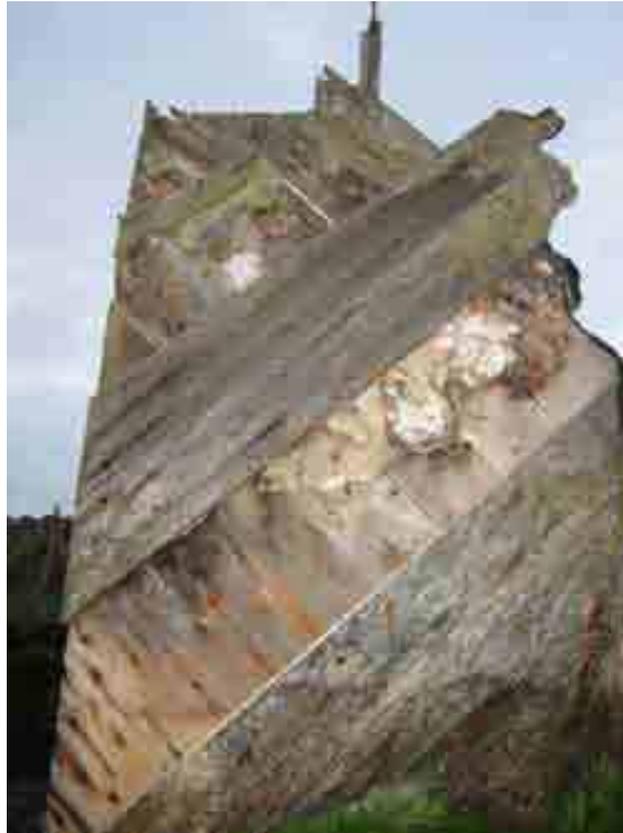
The bulkheads are constructed of diagonally opposed double laminate plywood planking that is key-scarfed together (Figure HAM050-9). A series of ten uprights provides vertical support. A layer of painted canvas was attached to these bulkheads, which may have acted as soundproofing from the engines. It is also possible that the paint may have been fire retardant, offering some protection to the timbers. At the central section bulkhead there are two diagonal beams. On the top of these there are substantial metal fastenings (Figure HAM050-10). These would have been attached to deck beams and were part of the structure that supported the deck. Some of the corresponding beams lie detached in the hull below their original positions.

Figure HAM050- 9 The bulkheads are constructed from composite laminate plywood

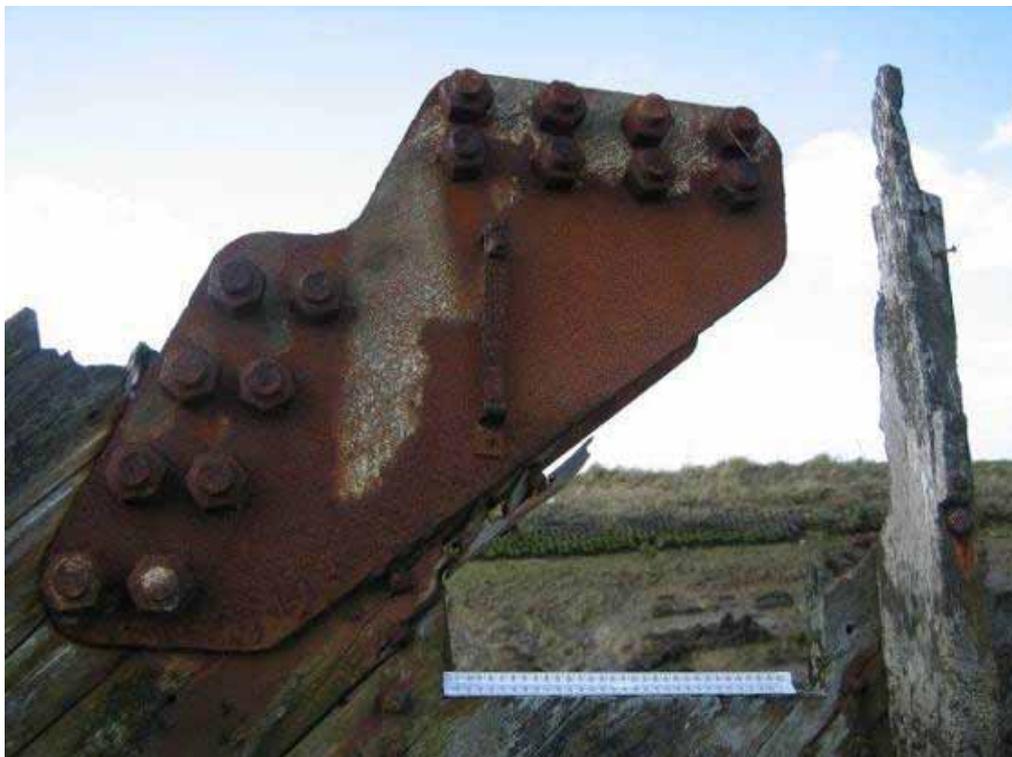
Figure HAM050- 10 Metal deck support located on the central bulkhead

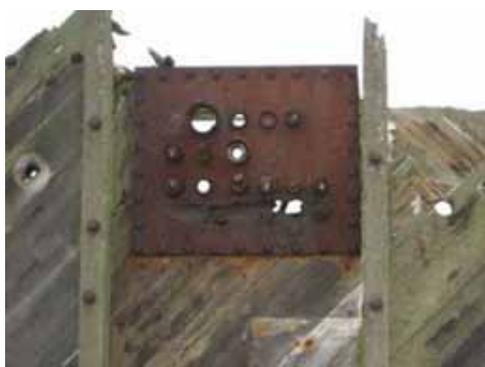
In the central bulkhead there is a circular hole, with rivet holes around it (Figure HAM050-11). A porthole may have been positioned here that would have enabled visual inspection of what may have been an engine bay. A rectangular section has been cut into the portside of the forward bulkhead. Rough cut marks and saw damage can be seen around this, which indicates that it is contemporaneous with salvage activity. On the uppermost part there is a metal plate with a number of circular holes of varying diameters. This is a conduit which would have enabled wires and pipes to pass through the bulkhead (Figure HAM050-12).

Figure HAM050- 12 Metal cable conduit

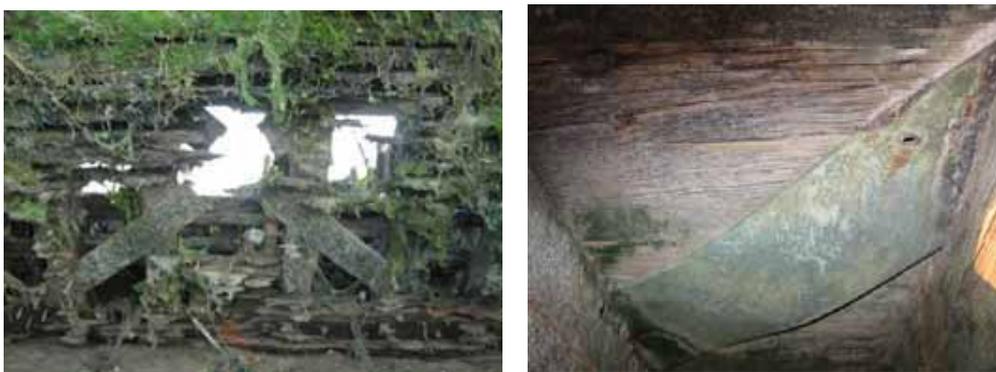
Around the vessel copper alloy strips have been inserted between the frames and the planking (Figure HAM050-13). These appear in a diagonal mesh pattern along the entire length of both sides of the hull. A number of insulated

Figure HAM050- 13 Two diagonal copper strips and a wider copper alloy plate all of which would have formed part of the vessel's degaussing system

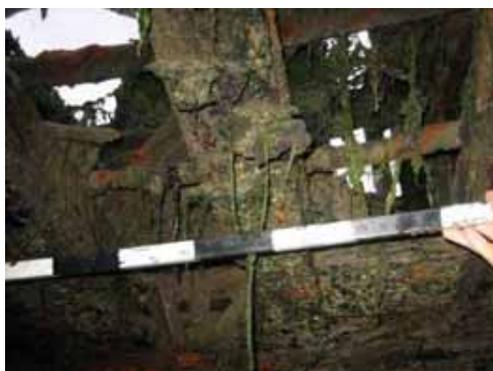
cables lie alongside the copper alloy plates. These run longitudinally around the length of the hull as two loops in parallel in the vicinity of the bilge keel (Figure HAM050-14). Pairs of identical cabling also run parallel to the frames across the hull at intervals of 5 frames (Figure HAM050-15). These cables create a web that was designed to balance out the effects of the vessel's power supply on its own magnetic field. The copper strips and insulated wire would have originally been part of the ship's degaussing system. Degaussing is a method of decreasing the magnetic signature of a vessel, thus reducing its vulnerability to magnetically initiated mines. Around the vessel's hull there are numerous saw marks where salvaging of the copper has taken place.

Figure HAM050- 14 Photograph showing the insulated wires in the vicinity of the bilge keel

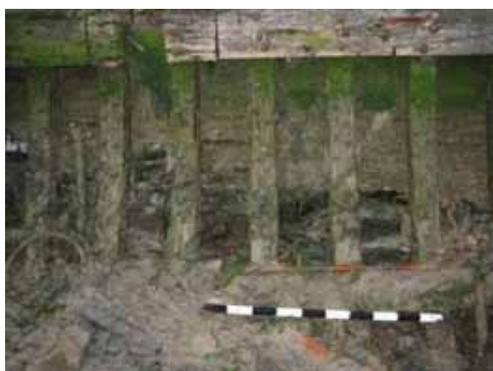
Figure HAM050- 15 Insulated wires was encountered every fifth frame

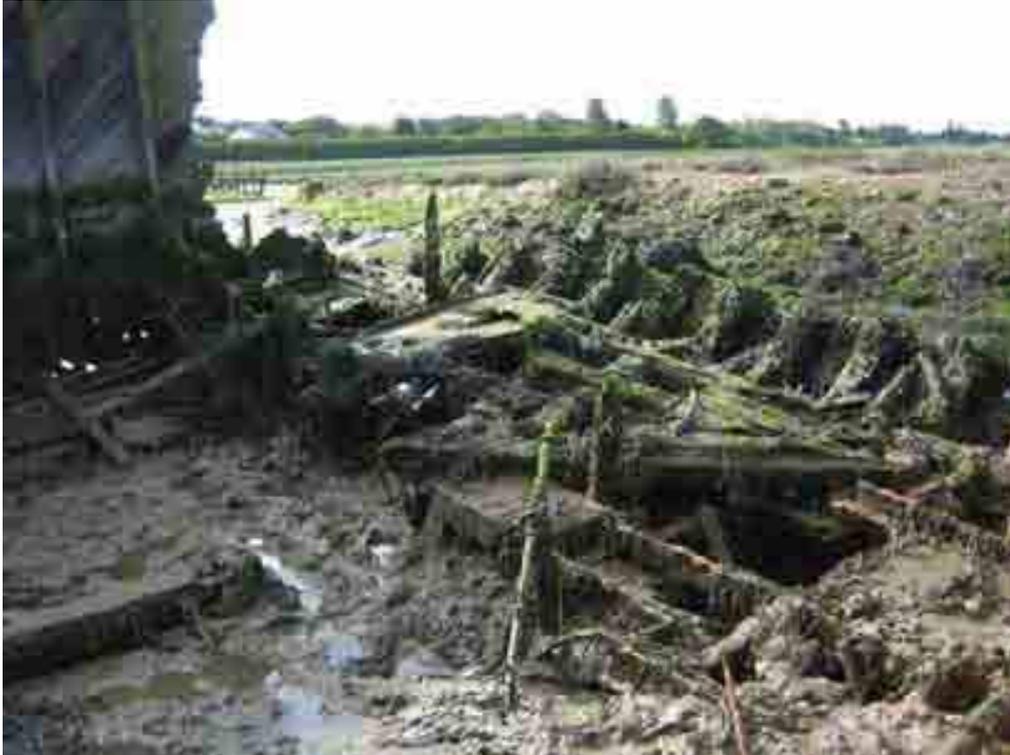
Further *in-situ* features include structural girders, metal components and a number of cylinders located along the interior of the starboard hull planking. These features may be evidence that this area was an engine room (Figure HAM050-16). Towards the stern on the port side there is a large wedge shaped metal tank (Figure HAM050-17). The tank would have been bolted to the hull, which has since collapsed due to the weight of the tank. A similar tank is located towards the south on the mudflats of bunny meadows (Figure HAM050-18). It is likely these originally formed a pair on either side of the hull at this point.

Figure HAM050- 16 A metal frame is located in the base of the vessel that indicates that this would have been the engine room

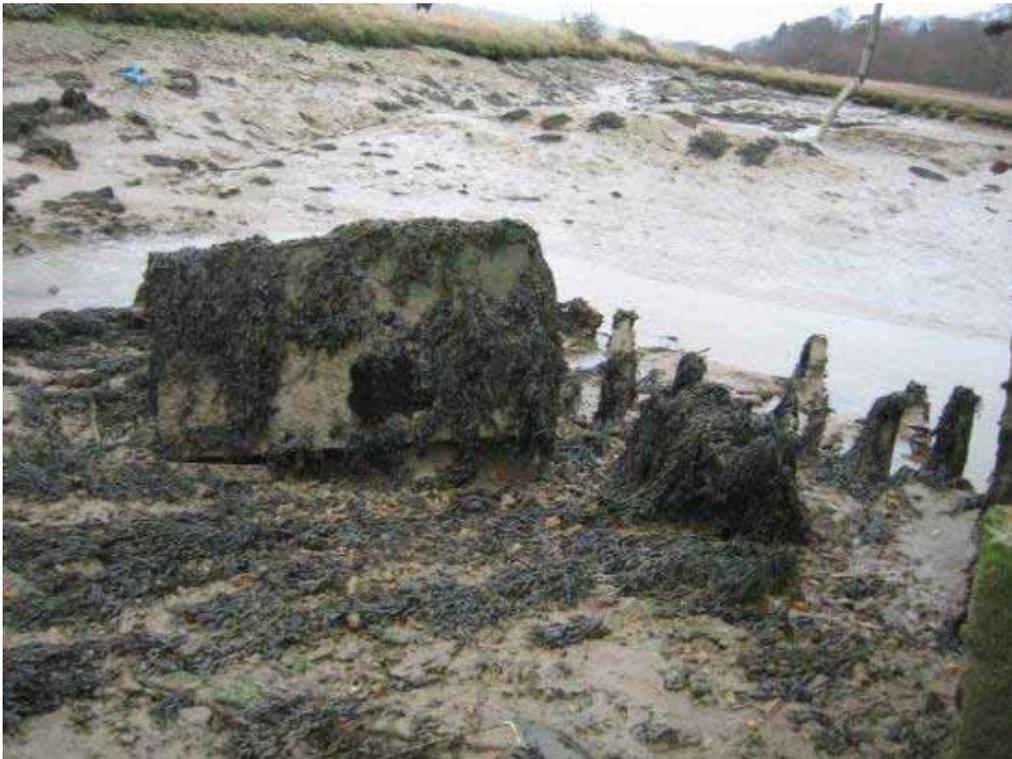
The total length of the surviving section of hull is approximately 13m, the breadth measured 6.9m at the forward bulkhead. The best preserved section of hull planking is located on the port side abutting the forward bulkhead. At this point the hull is buried to the level of the bilge keel (Figure HAM050-4). The height of the surviving planking was recorded at 1.5m from the bilge keel. The starboard side measured 1m from the bilge keel to the true keel, giving a total height of 2.5m. However, it is believed that a height of 2.5m would represent only approximately half of the original depth of hull as deckhead mounts can be seen (see below). The portside aft has collapsed under the weight of a steel tank that was originally bolted to the frames (Figure HAM050-17),

Figure HAM050- 17 A wedge shaped tank from the port side

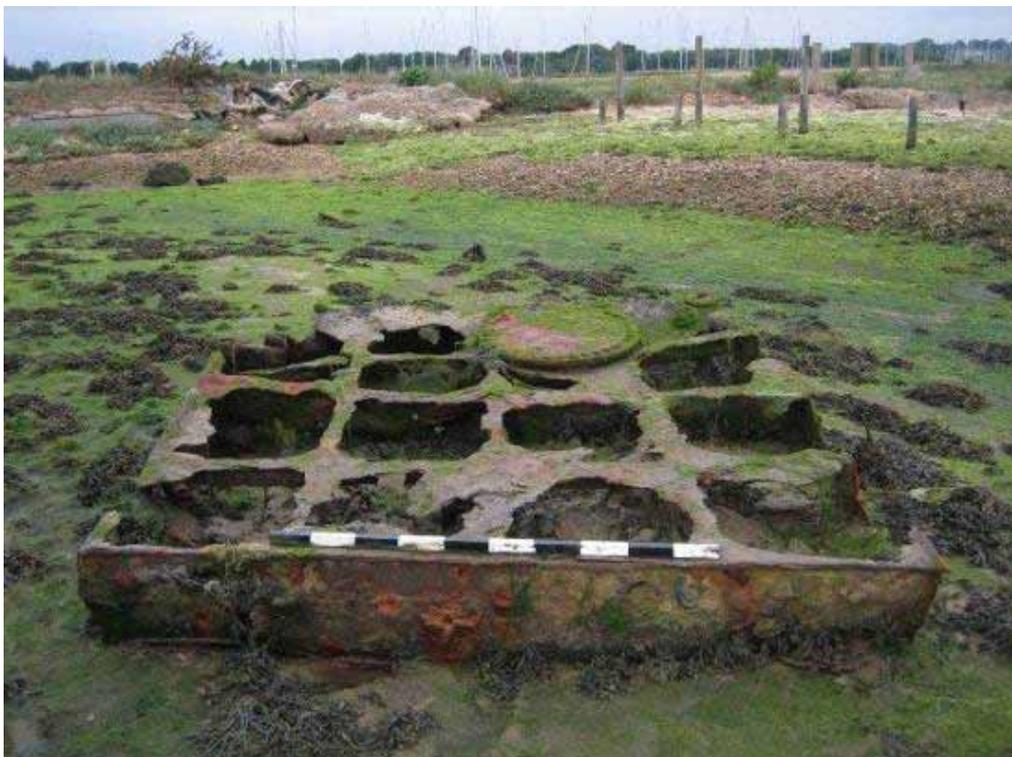
Figure HAM050- 18 The probable remains of the starboard tank that now lies a short distance from the vessel

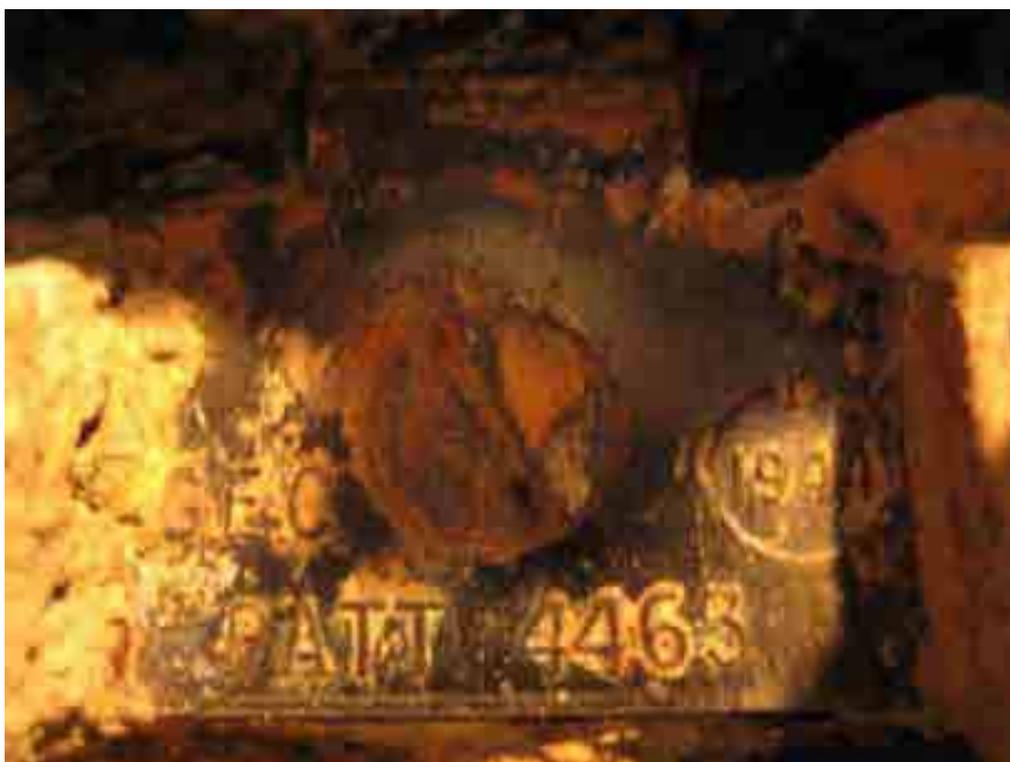
To the front of the aft bulkhead there is a small box with a wooden lid and rope handles, which appears to be *in-situ*. The majority of interior structures and components were found against the starboard side running between both bulkheads. Here lay an array of metal and wooden structures, including a hatch panel and various components associated with the engines. A bakelite component was found with the inscription G.E.C PATT 4463 '1944' (Figure HAM050-19). G.E.C. refers to the General Electric Company Ltd, which supplied electrical components to the Royal Navy during the war. The number 1944 may refer to the production date of this item. Despite finding a number of additional small components within the interior, some with serial numbers no further information about the identity of this vessel was found.

Figure HAM050- 19 A switch box with the date 1944

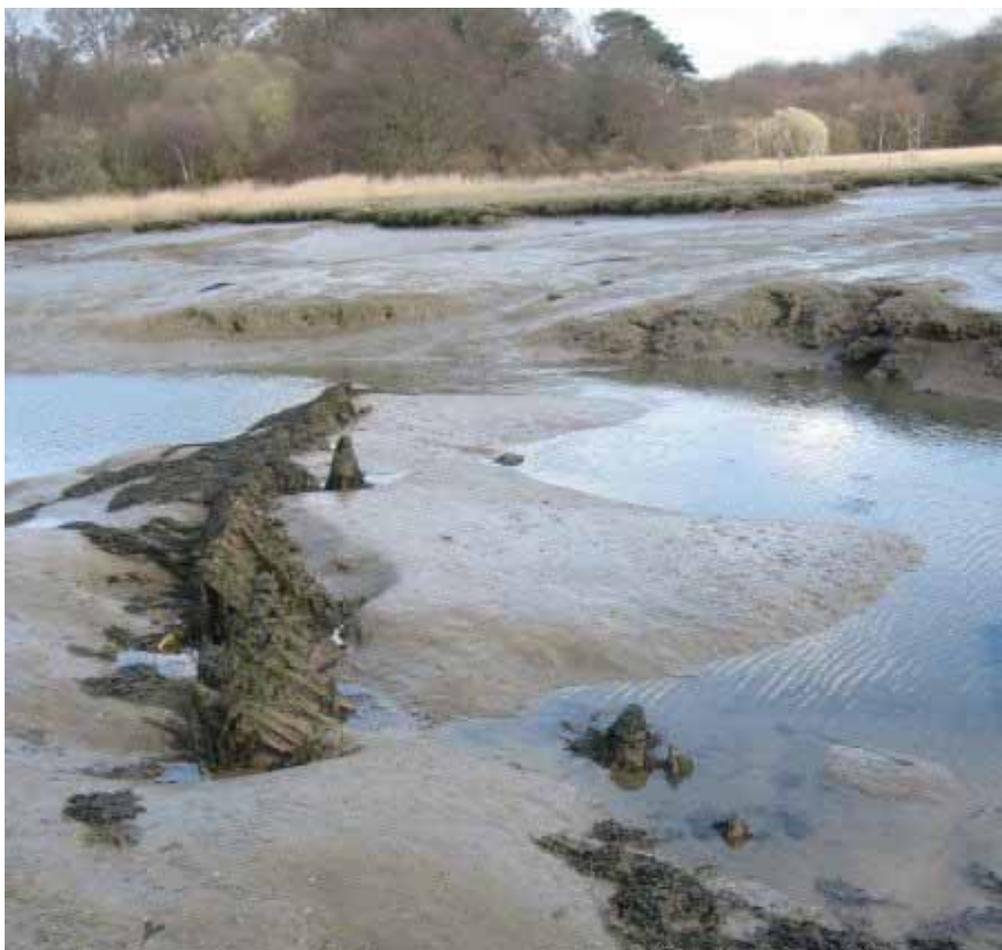
As mentioned above the hulk surveyed comprises of the central section of a vessel, the bows and stern of which have been sawn and removed. Further up the creek to the east there is a series of timbers, just visible above the current sediment level. The size of frames, frame spacing and method of construction, including at least one pair of insulated cables between frames, are identical to the main minesweeper hull surveyed. The location of this structure towards the forward end of the main hull and the pronounced curvature of the visible remains could represent the missing bow section of the vessel (Figures HAM050-21 and 22).

Figure HAM050- 21 A view taken from the west of the a series of timber frames that may be the remains of the bow section

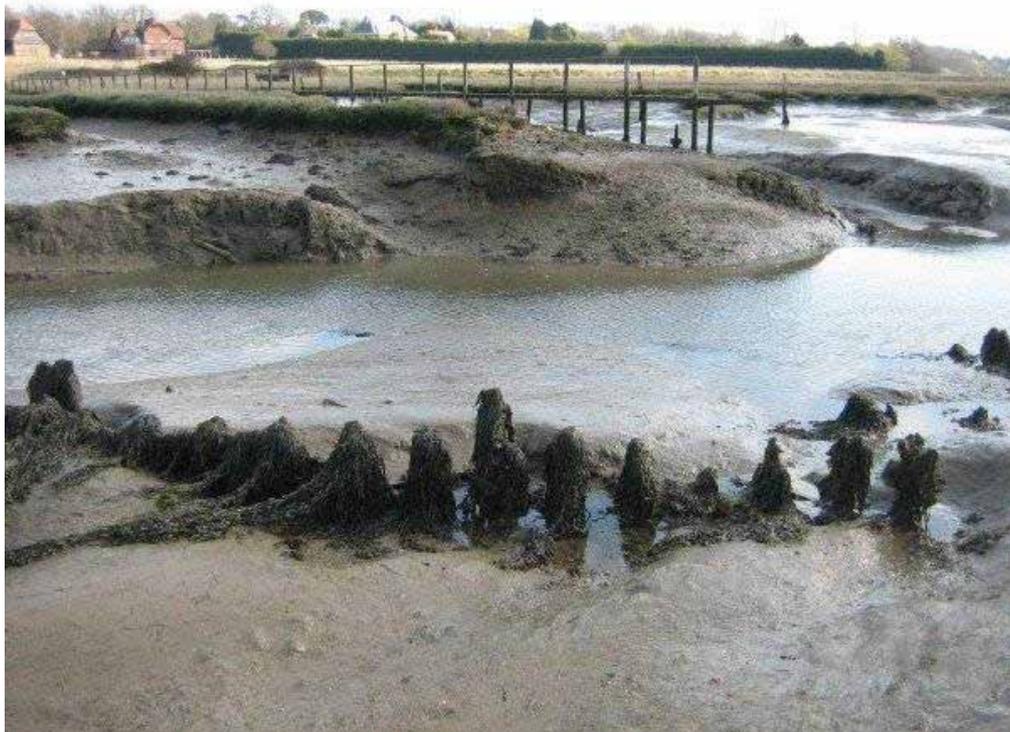
Figure HAM050- 22 The possible bow timbers viewed from the north

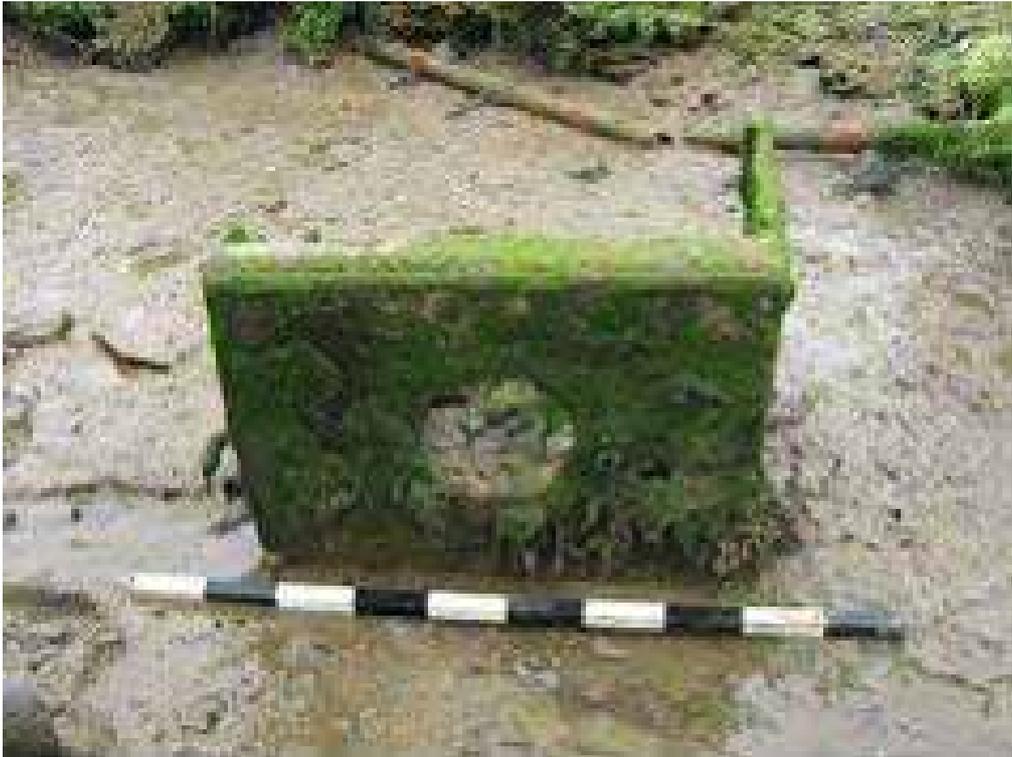
Figure HAM050- 23 Various unidentified structural components lie in a debris field around the vessel

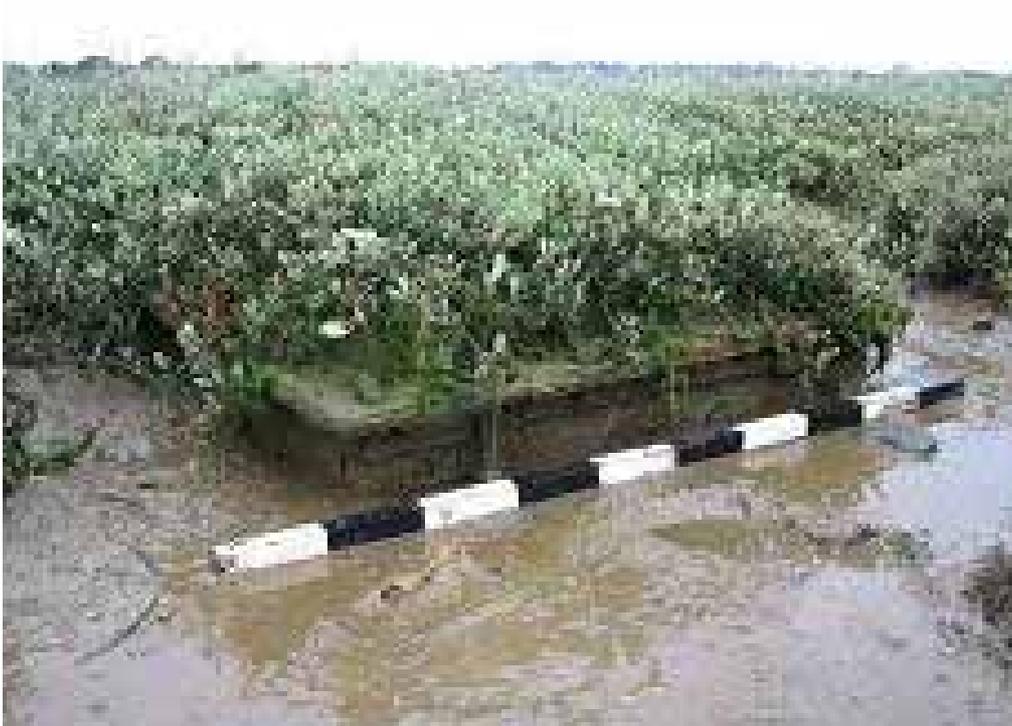
Figure HAM050- 24 There is a number unattached of structural components such as hatches in the area

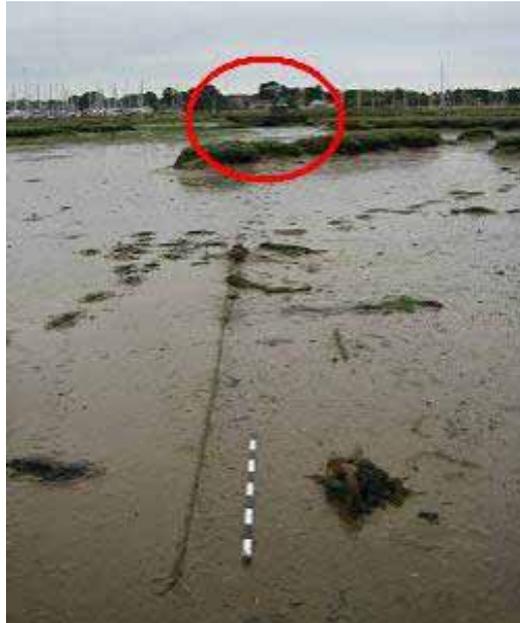
Figure HAM050- 25 The remains of HAM050 circled in red with a wire cable extending some distance into the mud

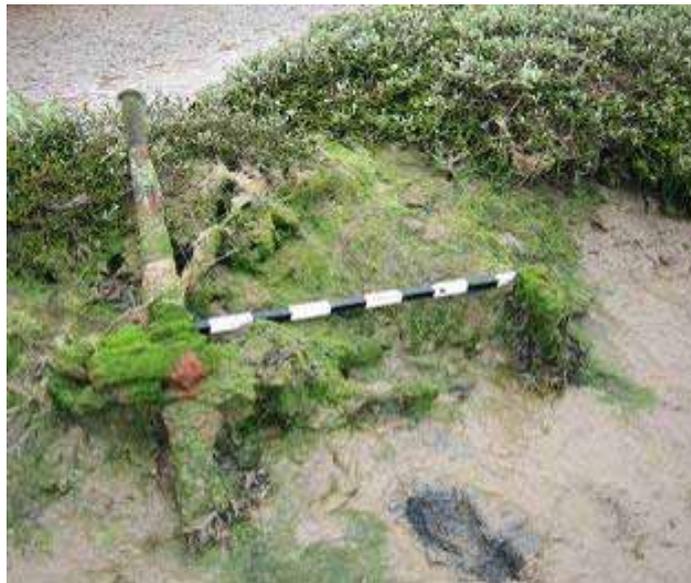
Figure HAM050- 26 An Admiralty style anchor

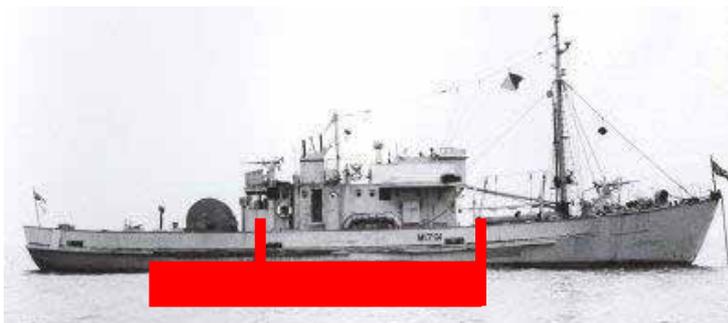
The MMS 1 series has a beam of 6.6m and is the closest match to the 6.8m beam measured on HAM050. The beam of HAM050 may have widened 0.2m as the hull collapsed. The beam measurements of the BYMS (7.6m) and 1001 class MMS 1001 (8.6m) are much wider than HAM050. This is further corroborated by the additional diagnostic measurements acquired from HAM050; the distance from keel to deck, height of surviving bulkheads, and distance between surviving bulkheads (Figures HAM050-27). As mentioned above, structural features located between the bulkheads of the hulk indicate that this area was probably an engine space (Melvin 1992). On the drawing of the 105 MMS the distance between the forward and aft engine room bulkheads matches the surveyed distance of HAM050. Directly above these bulkheads on the 105 MMS the superstructure was located (*Ibid*). Extra structural strength would be required at this location, and this would explain the large diagonal beams that have the substantial metal fastenings (Figure HAM050-10) at the top that are currently present on HAM050.

Figure HAM050- 27 Image of a MMS 1 Series with the location of the remains of HAM050 indicated in red (Courtesy MPL Photograph)

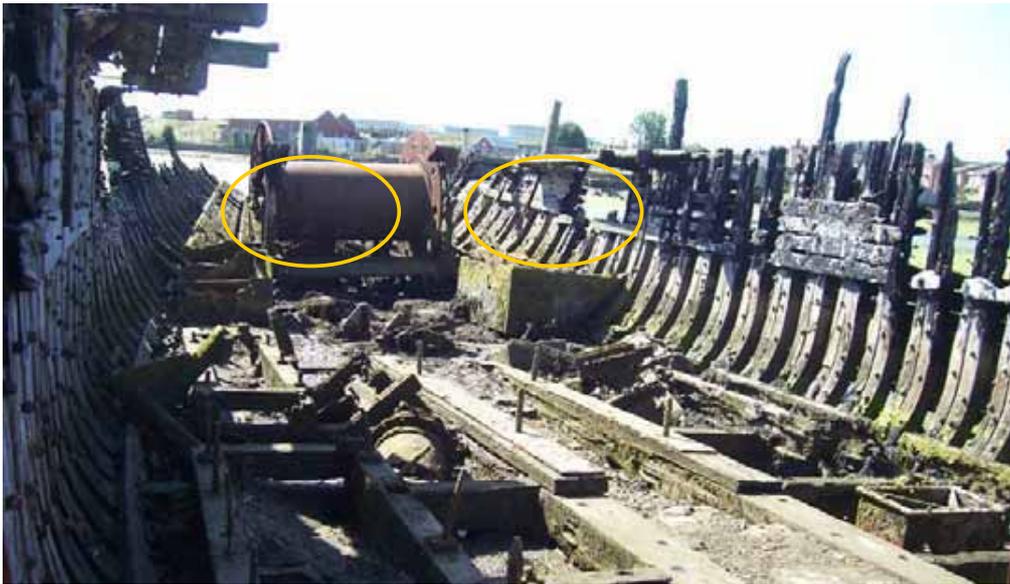
Figure HAM050- 29 Two metal tanks can be seen within the hull of MMS 293 that are similar in appearance to the one found *in-situ* on the port side of HAM050

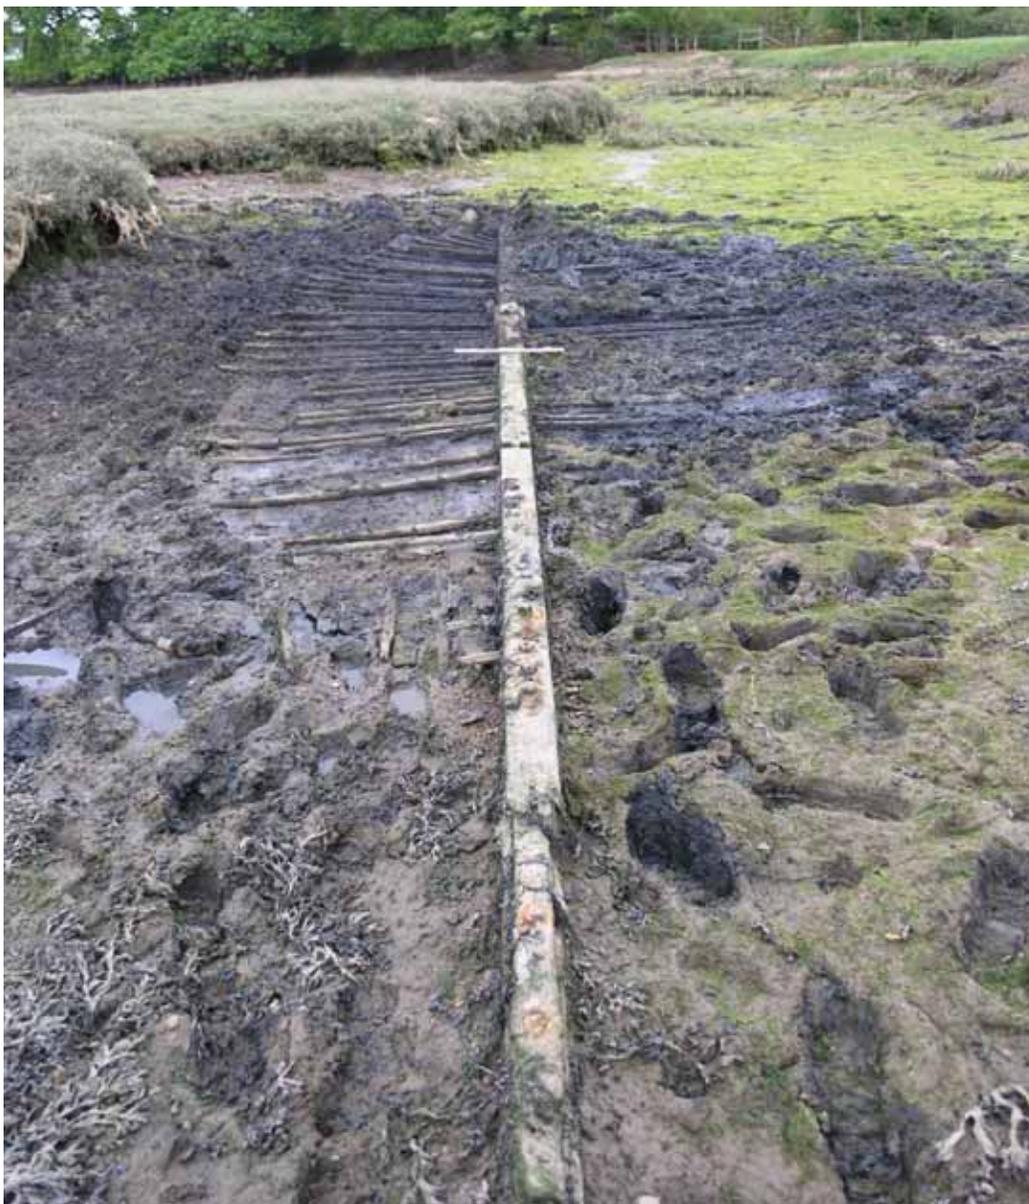
On the eastern bank of the Hamble River, near to the Protected Historic Wreck Site of the *Grace Dieu* lie the remains of a small boat. This is between the shore and a small 40m long island. The tidal island contains building debris, glass and pottery, so may be of human construction. HAM052 is partially buried beneath the tidal sediments. The vessel has its bow pointing towards the west (Figure HAM052-1).

Figure HAM052- 1 The remains of a small clinker boat near Grace Dieu Corner (looking east)

This boat has been comprehensively surveyed and at present does not warrant any further survey. As this vessel is considered to be of low archaeological significance archaeological survey to monitor its condition is not recommended. However, it is suggested that periodic visits and the taking of photographs may be useful for analysing the rate of decay of the vessel and the erosion of the riverbank in this area.

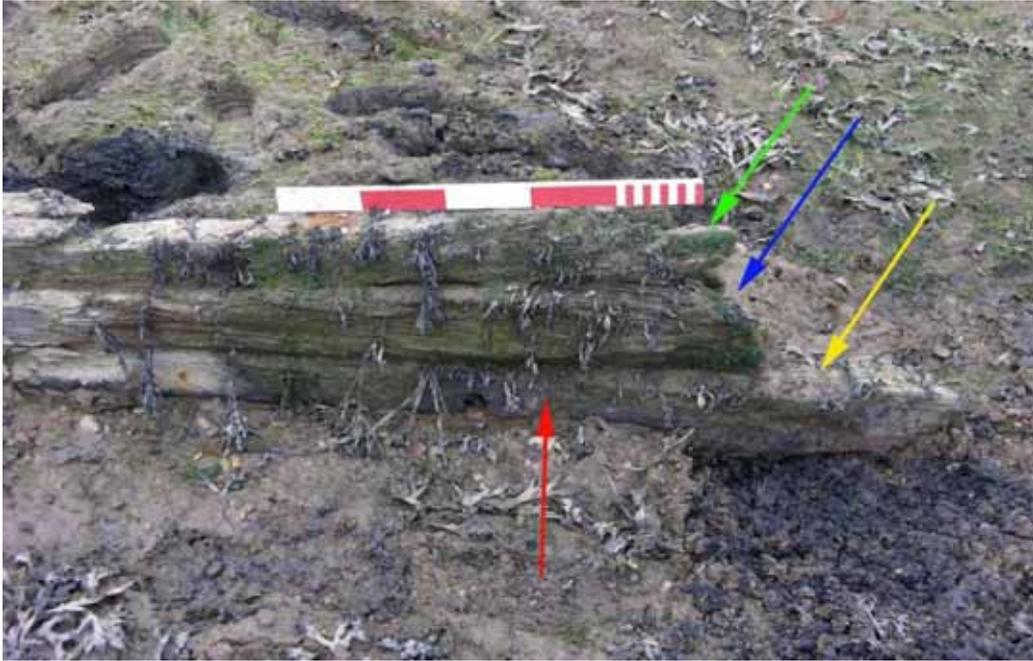
Remains of a small boat of clinker construction; the planks are fastened with copper rove nails. Other fastenings were encountered, such as brass screws but it is not certain whether these are associated with the original vessel. The vessel's remains measure 10.24m long by 2.95m wide. The bows of the vessel are exposed from sediments (Figure HAM052-4). A keel and associated composite keelson is present. Above the keelson there is a rider

Figure HAM052- 4 The bows of HAM052, with the keel (red arrow), the keelson (blue arrow), the keelson rider (green arrow) and the stempost step (yellow arrow) indicated (looking south)
