3.7.3. Site Description

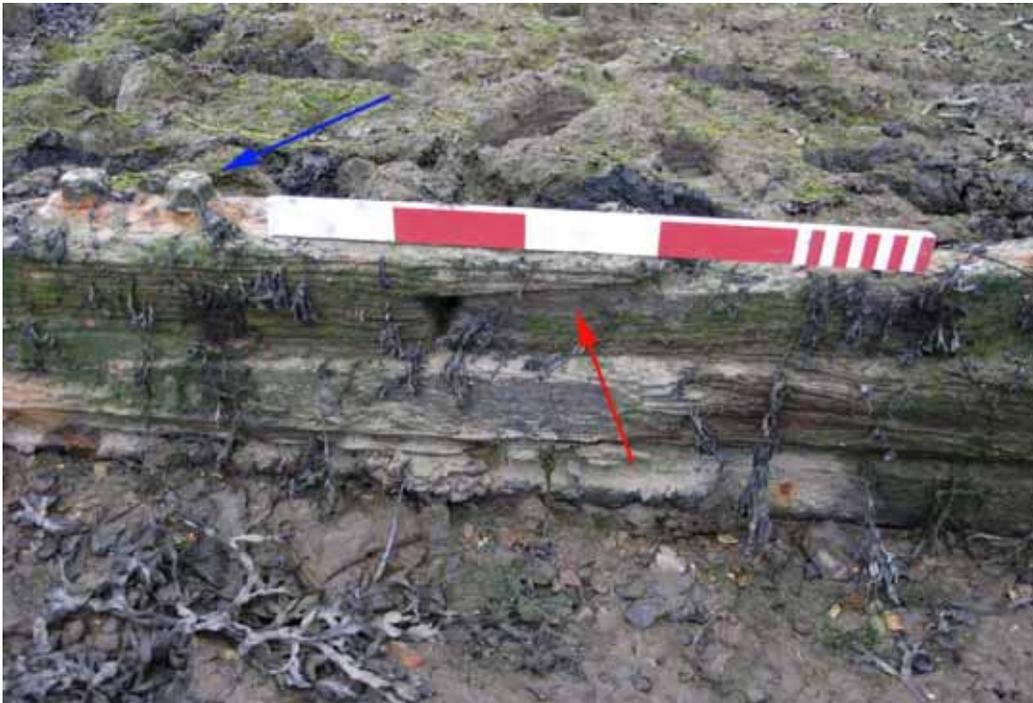
keelson. These three timber elements are fastened together by metal threaded bolts (Figure HAM052-5). The keelson rider has a scarf joint towards the bows (Figure HAM052-5).

Figure HAM052- 5 The scarf joint of the keelson rider aft of the bows (red arrow) and two bolts (blue arrow) that fasten the rider, the keelson and the keel together (looking south)

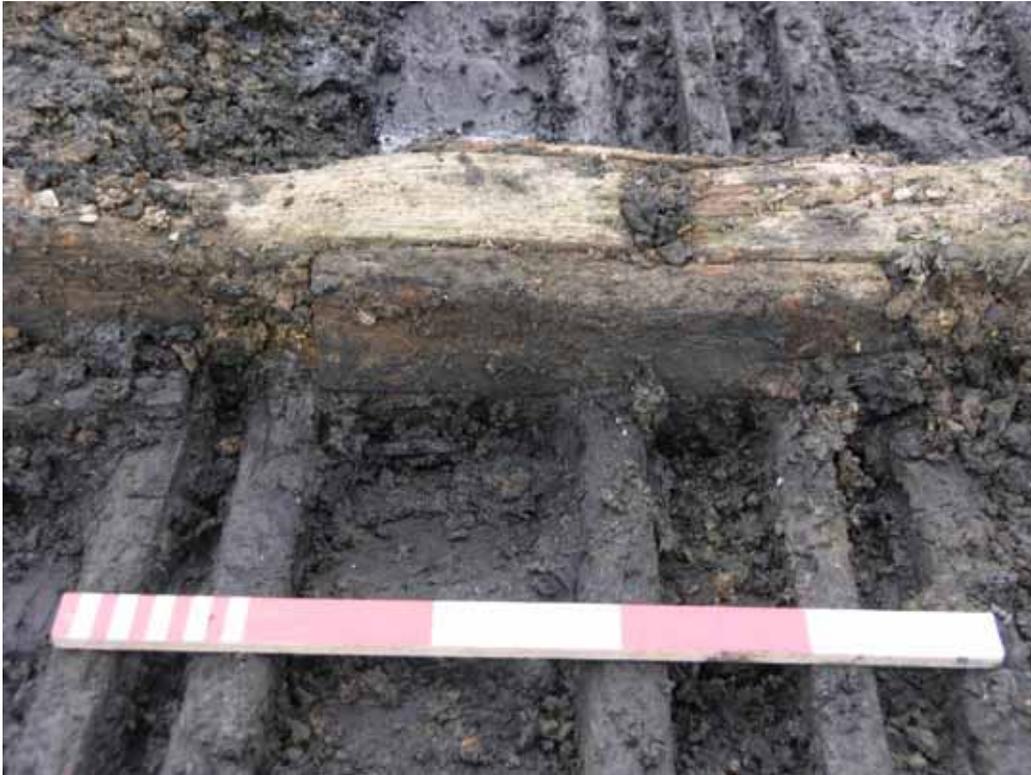
Amidships there is a scarf joint in the keelson, which has been strengthened with additional butt-straps (Figure HAM052-6). Most of the ribs remain and towards the bows there are stringers. The ribs are positioned in groups of three; each rib is 0.04m wide (Figure HAM052-7). The spacing between the first rib and the second is 0.05cm, and is 0.08cm between the second and the third. The spacing between each group is about 0.20m. There are larger transverse timbers in the bottom of the hull located in the final third of the vessel (Figure HAM052-8). These are the remains of floor timbers and would have given additional strength to the hull, these are 0.08m wide.

Figure HAM052- 6 The scarf joint in the keelson amidships, with butt-straps supports (looking south)

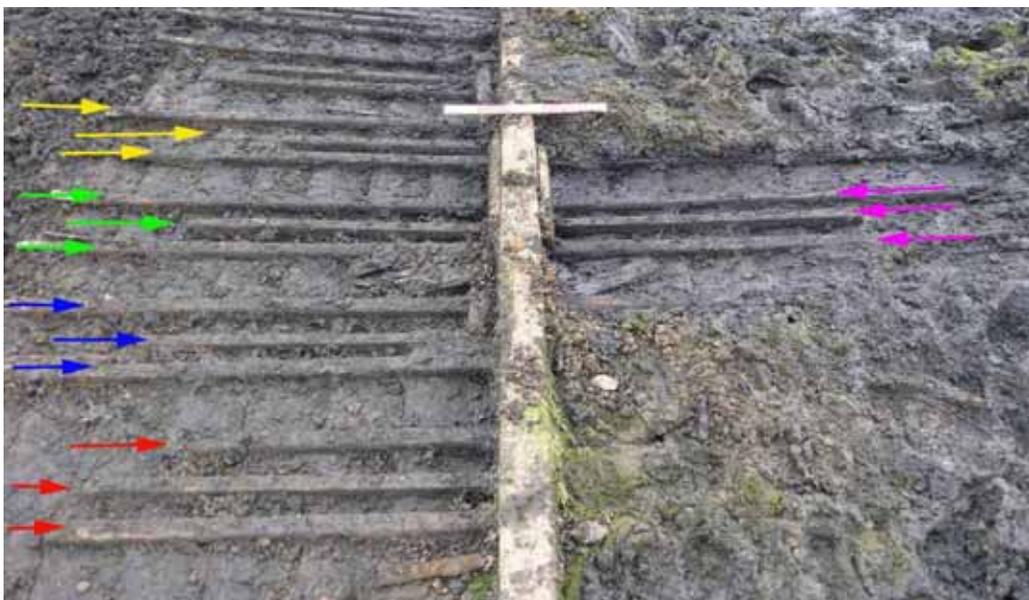
Figure HAM052- 7 An image showing the rib spacing. Arrow colours indicate groups of three (looking east)

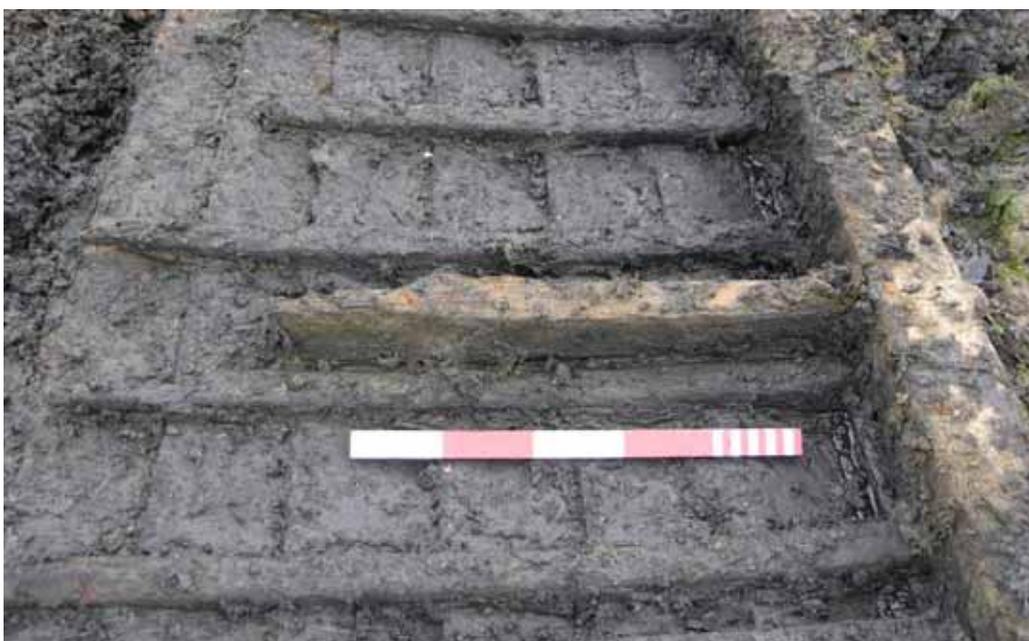
Figure HAM052- 8 A floor timber located on the starboard side towards the aft of the vessel (looking east)

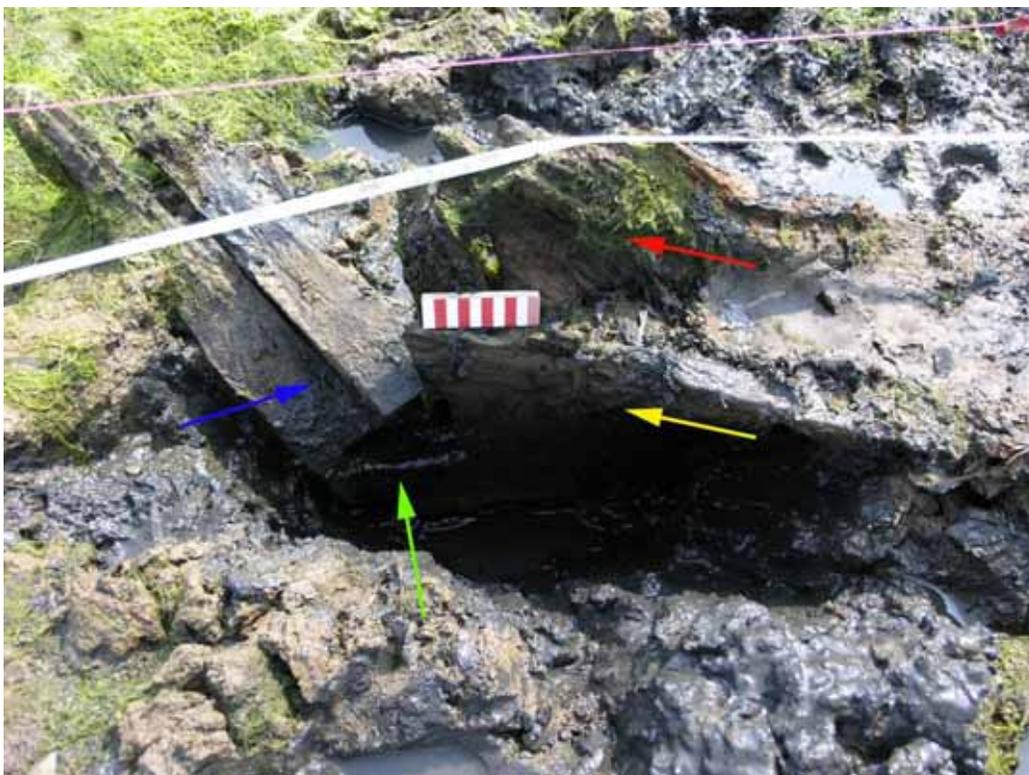
The stern section and rudder step remains, with a section of collapsed but articulated rudder present (Figure HAM052-9). At the stern, the run of planks are rebated into the sternpost. The stern is buried deep within the mud. In the vicinity of the stern a hard thick layer of pitch was encountered. This may be the caulking (waterproofing), but it is not certain if this is original or a later addition. In the bilges of the stern there are two large timbers, one on the port and one on the starboard (Figure HAM052-3). These are 0.58m long by 0.18m wide; it is probable that these are the mountings for a small engine.

Figure HAM052- 9 Starboard view of the stern, with the sternpost (red arrow), rudder (blue arrow), rudder step (green arrow) and planks (yellow arrow) indicated (looking south)

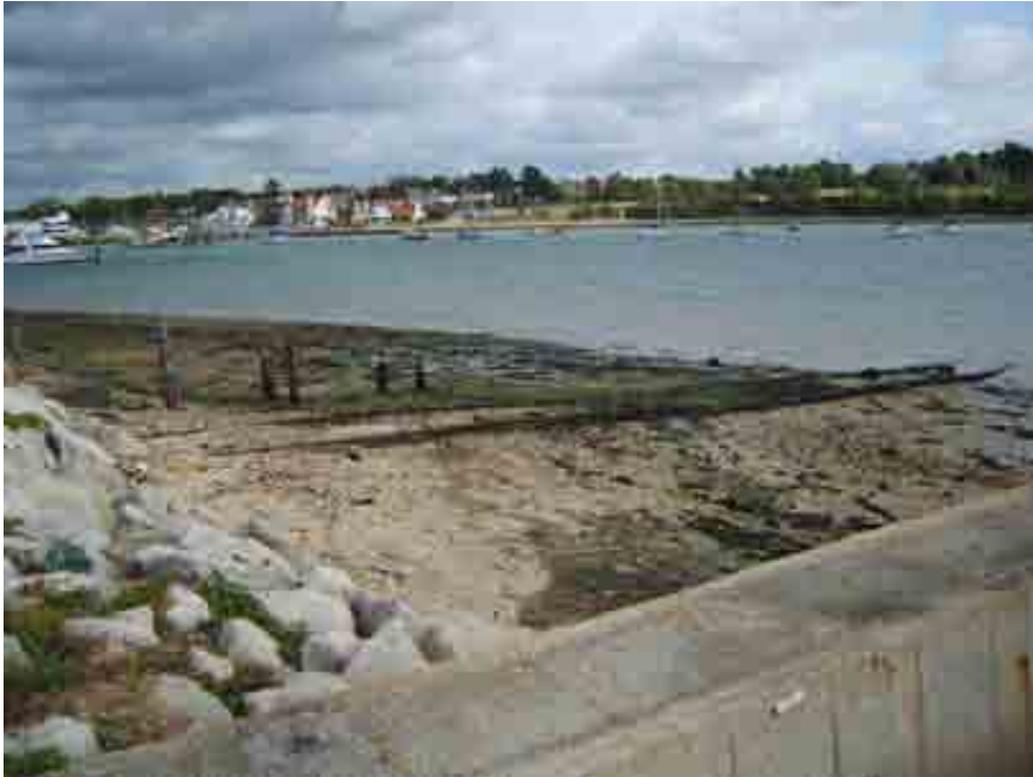
About 75m to the south the second slipway can be found (Figure HAM054-2). This feature comprises of two parallel metal rails, laid upon concrete foundations. It is approximately 45m long by 2m wide, and has a west – northwest by east-southeast orientation. The rails run from the low water mark to the shore, and at this point they are buried beneath the large rocks of the seawall. The metal rails are highly corroded, and have broken from their foundations in sections. To the north there is a series of parallel posts that appear to be the remains of a wooden jetty. To the south there is a concrete mole, which may be a drain.

Figure HAM054- 2 The southern slip comprises of two metal rails, post remains from a jetty can be seen at the top of the image, while the concrete drain can be seen in the foreground

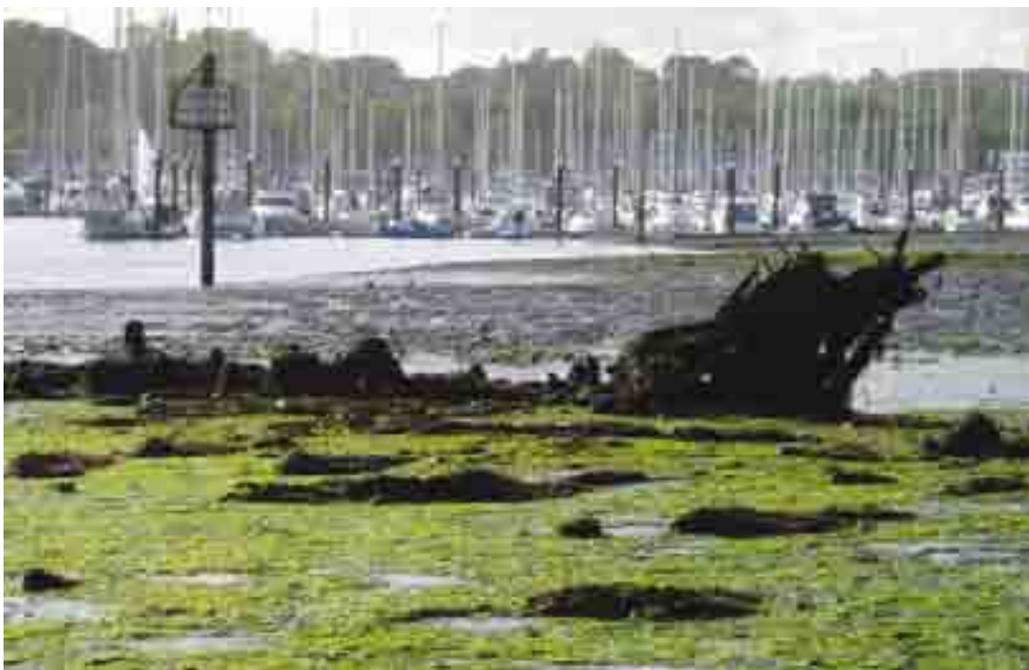
On the eastern bank of the Hamble River, between Lower Swanick and Brooklands where the river bends, there are the remains of a predominately wooden vessel. This vessel is well known by local residents, and was a former yacht converted to a houseboat called the *Norseman* (Figure HAM064-1). The hulk lies about 70m from the shore, in an area of thick sediments that deepen towards the stern.

Figure HAM064- 1 The remains of the Norseman looking northwest, with Moody's Marine in the background (photo K. Clark)

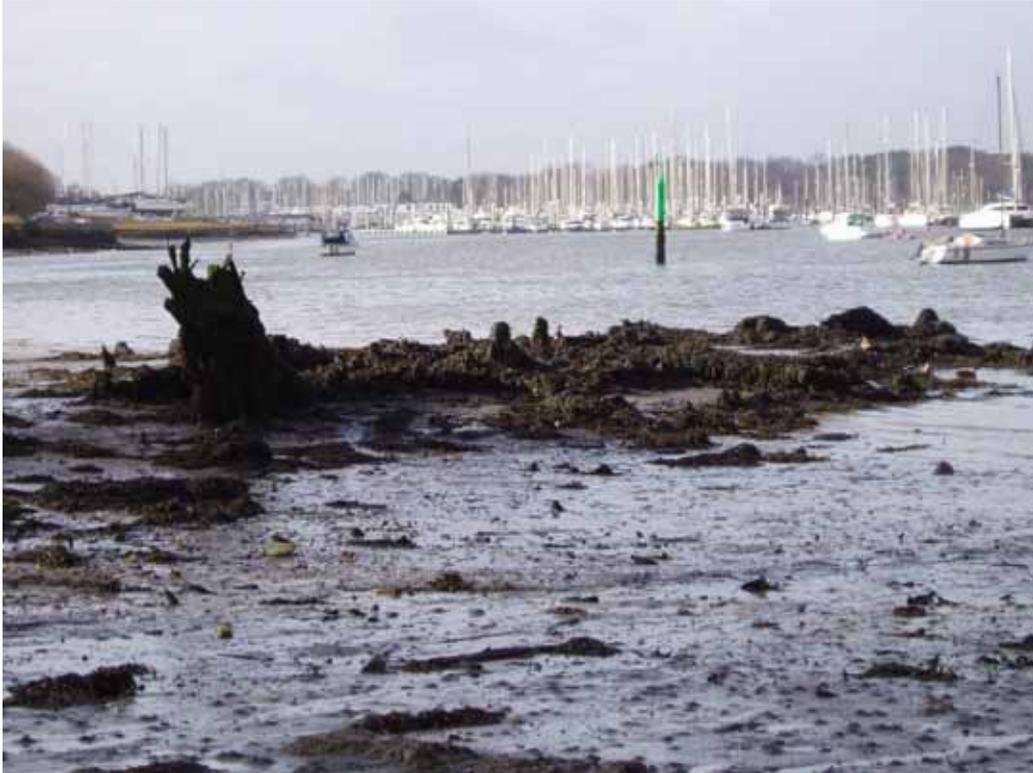
Little of the vessel remains exposed from the sediments, except for the stempost (Figure HAM064-2). The stempost protrudes from the mud to a height of 1.86m, while the rest of the remaining hull rises to a maximum height of 0.30m. The outline of the hull is visible, which is of carvel construction. Visual inspection of the timbers shows evidence of burning.

Figure HAM064- 2 Looking southwest it can be seen that very little of the vessel structure is visible, except for the stempost seen on the left of the photograph (photo K.Clark)

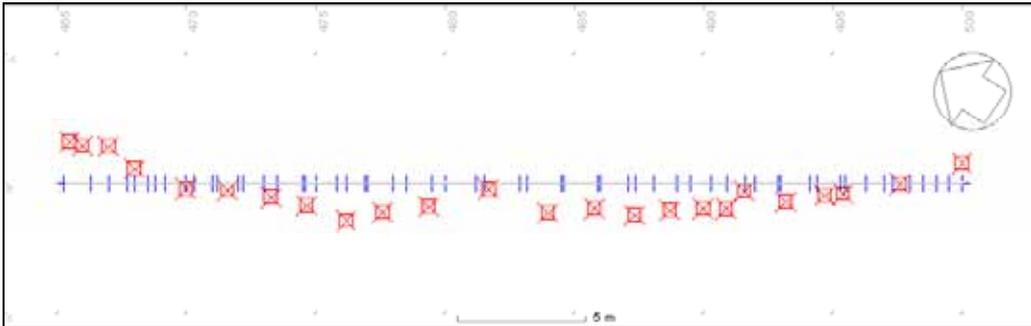
Figure HAM064- 4 An indication of the elevations of the structural remains from the relative base line in blue (Courtesy of K. Clark)

To obtain a profile of the base of the hull, the sediments within the vessel were probed with a cane and subsequent measurements were taken from a spirit levelled line. It was then possible to create a relative longitudinal profile. There were many obstructions beneath the sediment that prevented an accurate hull curve. However, an indication of structural shape was acquired. Currently, the majority of the hull is beneath the sediments, and a maximum depth of 1.45m was encountered. Research has shown that the *Norseman's* original hold had a depth 3.5m, estimating that around 40% of the original hull lies beneath the sediments (Record of American and Foreign Shipping, 1883).

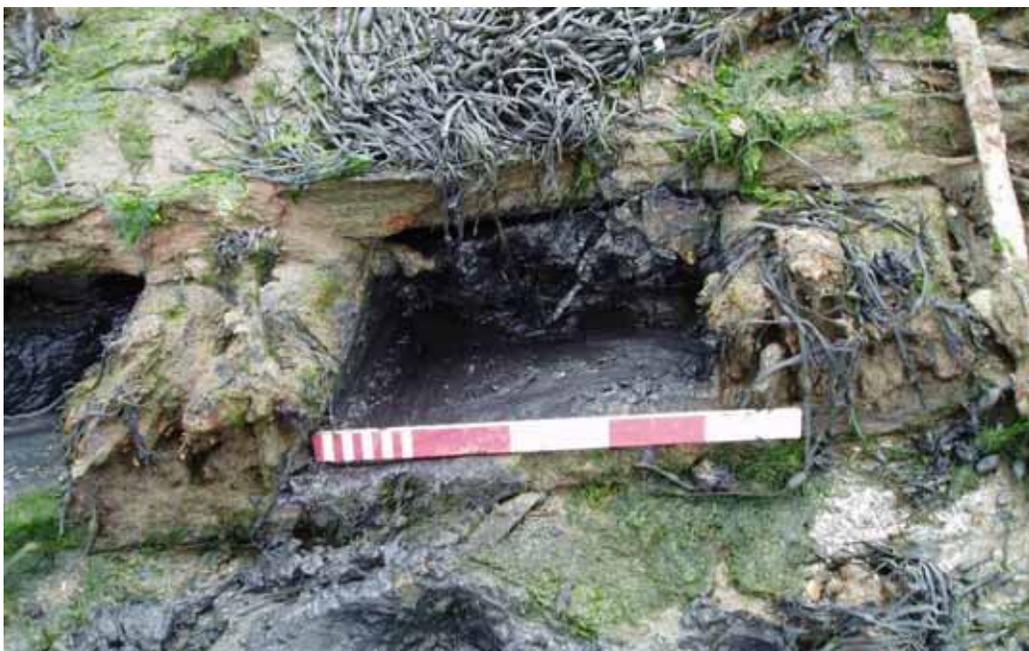
Figure HAM064- 5 Sediment was removed from two frames so that measurements could be collected (photo K.Clark)

There were a number of exposed frames remaining, with both outer and ceiling planking attached. To obtain diagnostic measurements of the frame timbers a small area of sediment had to be removed (Figure Ham064-5). This allowed the dimensions of the frame size and planking thickness to be collected. The frames were approximately 0.15m x 0.22m, while the outer planks had a thickness of 0.06m and the ceiling planking was 0.08m (Figure HAM064-6).

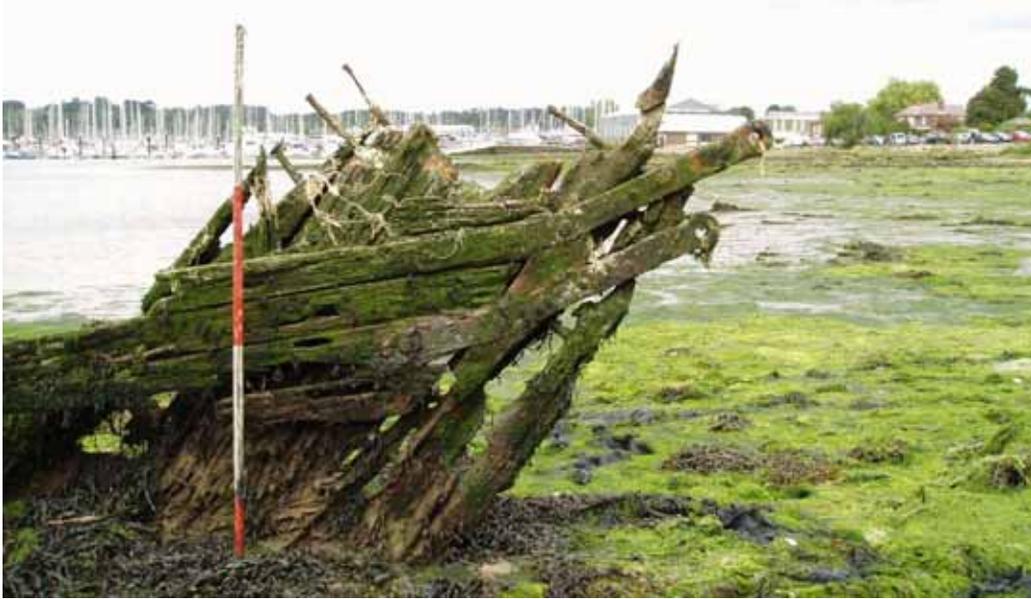
Figure HAM064- 7 Starboard view of the stempost with the bobstay supports clearly visible (photo K. Clark)

Even though a significant number of metal artefacts were found within the hulk of the *Norseman*, the engine was not present. A large tank was encountered, but it is not certain if this was for water, fuel or waste. At the stempost, there are two metal strip bars, with bolt fastenings. These were interpreted as being where the bobstay would have been attached (Figure HAM064-7). A large number of metal construction elements were found throughout the hulk, including bolts, metal spikes, eyes and ringbolts. Many of these objects are still *in-situ* and can be seen attached to the original timber elements, including a collapsed hanging knee that still had iron bolts attached (Figure HAM064-8). For diagnostic and recording purposes, a selection of copper alloy artefacts

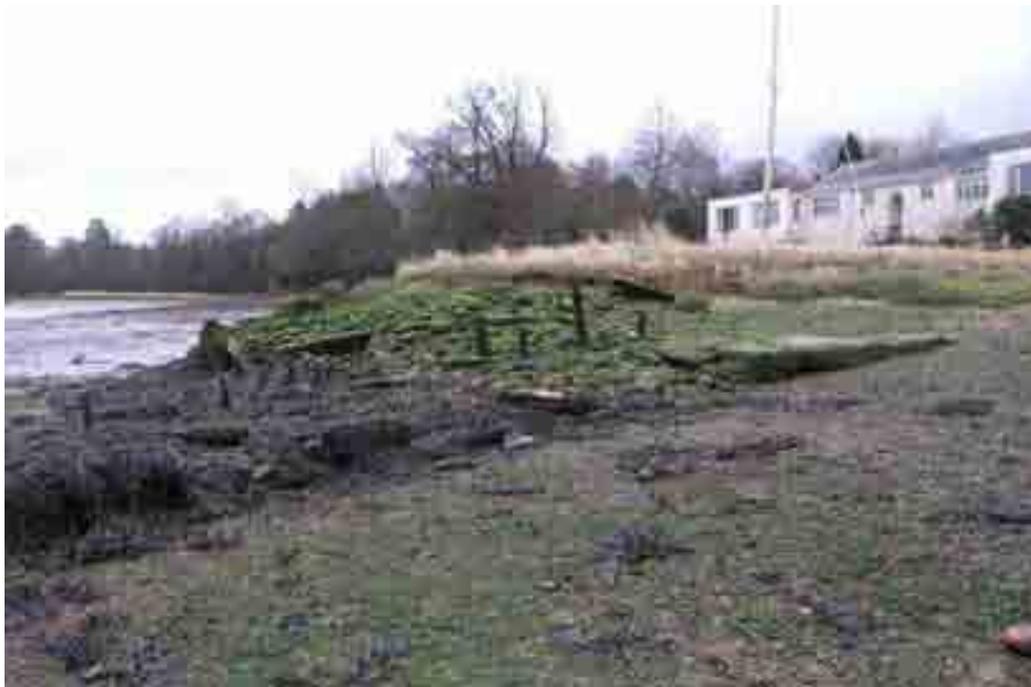
At the northeast corner of the site there was a small pleasure yacht that had been hauled up onto stocks and has been positioned at the high water mark, probably for maintenance purposes. The vessel position appears to be in the natural inter-tidal zone, although there is a large amount of building debris in this area. The yacht has been positioned parallel to an outcrop of land. This outcrop has been constructed from building debris (Figure HAM066-2). It is approximately 20m long, is rectilinear in shape and has some evidence of revetment.

Figure HAM066- 2 From this image it is possible to see that the northeastern promontory has been constructed from building debris

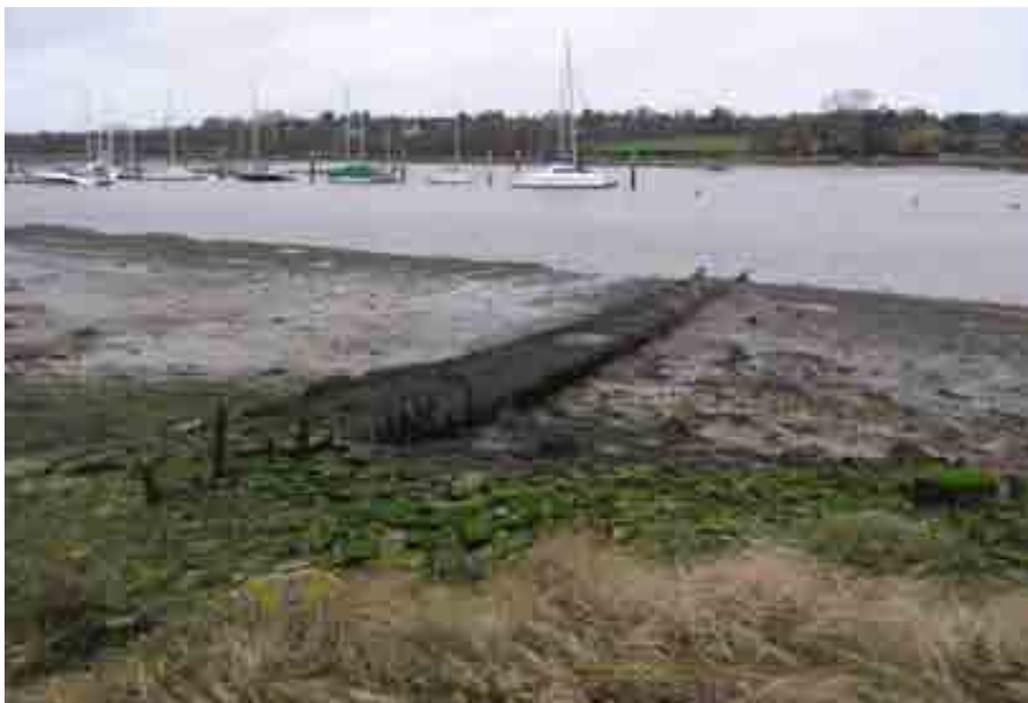
At the northwest tip of the promontory, there is the remains of a structure that may have been a slipway or jetty (Figure HAM066-3). This extends

approximately 60m into the river channel. This structure has been built from timber and concrete, and comprises of two parallel rows with a hard central surface area. The feature is in a poor condition and does not appear to have been used for a long time.

Figure HAM066- 3 Photograph taken from the north-eastern promontory of the possible slip or jetty

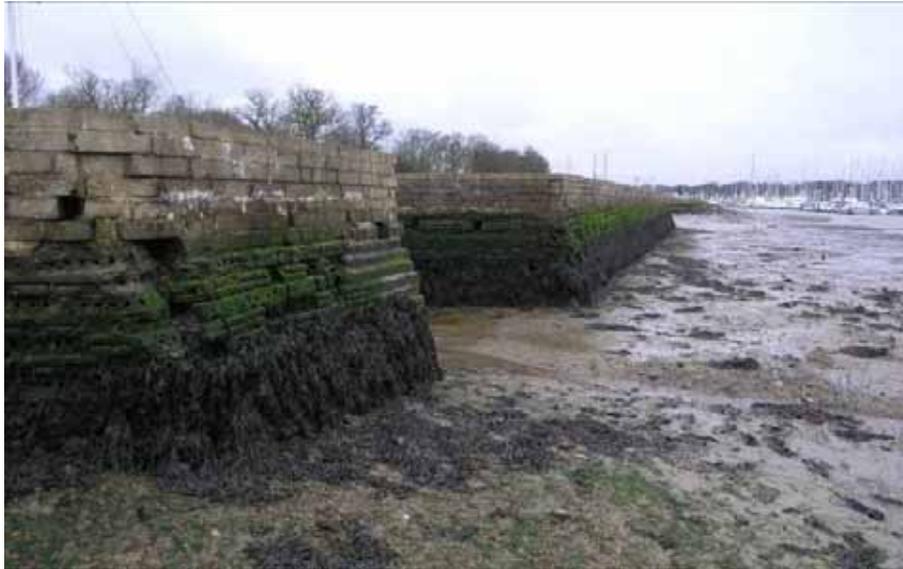
The slipway is positioned at a point where the promontory dips towards the shore, before returning and extending again towards the river. From this point the land is enclosed behind a tall dock wall made up of concrete blocks (Figure HAM066-4). This dock wall is straight and rectilinear, with acute angled corners and surrounding a grassed area that is well mown. Parallel to the river the wall stretches for about 60m, and extends 20m from the shore. Analysis of the materials indicates two phases of construction. Most of the lower half of the wall is made up of a type of brick (first phase), while the upper sections consist of larger concrete blocks (second phase). The area encompassed within the wall looks as if it is not natural and has been built up. About 5m from the northeast corner of this wall there is a recess that forms a single boat berth, measuring about 15m long by 6m wide. At the mouth of this berth the area is covered with tidal-silts, however in sections this is missing exposing a hard compact surface. This is probably the remains of an associated slipway.

Figure HAM066- 4 The entrance to the boat berth in the dock wall, the changes between the construction materials are demarcated by the algae growth

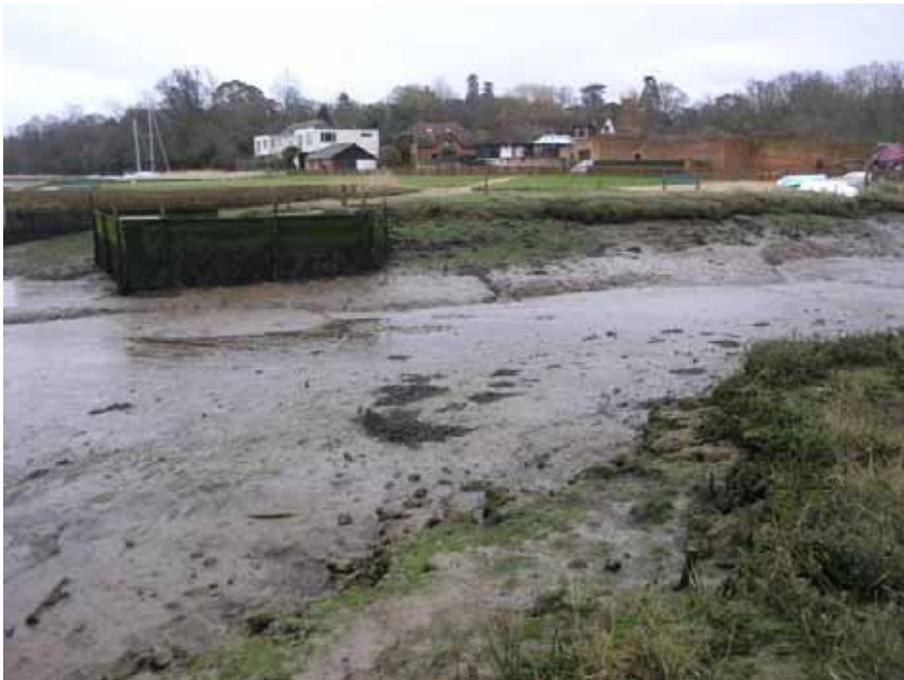
Parallel to the dock wall, on its southwest side, there is a slipway that runs in a northwest – southeast orientation (Figure HAM066-5). The slipway is made of concrete and about 7m wide. Towards the southwest side of Brooklands Farm there is a road with a gate. During the visit there were a number of small boats parked in a hard standing area, which suggests that this slip is still in use. At the southwest end of the slip, there is another small promontory. Two sides of this promontory are boxed behind timber revetment (Figure HAM066-5). This feature lies at the mouth of the creek.

Figure HAM066- 5 The entrance to the creek, with the southwest slip behind the boxed promontory

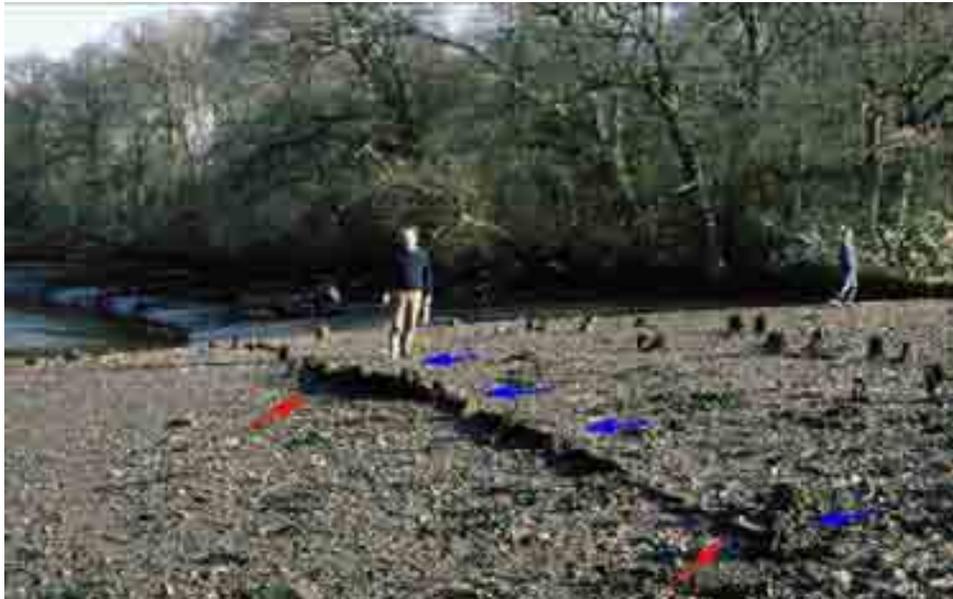
The quay structure covers an area of 20.6m (east-west) by 15.4m (north south). Within this area there are three types of timber element; posts, revetment and diagonal bracing struts. Revetment is visible in two areas of the structure. On the offshore-side the revetment runs east-west for the total length the quay (Figure HAM076-3). The second run of revetment is located at

Figure HAM076- 3 The east-west revetment (red arrows), with some of the revetment posts (blue arrows) indicated (looking southeast)

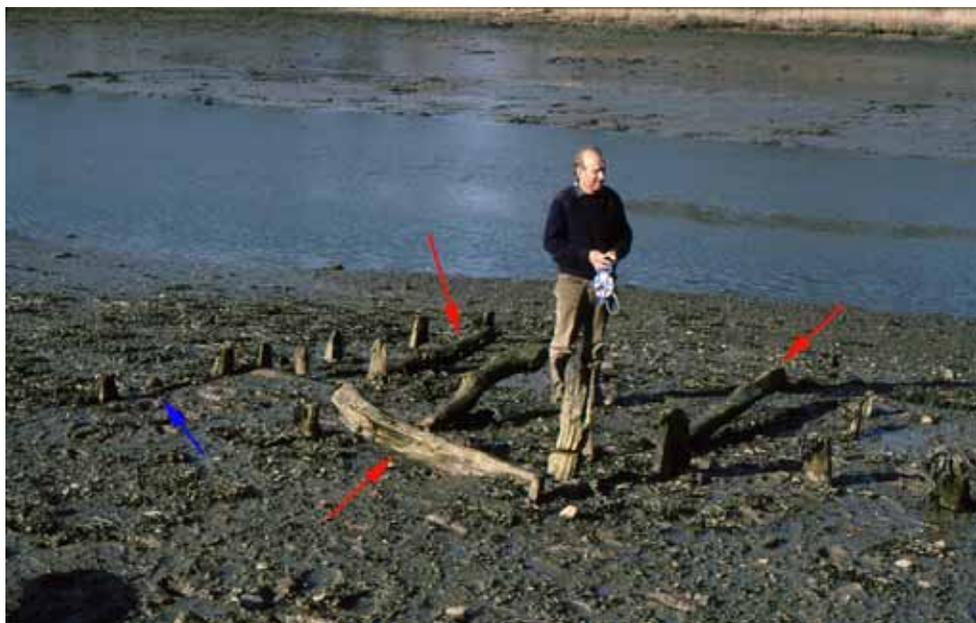
the western edge of the site, and runs in a north-south orientation. Here the revetment is 10.46m long (Figure HAM076-4). Originally this would have been longer (up to 15.4m), but some of the revetment planks are missing. The true length is marked by revetment posts. The revetment structure of both areas is similar. It comprises of sections of planks lying horizontal on their side. On average they have a width of 0.06m, but are of varying lengths. These planks are held in position by posts (Figure HAM076-3). The posts have varying sizes, up to 0.12m in width. The variation in sizes appears to be a feature of the original posts.

To the east of the north-south revetment are nine diagonal bracing struts. These are the most substantial timbers to remain. These would have supported the quays decking. Their appearance shows that little work has been done to them and they are crudely fashioned. They have been sawn at the uppermost end to receive the deck planking, and reduced to a point at the other so they could be driven into the ground. Along their length they have not been faced, and in sections show the natural shape. The struts are of varying sizes the largest being 2.3m long by 0.2m wide, and the smallest being 0.75m by 0.16m. The largest of the struts are positioned towards the northwest side of the structure.

Figure HAM076- 4 On the west side of the site lies the second run of revetment (blue arrow), besides this is an area of bracing struts (red arrows) (looking northwest)

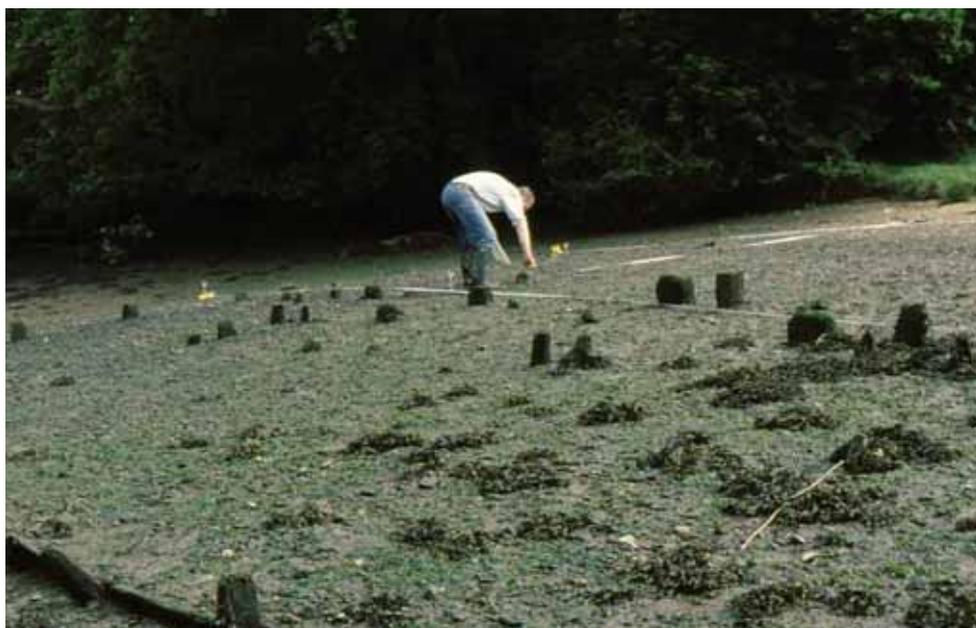
Other than those posts associated with the revetment, there are a large number of posts located within the structure (Figures HAM076- 2 and 5). From their positioning it is possible to define four linear rows; one to the west running north-south and two towards the east running north-south. Parallel to the east-west revetment, 3.7m to the south, is the fourth row of posts. These posts are of varying sizes up to 0.22m. There are signs of erosion, but they were probably originally circular. These posts would have been additional support for the quay decking.

Figure HAM076- 5 A volunteer surveying the rows of posts that would have supported the quay decking (looking southeast)

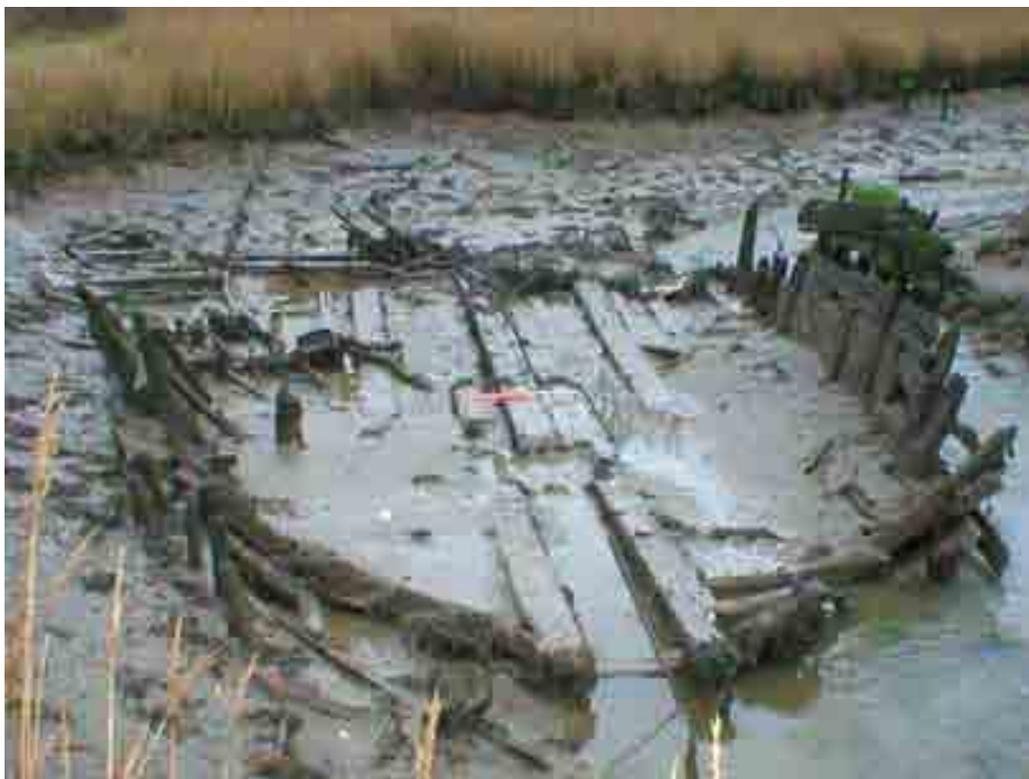
As the river meanders northwards towards Botley there is a creek that branches off from the main channel at Fairthorne Manor. At the mouth of this creek there are the remains of a hulk (Figure HAM098-1). The vessel was probably a Sailing Barge called the *Wessex*. The hulk lies in the inter-tidal zone, in an area of tidal sediments and reeds. During periods of low tide the site is accessible and the structure that protrudes through the sediments is visible. At high tide only a small section of the port side hull is exposed from the water. The hulk is orientated almost east west.

Figure HAM098- 1 A photograph taken from the mouth of the creek of remains of the barge *Wessex* looking east, with what is believed to be the stern nearest to the camera

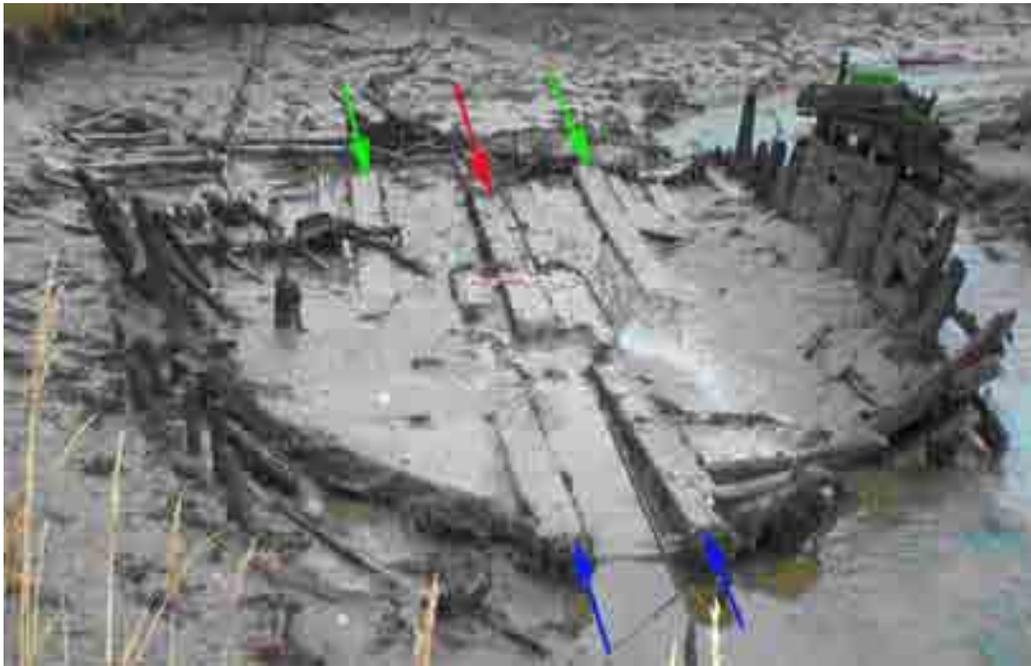
The major components at the base of the hull that are visible are the keelsons (Figure HAM098-4). There is a 7m long central keelson that finishes towards what seems to be the mast-step of the vessel. Either side of this central timber there are butt-strap planks, fitted to add strength. From about 1m before the end of the central keelson there are two side keelson 6.4m in length, one either side. These continue to the extremities of what remains of the stern. At this position the timbers have scarf joints cut, and probably mark the point at which stern frames would have risen. At a distance of 1m to the port and starboard of the central keelson there are two bilge keelsons, which are 5.1m in length. All the keelsons are substantial timbers with a width of 0.30m.

Figure HAM098- 4 Image showing the central keelsons (red arrow), side keelsons (blue arrows) and bilge keelsons (green arrows)

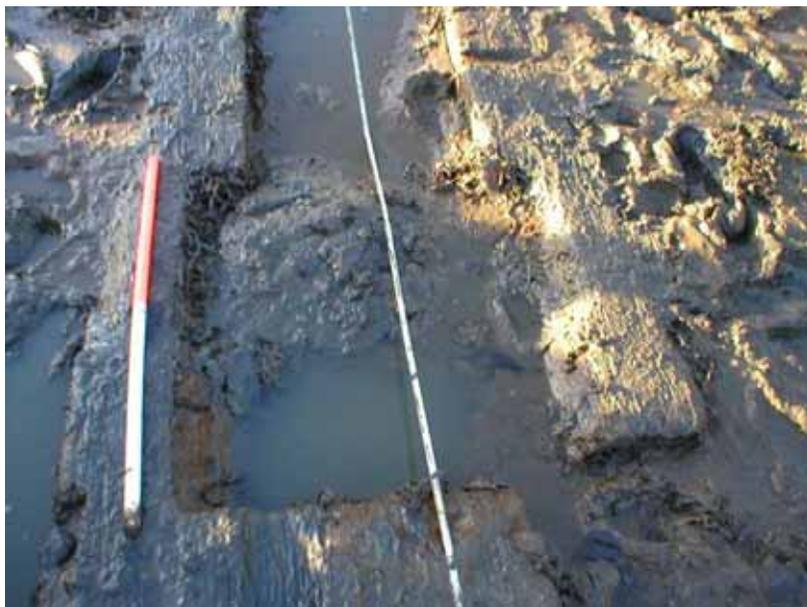
There is evidence to suggest that there is a mast-step present. This is located at the aft end of the central keelson, and between the two side keelsons. The side keelsons have been rebated at this point to form a square. Within this square the foot of the mast would have been seated, and the substantial keelsons would have given added strength to keep the mast in position. As the feature is located towards the aft of the vessel, this could be the mast-step for a mizzenmast (Figure HAM098-5).

Figure HAM098- 5 The mast-step looking west, the two timbers at the top are the side keelsons, while the timber at the bottom is the central keelson

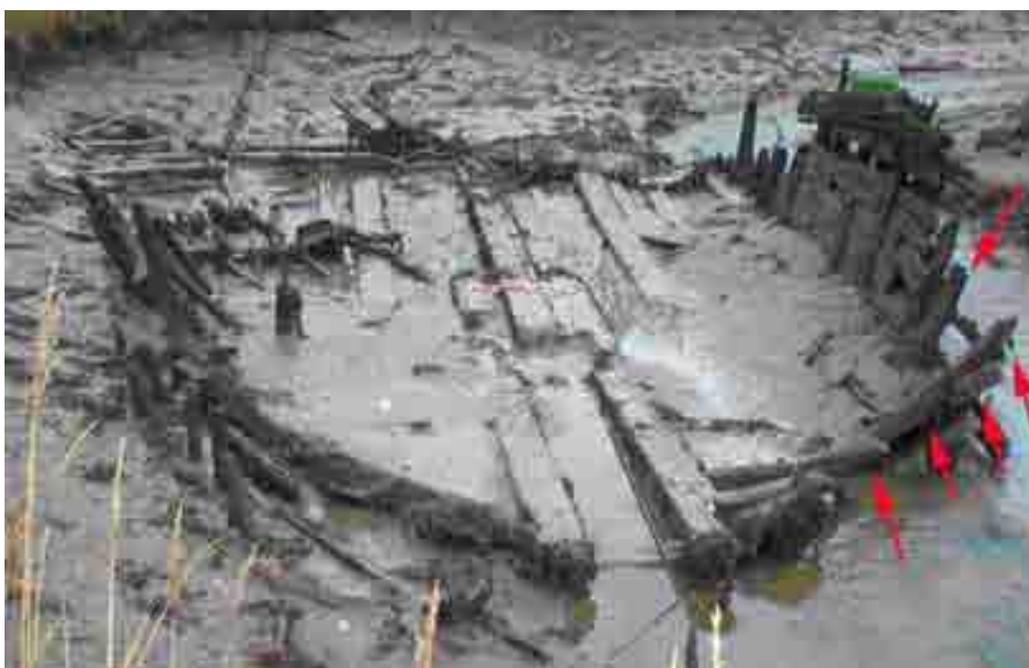
The vessel frame timbers remain, comprising of floor timbers and futtocks scarfed together. These are of varying sizes depending on where they are in the vessel. The stoutest of the frames are towards the stern where they are 0.20m wide. Towards the stern there is a noticeable change in the frames, as they become more curved to accommodate the narrowing of the hull (Figure HAM098-6).

Figure HAM098- 6 The shape of the frames change towards the stern (red arrows)

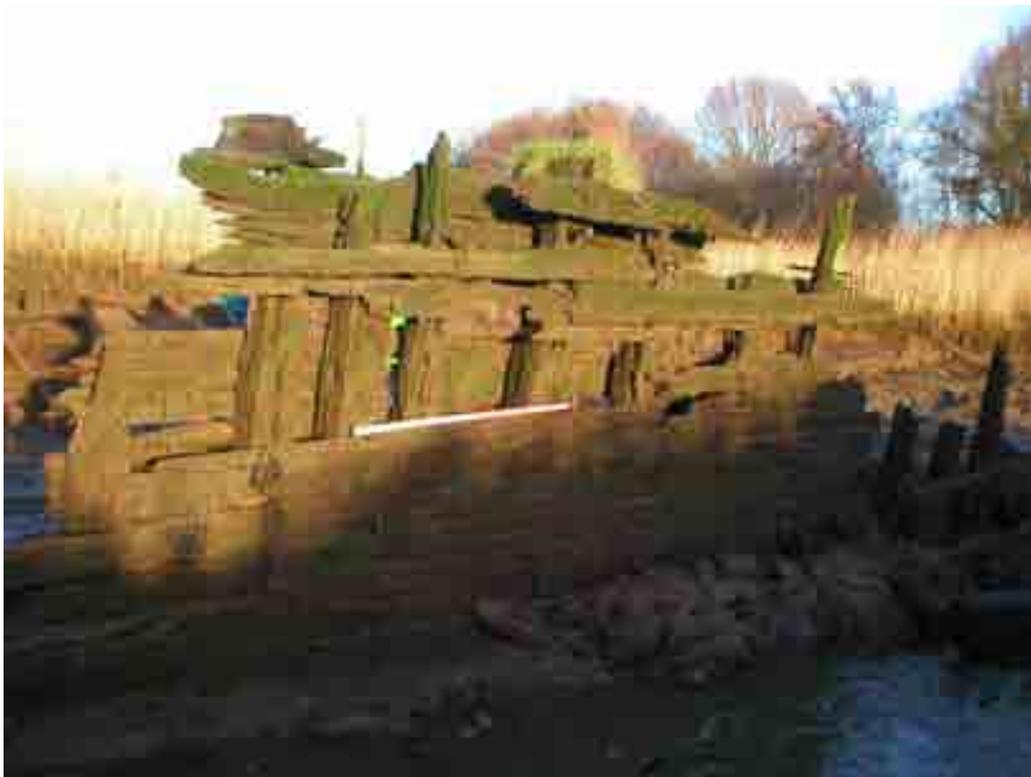
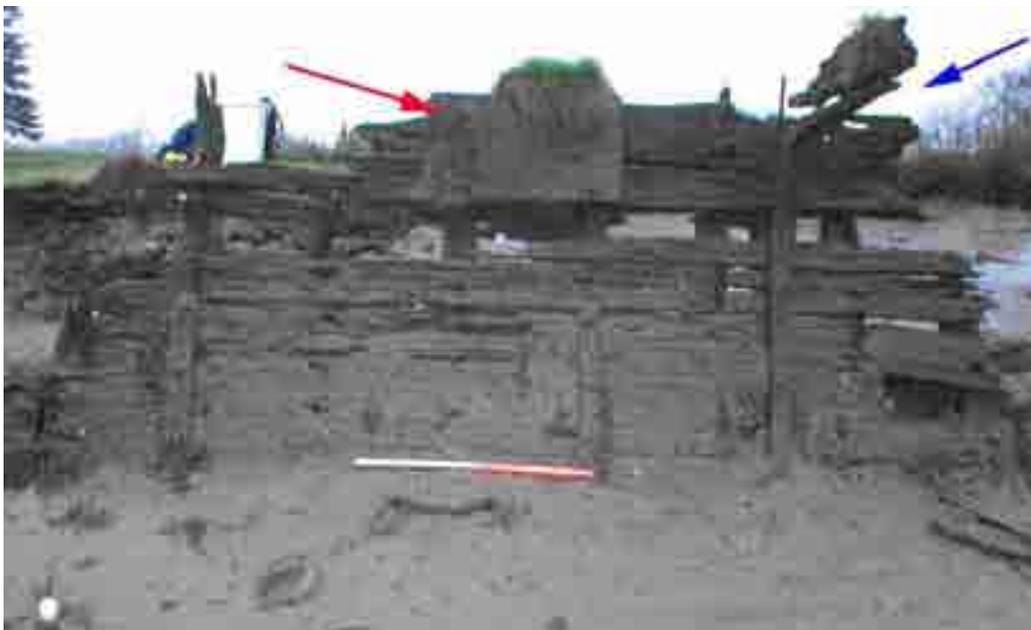
Figure HAM098- 7 The outside of the starboard section of hull, looking northeast

Figure HAM098- 8 The inside of the starboard section of hull, showing the large metal plate at the top of the structure (red arrow) and the metal knee to the right (blue arrow)

On the starboard side there is the most complete section of the remaining hull and this shows how the hull was constructed (Figures HAM098-7 and 8). Upper sections of the frames have broken leaving the tips of the frames at varying heights. The frames would have been about 0.16 wide with a spacing

of 0.14m. Attached to these frames there was an outer layer of planks and on the inner side there were ceiling planks. On the inner side there are the remains of four vertical metal strips, which originally were knees. One of these is attached to the hull. It rises to the deckhead level, and then curves to the horizontal. At the top of this knee there is a small piece of deckbeam present (Figure HAM098-9). At the top of this section of hull there is a 0.8m long metal plate attached to the inside, the purpose of which is not known.

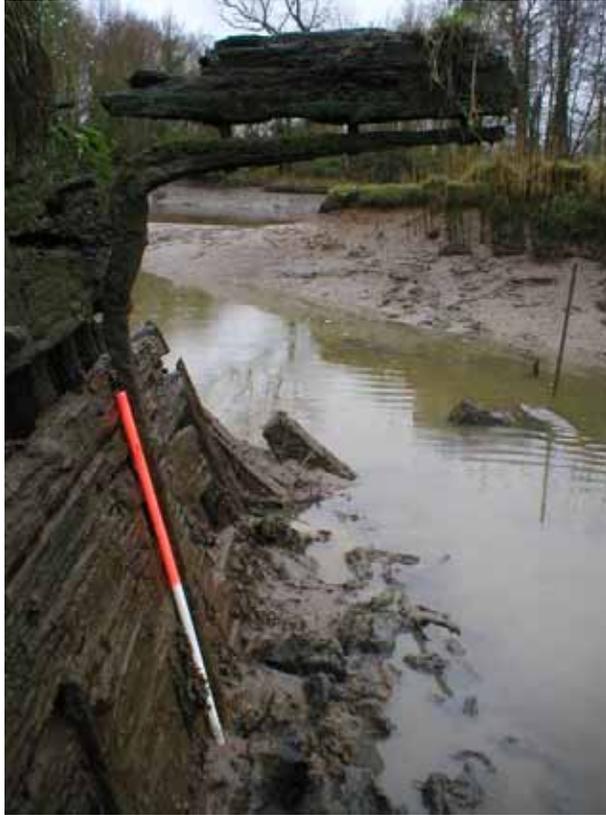
Figure HAM098- 9 The remaining complete in-situ knee with a portion of deckbeam remaining, looking west

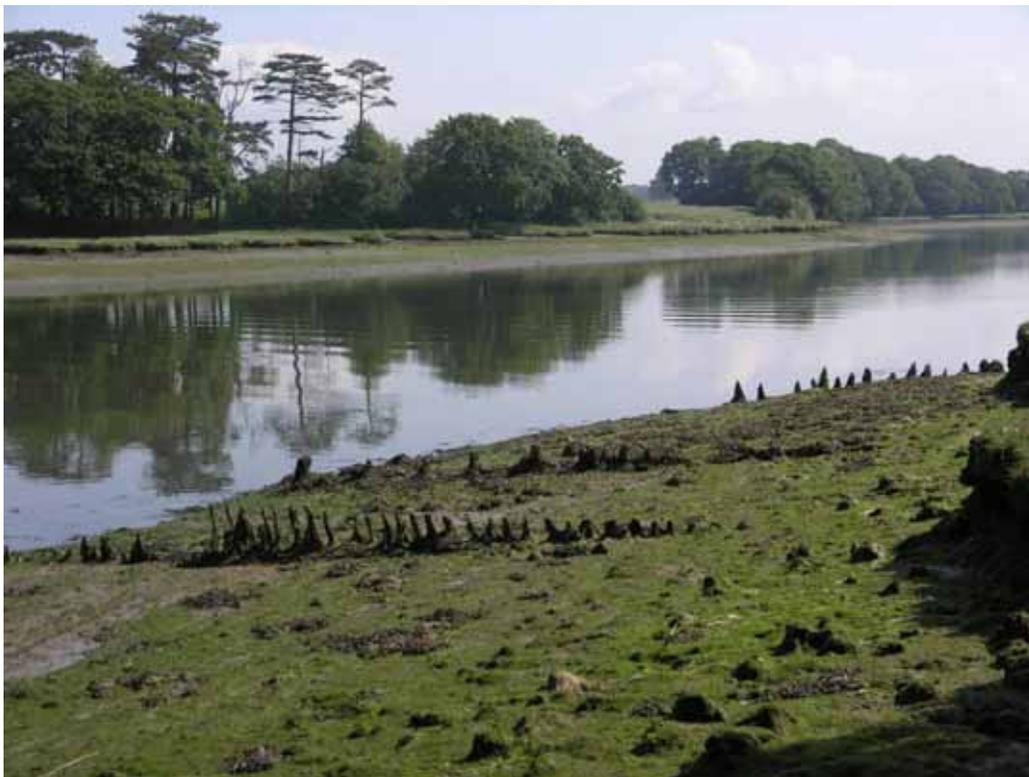
As the Hamble River flows past Dock Copse and Burr ridge Farm there is the remains of a maritime structure on the southern bank. This comprises of three rows of posts that protrude through the tidal sediments (Figure HAM099-1).

Figure HAM099- 1 Two rows of posts either side of a hard, and a third row to the west (photo taken from the southwest)
