3.7.3. Site Description

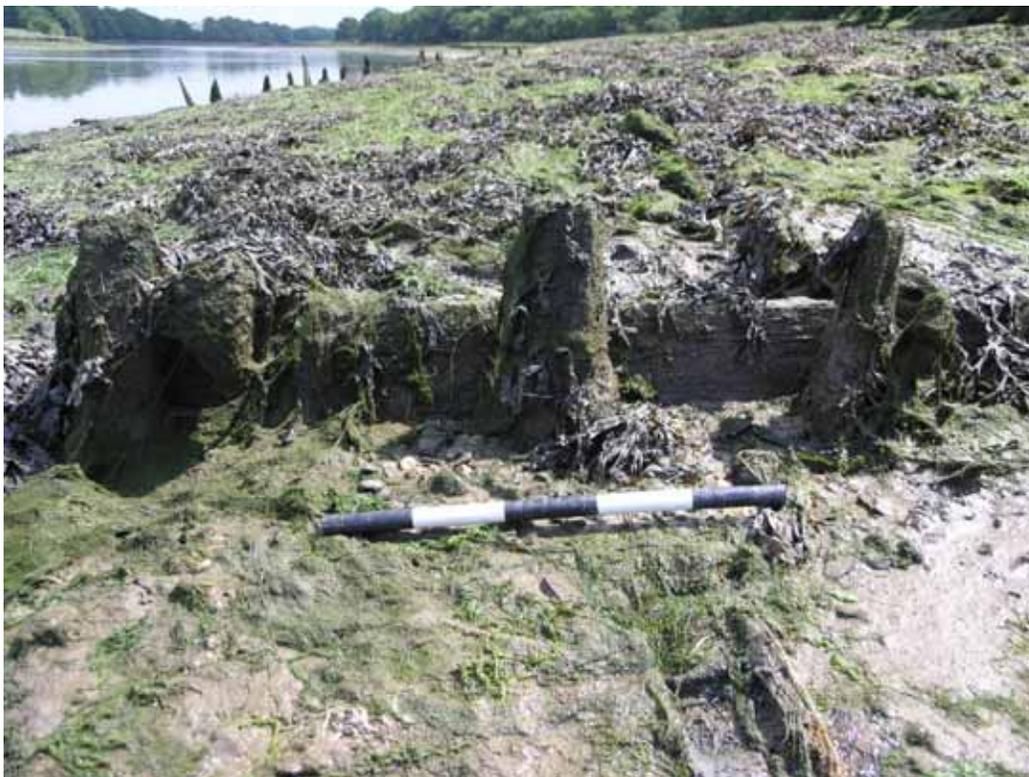
The site includes three rows of timbers posts, with some revetment and cross bracing, which runs from the shore in the south towards the Hamble River main channel (Figure HAM099-1). The rows of timbers are in the region of 10m in length and the site is about 18m wide. The western row of timbers comprises of upright posts, about 8cm in diameter. Where the timbers are still buried they are sub-circular, while the uppermost sections of these timbers have been eroded into triangular forms (Figure HAM099-2). 5m to the east lie the middle row of timbers; here there are a series of post, revetment planks and four bracing cross timbers. The eastern most row is located a further 18m towards the east. This row comprises of upright posts and a small section of revetment planking (Figure HAM099-3).

Figure HAM099- 3 The central area of compacted gravels is held in situ by two series of post alignments with horizontal revetment

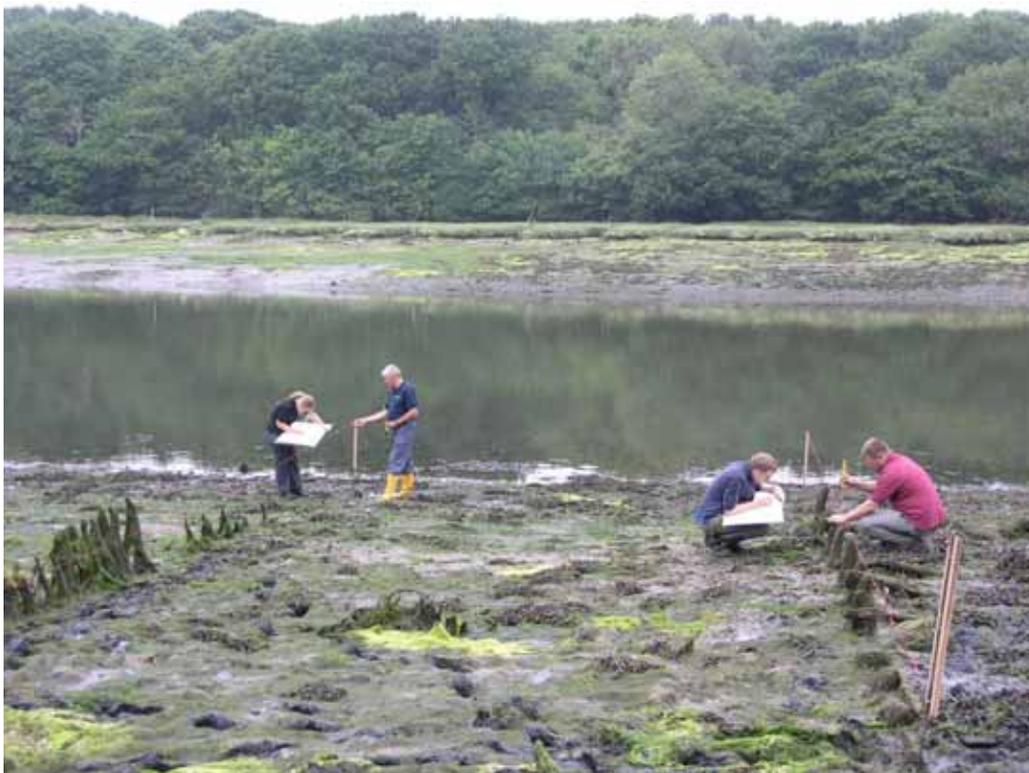
The surface between the eastern most timbers and the middle row is an area of fairly compact gravels, which gives it a degree of integrity that makes it easy to walk upon. The area between the western timbers and the middle row is made up of tidal sediments (Figure HAM099-4); this area has little surface integrity and was very difficult to walk on.

Figure HAM099- 4 The western section of the structure is made up of unconsolidated tidal sediments, and is probably the remains of a boat berth

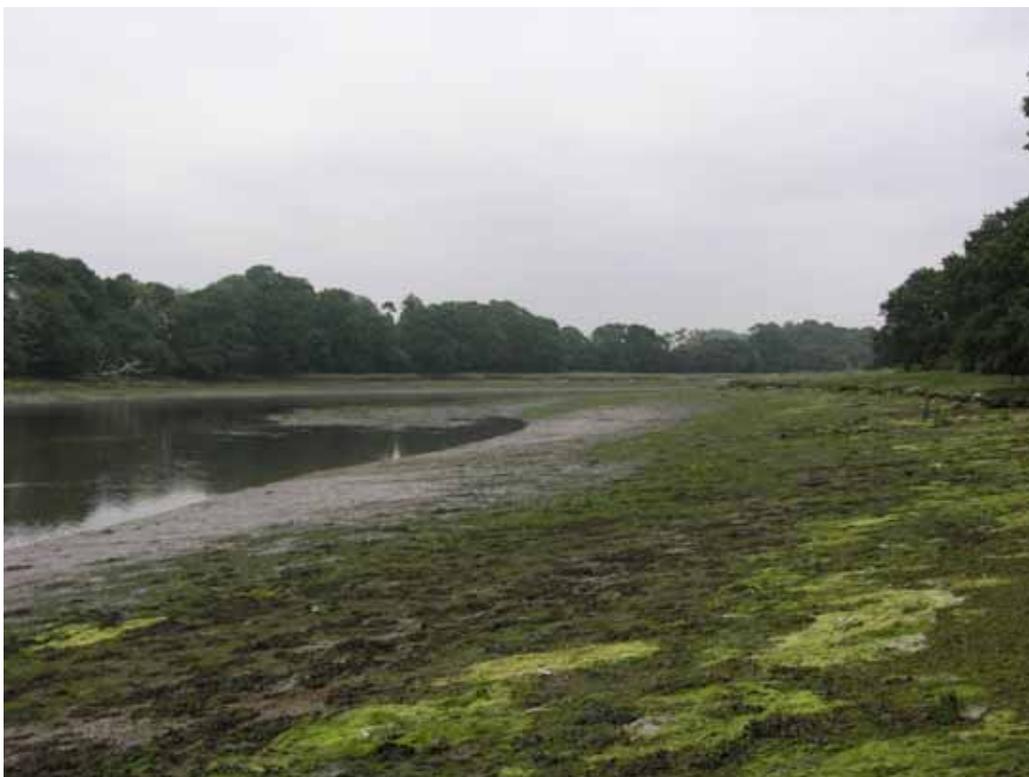
Figure HAM099- 7 The shore east of the creek that runs through Bloomfield Copse was inspected for structural remains; none was encountered

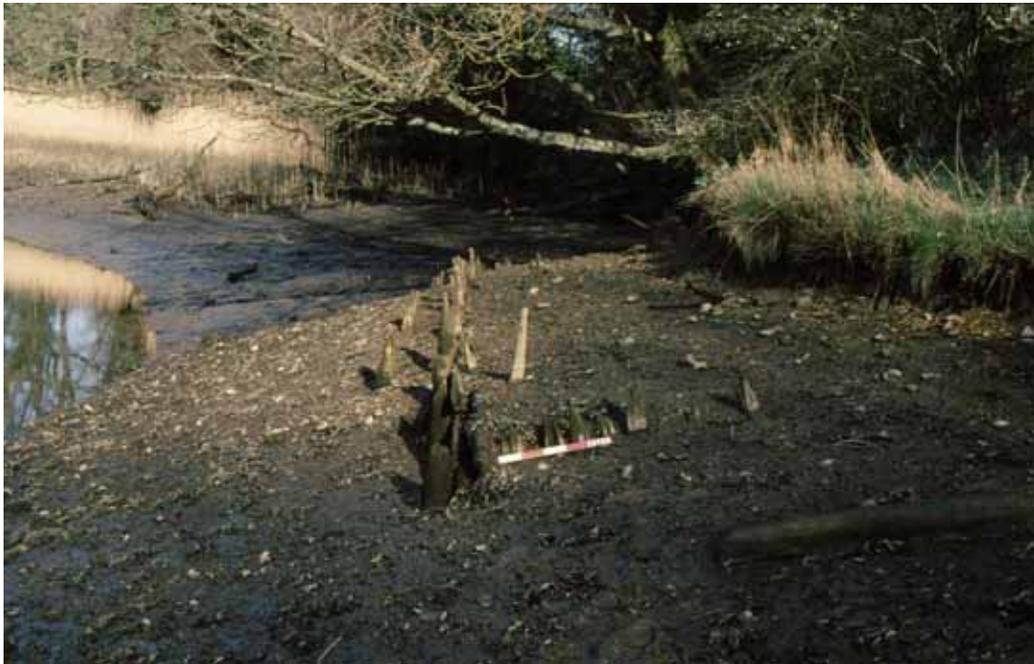
On the east-side of the site there is an area of revetment that is 10.28m long and runs parallel to the shore (Figure HAM102-3). The revetment is made up of planks of wood lying horizontal on their side (Figure HAM102-4). The planks are of varying sizes in length, but are 0.06m-0.09m in thickness. These planks are held in position by upright posts, which are of varying sizes up to 0.18m in diameter (Figure HAM102-4). In the run of planks that makes up the revetment there is a gap. This is located 3.40m from the east and is 1.90m wide. Towards the west of this the timber plank is partially buried. It is possible that the plank from the gap has either disappeared or is buried. On the western side of the revetment there is a series of posts that run 90° from the final plank in a north-south direction (Figure HAM102-4). The posts demarcate the eastern side of the quay from the slip. There are eight posts of varying dimensions, up to 0.12m, which run for a distance of 1.68m.

Figure HAM102- 3 The eastern area of revetment, with one of the slipway timbers in the foreground (looking east)

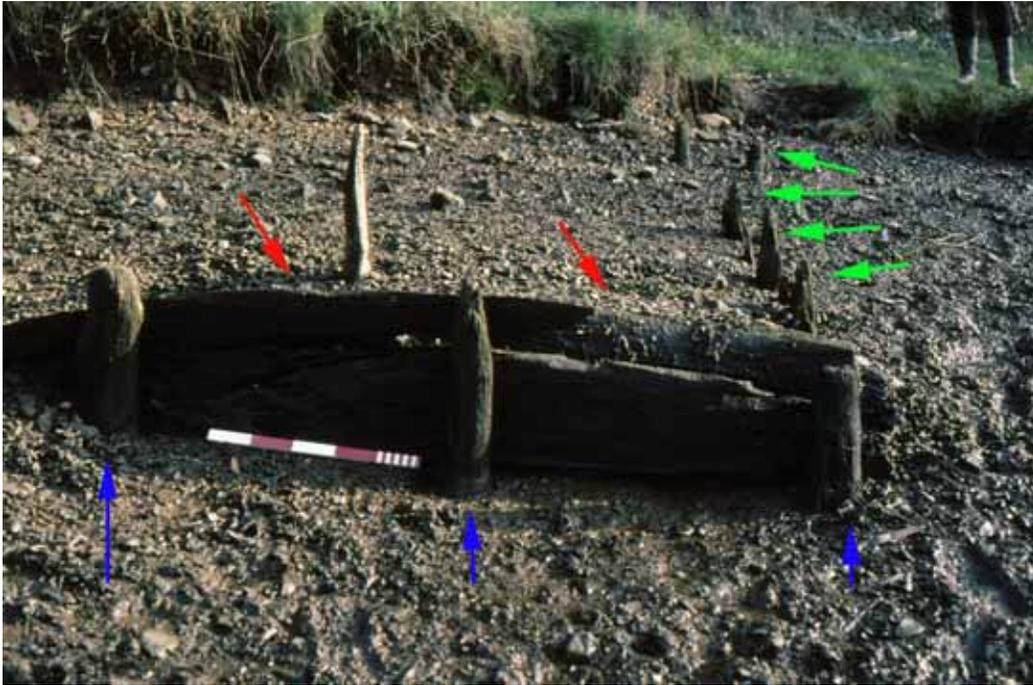
Figure HAM102- 4 An image showing the revetment planks (red arrows), the revetment posts (blue arrows) and the north-south series of post (green arrow) (looking south)

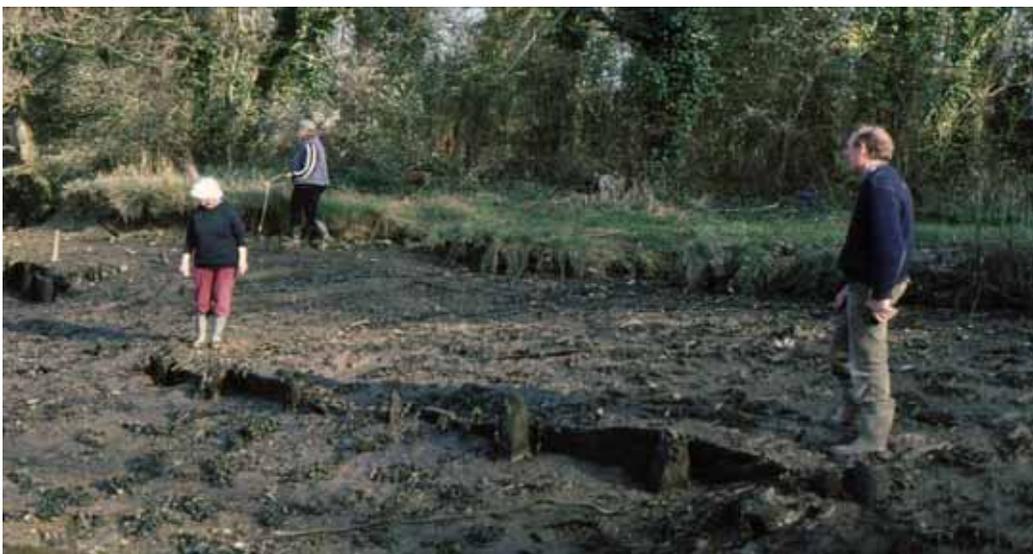
Towards the western side of the site there is the second area of revetment (Figure HAM102-5). This runs for a distance of 7.72m in an east-west direction. The method of construction and sizes are similar to the eastern area. There are no posts visible that demarcate the revetment area from the slipway. It is possible that these have either disappeared or have become buried. Between the revetment and the shore there are two planks (Figure HAM102-2). One measures 3.70m long by 0.18m wide, the other 1.42m long by 0.16m wide. These are probably disarticulated timber from the quay structure.

Figure HAM102- 5 The western area of revetment (looking southeast)

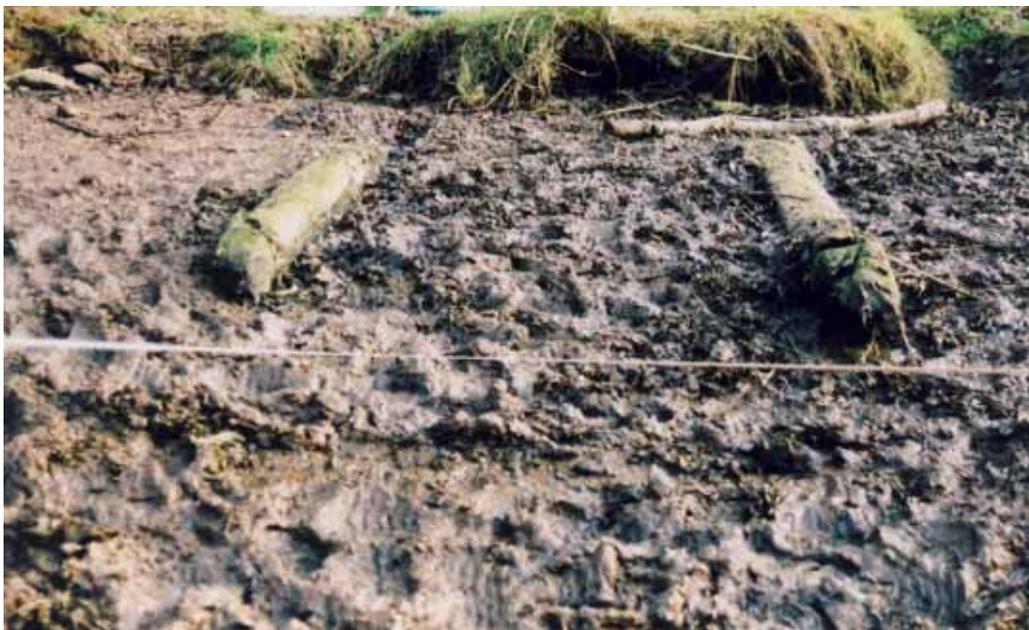
Between the two areas of revetment is a slipway area (Figure HAM102-2). The slipway is 4.28m wide. In the centre of the slipway there are two substantial parallel timbers in a north-south direction. These timbers are 2.50m in length, 0.16m in width and protrude 0.10m from the sediments. The distance between the two timbers is 1.38m.

Figure HAM102- 6 The two large timbers located in the centre of the slipway (looking south)

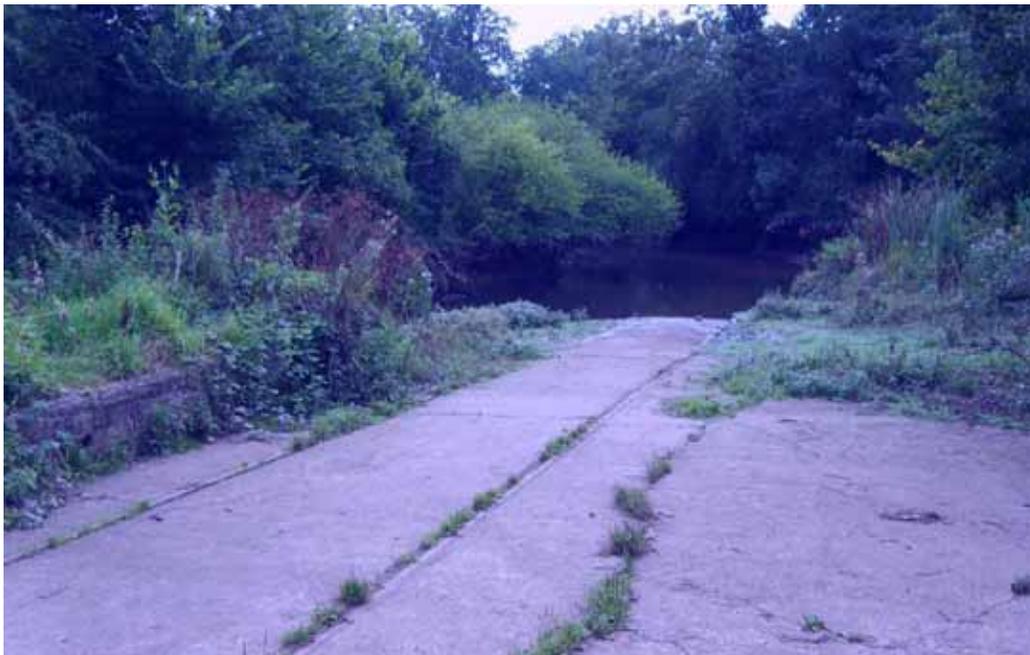
The slip lies to east of the quay and runs north-south, and enters the water at the apex of the two branches of the river. There are two adjacent stonewalls, the eastern wall forms a promontory for half of the length of the slip, while the quayside wall to the west runs for the complete length. The quayside wall here is held together with mortar and appears to be a more recent addition. The surface of the slip is concrete and two parallel metal rails run its entire length (Figure HAM103-2)

Figure HAM103- 2 The slip has two metal rails embedded in its concrete surface, with the more recent wall on the left of the photograph

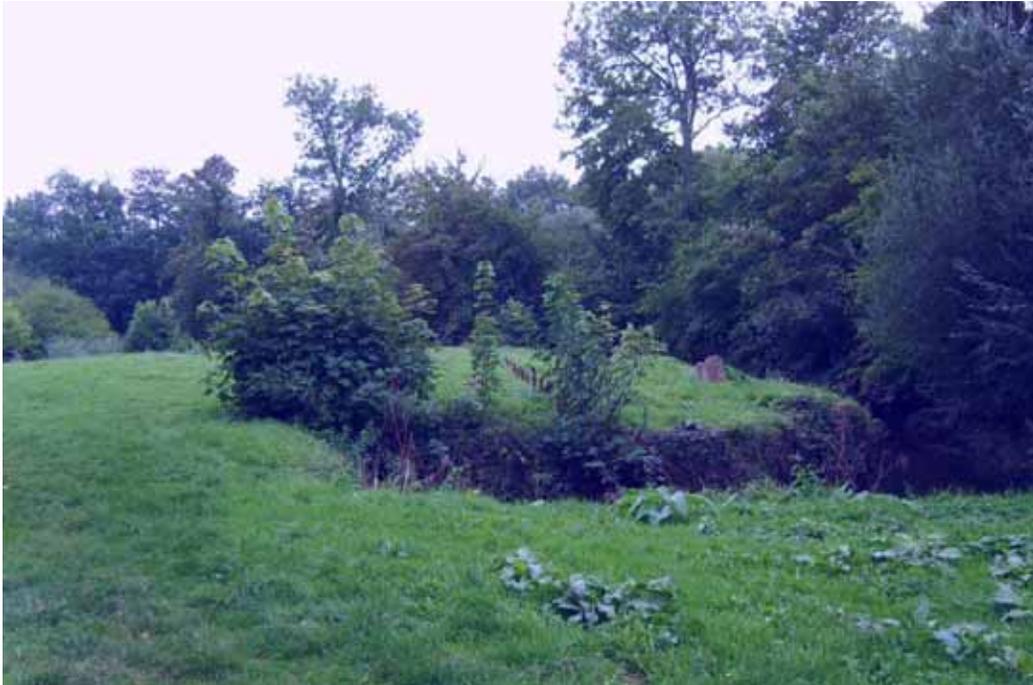
The main part of the quay area is a large flat area with what appears to be three boat berths cut into it. The quay is raised from the riverbed by about 1.2m, with the embankment surrounded by a stonewall. In parts this wall is drystone and in others mortar is present. Adjacent to the slip the quay measures 30m before turning 90° to the west and running for a further 10m. At this point there is a triangular cut in the quay. This measures approximately 3m x 7m, and is the first of the probable boat berths. From this point the stonewall turns towards the northwest and continues for about 30m. It is at this point the most obvious boat berth can be found. It is rectangular in shape measuring about 11m x 5.5m, and has a northeast-southwest orientation (Figure HAM103-3). After this the quay continues in a northwest direction for a further 15m, until it joins the third boat berth, which appears as a long indentation (around 23m long by 4m wide). This berth is very close to the warehouse (Figure HAM103-4).

Figure HAM103- 3 The remains of at least three boat berths are present at Botley Hard, including this rectangular berth

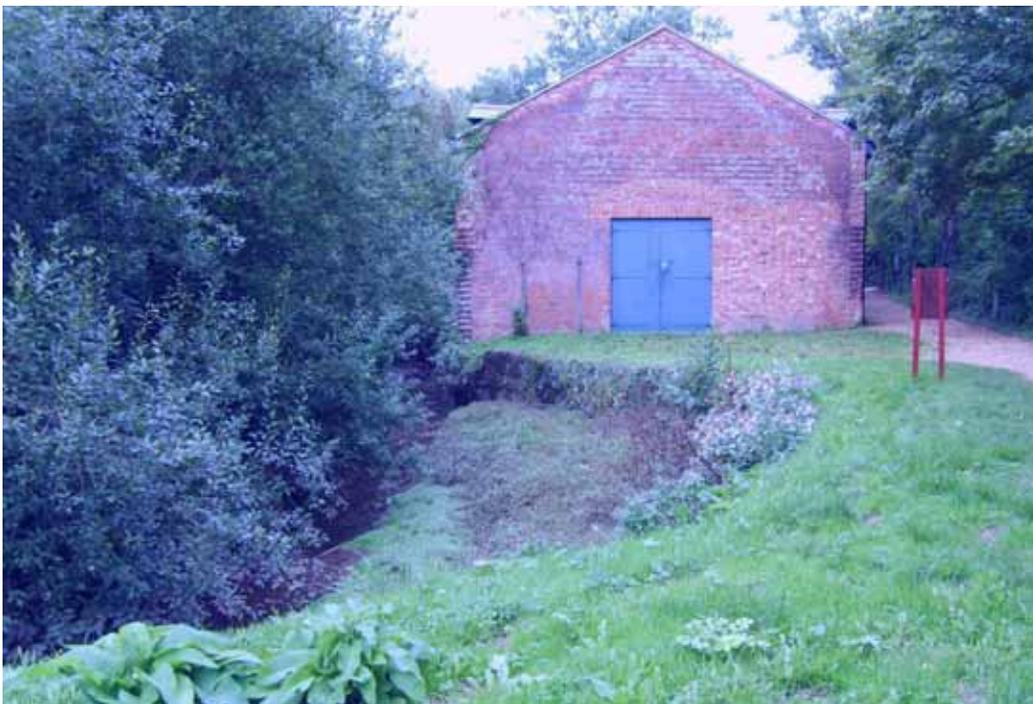
Figure HAM103- 4 View from the east of the warehouse, with a boat berth in the foreground

The warehouse is a brick rectangular building, around 20m in length. At the quayside end there are large double doors. These doors are a later addition, as evidence of an earlier, larger arch can be seen (Figure HAM103-4). By the access road there are also sets of large double doors located in the long sidewall of the warehouse. The far side of the warehouse is located on

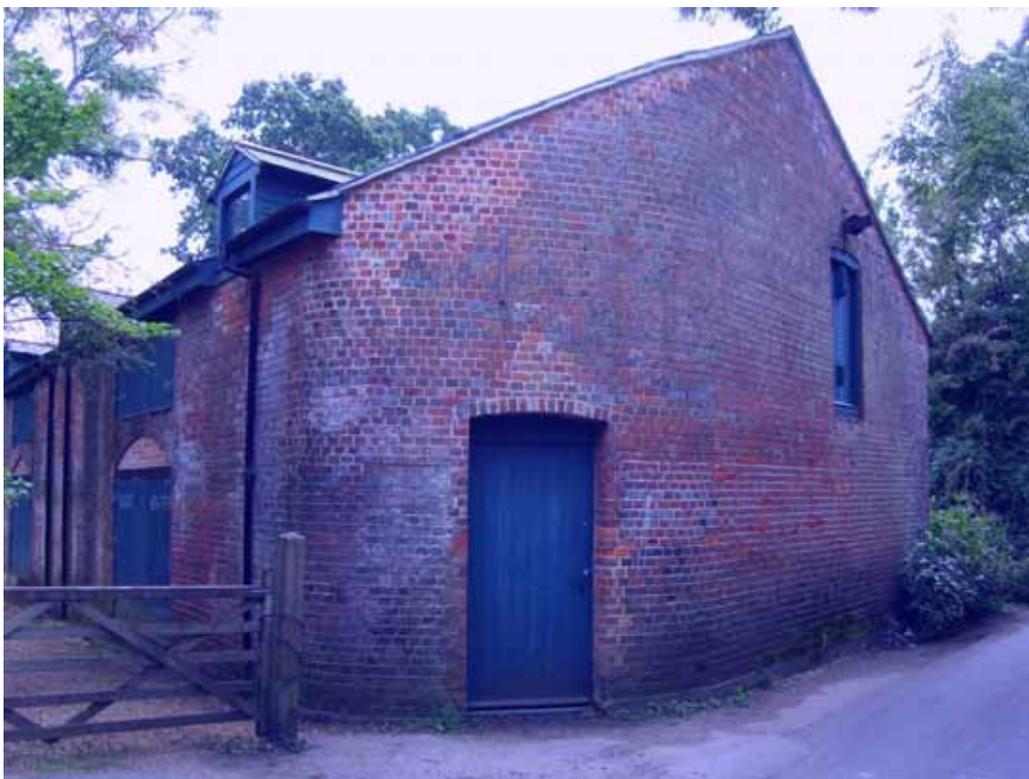
Church Lane. In this side there is a single entrance at ground level, and there is a door on the first floor. Above this door there is a pulley block that would have enabled the hoisting of items to and from the upper store (Figure HAM103-5).

Figure HAM103- 5 One end of the warehouse lies on Church Lane. It has two entrances, including one on the first floor that has a pulley above

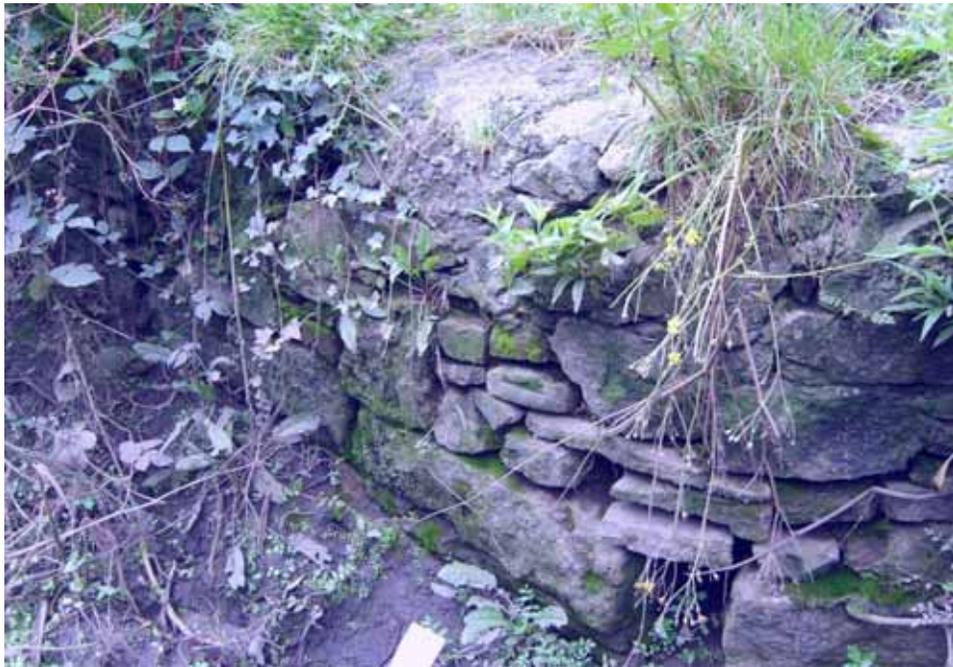
A section of the wall that surrounds the promontory to the east of the slip is very similar in nature to the main quay wall (Figure HAM103-9). This suggests that the slip is a later addition, and that a section of the quay was removed to build it. Cartographic evidence suggests that the slip was built after 1962. Therefore, originally the quay would have moorings on both branches of the river at this point.

Figure HAM103- 9 Much of the quay comprises of a dry stone wall

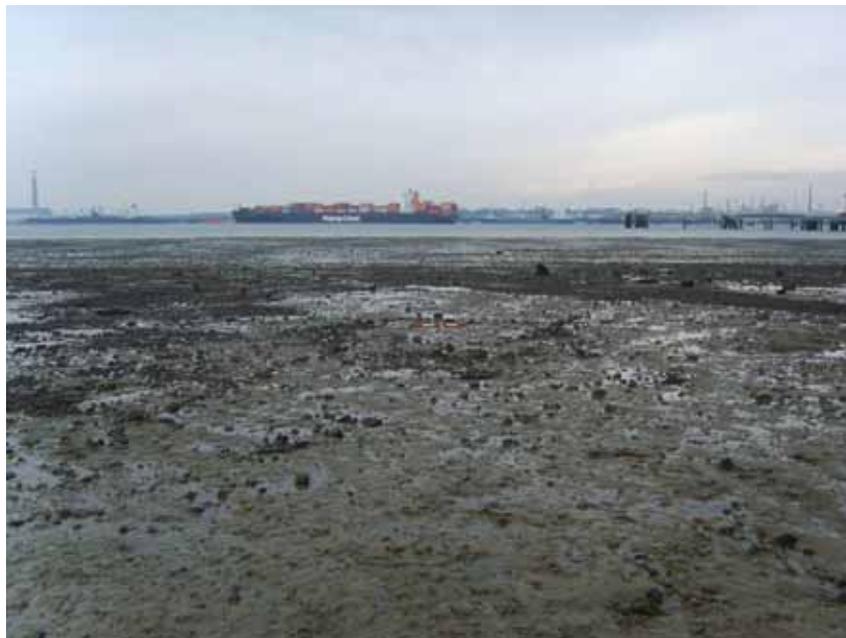
In the inter-tidal zone near Hamble Common there is a semi-circle of small timber posts. These timbers are highly degraded and are difficult to distinguish from the shingle that makes up the shore (Figure HAM115-1). The feature is located low down in the tidal zone and is only visible during very low tides. HAM116 was first visited by HWTMA in March 2002.

Figure HAM116- 1 Viewed from the northwest the structure in its environment, marked by red and white scales

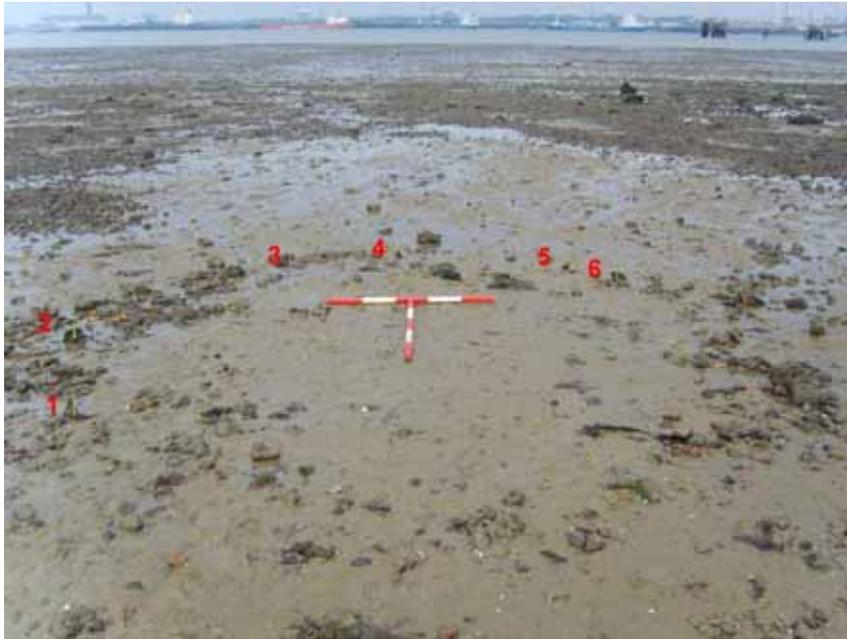
During the initial visit to the site in 2002 a semi-circle consisted of eight posts was encountered. Two of the posts have subsequently disappeared, probably due to erosion. There are six posts remaining and the semi-circle has a diameter of 3.6m meters at it widest point (Figure HAM116-3). The open side to the semi-circle is on the northwest side. The assumption is that this equates to the structures original diameter.

Figure HAM116- 3 Six posts are visible in the structure; these have been numbered to aid the recording process

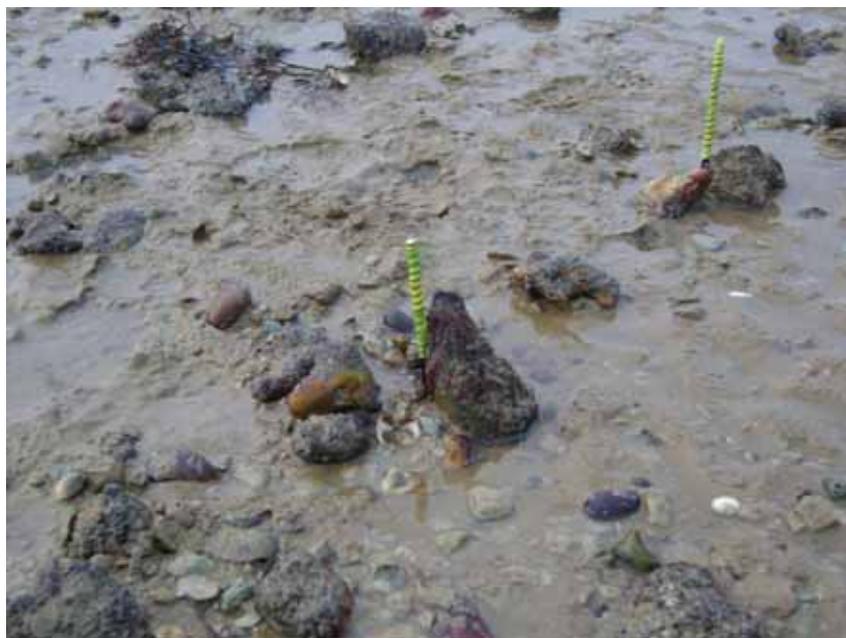
The visible sections of the six timber posts are in a poor condition and the posts have an irregular shape (Figure HAM116-4). The timbers are approximately the same size, with the diameter being up to 0.15m and a height up to 0.10m.

Figure HAM116- 4 Looking southeast, posts 5 and 6 showing their irregular nature

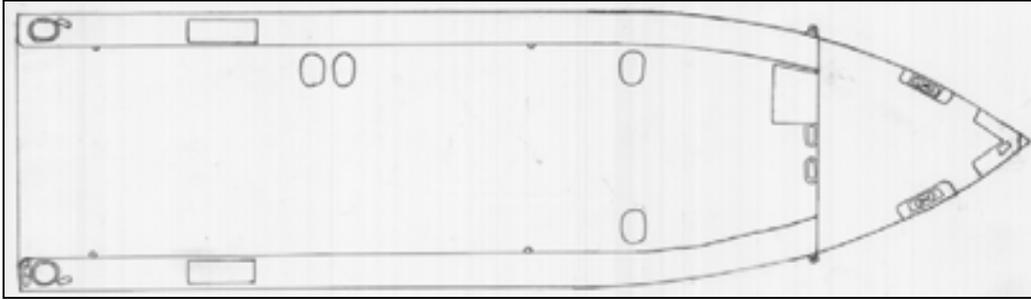
Figure HAM153- 2 Plan drawing of the hulked Seaplane Lighter located on the Hamble River

The vessel is in a poor condition, although it is possible to see the main layout of the hull. Inspection shows it is an unusual design. The leading edge of the bow section, and the angle of the chine is acute, giving a v-shaped profile. The forward profile is concave; this would have the resultant effect of lifting the bows as the vessel cut through the water allowing it to make way efficiently in the chop created by the towing vessel. As the hull continues aft the chine levels out considerably so that from about 4m to the stern the vessel is flat bottomed. This creates sufficient beam to house the aircraft, as well as providing enough working space for the crew (DNC 1921).

The career of the Seaplane Towing Lighter on the Hamble River is currently unknown. It is recommended that additional research be conducted. From this it may be possible to identify the operations this craft was involved with during the war. Nothing is known about how this vessel was employed after the war and how it came to be located on the river. This vessel does have high archaeological significance, however, due to its poor condition it is suggested that preservation may not be a viable option.

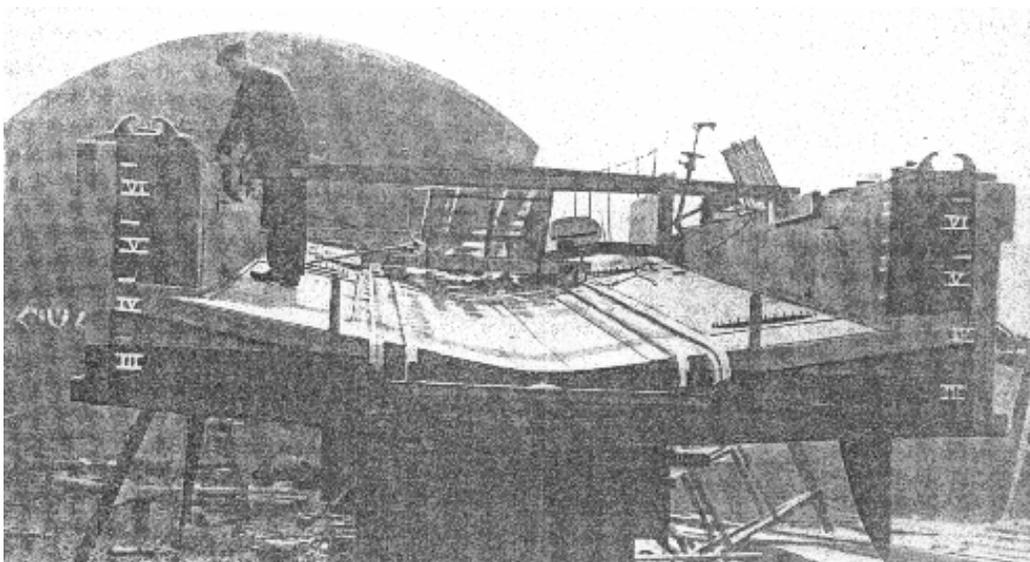
The majority of the vessel's hull is made up of two rectilinear steel tanks that run either side of the vessel (Figure HAM153-5). These are the trimming tanks of the vessel. To assist the embarkation of the seaplanes the vessel could be partially submerged by flooding these tanks.

Figure HAM153- 5 Stern view of Seaplane Tender showing the port and starboard trimming tanks, skeg plates and cradle rails (DNC 1921)

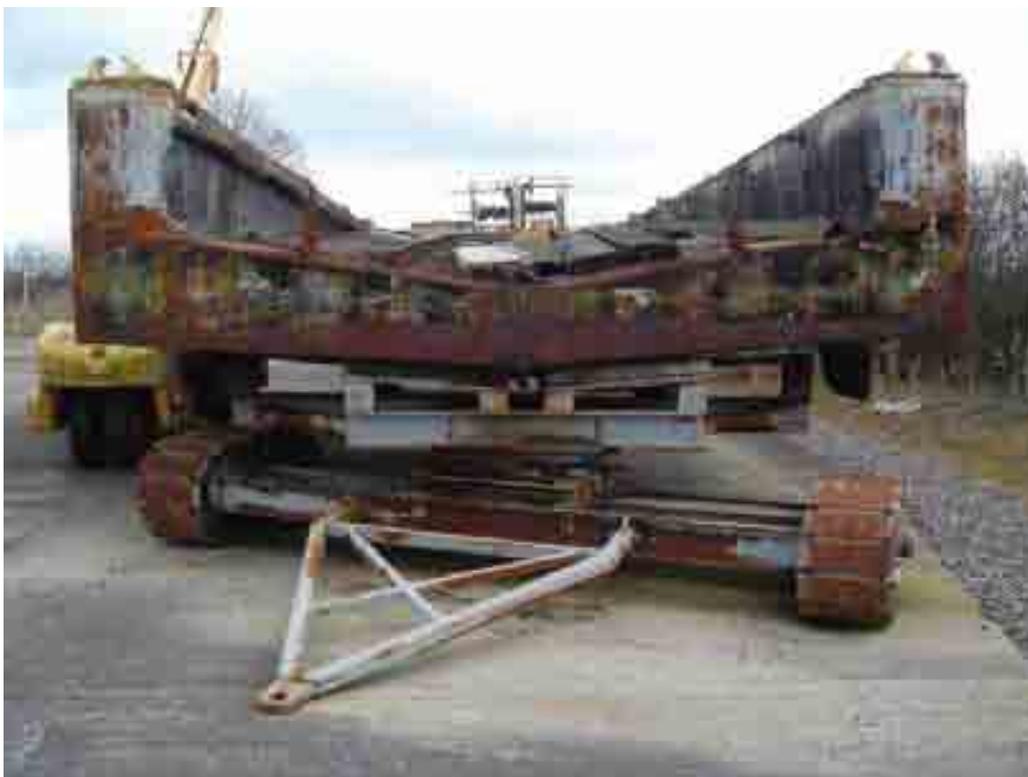
Figure HAM153- 7 Stern view of Seaplane Lighter Fleet Arm Museum Collection showing trimming tanks and skeg plates

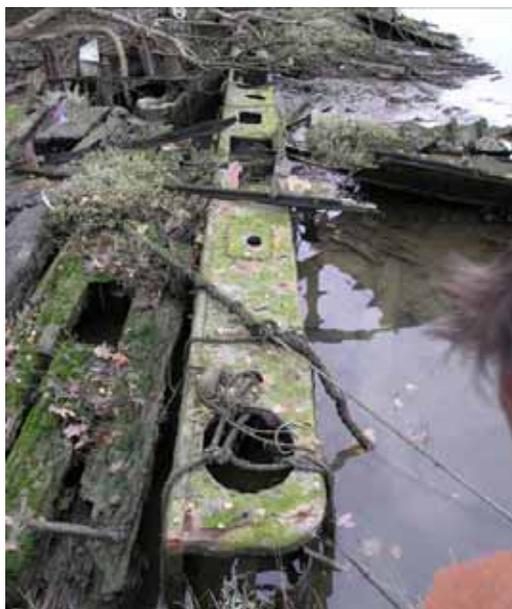
Other diagnostic features that could be seen on the hulked lighter included a number of hatches and deck fittings located on the port caisson. On the port quarter an open sub-circular hatch could be seen (Figure HAM153-9), which corresponds with the 'Flush W.T. Manhole' on the original plan. Forward of this is another open hatch, this time rectangular measuring 1.2m by 0.5m wide. This is marked on the original plan as the 'Hatch to Air Bottle Comp' (Figure HAM153-3). On the bulkhead of the port caisson there is an eye plate located between the two hatches, this is depicted on the plan. There were many large mooring cleats located aft, port, starboard and forward. Two such cleats are present at 2 metres from the tip of the bow on both the port and starboard. A forward control box is present and is located 3.75 metres aft of the bow to port. At the control box there is a deteriorated ladder, which leads down to the large 'Kingston Valve'. A crewmember would have trimmed the lighter by opening and closing the 'Kingston Valve'. The remains of a thin strip of wood approximately 5 centimetres thick can be seen running the whole length of the vessel and is located just below the upper edge of the hull.

Figure HAM153- 8 View of port trimming tank looking forward with the open hatches
