the play inspection company

Annual Inspection

Ninfield Parish Council

The Recreation Ground

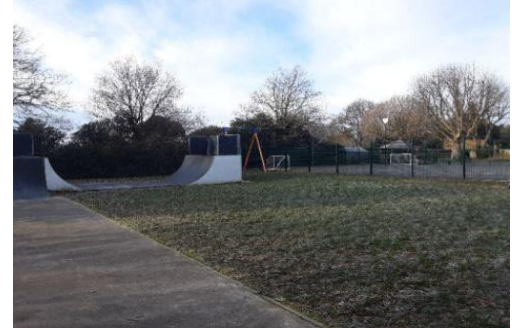
Item: Site General
Manufacturer: Owner/Operator
Surface Type: N/A
Item Quantity: 1
Equipment Compliance: N/A
Surface Area Compliance: N/A

Signage of the wheeled sports area should be provided as recommended in BS EN 14974; this will include, but not exclusively, the use of the area, a recommendation to wear protective equipment, emergency contact details etc. - Provide signage as recommended by BS EN 14974 for wheeled sports areas

The surface has eroded and old foundations are exposed - Reinststate surrounding surfaces to cover the foundations

The grass mats are silted up and the soil is compacted; this may have an effect on the impact absorbing properties of the surface - Consider HIC testing impact absorbing properties to ensure the correct surface qualities are maintained for the equipment and replace as required

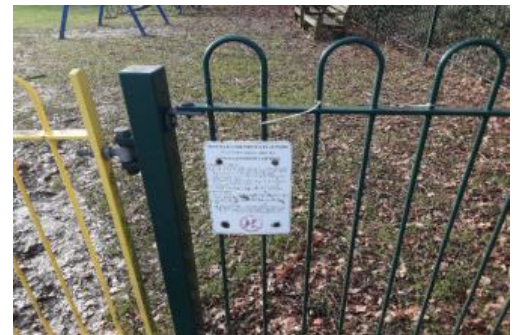
Item: Sign
Manufacturer: Owner/Operator
Surface Type: N/A
Item Quantity: 1
Equipment Compliance: N/A
Surface Area Compliance: N/A

This item is satisfactory - no work required -

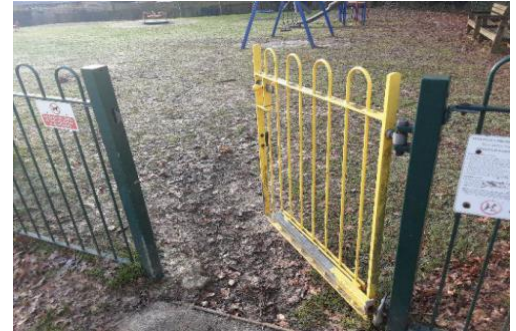
Item: Gate - Self Closing
Manufacturer: Owner/Operator
Surface Type: Grass
Item Quantity: 1
Equipment Compliance: N/A
Surface Area Compliance: N/A

The self closing mechanism is missing - Replace all missing components

The area under the gate has eroded leaving uneven areas, or the concrete foundations exposed, resulting in trip hazards at the entrance/exit to the playground - Reinstate to level with surrounding surfaces

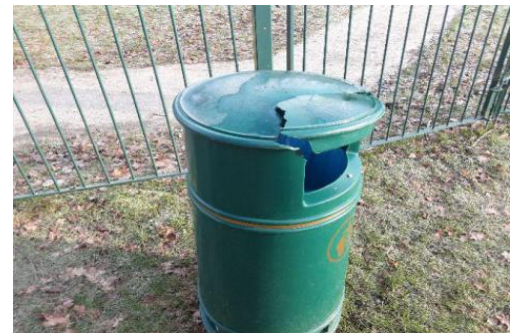
Item: Litter Bin
Manufacturer: Owner/Operator
Surface Type: Grass
Item Quantity: 3
Equipment Compliance: N/A
Surface Area Compliance: N/A

The item has been severely damaged - Repair or replace the item

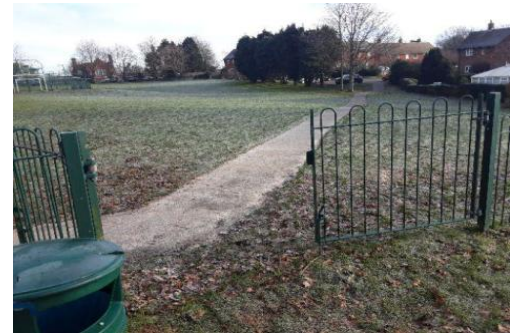
Item: Gate - Maintenance
Manufacturer: Owner/Operator
Surface Type: Grass
Item Quantity: 1
Equipment Compliance: N/A
Surface Area Compliance: N/A

There is no padlock on the maintenance gate - Provide a padlock to secure the gate

The dropbolt sleeves are damaged - Repair or replace as required

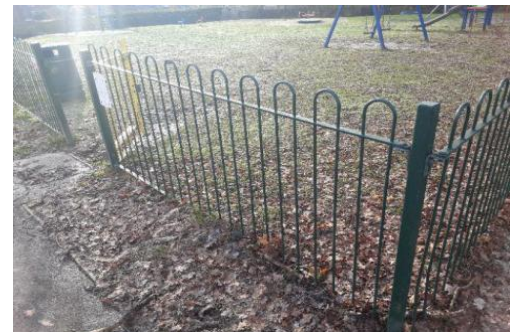
Item: Fence - Bow Top
Manufacturer: Owner/Operator
Surface Type: Grass
Item Quantity: 1
Equipment Compliance: N/A
Surface Area Compliance: N/A

There is some damage to the fence sections - Monitor for any further deterioration and repair as required

There are a number of fixings missing from the fence - Replace missing fixings

A number of fixings have worked loose around the fencing - Secure all loose fixings

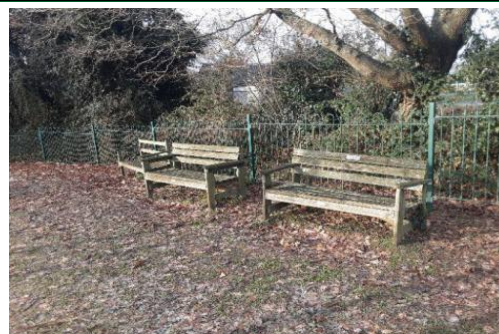
Item: Bench
Manufacturer: Owner/Operator
Surface Type: Grass
Item Quantity: 3
Equipment Compliance: N/A
Surface Area Compliance: N/A

There are areas or parts of the timber on the structure that have rotted - Replace all affected timbers

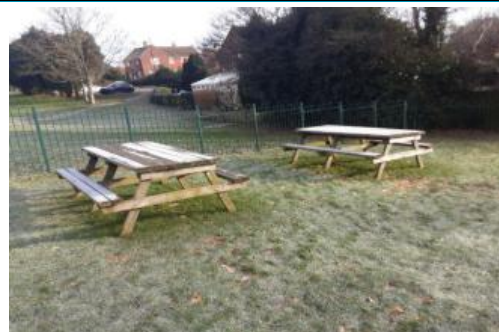
Item: Picnic Table
Manufacturer: Owner/Operator
Surface Type: Grass
Item Quantity: 2
Equipment Compliance: N/A
Surface Area Compliance: N/A

This item is satisfactory - no work required -

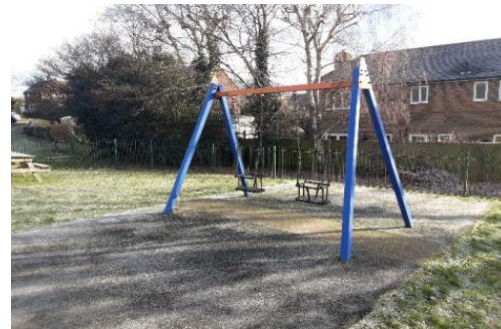
Item: 1 Bay 1 Seat (Cradle) - Type 1
Manufacturer: Wicksteed Playgrounds
Surface Type: Wet Pour
Item Quantity: 1
Equipment Compliance: No
Surface Area Compliance: Yes
Life Expectancy: 5 -10 Years
Total Findings: 8

The safety surface around the area is beginning to wear - Monitor for any further deterioration and repair as required

The seats are severely damaged and requires replacing - Replace damaged seats

The chain openings are in excess of the 8.6mm as recommended by BS EN 1176 - Monitor - No remedial work recommended

There is moderate damage to the surface - Repair the damaged areas of surfacing

There is algae, silt or moss growth on the surface resulting in slippery conditions - Clean and treat appropriately

There is some notable evidence of chain wear - Monitor for any further deterioration and replace when 40% worn

There is some wear to the shackles. - Monitor for any further deterioration and replace when 40% worn

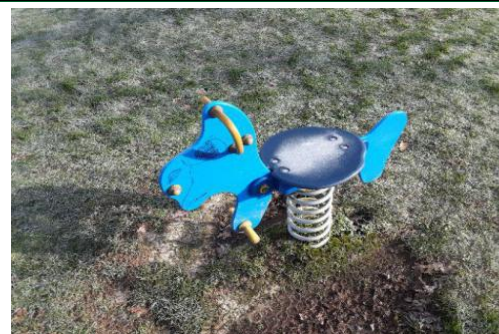
Item: Spring Camel
Manufacturer: Ledon
Surface Type: Grass Matrix Tiles
Item Quantity: 1
Equipment Compliance: No
Surface Area Compliance: Yes
Life Expectancy: 3 - 5 Years
Total Findings: 6

There is some graffiti present - Remove the graffiti

The end of handgrips and/or footrests have a cross section of less than 15cm² and fail to meet the requirements of BS EN 1176 Part 6 - Monitor - No remedial work recommended

There is moderate damage to the surface - Repair the damaged areas of surfacing

The item has been damaged - Monitor for any further deterioration and replace as required

There is/are bolt cap covers missing or damaged on the item - Replace missing or damaged bolt cap covers

The paintwork on the spring has been damaged or worn exposing the metal underneath which is rusting - Treat any rusting components and repaint

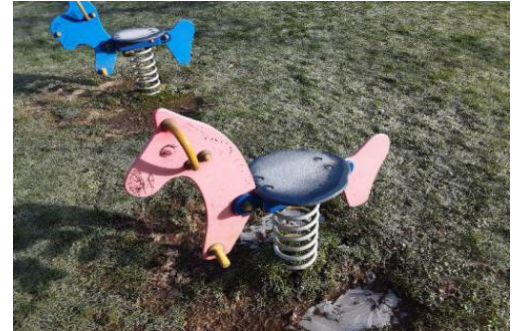
Item: Spring Horse
Manufacturer: Ledon
Surface Type: Grass Matrix Tiles
Item Quantity: 1
Equipment Compliance: No
Surface Area Compliance: Yes
Life Expectancy: 3 - 5 Years
Total Findings: 5

There is some graffiti present - Remove the graffiti

The end of handgrips and/or footrests have a cross section of less than 15cm² and fail to meet the requirements of BS EN 1176 Part 6 - Monitor - No remedial work recommended

The paintwork on the spring has been damaged or worn exposing the metal underneath which is rusting - Treat any rusting components and repaint

The item has been damaged - Monitor for any further deterioration and replace as required

There is some minor damage to the surface - Monitor for any further deterioration and repair as required

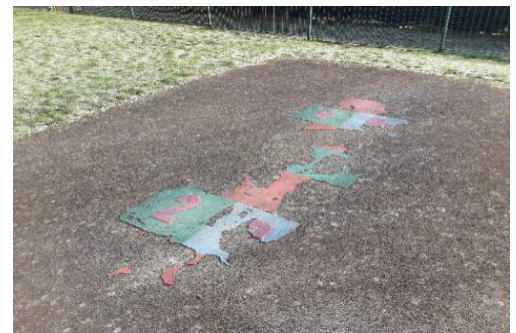
Item: Hopscotch
Manufacturer: Owner/Operator
Surface Type: Bitmac
Item Quantity: 1
Equipment Compliance: N/A
Surface Area Compliance: N/A
Life Expectancy: <12 Months
Total Findings: 1

The item is damaged - Repair or replace the item

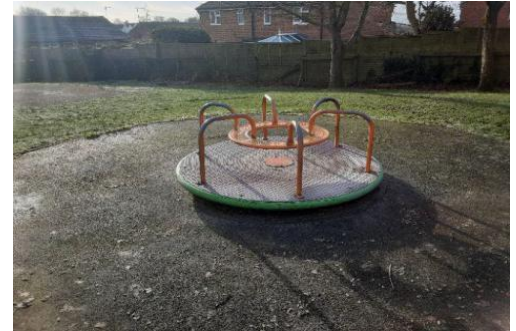
Item: Roundabout
Manufacturer: Wicksteed Playgrounds
Surface Type: Wet Pour
Item Quantity: 1
Equipment Compliance: No
Surface Area Compliance: Yes
Life Expectancy: 5 -10 Years
Total Findings: 7

There are significant gaps (over 30mm) between the surface and the edging or between the joints in the surface; these are large enough for a small foot to enter - Repair surfacing

The safety surface around the area is beginning to wear - Monitor for any further deterioration and repair as required

There are trip hazards at the edges of the surface - Reinstate surrounding surface levels to remove the trip points

The distance between the underside of the roundabout platform and the playing surface is in excess of 110mm and contravenes the requirements of BS EN 1176 Part 5 which requires that the distance be maintained between 60mm-110mm - for the entire circumference of the roundabout - Monitor - No remedial work recommended

There is algae, silt or moss growth on the surface resulting in slippery conditions - Clean and treat appropriately

The paintwork on this item has been damaged or worn exposing the metal underneath which is rusting - Treat any rusting components and repaint

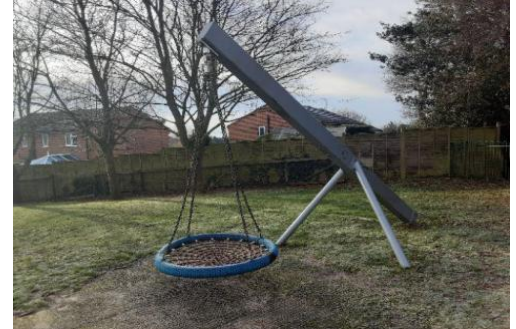
Item: Cantilever Swing - Type 3
Manufacturer: Miracle Recreation Equipment Company
Surface Type: Grass Matrix Tiles
Item Quantity: 1
Equipment Compliance: No
Surface Area Compliance: Yes
Life Expectancy: 5 -10 Years
Total Findings: 10

The seat clearance from finished surface level to the underside of the seat is too low and does not meet the requirements of BS EN 1176 Part 2 (400mm minimum clearance required from rigid part of seat in most onerous position) - Adjust seat clearance

The incorrect seat design has been installed on this swing; there are unique designs for Type 1 and Type 3 swings that provide differing impact attenuating properties to the leading edges of the seat and/or has incorrectly aligned seat eye fixings which will lead to accelerated wear. - Consider replacing with the correct design seat

The bushes are worn or missing - Replace worn or missing bushes

The swing seat connectors have some wear present - Monitor for further deterioration and replace when 40% worn

There is some notable evidence of chain wear - Monitor for any further deterioration and replace when 40% worn

There is some wear to the shackles. - Monitor for any further deterioration and replace when 40% worn

The chain openings are in excess of the 8.6mm as recommended by BS EN 1176 - Monitor - No remedial work recommended

The beam buffer is missing and there are projecting fixings present - Remove the projecting fixings and replace all missing components

The seat has minor damage or wear - Monitor for any further deterioration and replace as required

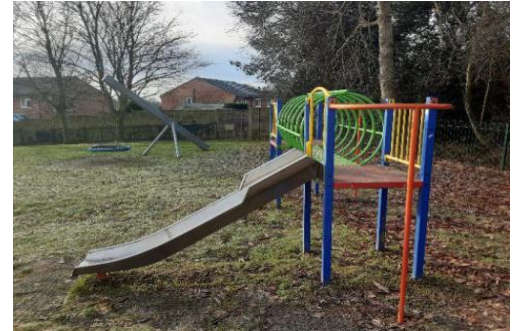
Item: Multi Play (Junior)
Manufacturer: Wicksteed Playgrounds
Surface Type: Grass Matrix Tiles
Item Quantity: 1
Equipment Compliance: No
Surface Area Compliance: Yes
Life Expectancy: 1 - 3 Years
Total Findings: 10

The unit is easily accessible and has an opening in the barrier to steep play elements in excess of 500mm in contravention of BS EN 1176 Part 1 - Monitor - No remedial work recommended

Parts of the steel on this item have corroded excessively and the metal has perforated in places - Ensure all affected areas are treated and repaired

There are a number of dents in the slide surface - Monitor for any further deterioration and repair as required

The height of the barrier(s) is insufficient and fails to meet the requirements of BS EN 1176 Part 1 - Monitor - No remedial work recommended

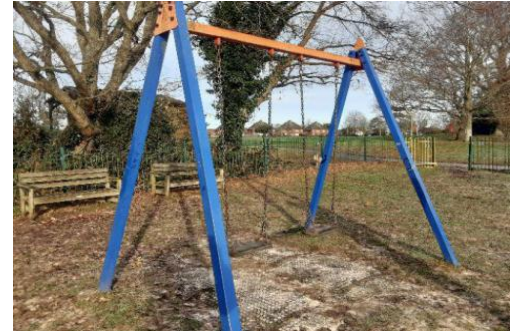
Item: 1 Bay 2 Seat (Flat)
Manufacturer: Wheelscape Ltd
Surface Type: Grass Matrix Tiles
Item Quantity: 1
Equipment Compliance: No
Surface Area Compliance: Yes
Life Expectancy: 5 -10 Years
Total Findings: 11

There is some graffiti present - Remove the graffiti

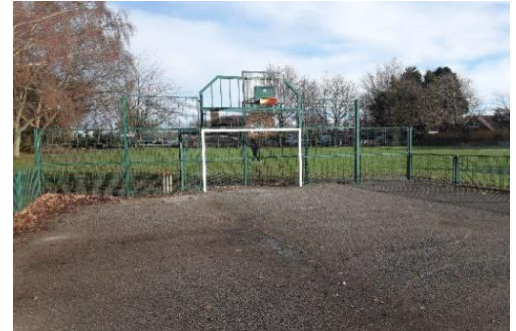
Item: Multi Use Games Area (MUGA)
Manufacturer: Wicksteed Playgrounds
Surface Type: Bitmac
Item Quantity: 1
Equipment Compliance: No
Surface Area Compliance: N/A
Life Expectancy: >10 Years
Total Findings: 8

The surface is crumbling in areas creating slippery conditions - Sweep and clear all loose debris and monitor

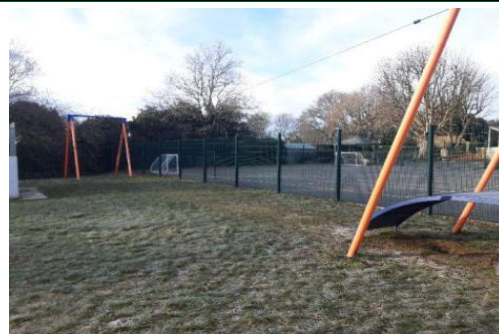
Item: Cable Runway
Manufacturer: Wicksteed Playgrounds
Surface Type: Grass Matrix Tiles
Item Quantity: 1
Equipment Compliance: No
Surface Area Compliance: Yes
Life Expectancy: >10 Years
Total Findings: 6

The unit is easily accessible and should have the appropriate barriers installed to meet the requirements of BS EN 1176 Part 1 as the height of the unit exceeds 600mm - Monitor - No remedial work recommended

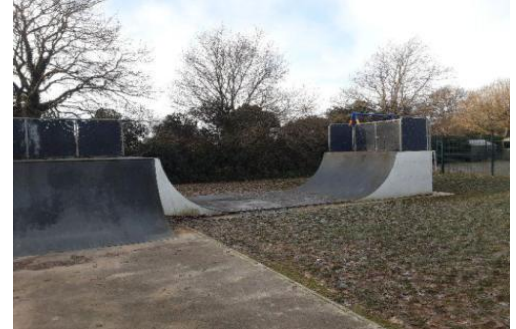
Item: Half Pipe
Manufacturer: Not Identified
Surface Type: Bitmac
Item Quantity: 1
Equipment Compliance: Yes
Surface Area Compliance: Yes
Life Expectancy: 5 -10 Years
Total Findings: 2

The paintwork on this item has been damaged or worn exposing the metal underneath which is rusting - Treat any rusting components and repaint

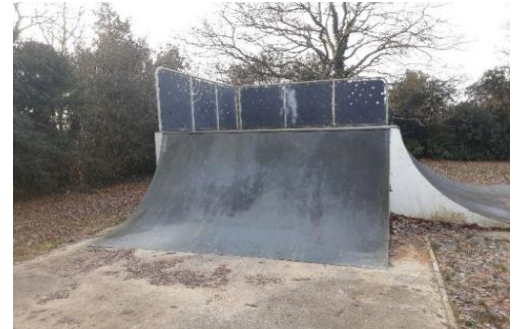
Item: Quarter Pipe
Manufacturer: Not Identified
Surface Type: Bitmac
Item Quantity: 1
Equipment Compliance: No
Surface Area Compliance: N/A
Life Expectancy: 5 -10 Years
Total Findings: 1

The kicker plate protrudes more than 5mm above the surrounding surface level, BS EN 14974 recommends a maximum of 5mm with 3mm preferred - Adjust height to ensure a maximum of 5mm change in level

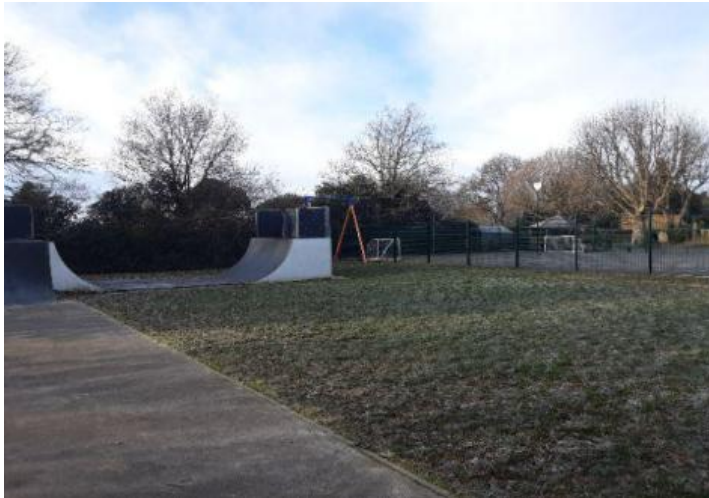
Item: Ancillary Items - Site General
Manufacturer: Owner/Operator

Finding: The grass mats are silted up and the soil is compacted; this may have an effect on the impact absorbing properties of the surface

Action: Consider HIC testing impact absorbing properties to ensure the correct surface qualities are maintained for the equipment and replace as required

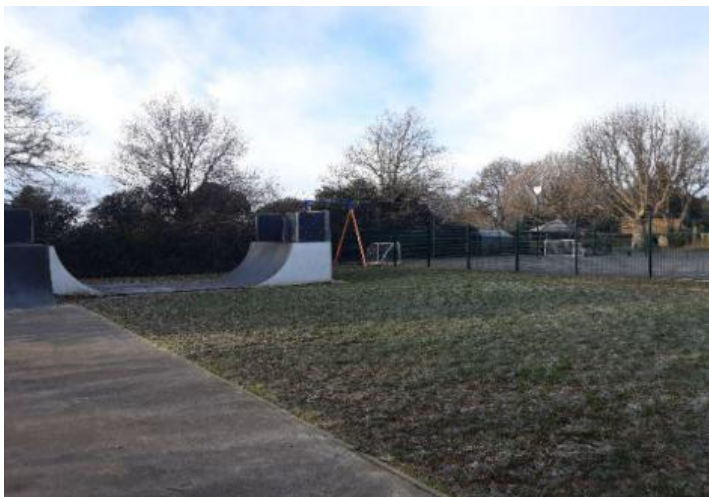
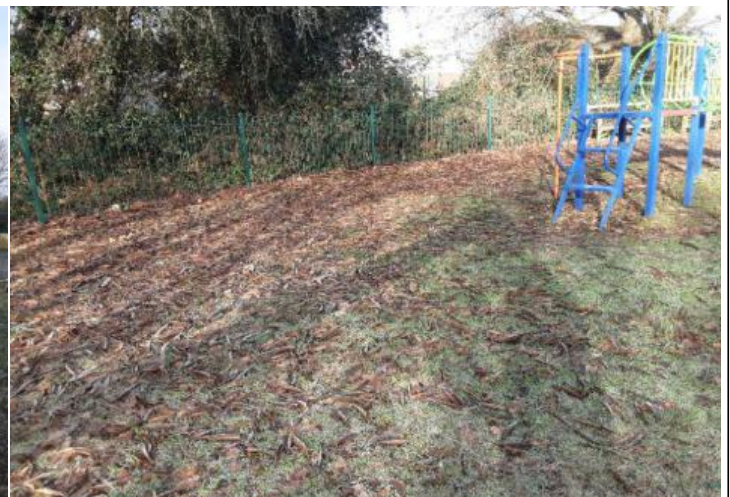
Item: Ancillary Items - Site General
Manufacturer: Owner/Operator

Finding: There is some tree debris on the surfacing

Action: Remove and maintain

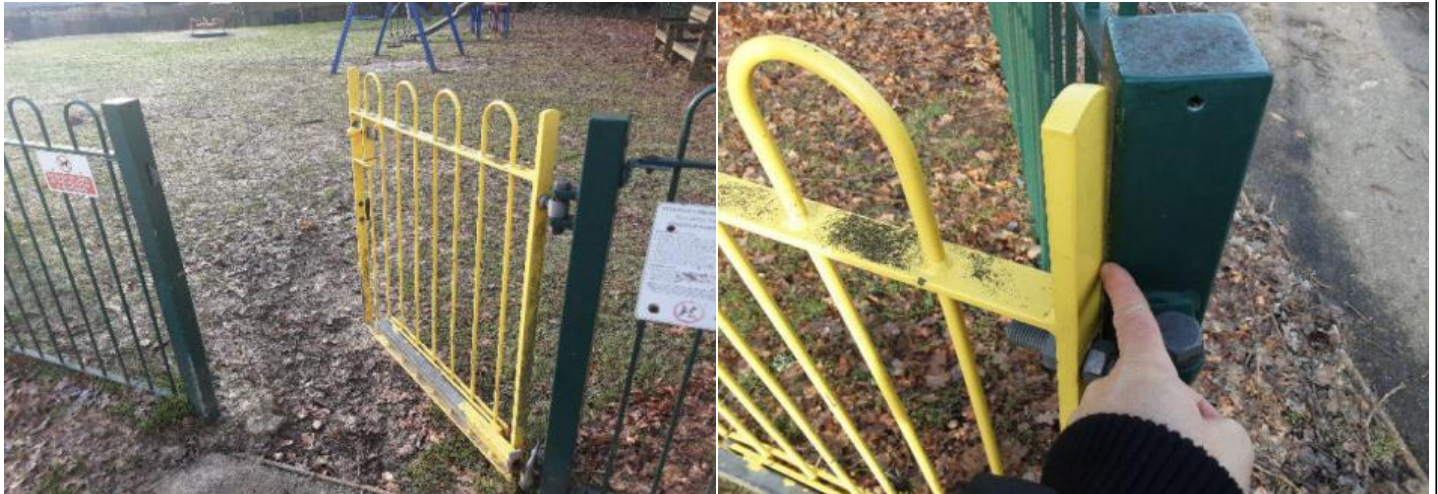
Item: Gates - Gate - Self Closing
Manufacturer: Owner/Operator

Finding: There are openings that are less than 12mm that could trap or crush fingers

Action: Where possible a 12mm gap should be provided on both sides or between the gate leaves

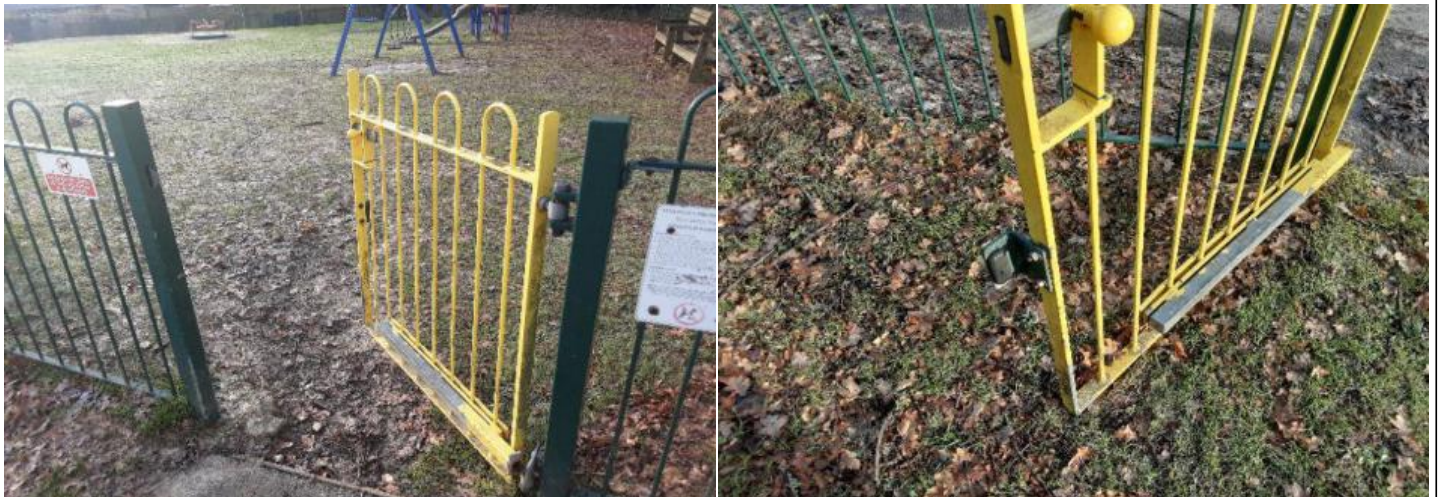
Item: Gates - Gate - Self Closing
Manufacturer: Owner/Operator

Finding: The paint is flaking off the metalwork

Action: Rub down and re-paint

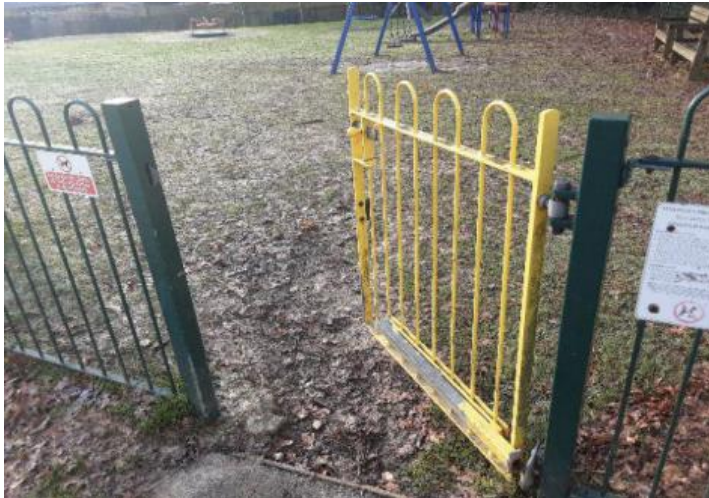
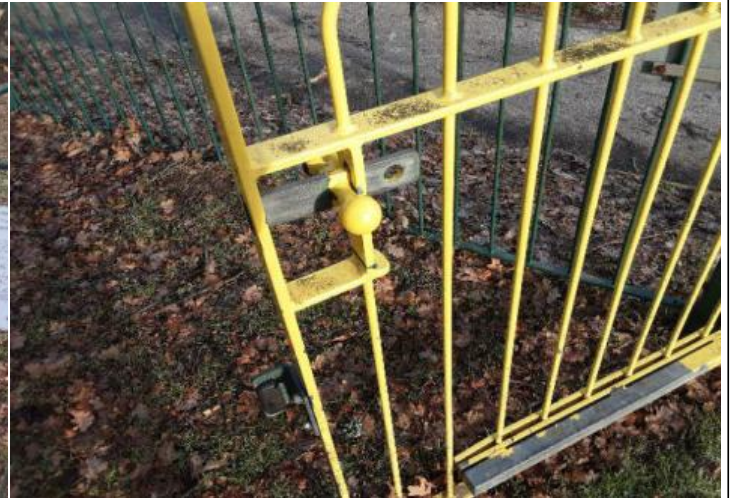
Item: Gates - Gate - Self Closing
Manufacturer: Owner/Operator

Finding: There are a number of redundant cable ties attached to the equipment

Action: Remove

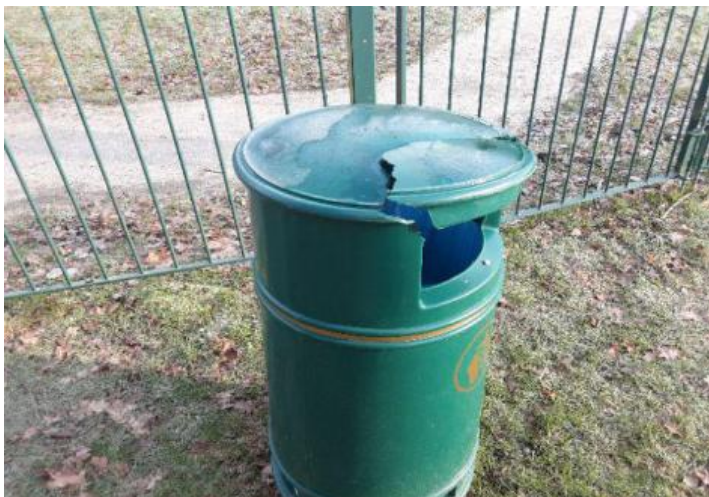
Item: Ancillary Items - Litter Bin
Manufacturer: Owner/Operator

Finding: The item has been severely damaged

Action: Repair or replace the item

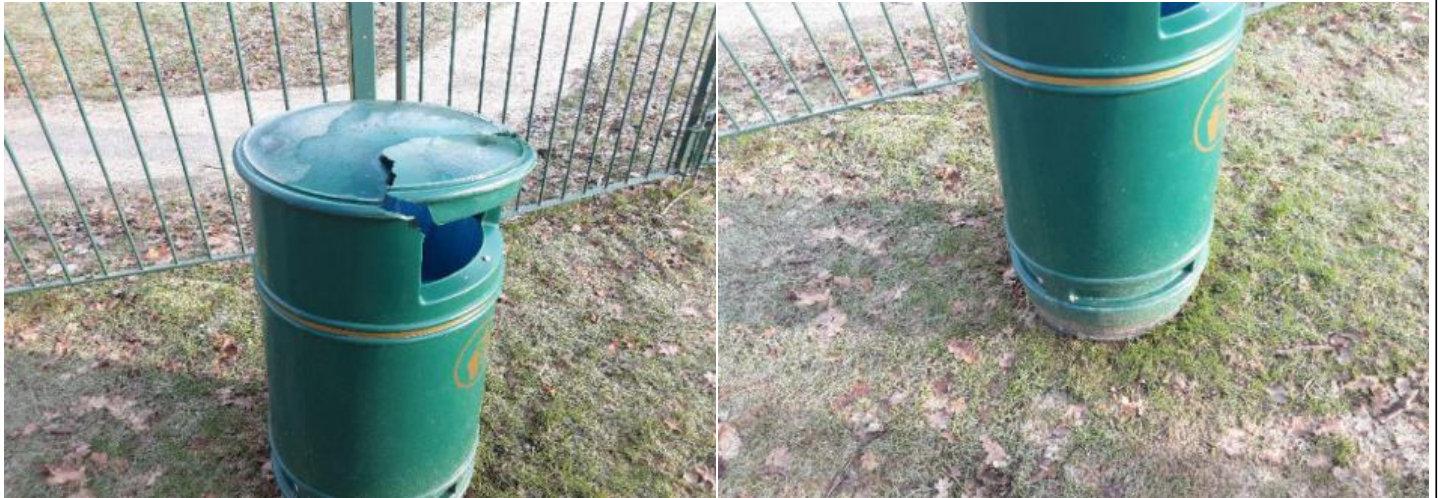
Item: Ancillary Items - Litter Bin
Manufacturer: Owner/Operator

Finding: The lid or door of the litter bin is not secured

Action: Ensure the lid or door is kept locked

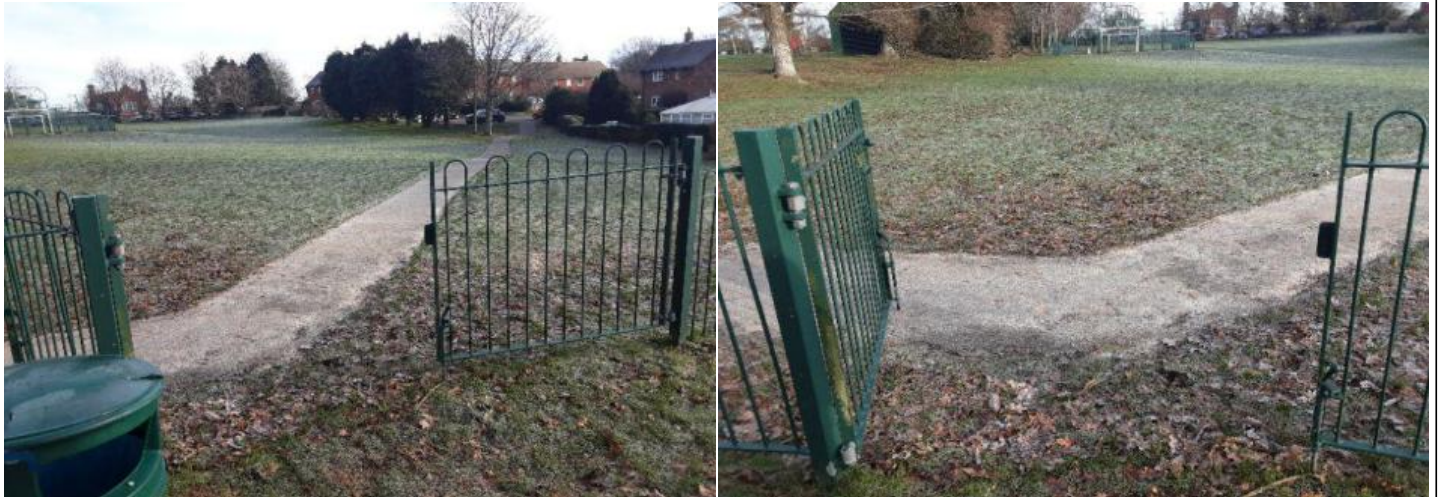
Item: Gates - Gate - Maintenance
Manufacturer: Owner/Operator

Finding: There is no padlock on the maintenance gate

Action: Provide a padlock to secure the gate

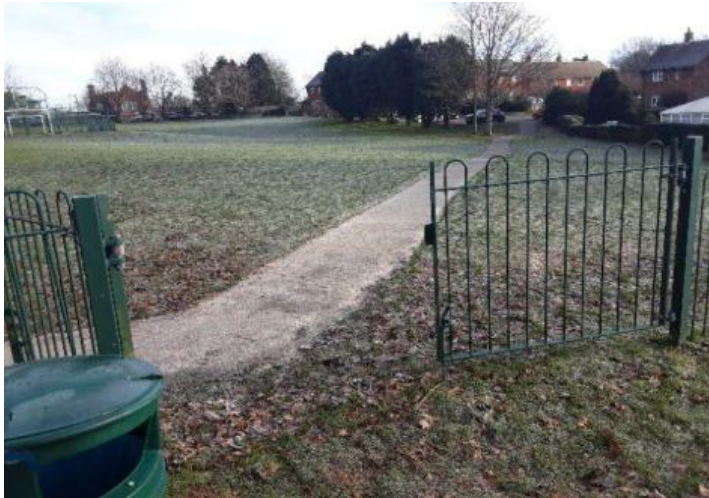
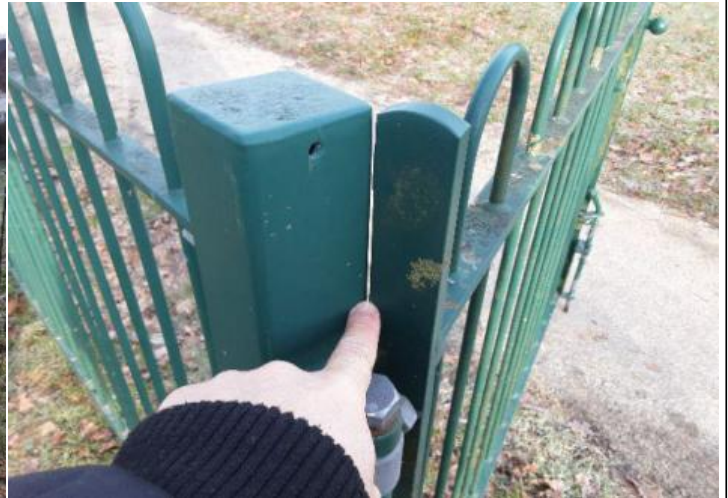
Item: Gates - Gate - Maintenance
Manufacturer: Owner/Operator

Finding: There are openings that are less than 12mm that could trap or crush fingers

Action: Where possible a 12mm gap should be provided on both sides or between the gate leaves

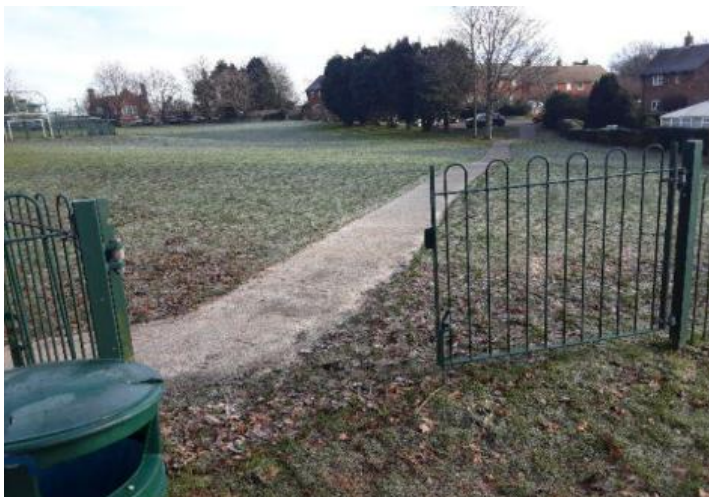
Item: Gates - Gate - Maintenance
Manufacturer: Owner/Operator

Finding: The dropbolt sleeves are damaged

Action: Repair or replace as required

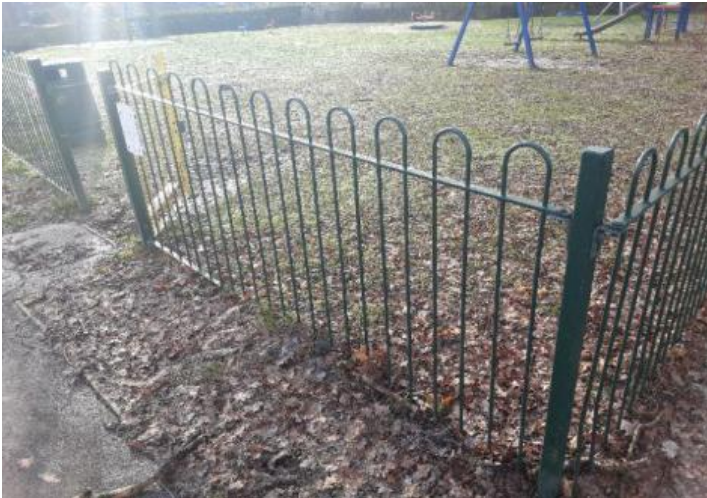
Item: Fences - Fence - Bow Top
Manufacturer: Owner/Operator

Finding: There is some damage to the fence sections

Action: Monitor for any further deterioration and repair as required

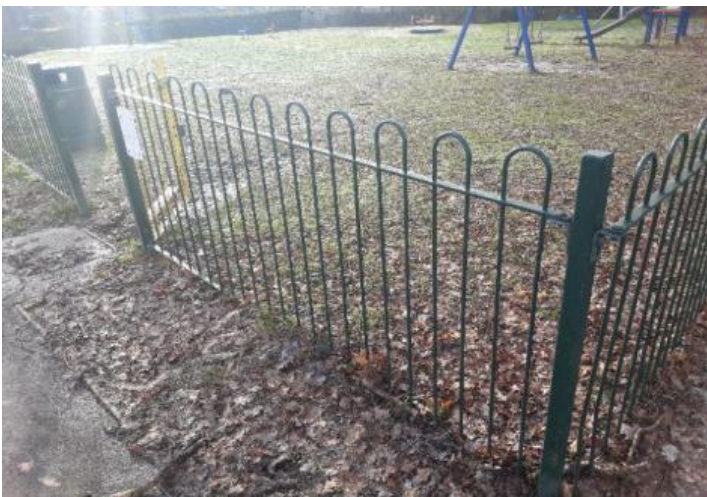
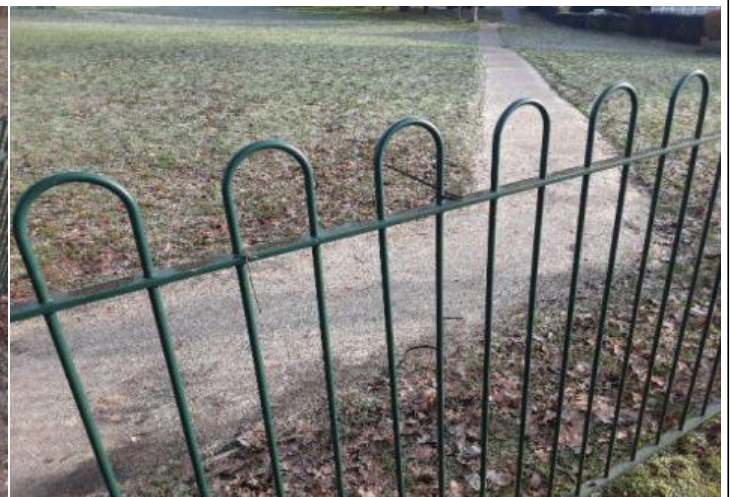
Item: Fences - Fence - Bow Top
Manufacturer: Owner/Operator

Finding: There are a number of redundant cable ties attached to the equipment

Action: Remove

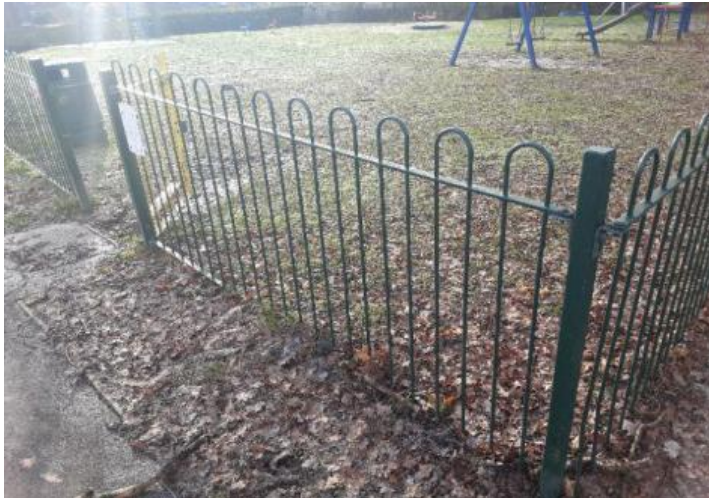
Item: Fences - Fence - Bow Top
Manufacturer: Owner/Operator

Finding: There are a number of fixings missing from the fence

Action: Replace missing fixings

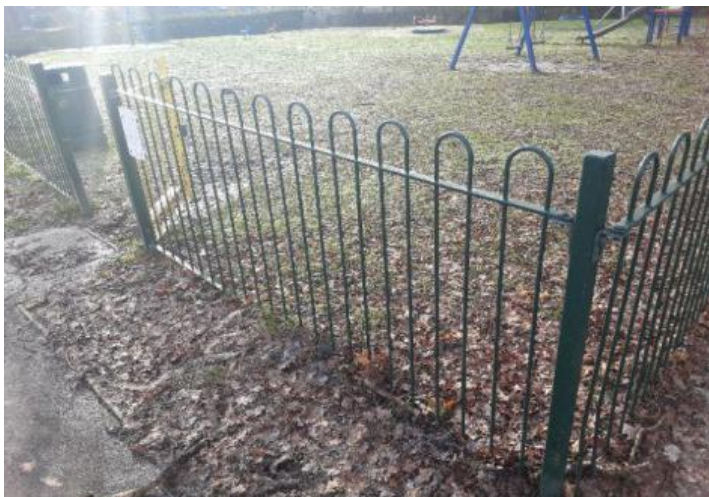
Item: Fences - Fence - Bow Top
Manufacturer: Owner/Operator

Finding: A number of fixings have worked loose around the fencing

Action: Secure all loose fixings

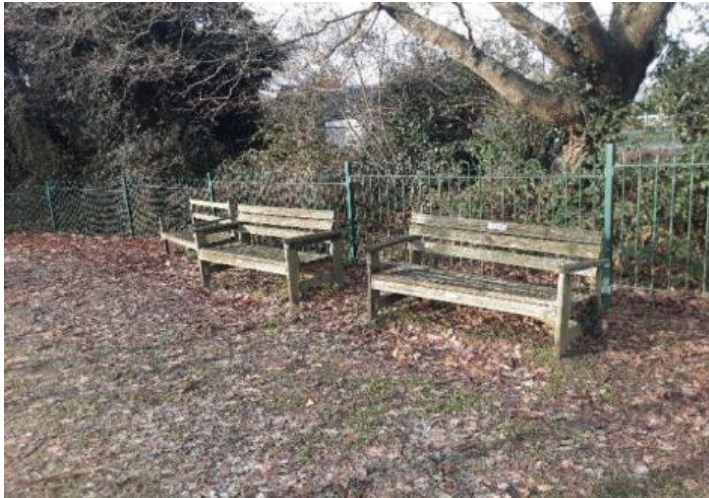
Item: Ancillary Items - Bench
Manufacturer: Owner/Operator

Finding: There are areas or parts of the timber on the structure that have rotted

Action: Replace all affected timbers

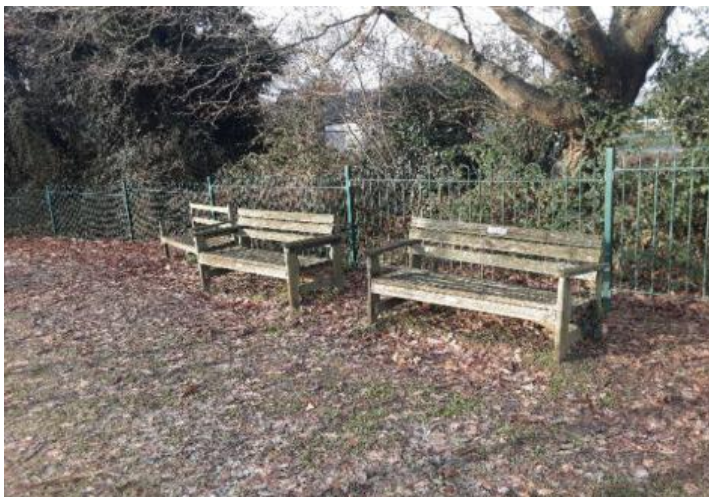
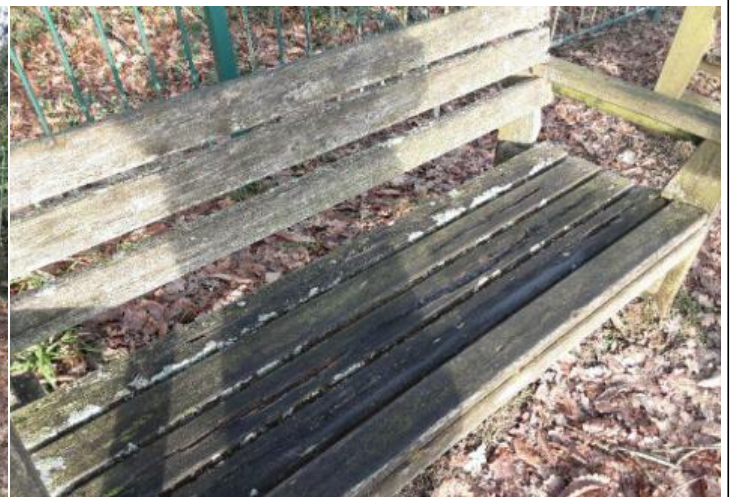
Item: Ancillary Items - Bench
Manufacturer: Owner/Operator

Finding: There is algae or moss on the surface of the equipment

Action: Clean and treat appropriately

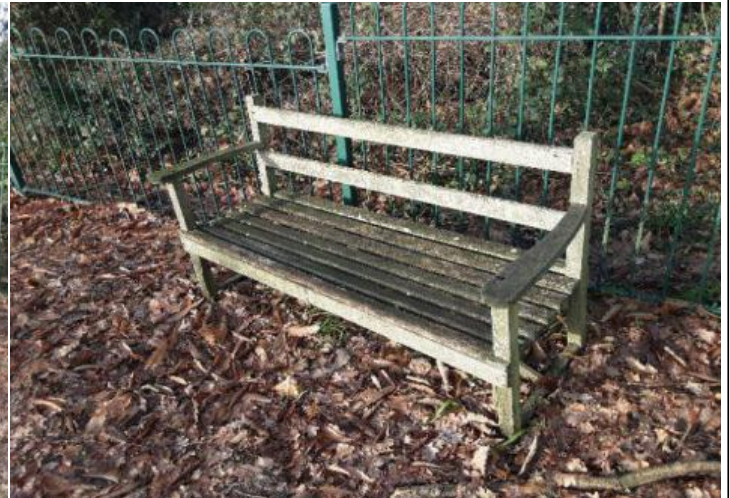
Item: Ancillary Items - Bench
Manufacturer: Owner/Operator

Finding: The bench/es is/are not securely fixed to the surface and there is some possibility of the item/s tipping or rolling over

Action: Secure to the ground

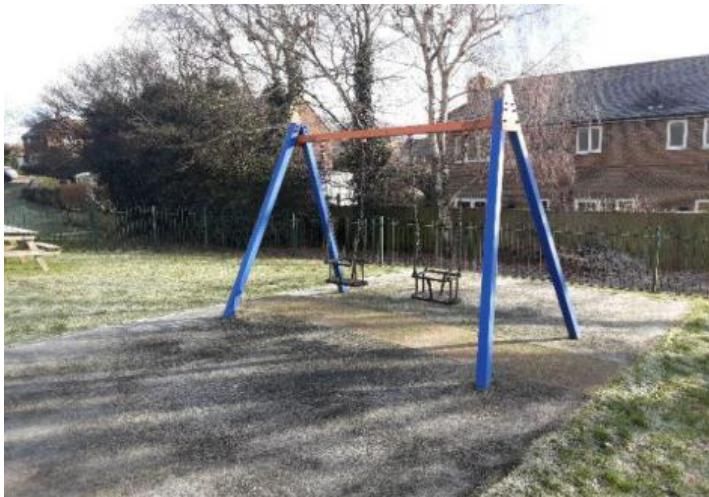
Item: Swings - 1 Bay 1 Seat (Cradle) - Type 1
Manufacturer: Wicksteed Playgrounds

Finding: The safety surface around the area is beginning to wear

Action: Monitor for any further deterioration and repair as required

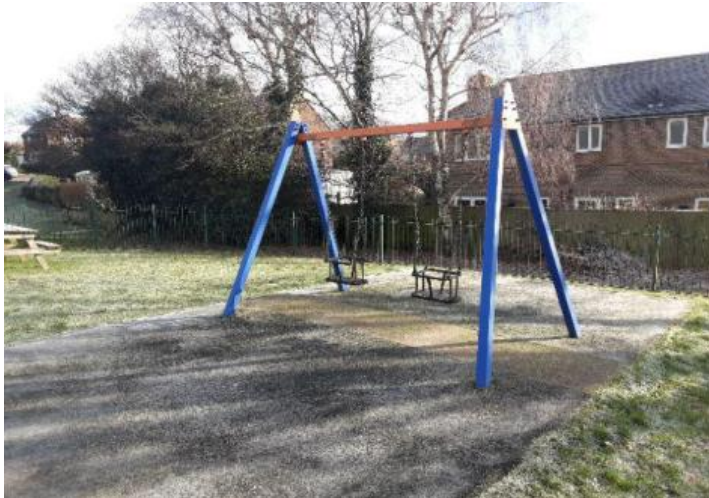
Item: Swings - 1 Bay 1 Seat (Cradle) - Type 1
Manufacturer: Wicksteed Playgrounds

Finding: There is algae, silt or moss growth on the surface resulting in slippery conditions

Action: Clean and treat appropriately

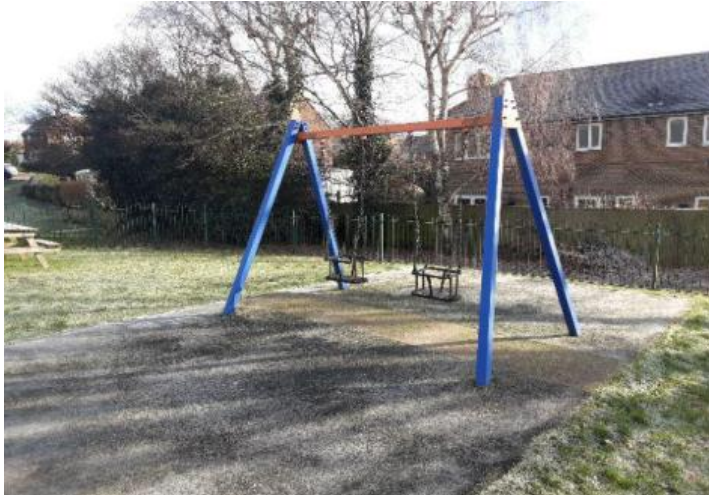
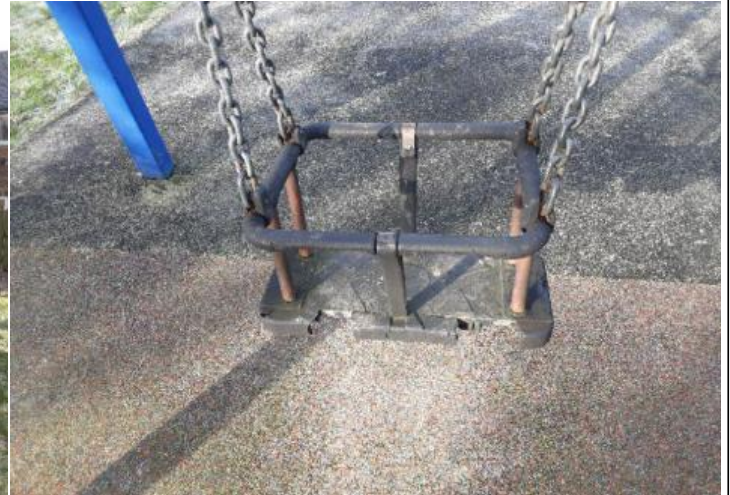
Item: Swings - 1 Bay 1 Seat (Cradle) - Type 1
Manufacturer: Wicksteed Playgrounds

Finding: The seats are severely damaged and requires replacing

Action: Replace damaged seats

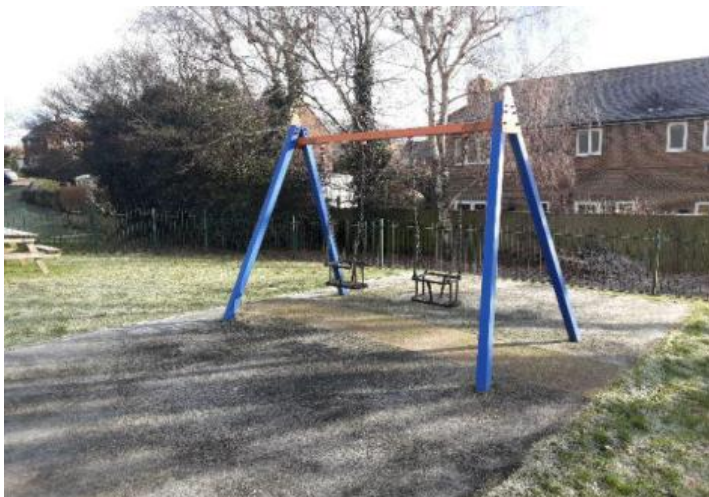
Item: Swings - 1 Bay 1 Seat (Cradle) - Type 1
Manufacturer: Wicksteed Playgrounds

Finding: The chain openings are in excess of the 8.6mm as recommended by BS EN 1176

Action: Monitor - No remedial work recommended

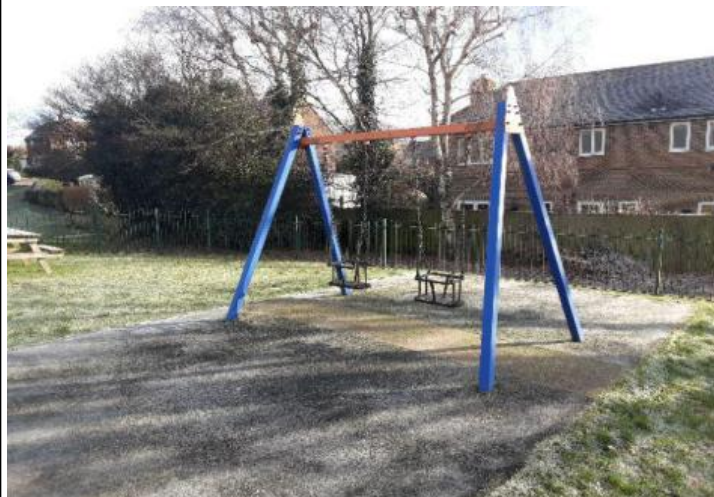
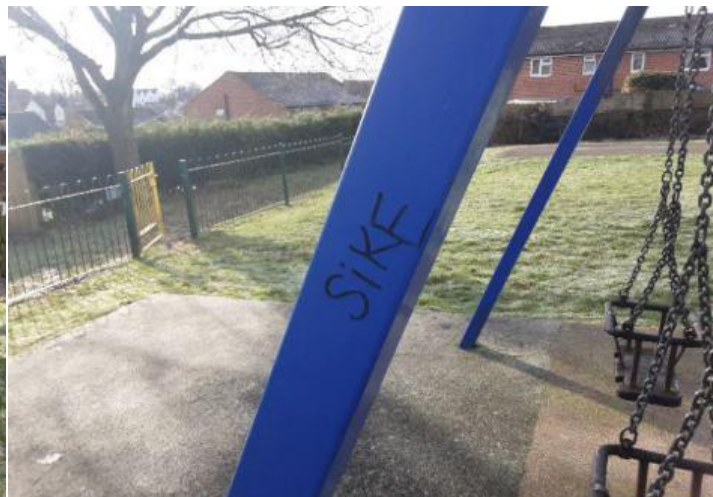
Item: Swings - 1 Bay 1 Seat (Cradle) - Type 1
Manufacturer: Wicksteed Playgrounds

Finding: There is some graffiti present

Action: Remove the graffiti

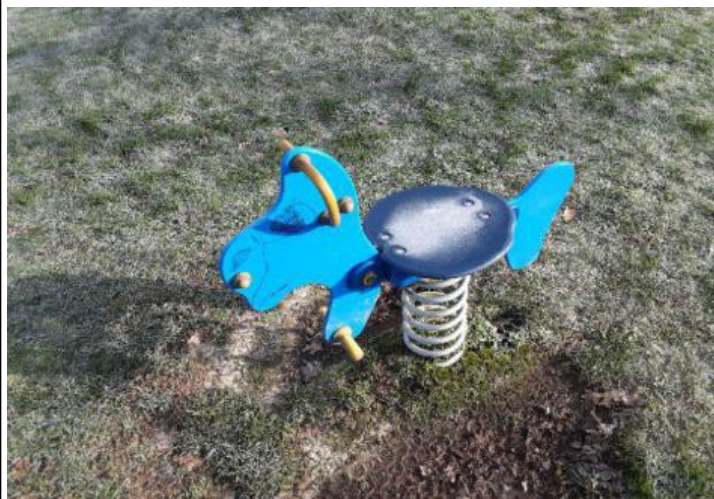
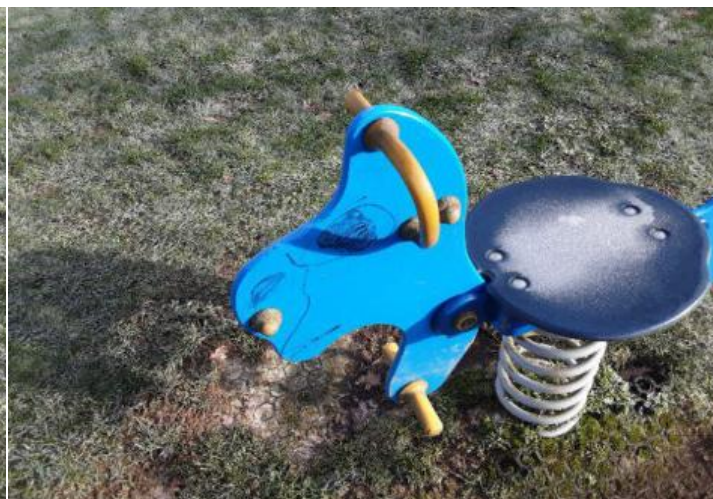
Item: Rocking Equipment - Spring Camel
Manufacturer: Ledon

Finding: There is some graffiti present

Action: Remove the graffiti

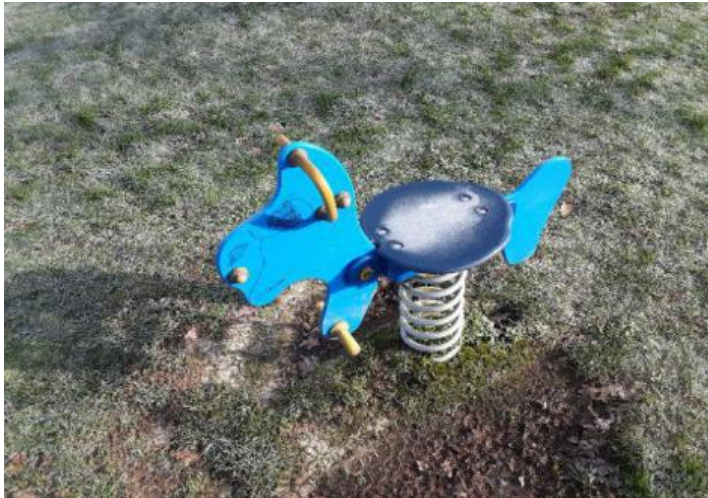
Item: Rocking Equipment - Spring Camel
Manufacturer: Ledon

Finding: The item has been damaged

Action: Monitor for any further deterioration and replace as required

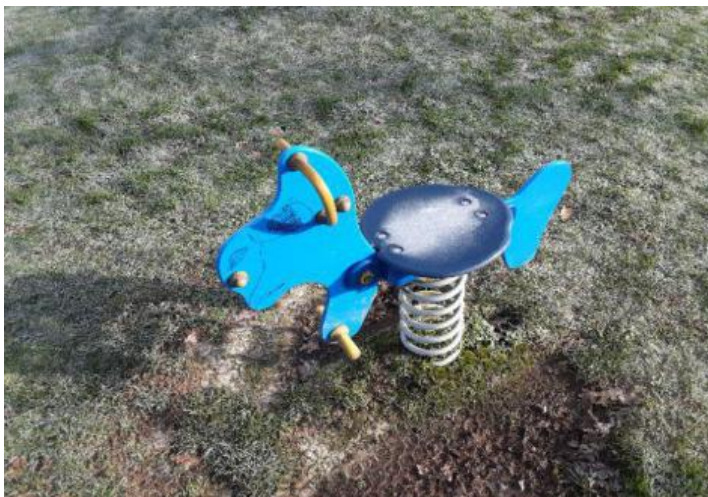
Item: Rocking Equipment - Spring Camel
Manufacturer: Ledon

Finding: The end of handgrips and/or footrests have a cross section of less than 15cm² and fail to meet the requirements of BS EN 1176 Part 6

Action: Monitor - No remedial work recommended

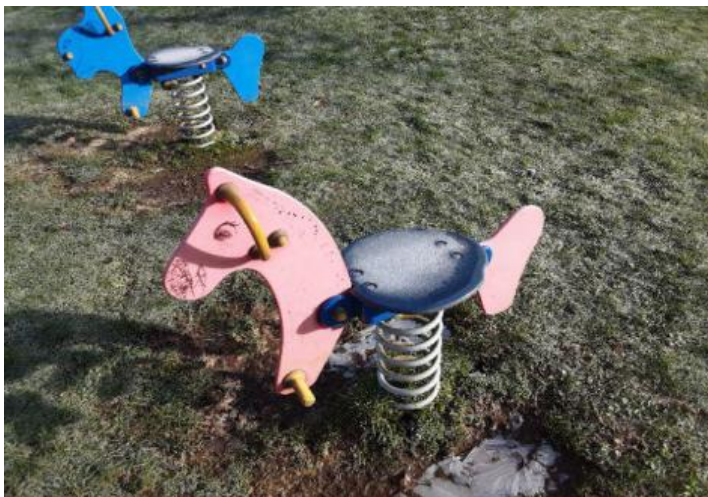
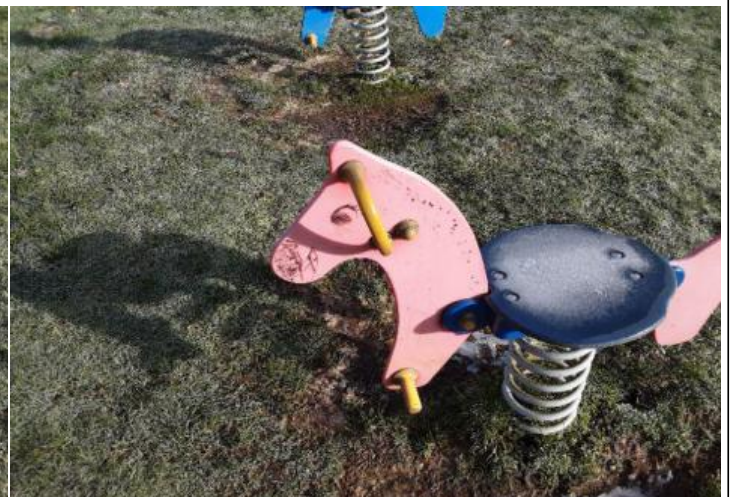
Item: Rocking Equipment - Spring Horse
Manufacturer: Ledon

Finding: There is some graffiti present

Action: Remove the graffiti

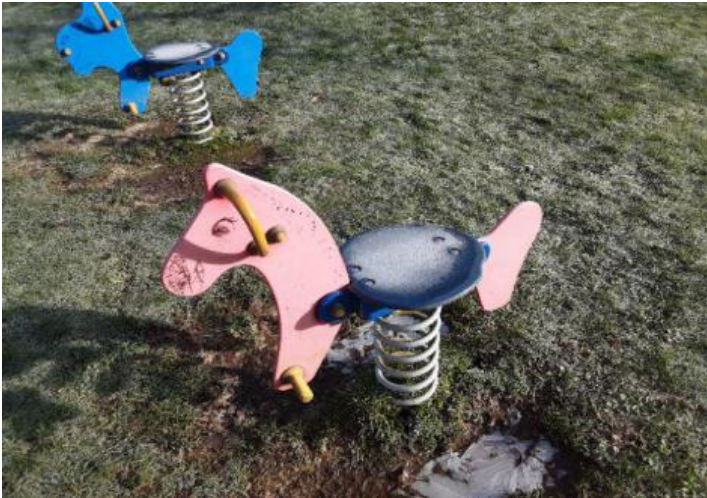
Item: Rocking Equipment - Spring Horse
Manufacturer: Ledon

Finding: The end of handgrips and/or footrests have a cross section of less than 15cm² and fail to meet the requirements of BS EN 1176 Part 6
Action: Monitor - No remedial work recommended

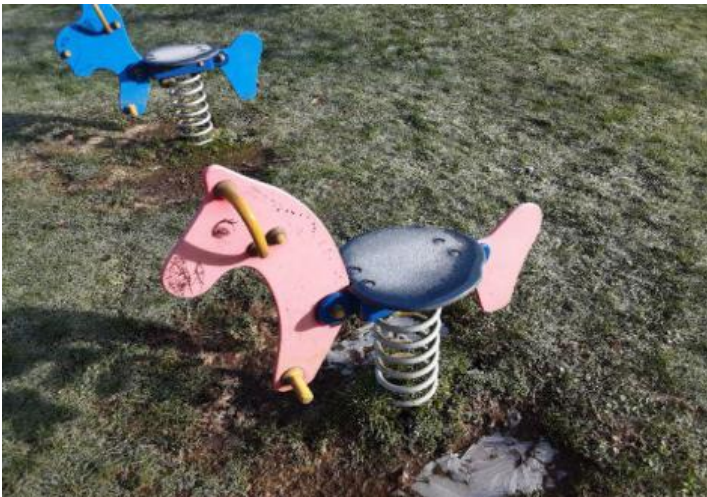
Item: Rocking Equipment - Spring Horse
Manufacturer: Ledon

Finding: The paintwork on the spring has been damaged or worn exposing the metal underneath which is rusting
Action: Treat any rusting components and repaint

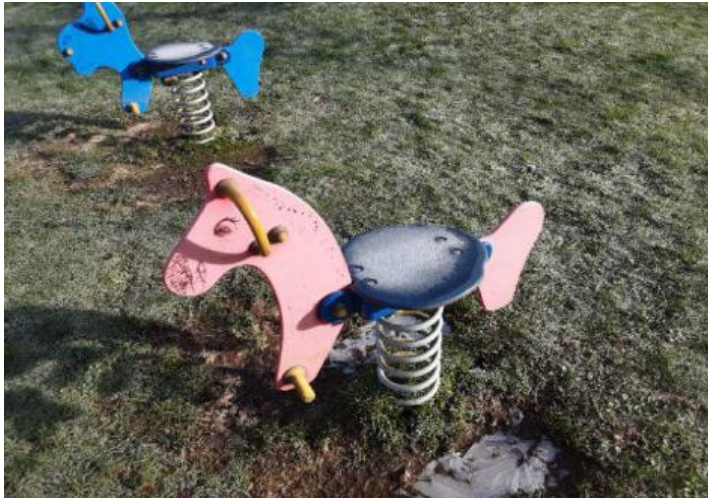
Item: Rocking Equipment - Spring Horse
Manufacturer: Ledon

Finding: The item has been damaged

Action: Monitor for any further deterioration and replace as required
