the play inspection company

Annual Inspection

Ninfield Parish Council

The Recreation Ground

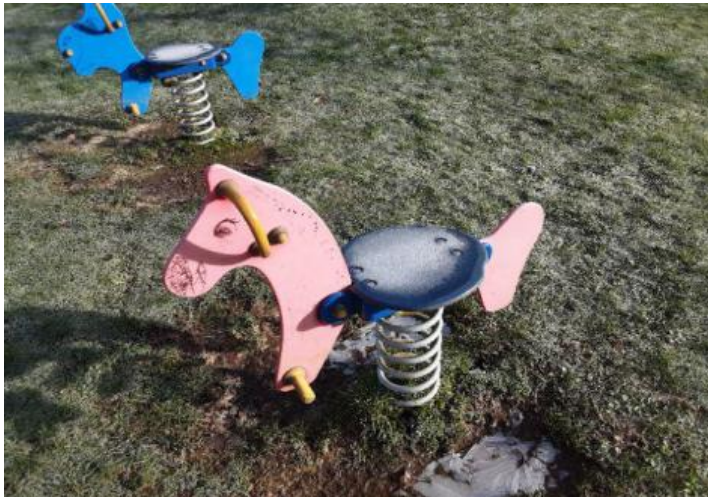
Item: Rocking Equipment - Spring Horse
Manufacturer: Ledon

Finding: There is some minor damage to the surface

Action: Monitor for any further deterioration and repair as required

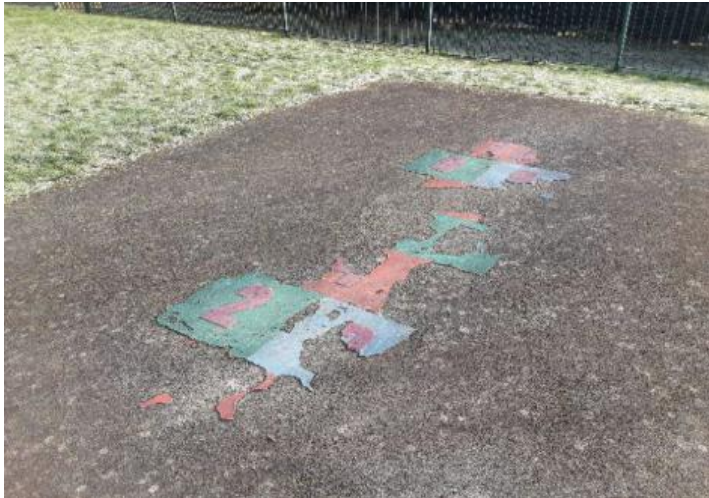
Item: Other - Hopscotch
Manufacturer: Owner/Operator

Finding: The item is damaged

Action: Repair or replace the item

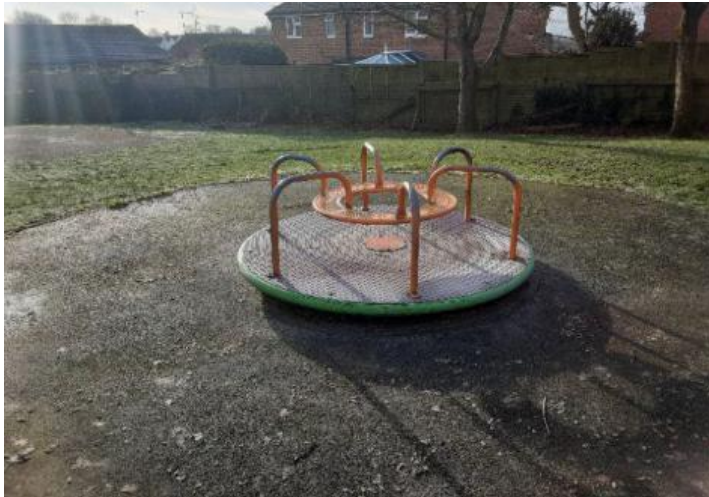
Item: Rotor Play - Roundabout
Manufacturer: Wicksteed Playgrounds

Finding: There are significant gaps (over 30mm) between the surface and the edging or between the joints in the surface; these are large enough for a small foot to enter

Action: Repair surfacing

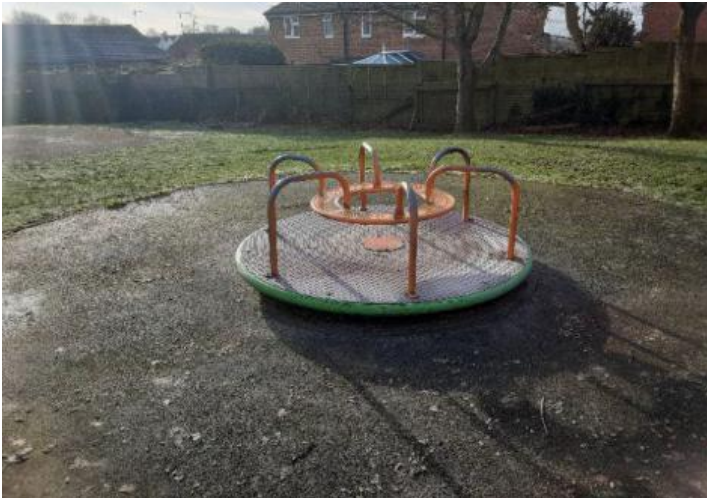
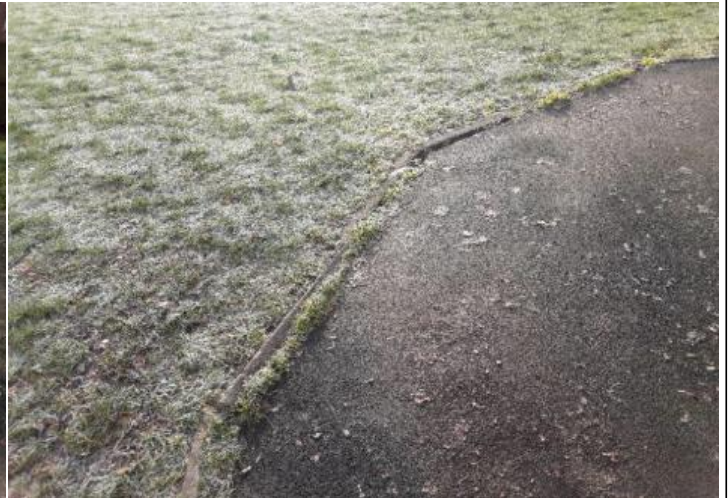
Item: Rotor Play - Roundabout
Manufacturer: Wicksteed Playgrounds

Finding: There is weed / vegetation growth on, between, or around the edges of the surfacing
Action: Remove weed / vegetation growth

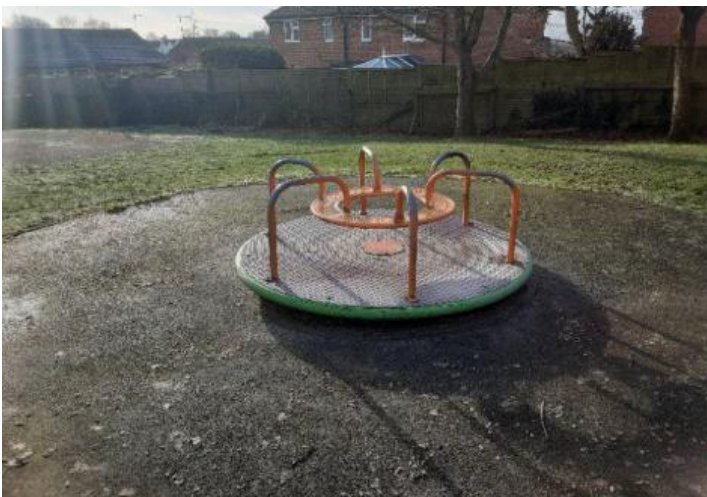
Item: Rotor Play - Roundabout
Manufacturer: Wicksteed Playgrounds

Finding: The safety surface around the area is beginning to wear
Action: Monitor for any further deterioration and repair as required

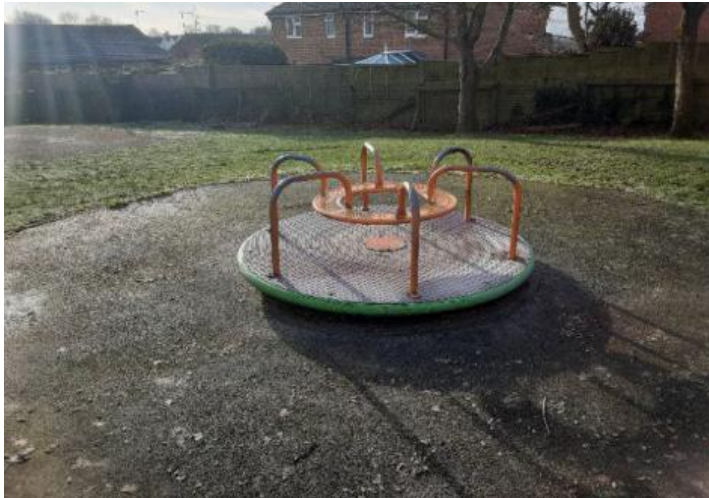
Item: Rotor Play - Roundabout
Manufacturer: Wicksteed Playgrounds

Finding: There is algae, silt or moss growth on the surface resulting in slippery conditions

Action: Clean and treat appropriately

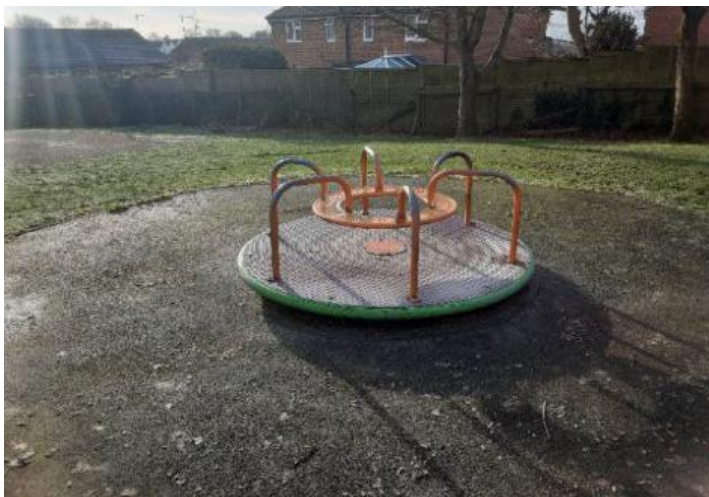
Item: Rotor Play - Roundabout
Manufacturer: Wicksteed Playgrounds

Finding: There are trip hazards at the edges of the surface

Action: Reinstate surrounding surface levels to remove the trip points

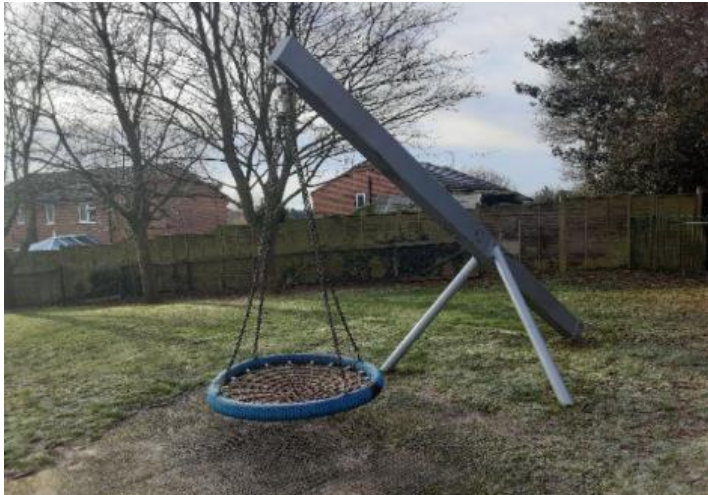
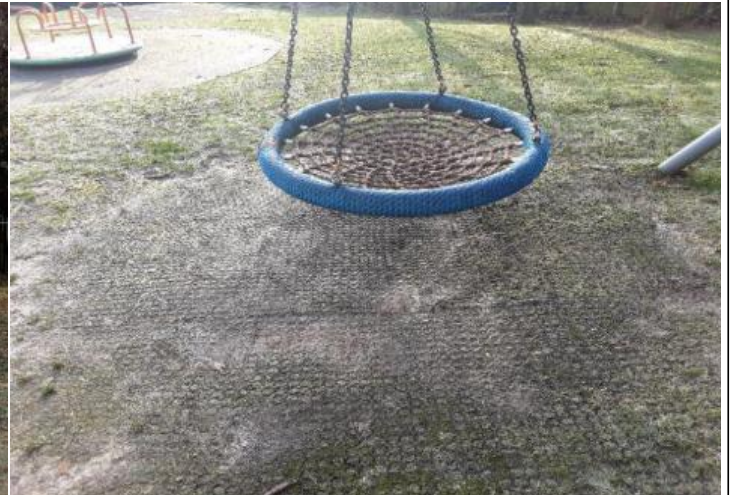
Item: Swings - Cantilever Swing - Type 3
Manufacturer: Miracle Recreation Equipment Company

Finding: The seat clearance from finished surface level to the underside of the seat is too low and does not meet the requirements of BS EN 1176 Part 2 (400mm minimum clearance required from rigid part of seat in most onerous position)

Action: Adjust seat clearance

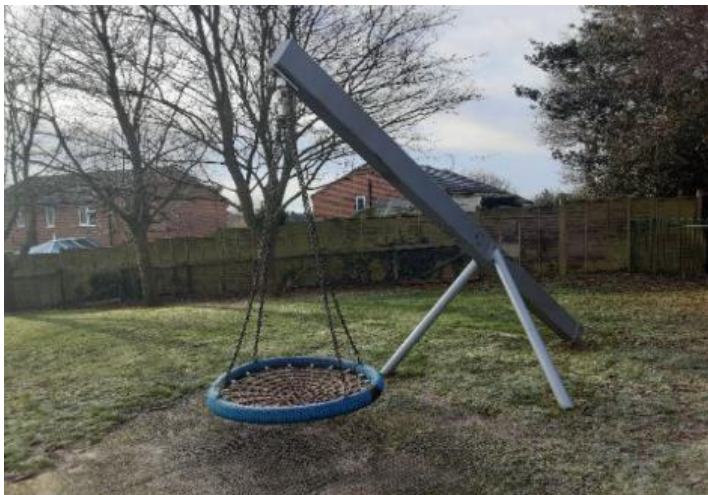
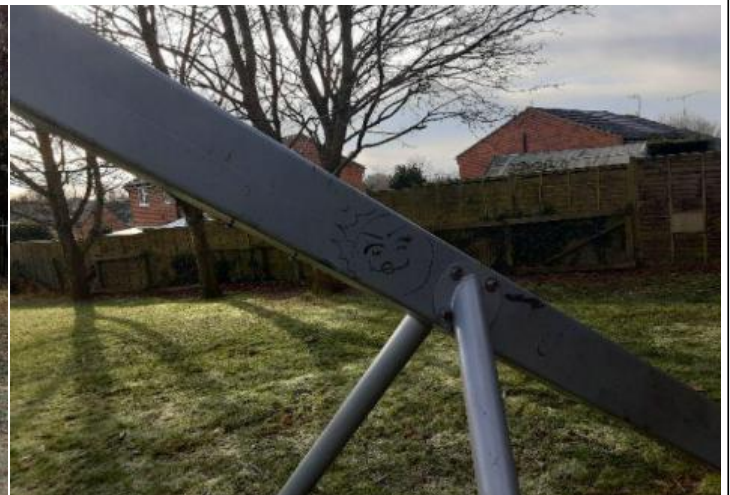
Item: Swings - Cantilever Swing - Type 3
Manufacturer: Miracle Recreation Equipment Company

Finding: There is some graffiti present

Action: Remove the graffiti

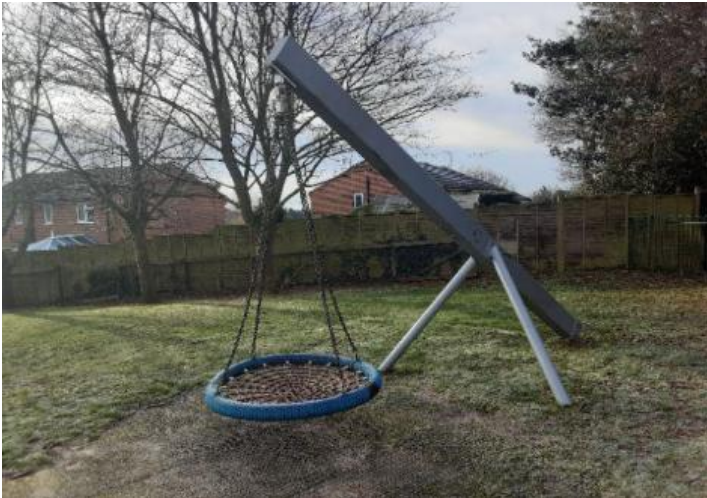
Item: Swings - Cantilever Swing - Type 3
Manufacturer: Miracle Recreation Equipment Company

Finding: The incorrect seat design has been installed on this swing; there are unique designs for Type 1 and Type 3 swings that provide differing impact attenuating properties to the leading edges of the seat and/or has incorrectly aligned seat eye fixings which will lead to accelerated wear.

Action: Consider replacing with the correct design seat

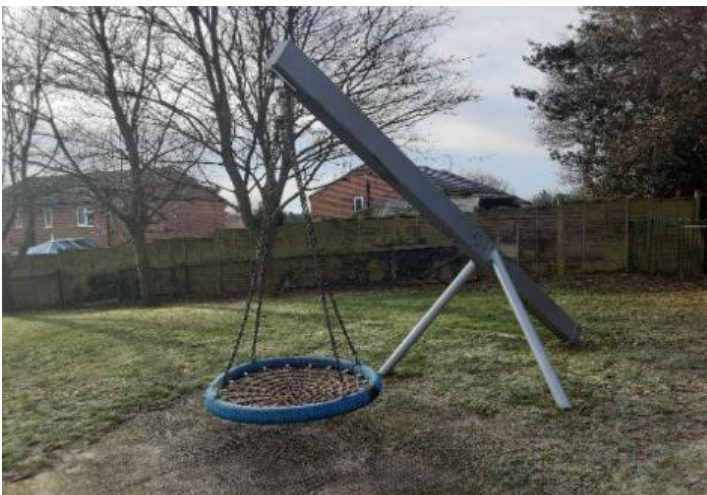
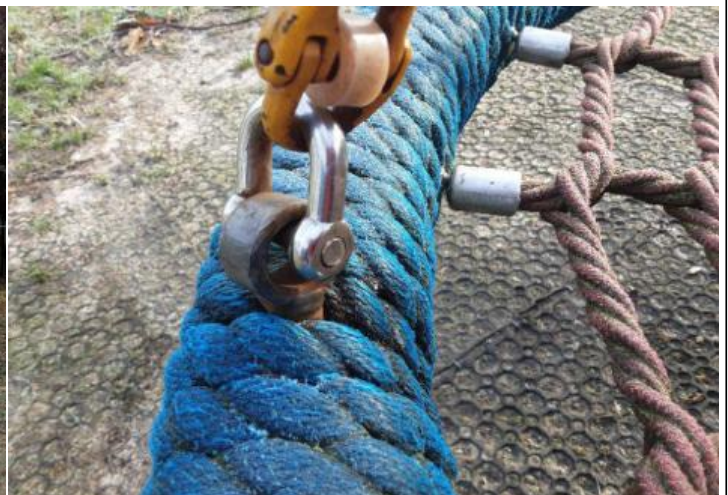
Item: Swings - Cantilever Swing - Type 3
Manufacturer: Miracle Recreation Equipment Company

Finding: The bushes are worn or missing

Action: Replace worn or missing bushes

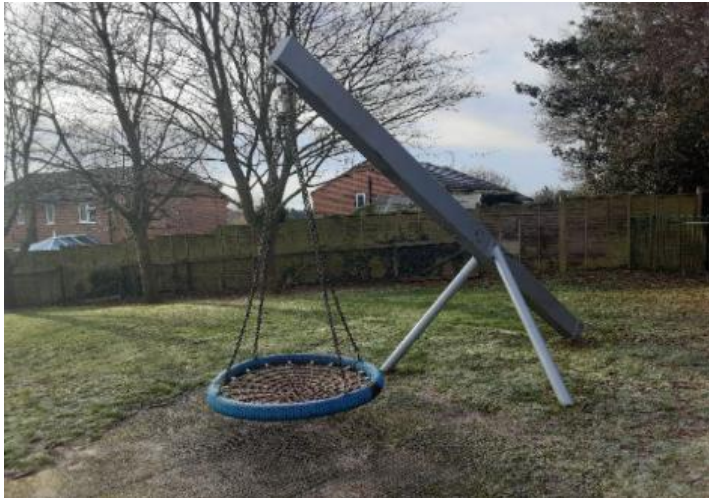
Item: Swings - Cantilever Swing - Type 3
Manufacturer: Miracle Recreation Equipment Company

Finding: The swing seat connectors have some wear present

Action: Monitor for further deterioration and replace when 40% worn

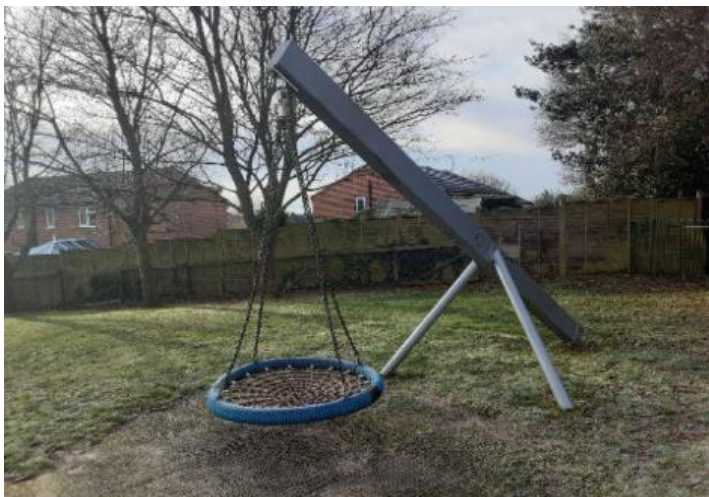
Item: Swings - Cantilever Swing - Type 3
Manufacturer: Miracle Recreation Equipment Company

Finding: There is some notable evidence of chain wear

Action: Monitor for any further deterioration and replace when 40% worn

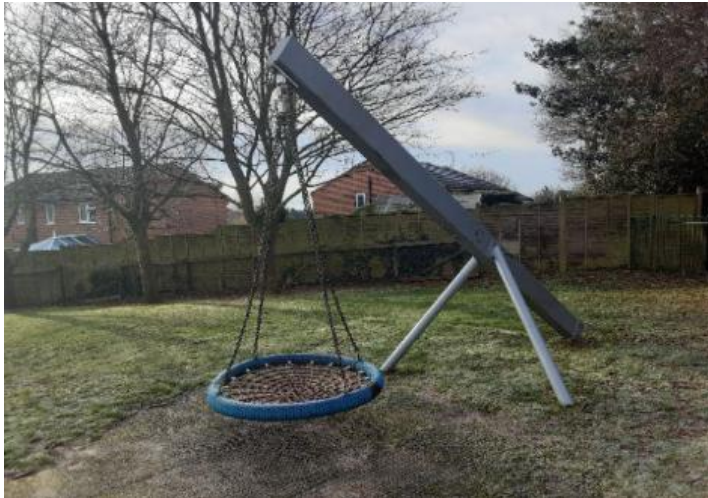
Item: Swings - Cantilever Swing - Type 3
Manufacturer: Miracle Recreation Equipment Company

Finding: There is some wear to the shackles.

Action: Monitor for any further deterioration and replace when 40% worn

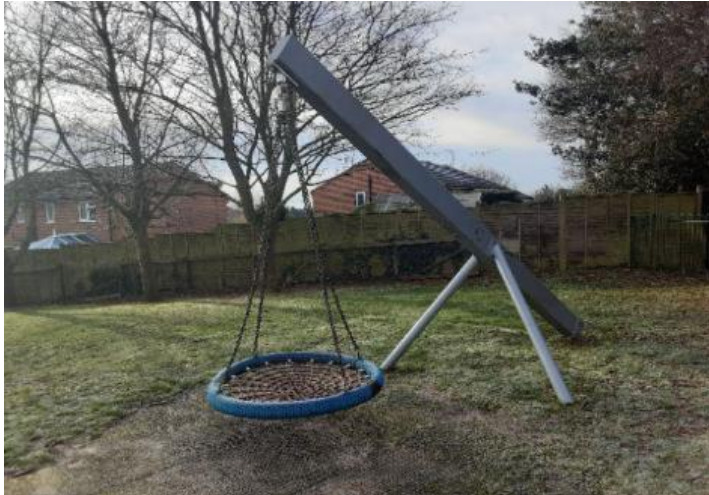
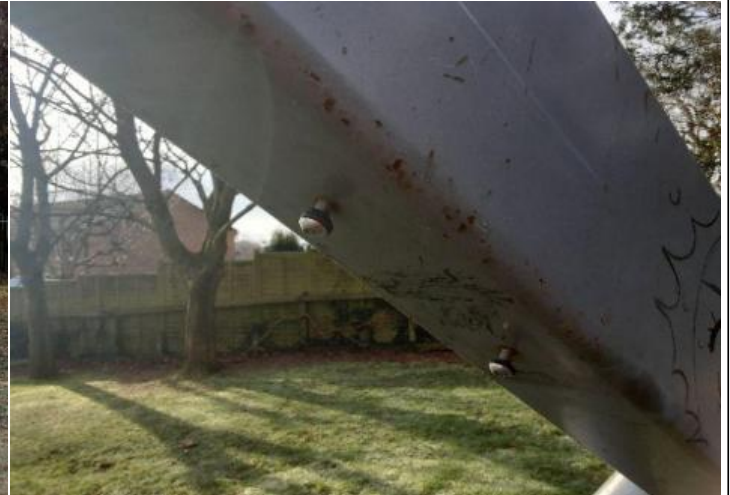
Item: Swings - Cantilever Swing - Type 3
Manufacturer: Miracle Recreation Equipment Company

Risk Level: M - Moderate Risk
Surface: Grass Matrix Tiles

Finding: The beam buffer is missing and there are projecting fixings present

Action: Remove the projecting fixings and replace all missing components

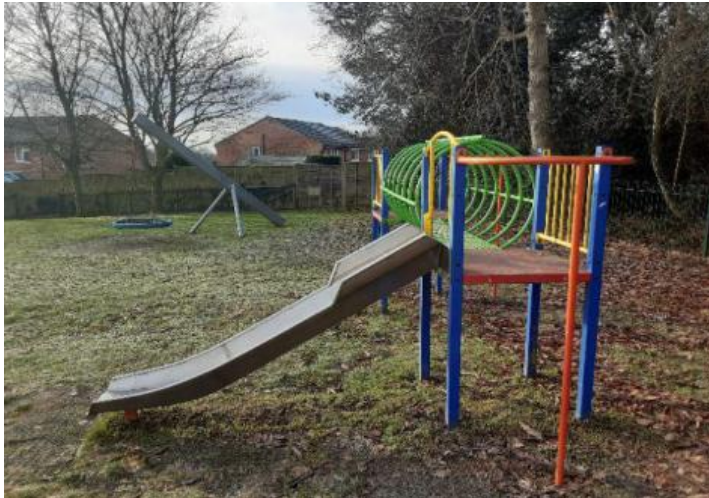
Item: Activity Equipment - Multi Play (Junior)
Manufacturer: Wicksteed Playgrounds

Risk Level: L - Low Risk
Surface: Grass Matrix Tiles

Finding: The unit is easily accessible and has an opening in the barrier to steep play elements in excess of 500mm in contravention of BS EN 1176 Part 1
Action: Monitor - No remedial work recommended

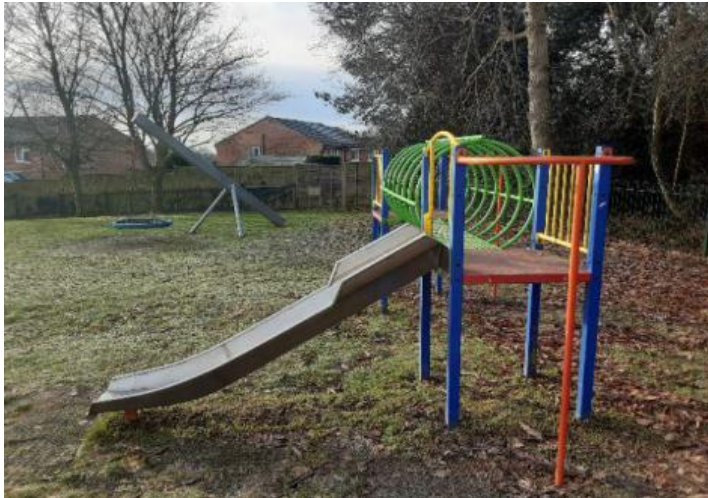
Item: Activity Equipment - Multi Play (Junior)
Manufacturer: Wicksteed Playgrounds

Risk Level: V - Very Low Risk
Surface: Grass Matrix Tiles

Finding: There is/are finger entrapment/s in the frame and the item fails to meet the requirements of BS EN 1176 Part 1 4.2.7.6 Entrapment of fingers

Action: Monitor - No remedial work recommended

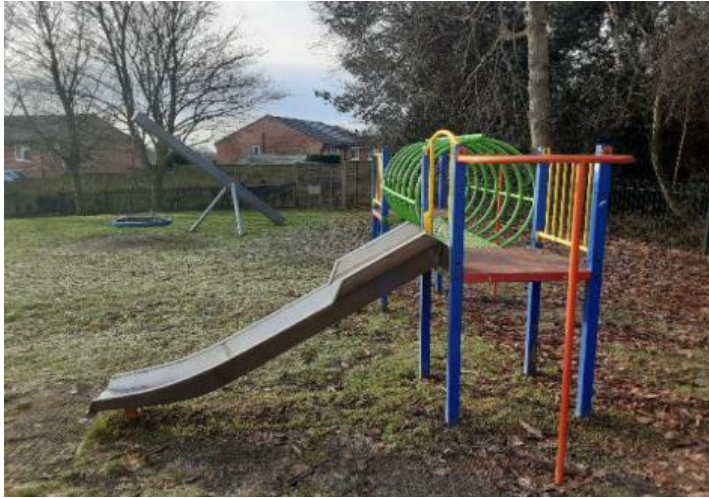
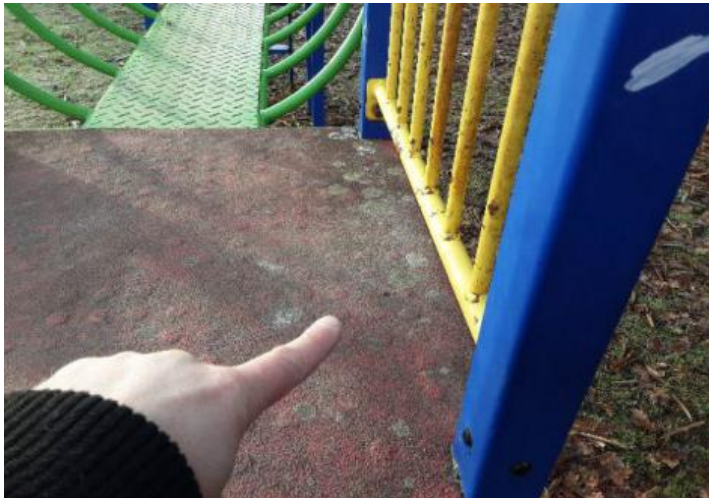
Item: Activity Equipment - Multi Play (Junior)
Manufacturer: Wicksteed Playgrounds

Risk Level: M - Moderate Risk
Surface: Grass Matrix Tiles

Finding: Parts of the steel on this item have corroded excessively and the metal has perforated in places

Action: Ensure all affected areas are treated and repaired

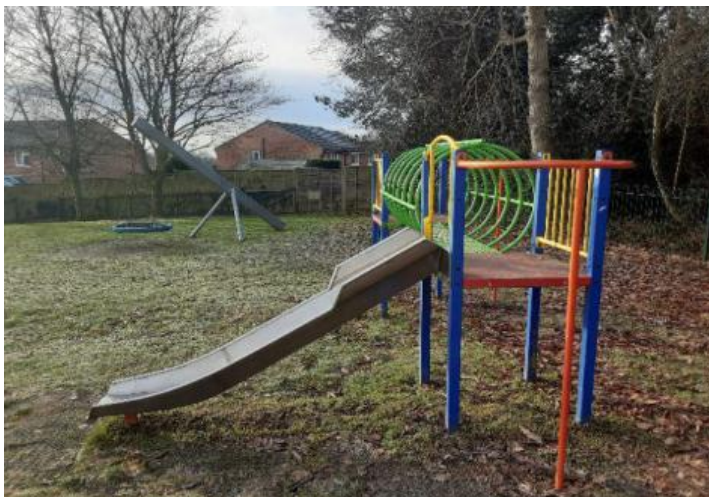
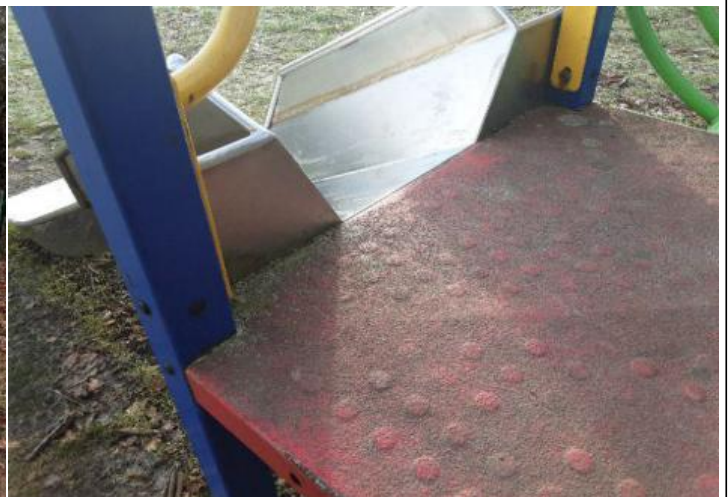
Item: Activity Equipment - Multi Play (Junior)
Manufacturer: Wicksteed Playgrounds

Risk Level: L - Low Risk
Surface: Grass Matrix Tiles

Finding: There is algae or moss on the surface of the equipment

Action: Clean and treat appropriately

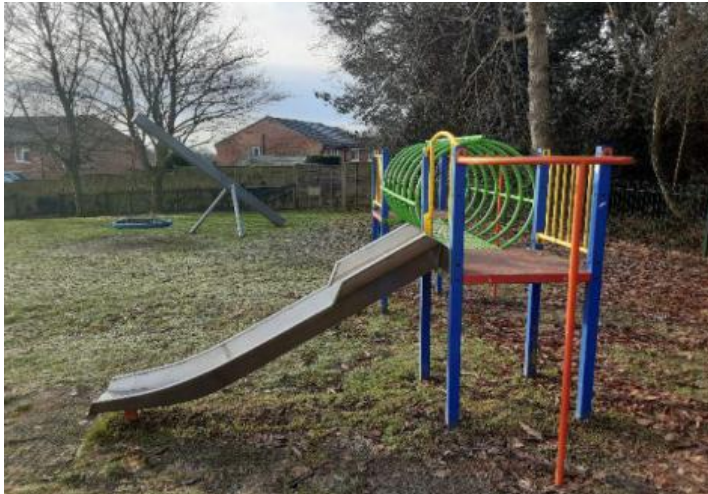
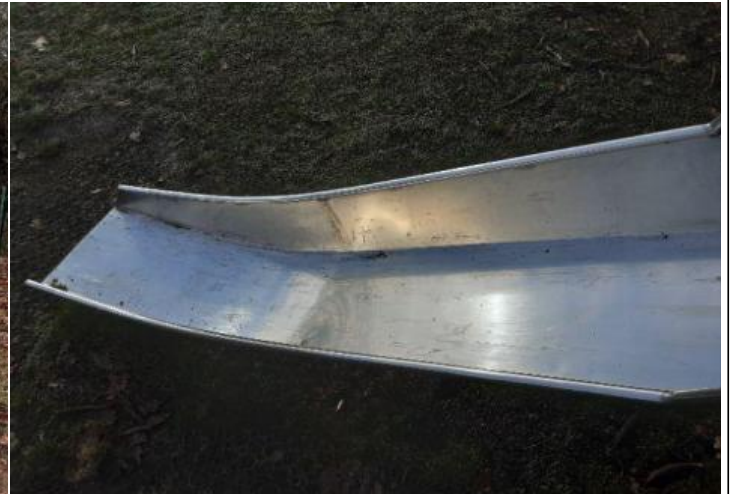
Item: Activity Equipment - Multi Play (Junior)
Manufacturer: Wicksteed Playgrounds

Risk Level: V - Very Low Risk
Surface: Grass Matrix Tiles

Finding: There are a number of dents in the slide surface

Action: Monitor for any further deterioration and repair as required

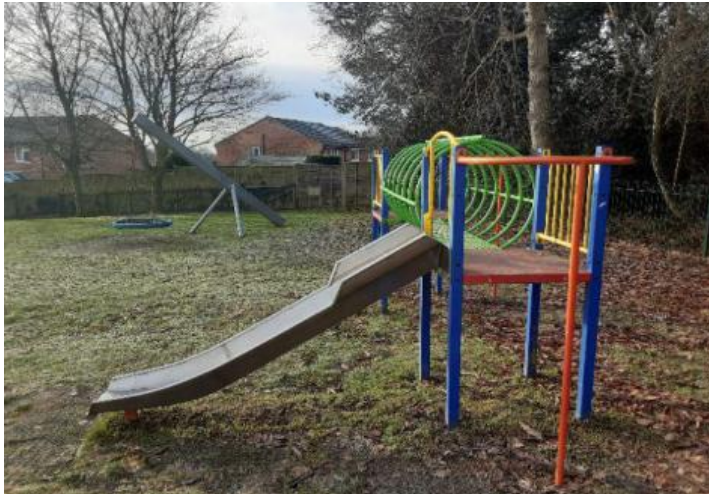
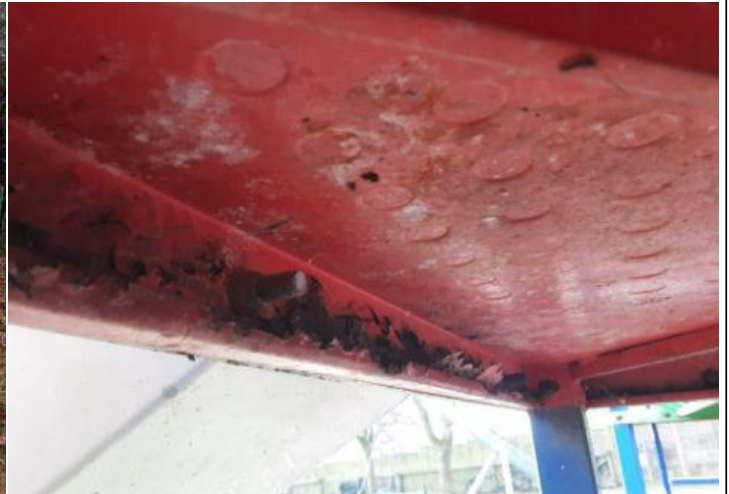
Item: Activity Equipment - Multi Play (Junior)
Manufacturer: Wicksteed Playgrounds

Risk Level: L - Low Risk
Surface: Grass Matrix Tiles

Finding: There are projecting bolt thread(s) present

Action: Remove excess thread length and deburr or provide cap

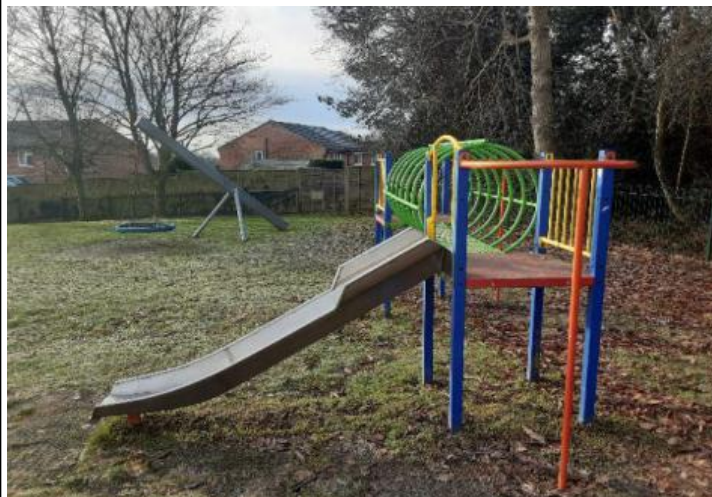
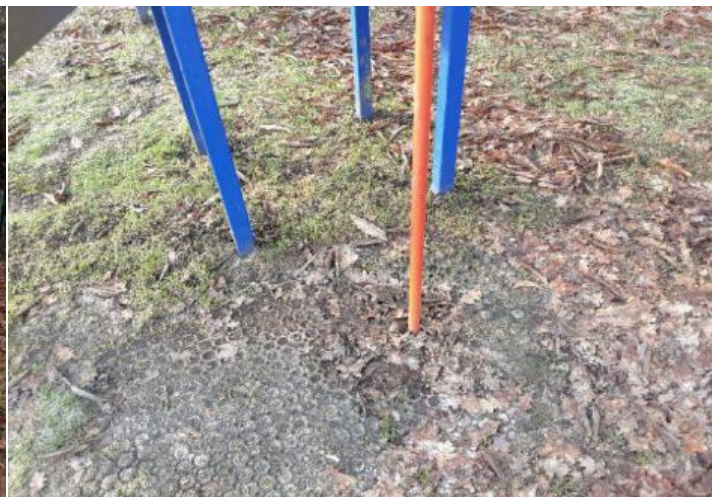
Item: Activity Equipment - Multi Play (Junior)
Manufacturer: Wicksteed Playgrounds

Risk Level: L - Low Risk
Surface: Grass Matrix Tiles

Finding: There is moderate damage to the surface

Action: Repair the damaged areas of surfacing

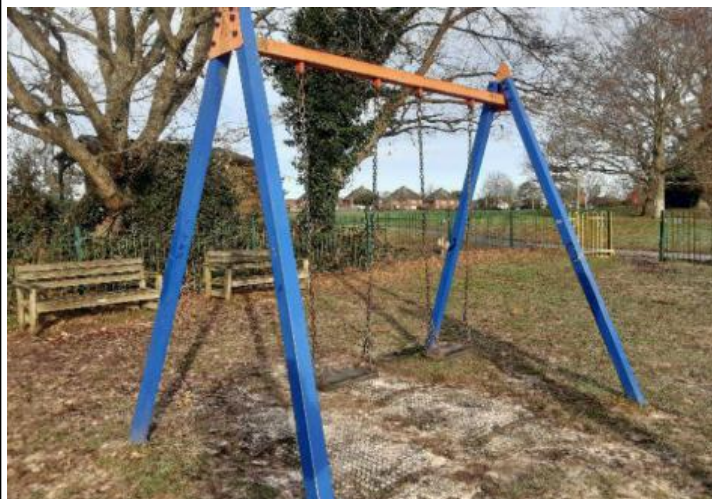
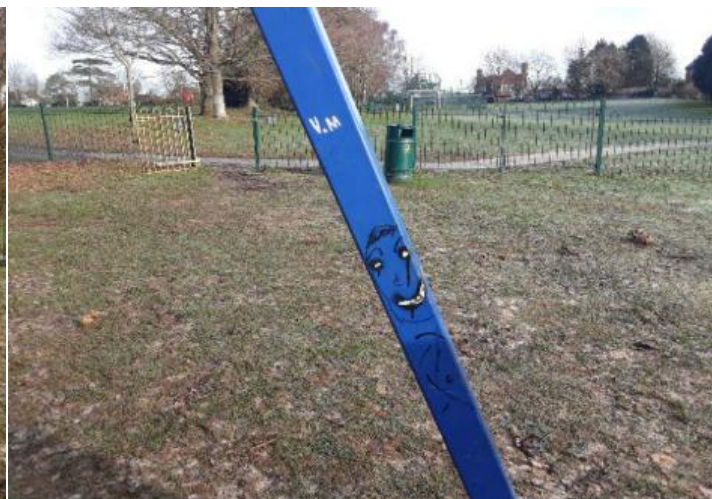
Item: Swings - 1 Bay 2 Seat (Flat)
Manufacturer: Wheelscape Ltd

Risk Level: N - Risk Assessment not Undertaken
Surface: Grass Matrix Tiles

Finding: There is some graffiti present

Action: Remove the graffiti

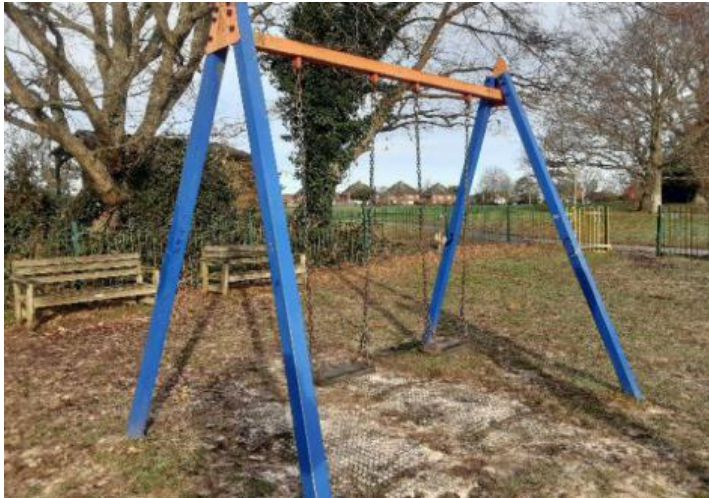
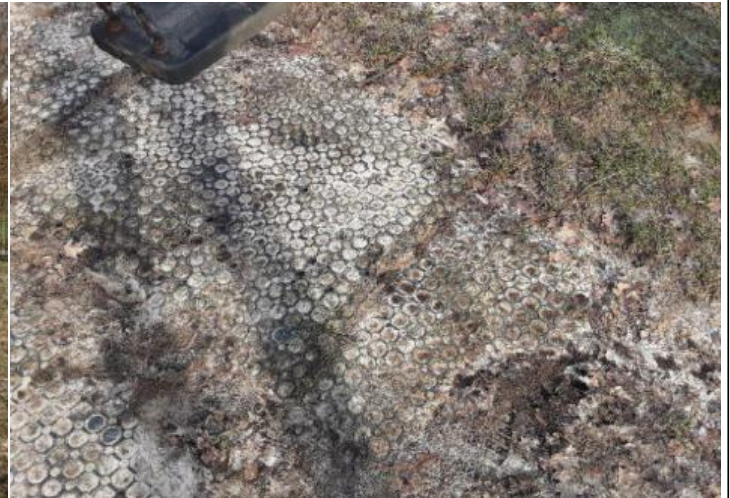
Item: Swings - 1 Bay 2 Seat (Flat)
Manufacturer: Wheelscape Ltd

Risk Level: L - Low Risk
Surface: Grass Matrix Tiles

Finding: Fixing Pins have been installed in the impact areas of the grass mats **Action:** Remove pins from impact areas

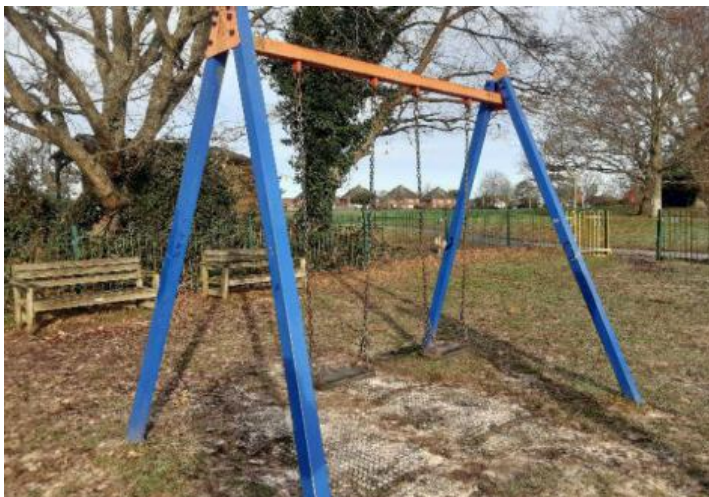
Item: Swings - 1 Bay 2 Seat (Flat)
Manufacturer: Wheelscape Ltd

Risk Level: L - Low Risk
Surface: Grass Matrix Tiles

Finding: There is moderate damage to the surface **Action:** Repair the damaged areas of surfacing

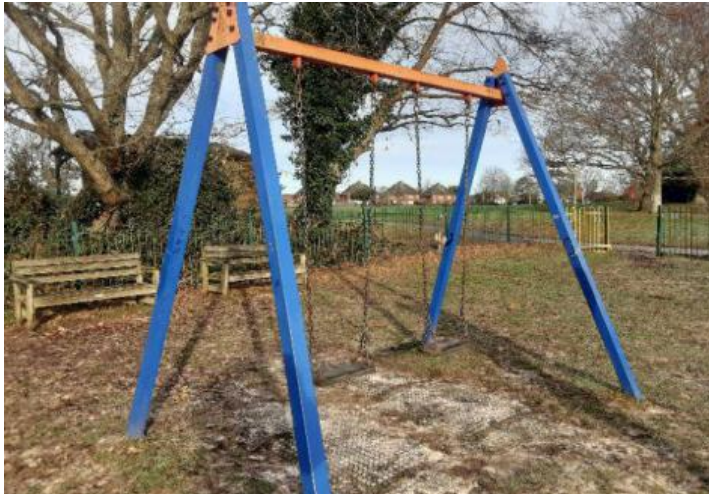
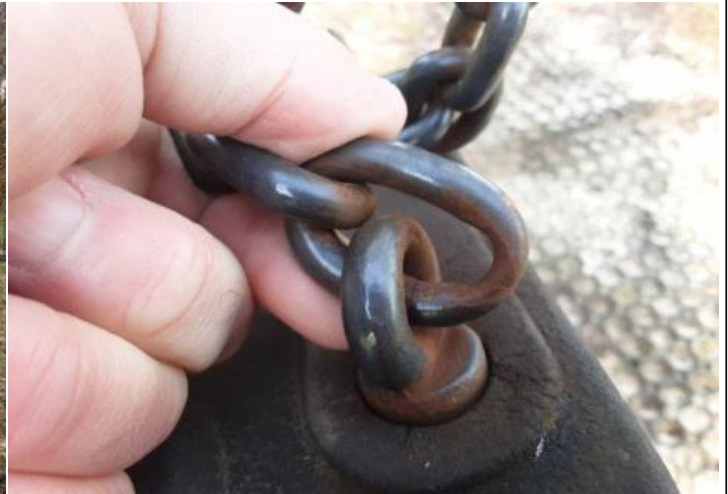
Item: Swings - 1 Bay 2 Seat (Flat)
Manufacturer: Wheelscape Ltd

Risk Level: L - Low Risk
Surface: Grass Matrix Tiles

Finding: The chain links are worn in excess of 40% and require renewing

Action: Replace worn chains

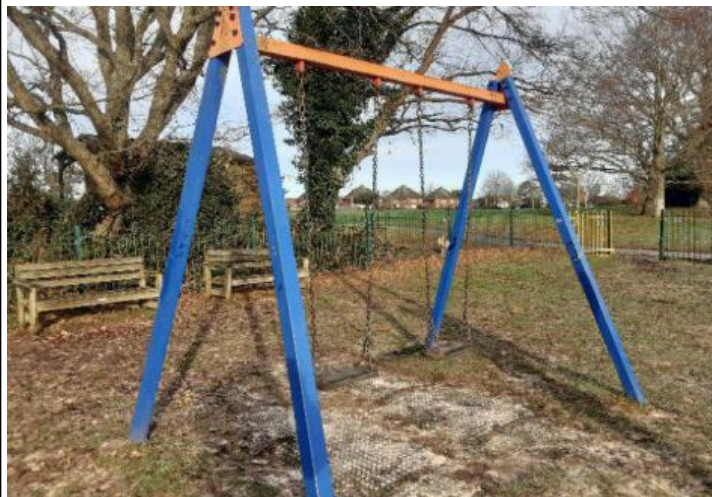
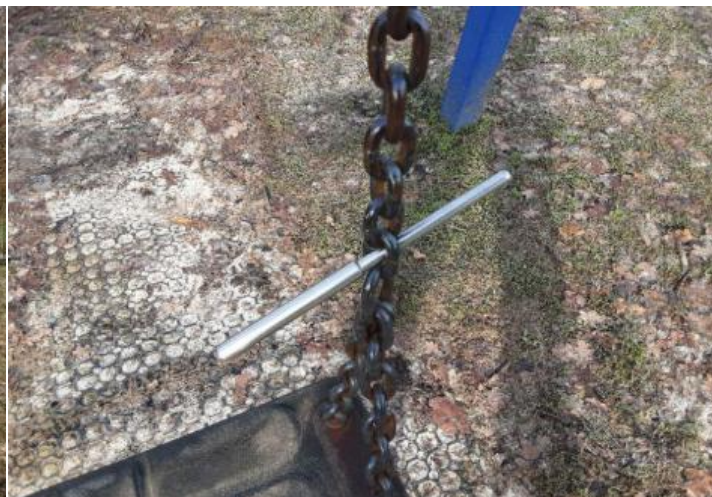
Item: Swings - 1 Bay 2 Seat (Flat)
Manufacturer: Wheelscape Ltd

Risk Level: V - Very Low Risk
Surface: Grass Matrix Tiles

Finding: The chain openings are in excess of the 8.6mm as recommended by BS EN 1176
Action: Monitor - No remedial work recommended

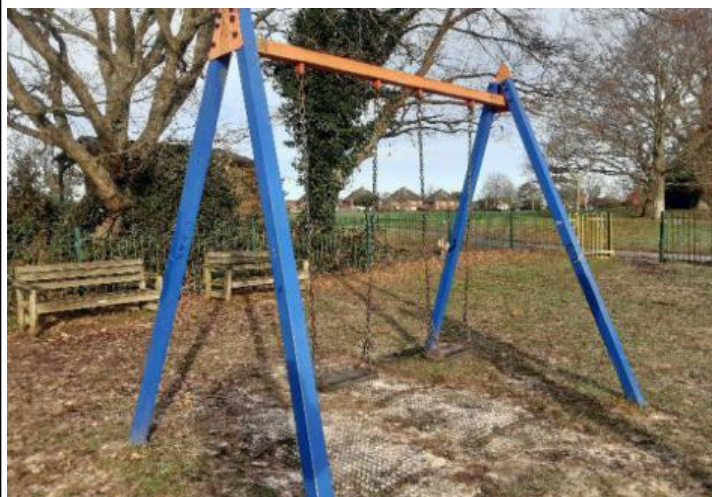
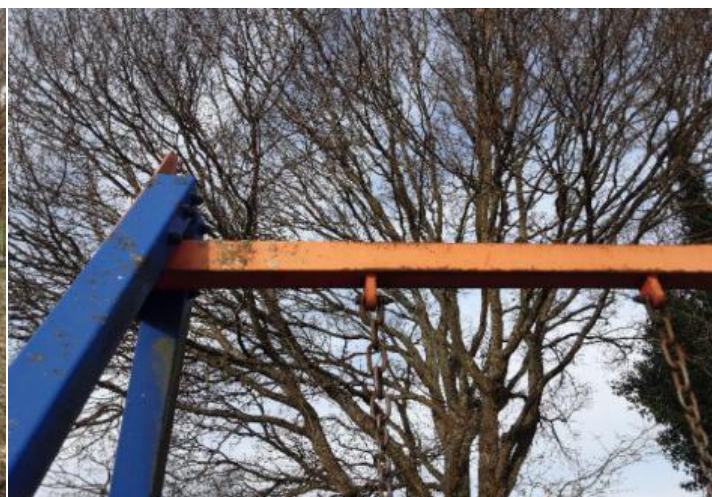
Item: Swings - 1 Bay 2 Seat (Flat)
Manufacturer: Wheelscape Ltd

Risk Level: L - Low Risk
Surface: Grass Matrix Tiles

Finding: There is some wear to the shackles.

Action: Monitor for any further deterioration and replace when 40% worn

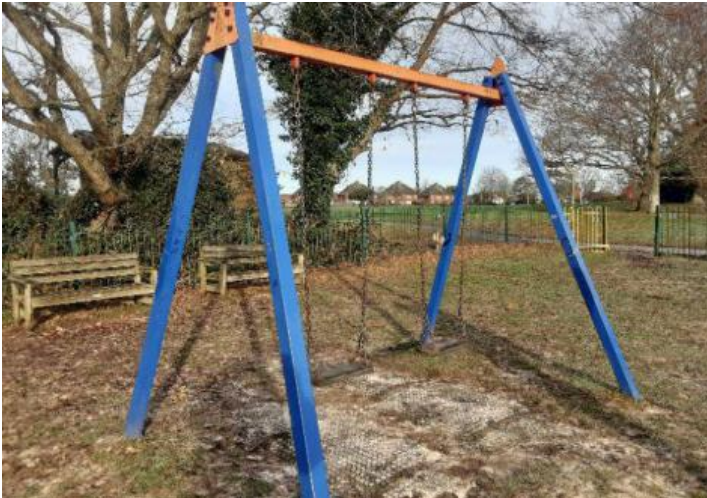
Item: Swings - 1 Bay 2 Seat (Flat)
Manufacturer: Wheelscape Ltd

Risk Level: V - Very Low Risk
Surface: Grass Matrix Tiles

Finding: The seats are too close to each other as defined in BS EN 1176 Part 2; this is a low risk failure and no remedial action is required
Action: Monitor - No remedial work recommended

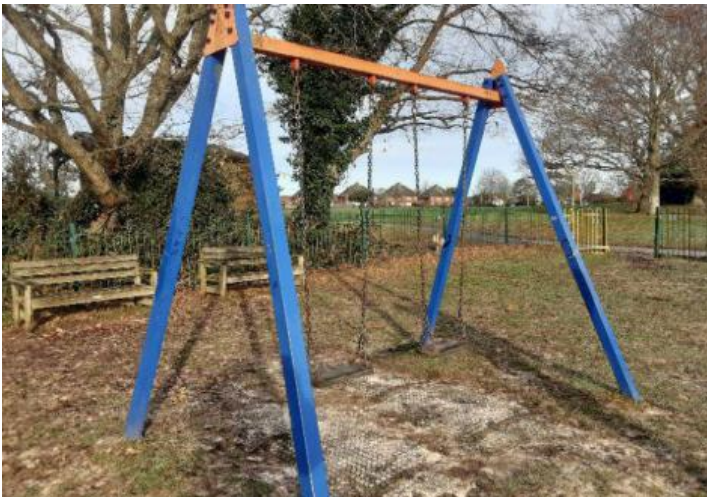
Item: Swings - 1 Bay 2 Seat (Flat)
Manufacturer: Wheelscape Ltd

Risk Level: L - Low Risk
Surface: Grass Matrix Tiles

Finding: The swing seat connectors have some wear present

Action: Monitor for further deterioration and replace when 40% worn

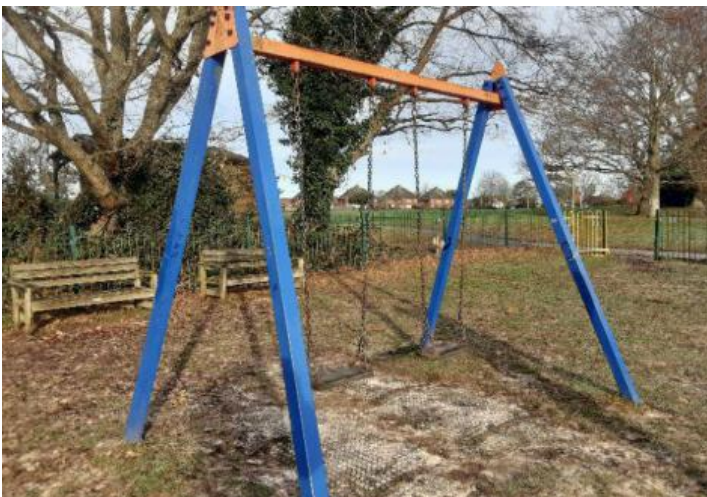
Item: Swings - 1 Bay 2 Seat (Flat)
Manufacturer: Wheelscape Ltd

Risk Level: L - Low Risk
Surface: Grass Matrix Tiles

Finding: The fixings have corroded excessively

Action: Replace all corroded fixings

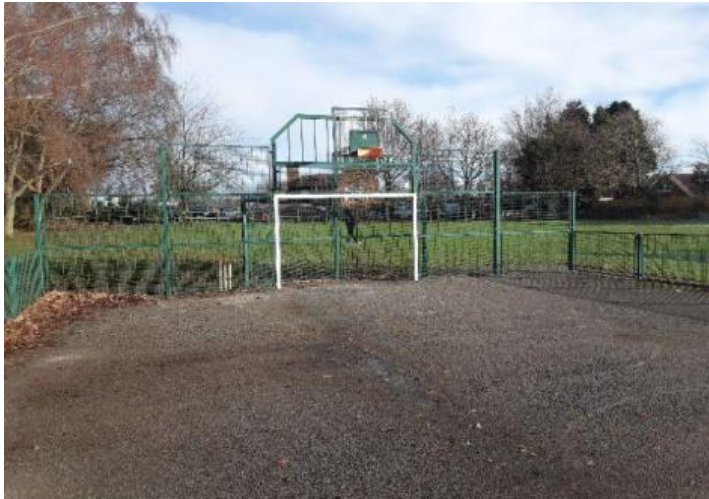
Item: Multi Use Games Area - Multi Use Games Area (MUGA)
Manufacturer: Wicksteed Playgrounds

Risk Level: L - Low Risk
Surface: Bitmac

Finding: The surface is crumbing in areas creating slippery conditions

Action: Sweep and clear all loose debris and monitor

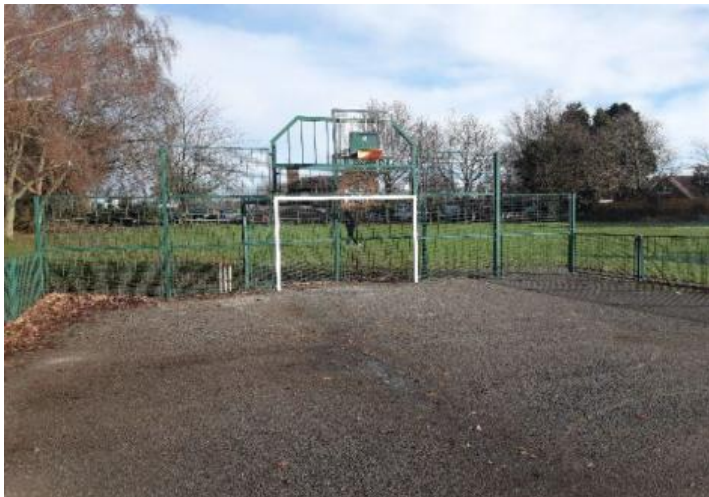
Item: Multi Use Games Area - Multi Use Games Area (MUGA)
Manufacturer: Wicksteed Playgrounds

Risk Level: L - Low Risk
Surface: Bitmac

Finding: There is algae, silt or moss growth on the surface resulting in slippery conditions

Action: Clean and treat appropriately

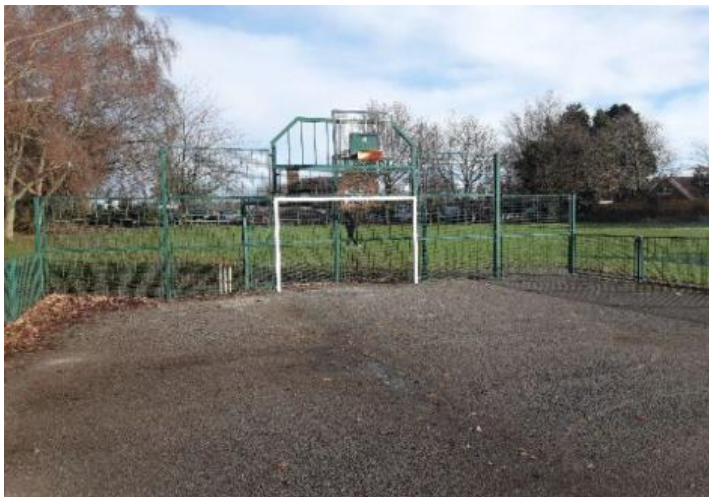
Risk Level: L - Low Risk

Finding: A number of fixing(s) have worked loose

Action: Secure all loose fixings

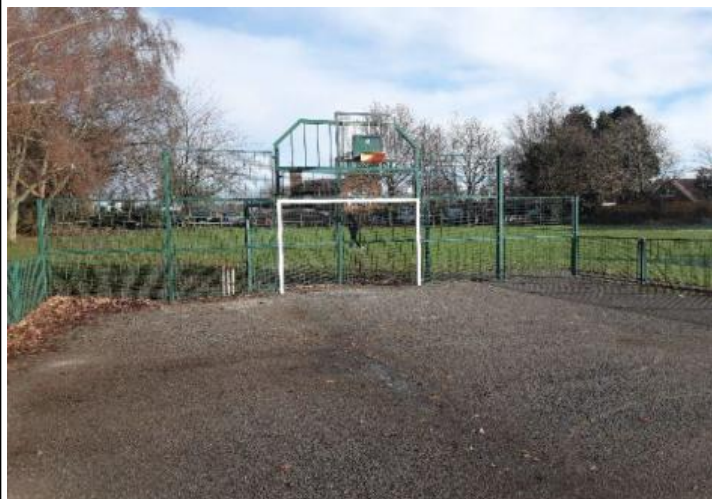
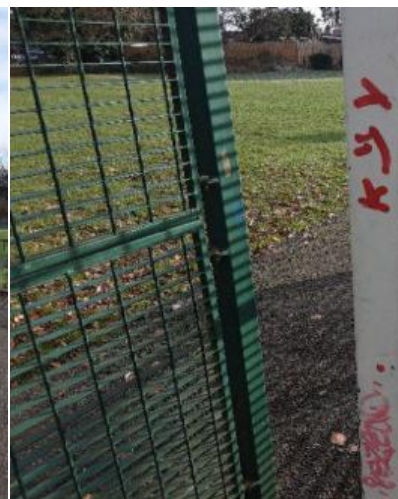
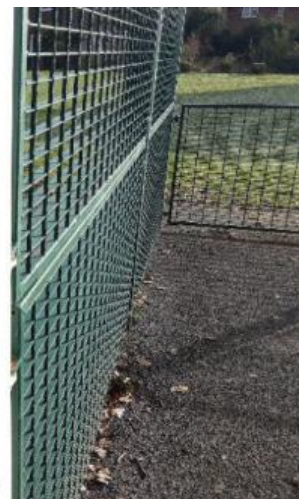
Item: Multi Use Games Area - Multi Use Games Area (MUGA)
Manufacturer: Wicksteed Playgrounds
Risk Level: N - Risk Assessment not Undertaken
Surface: Bitmac

Finding: There is some graffiti present

Action: Remove the graffiti

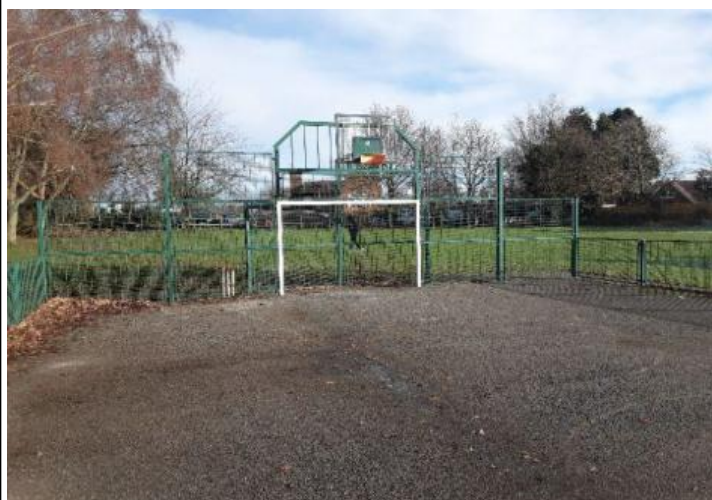
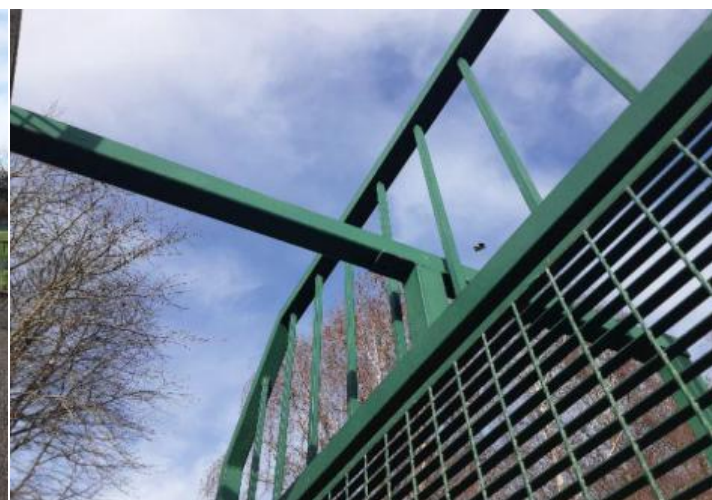
Item: Multi Use Games Area - Multi Use Games Area (MUGA)
Manufacturer: Wicksteed Playgrounds
Risk Level: L - Low Risk
Surface: Bitmac

Finding: There is or are fixings missing on the item

Action: Replace all missing fixings

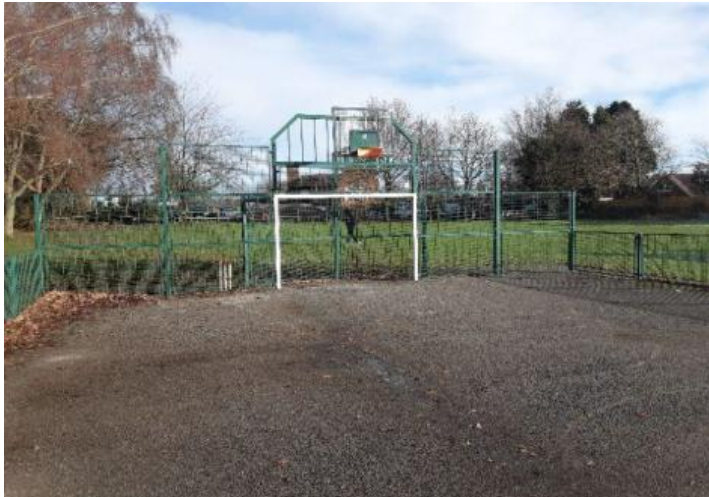
Risk Level: L - Low Risk

Finding: The paintwork on this item has been damaged or worn exposing the metal underneath which is rusting

Action: Treat any rusting components and repaint

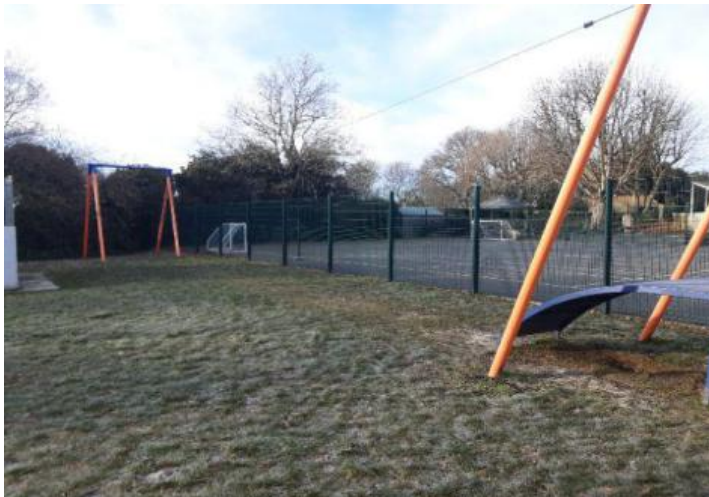
Risk Level: L - Low Risk

Finding: The unit is easily accessible and should have the appropriate barriers installed to meet the requirements of BS EN 1176 Part 1 as the height of the unit exceeds 600mm

Action: Monitor - No remedial work recommended

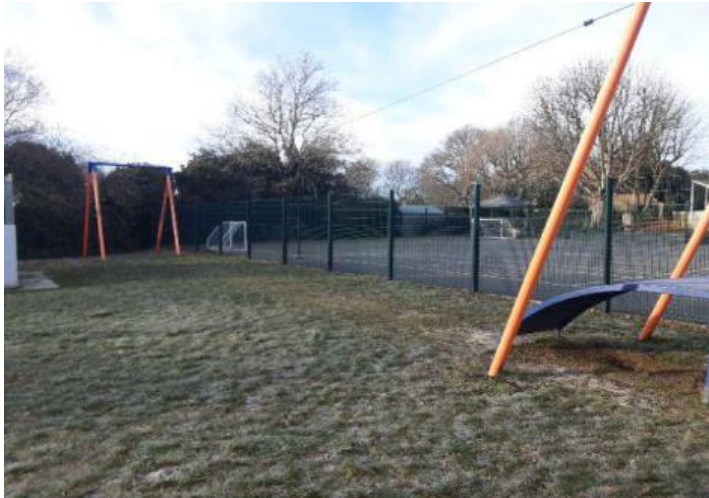
Item: Other - Cable Runway
Manufacturer: Wicksteed Playgrounds

Risk Level: L - Low Risk
Surface: Grass Matrix Tiles

Finding: There is moderate damage to the surface

Action: Repair the damaged areas of surfacing
