the play inspection company

Annual Inspection

Ninfield Parish Council

The Recreation Ground

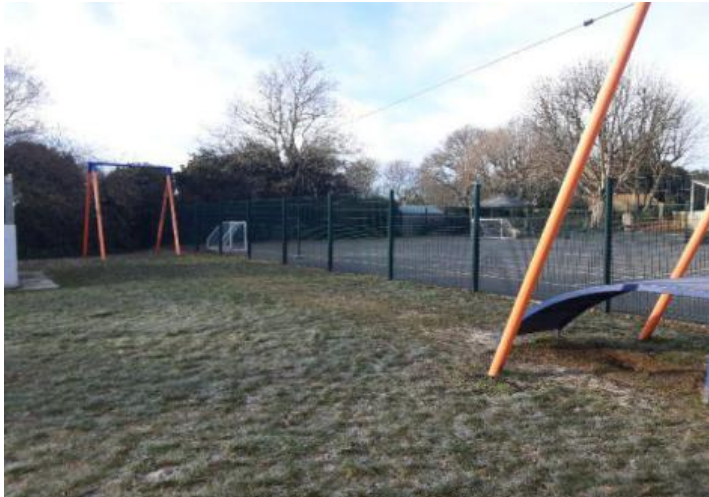
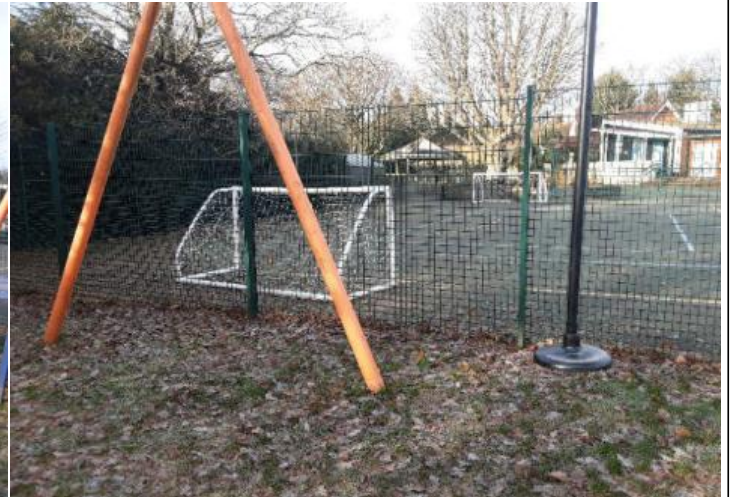
Item: Other - Cable Runway
Manufacturer: Wicksteed Playgrounds

Risk Level: L - Low Risk
Surface: Grass Matrix Tiles

Finding: The seat is less than 2.0 metres from the post when extended at 45 degrees at the end of the area of travel and does not meet the requirements of BS EN 1176 Part 4

Action: Adjust the cable stop position to ensure the minimum distance is maintained

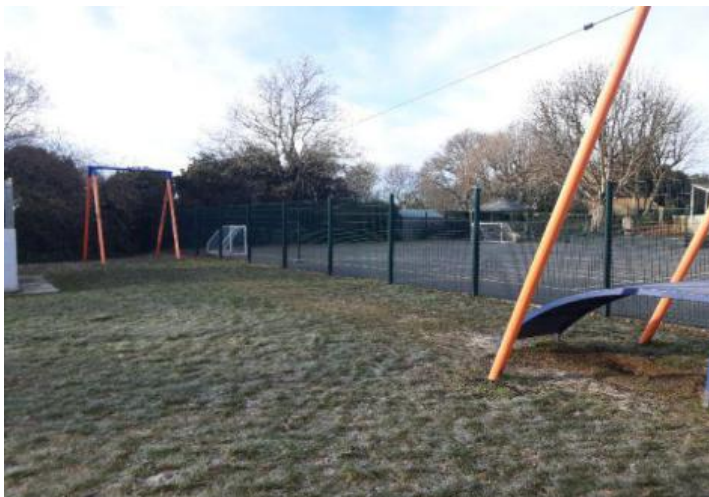
Item: Other - Cable Runway
Manufacturer: Wicksteed Playgrounds

Risk Level: L - Low Risk
Surface: Grass Matrix Tiles

Finding: The dampening spring or tyre is damaged or broken on the item

Action: Replace spring or tyre

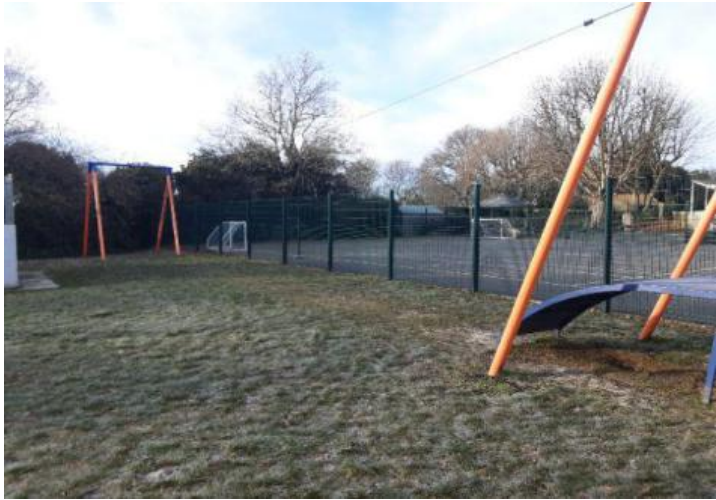
Item: Other - Cable Runway
Manufacturer: Wicksteed Playgrounds

Risk Level: N - Risk Assessment not Undertaken
Surface: Grass Matrix Tiles

Finding: We have completed a visual inspection of the suspension links, cable and fixing points from ground level, however it is not possible to fully inspect these areas without either hiring equipment to gain access or removing the cable and suspension and inspecting at ground level. We recommend that the main cable and fixing security is thoroughly inspected at least in accordance with the manufacturers recommendations to check for wear, damage, security or internal rusting; this will help to ensure the continued safe use of the equipment

Action: Inspect in accordance with the manufacturers recommendations

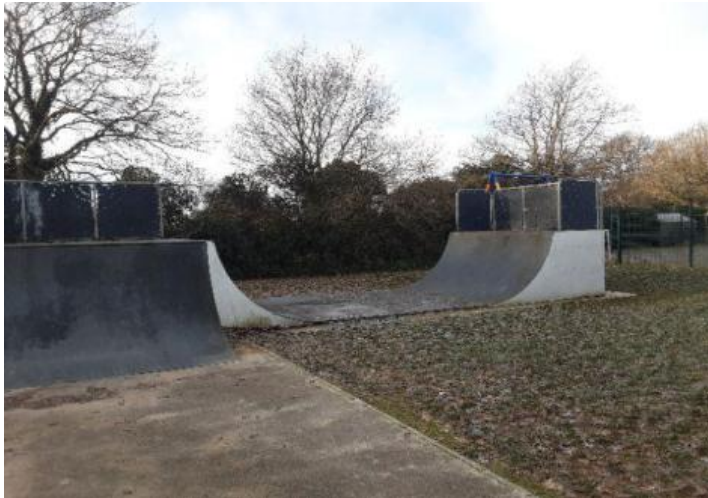
Item: Wheeled Sports - Half Pipe
Manufacturer: Not Identified

Risk Level: L - Low Risk
Surface: Bitmac

Finding: The paintwork on this item has been damaged or worn exposing the metal underneath which is rusting

Action: Treat any rusting components and repaint

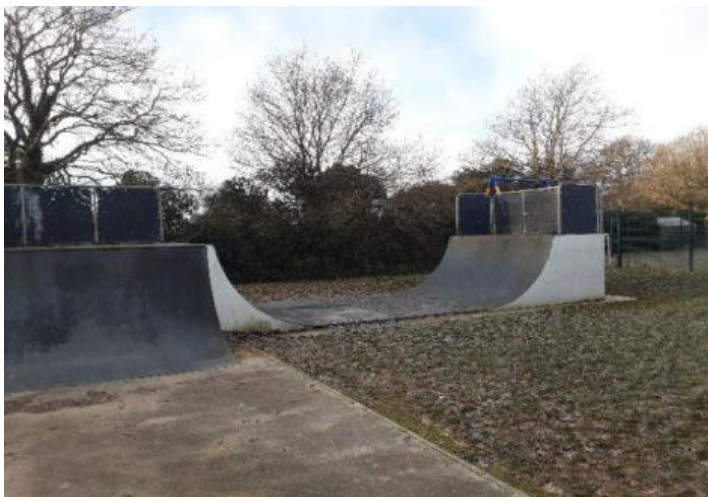
Item: Wheeled Sports - Half Pipe
Manufacturer: Not Identified

Risk Level: L - Low Risk
Surface: Bitmac

Finding: There is or are fixings missing on the item

Action: Replace all missing fixings

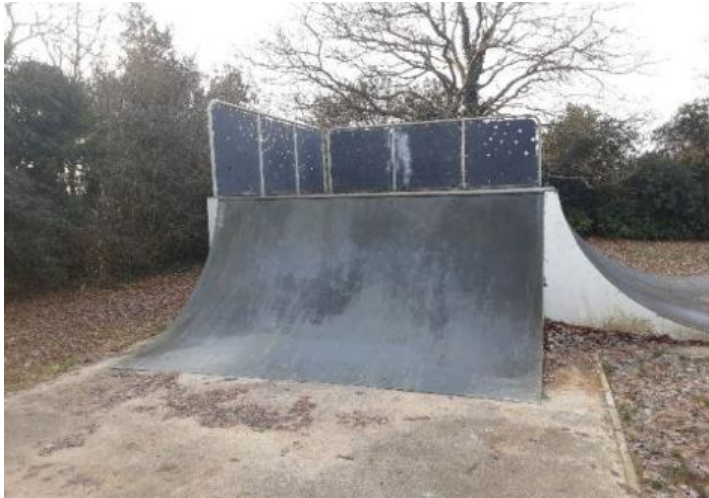
Item: Wheeled Sports - Quarter Pipe
Manufacturer: Not Identified

Risk Level: L - Low Risk
Surface: Bitmac

Finding: The kicker plate protrudes more than 5mm above the surrounding surface level, BS EN 14974 recommends a maximum of 5mm with 3mm preferred
Action: Adjust height to ensure a maximum of 5mm change in level
