the play inspection company

Annual Inspection

Battle Town Council - WPS

Battle Recreation Ground

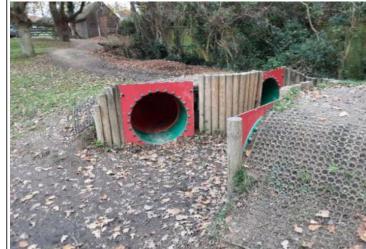
8 - Low Risk (Finding 1)

Activity Equipment - Crawling Tunnel Risk Level: L - Low Risk Item: Playdale Playgrounds Ltd Surface: Grass Manufacturer:

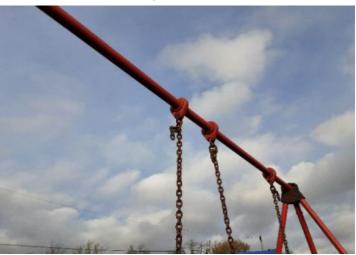
5 - Very Low Risk (Finding 1)

V - Very Low Risk Risk Level: Surface: Woodchip

Action: Monitor for any further deterioration and replace as required
