Operational Inspection

Thornhackett Parish Council

Thornford Play Area

adj The Village Hall, Blacksmiths Lane, Thornford,
Dorset, DT9 6PH

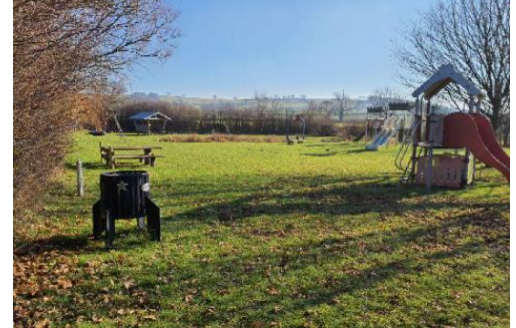
Item: Site General
Manufacturer: Owner/Operator
Surface Type: N/A
Item Quantity: 1
Equipment Compliance: N/A
Surface Area Compliance: N/A

There are trip hazards present due to ground erosion - Reinstate surrounding surfaces to level to remove the trip points

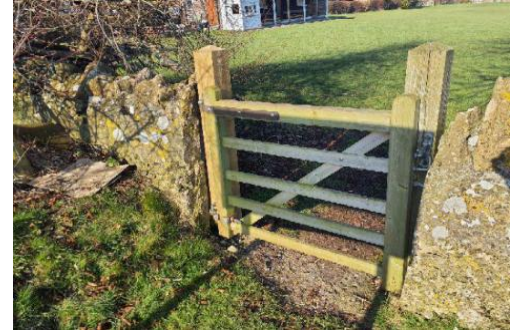
Item: Gate - Pedestrian
Manufacturer: Not Identified
Surface Type: Grass
Item Quantity: 1
Equipment Compliance: N/A
Surface Area Compliance: N/A

The area under the gate has eroded leaving uneven areas, or the concrete foundations exposed, resulting in trip hazards at the entrance/exit to the playground - Reinststate to level with surrounding surfaces

There is surface corrosion present on the item - Consider treating the item

There is some evidence of rot in the timber - Monitor for any further deterioration and replace as required

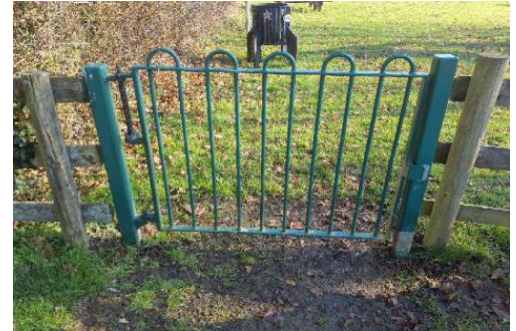
Item: Gate - Self Closing
Manufacturer: Not Identified
Surface Type: Grass
Item Quantity: 1
Equipment Compliance: N/A
Surface Area Compliance: N/A

The rubber buffer is missing from the latch plate - Replace rubber buffer

There is some evidence of rot in the timber - Monitor for any further deterioration and replace as required

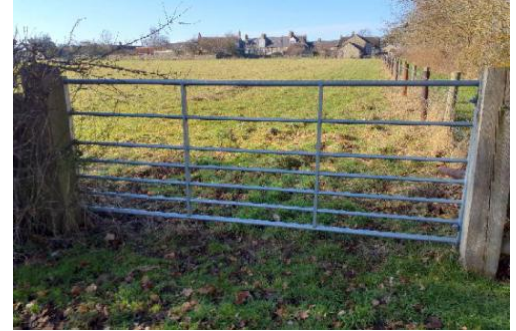
Item: Gate - Maintenance
Manufacturer: Not Identified
Surface Type: Grass
Item Quantity: 1
Equipment Compliance: N/A
Surface Area Compliance: N/A

There is some strimmer / machinery damage apparent on the posts, this can penetrate the preservative applied to the timber and accelerate the rotting process - Monitor for any deterioration (rot) and replace as required

There is some evidence of rot in the timber - Monitor for any further deterioration and replace as required

The timber has a number of splits/shakes or air cracks and this may affect the stability or allow water ingress which will accelerate the rotting process - Monitor to ensure the splits do not cross through fixing points of the structure and/or cause any instability

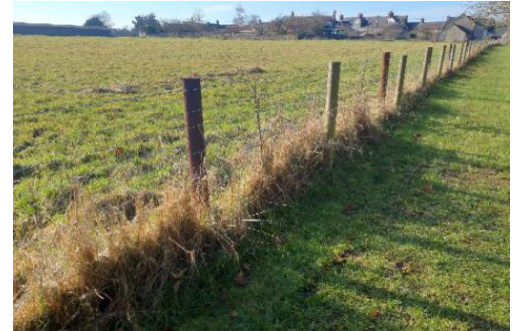
Item: Fence - Timber & Mesh Infill
Manufacturer: Not Identified
Surface Type: Grass
Item Quantity: 1
Equipment Compliance: N/A
Surface Area Compliance: N/A

There are areas or parts of the timber on the structure that have rotted - Replace all affected timbers

The timber has a number of splits/shakes or air cracks and this may affect the stability or allow water ingress which will accelerate the rotting process - Monitor to ensure the splits do not cross through fixing points of the structure and/or cause any instability

There are a number of loose posts around the fence - Monitor for any further deterioration and reset as required

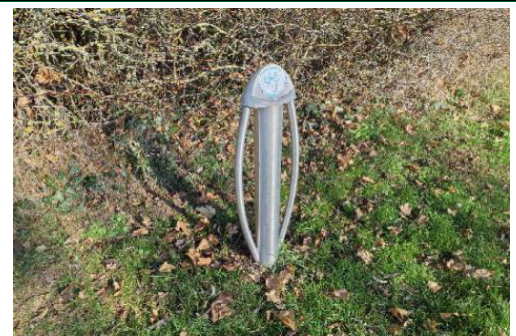
Item: Cycle Rack
Manufacturer: Husson UK
Surface Type: Grass
Item Quantity: 1
Equipment Compliance: N/A
Surface Area Compliance: N/A

There is some minor damage to the item - Monitor for any further deterioration and remove any rough or sharp edges

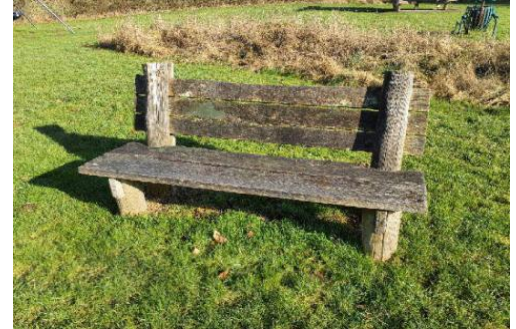
Item: Bench
Manufacturer: Not Identified
Surface Type: Grass
Item Quantity: 2
Equipment Compliance: N/A
Surface Area Compliance: N/A

There is some strimmer / machinery damage apparent on the posts, this can penetrate the preservative applied to the timber and accelerate the rotting process - Monitor for any deterioration (rot) and replace as required

There is some evidence of rot in the timber - Monitor for any further deterioration and replace as required

The timber has a number of splits/shakes or air cracks and this may affect the stability or allow water ingress which will accelerate the rotting process - Monitor to ensure the splits do not cross through fixing points of the structure and/or cause any instability

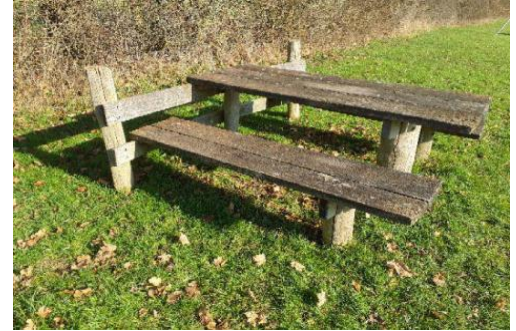
Item: Picnic Table
Manufacturer: Not Identified
Surface Type: Grass
Item Quantity: 2
Equipment Compliance: N/A
Surface Area Compliance: N/A

There is some strimmer / machinery damage apparent on the posts, this can penetrate the preservative applied to the timber and accelerate the rotting process - Monitor for any deterioration (rot) and replace as required

There is some evidence of rot in the timber - Monitor for any further deterioration and replace as required

There is some evidence of fire damage to the item - Monitor for any further deterioration and repair as required

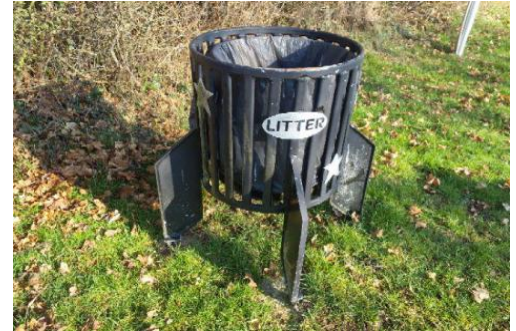
Item: Litter Bin
Manufacturer: Not Identified
Surface Type: Grass
Item Quantity: 2
Equipment Compliance: N/A
Surface Area Compliance: N/A

The paintwork on this item has been damaged or worn exposing the metal underneath which is rusting - Treat any rusting components and repaint

The bin lid is missing - Replace

The surface has eroded and the foundations are exposed - Reinststate surrounding surfaces to cover the foundations

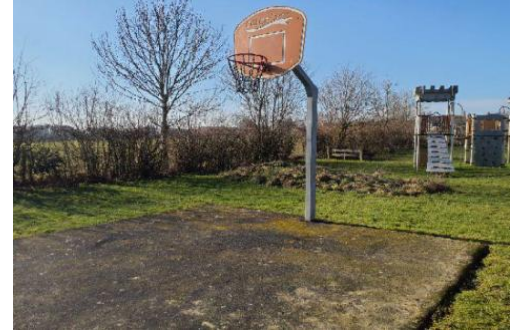
Item: Basketball Post
Manufacturer: Husson UK
Surface Type: Wet Pour
Item Quantity: 1
Equipment Compliance: No
Surface Area Compliance: N/A
Life Expectancy: 5 -10 Years
Total Findings: 9

There are trip hazards at the edges of the wet pour surfacing - Reinstate surrounding surface levels to remove the trip points

The surface is rippling - Repair surfacing

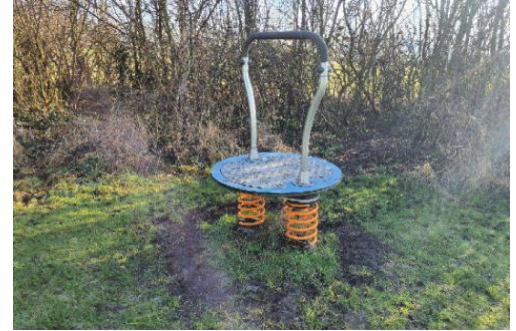
Item: Rotating Spring Board
Manufacturer: Proludic
Surface Type: Grass Matrix Tiles
Item Quantity: 1
Equipment Compliance: No
Surface Area Compliance: Yes
Life Expectancy: 5 -10 Years
Total Findings: 5

There is some graffiti present - Remove the graffiti

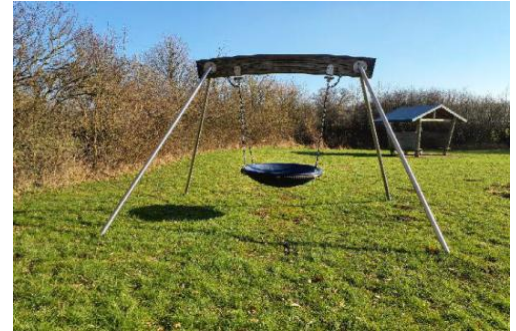
Item: Basket Swing - Type 1
Manufacturer: Proludic
Surface Type: Grass Matrix Tiles
Item Quantity: 1
Equipment Compliance: No
Surface Area Compliance: Yes
Life Expectancy: 3 - 5 Years
Total Findings: 7

There is some notable evidence of chain wear - Monitor for any further deterioration and replace when 40% worn

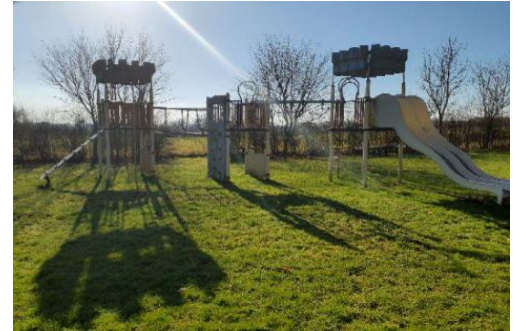
Item: Multi Play (Junior)
Manufacturer: Husson UK
Surface Type: Grass Matrix Tiles
Item Quantity: 1
Equipment Compliance: Yes
Surface Area Compliance: Yes
Life Expectancy: 5 -10 Years
Total Findings: 12

There is some notable evidence of chain wear - Monitor for any further deterioration and replace when 40% worn

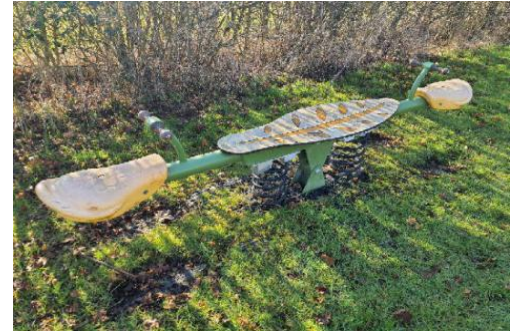
Item: See Saw
Manufacturer: Husson UK
Surface Type: Grass Matrix Tiles
Item Quantity: 1
Equipment Compliance: Yes
Surface Area Compliance: Yes
Life Expectancy: 5 -10 Years
Total Findings: 3

The pivot mechanism is showing signs of wear - Monitor for any further deterioration and repair as required

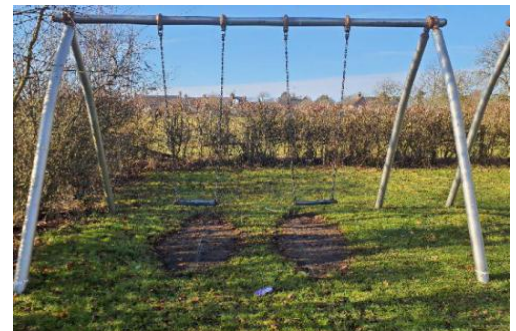
Item: 1 Bay 2 Seat (Flat)
Manufacturer: Husson UK
Surface Type: Grass Matrix Tiles
Item Quantity: 1
Equipment Compliance: No
Surface Area Compliance: Yes
Life Expectancy: 5 -10 Years
Total Findings: 5

There is some notable evidence of chain wear - Monitor for any further deterioration and replace when 40% worn

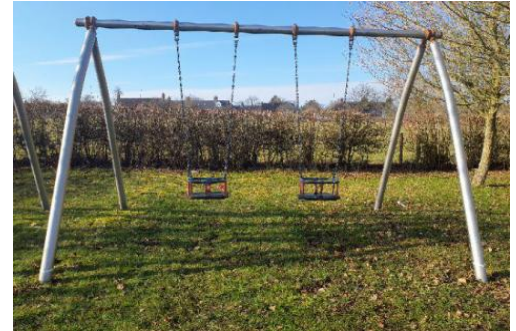
Item: 1 Bay 2 Seat (Cradle)
Manufacturer: Husson UK
Surface Type: Grass Matrix Tiles
Item Quantity: 1
Equipment Compliance: Yes
Surface Area Compliance: Yes
Life Expectancy: 5 -10 Years
Total Findings: 8

The seat has minor damage or wear - Monitor for any further deterioration and replace as required

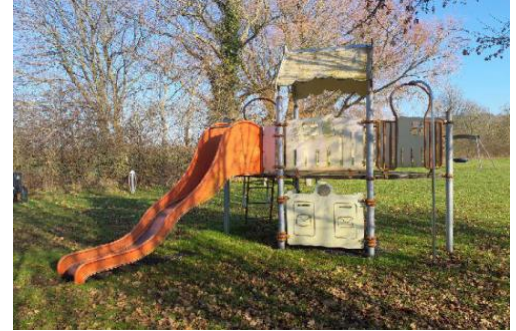
Item: Multi Play (Toddler)
Manufacturer: Husson UK
Surface Type: Grass Matrix Tiles
Item Quantity: 1
Equipment Compliance: Yes
Surface Area Compliance: Yes
Life Expectancy: 5 -10 Years
Total Findings: 6

A number of fixing(s) have worked loose beneath the platforms - Secure all loose fixings

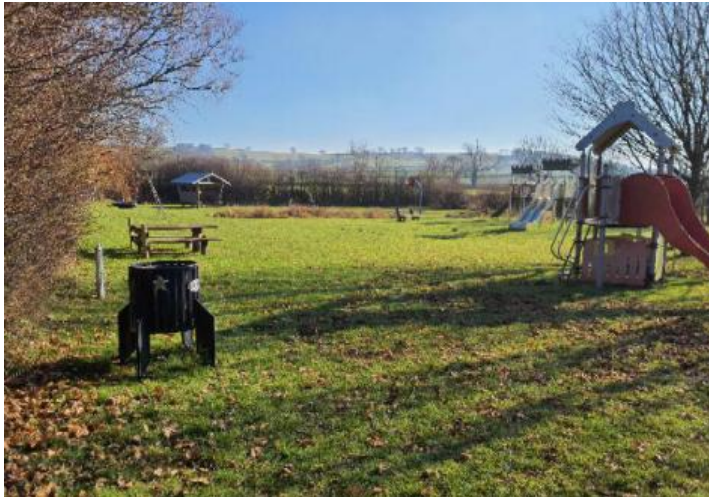
Item: Ancillary Items - Site General
Manufacturer: Owner/Operator

Finding: There are trip hazards present due to ground erosion

Action: Reinststate surrounding surfaces to level to remove the trip points

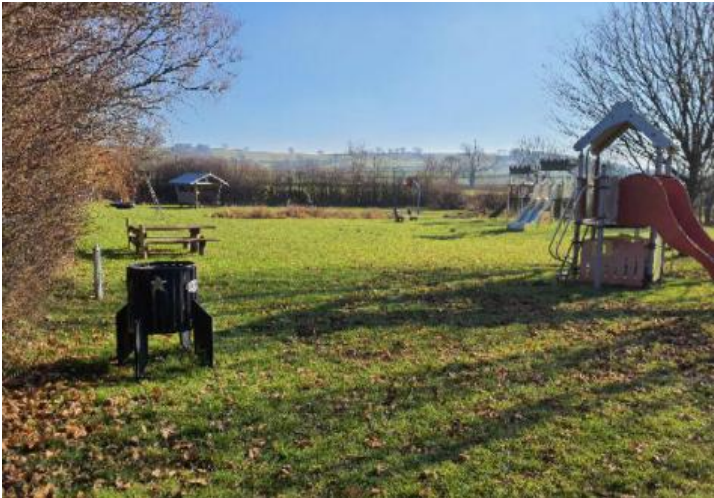
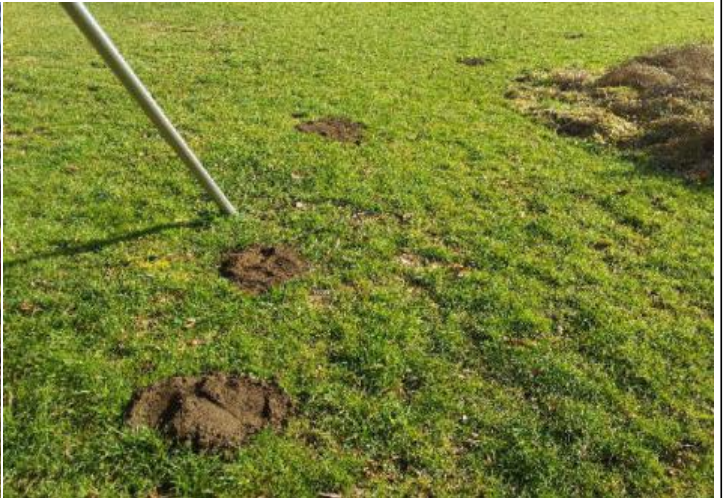
Item: Ancillary Items - Site General
Manufacturer: Owner/Operator

Finding: There are molehills in the area

Action: Provide a sound reasonably level surface.

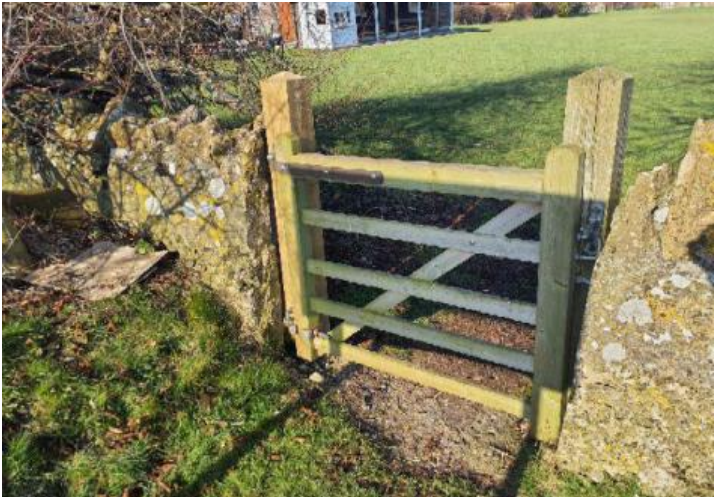
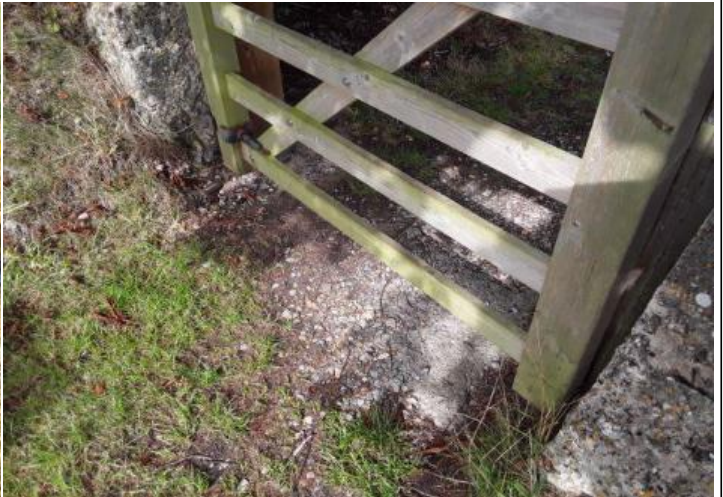
Item: Gates - Gate - Pedestrian
Manufacturer: Not Identified

Finding: The area under the gate has eroded leaving uneven areas, or the concrete foundations exposed, resulting in trip hazards at the entrance/exit to the playground

Action: Reinstate to level with surrounding surfaces

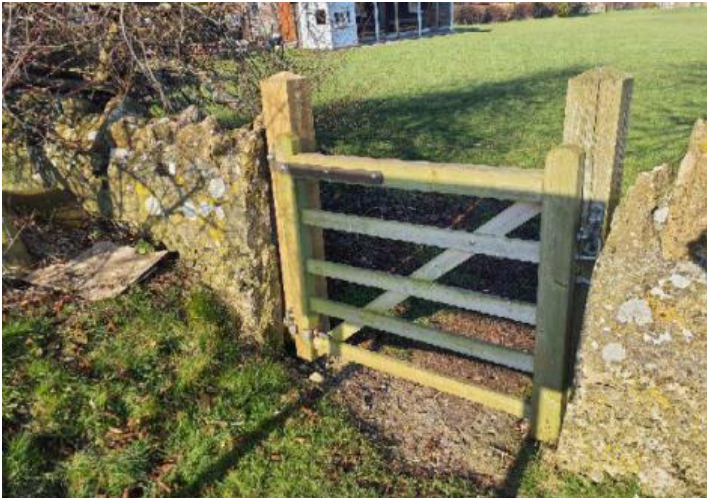
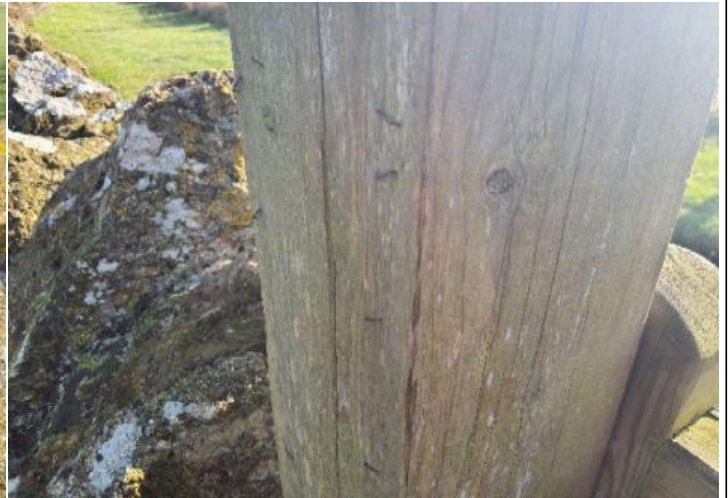
Item: Gates - Gate - Pedestrian
Manufacturer: Not Identified

Finding: There are redundant staples in the posts

Action: Remove staples

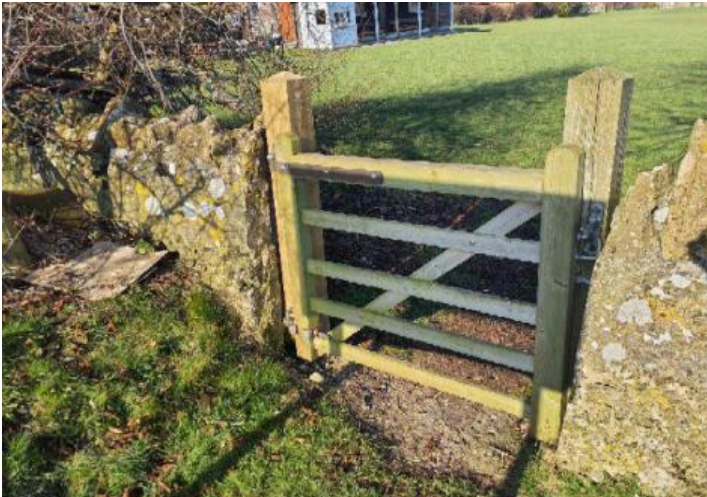
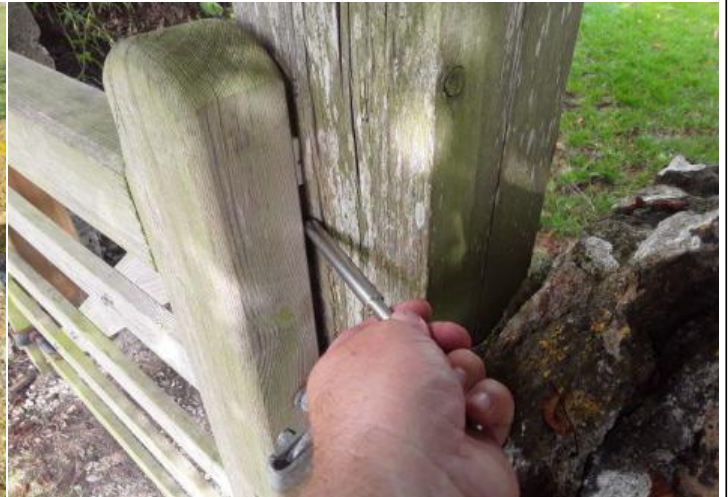
Item: Gates - Gate - Pedestrian
Manufacturer: Not Identified

Finding: There are openings that are less than 12mm that could trap or crush fingers

Action: Where possible a 12mm gap should be maintained on both sides or between the gate leaves

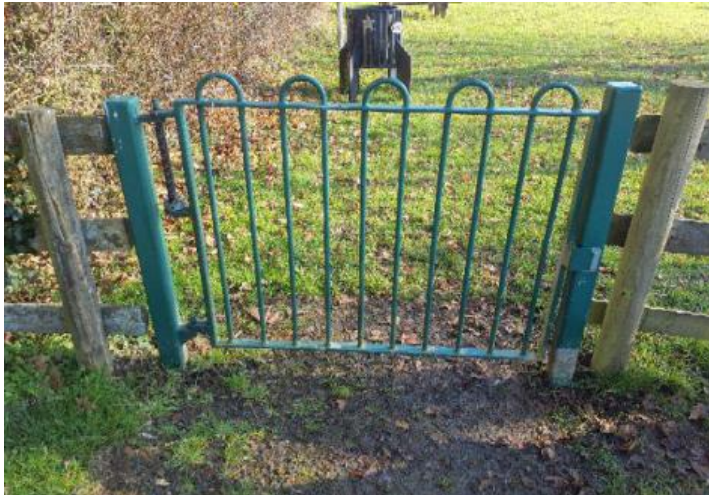
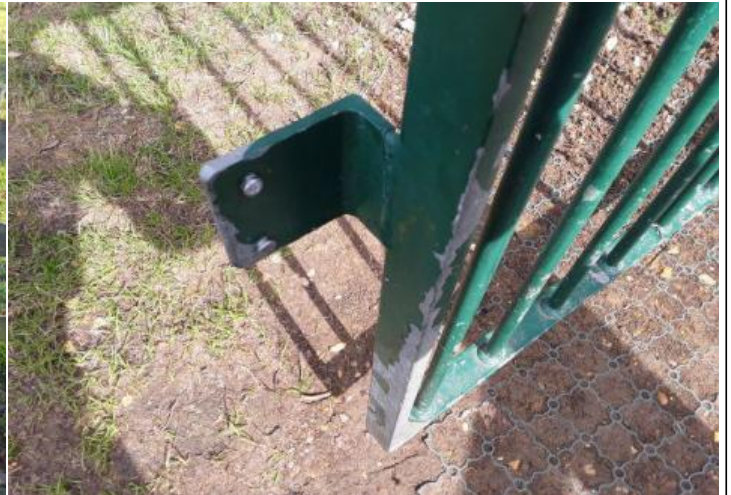
Item: Gates - Gate - Self Closing
Manufacturer: Not Identified

Finding: The rubber buffer is missing from the latch plate

Action: Replace rubber buffer

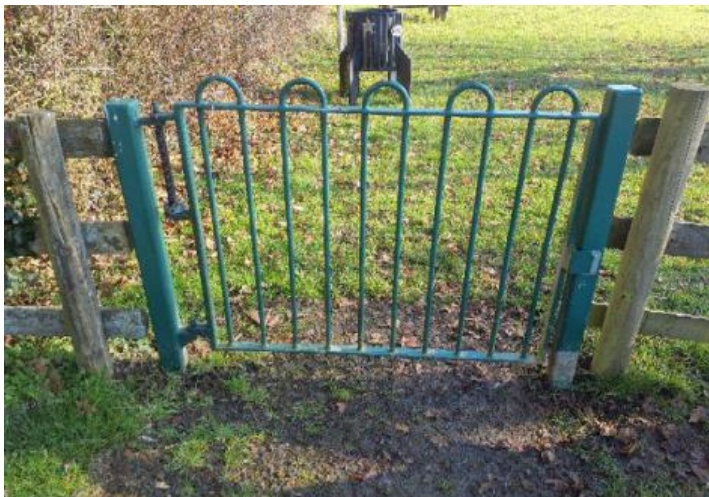
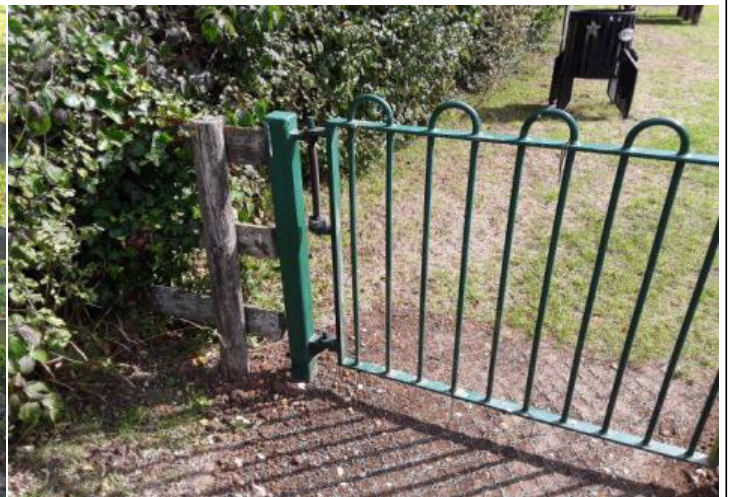
Item: Gates - Gate - Self Closing
Manufacturer: Not Identified

Finding: The gate is closing too quickly (less than 4 seconds)

Action: Take corrective action to ensure that the gate closes in 4-8 seconds

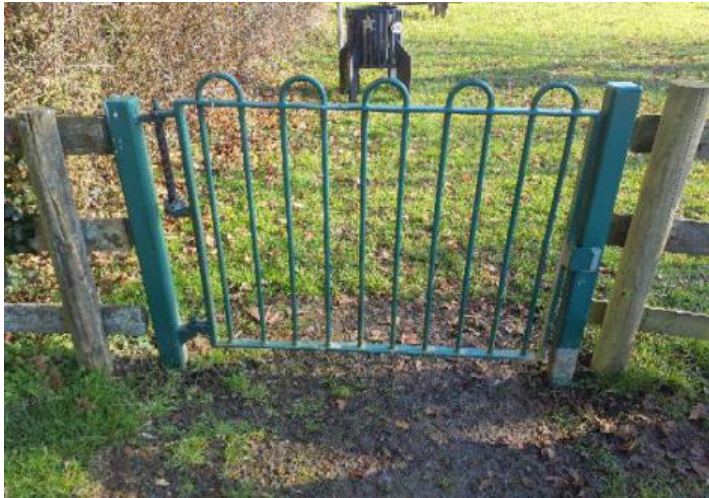
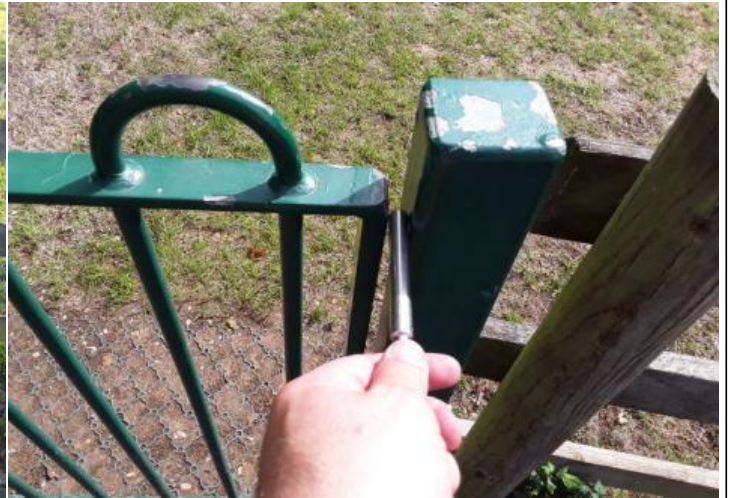
Item: Gates - Gate - Self Closing
Manufacturer: Not Identified

Finding: There are openings that are less than 12mm that could trap or crush fingers

Action: Where possible a 12mm gap should be maintained on both sides or between the gate leaves

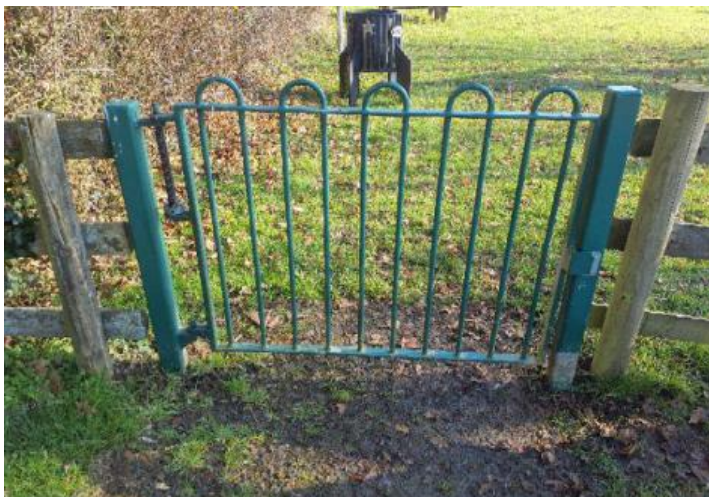
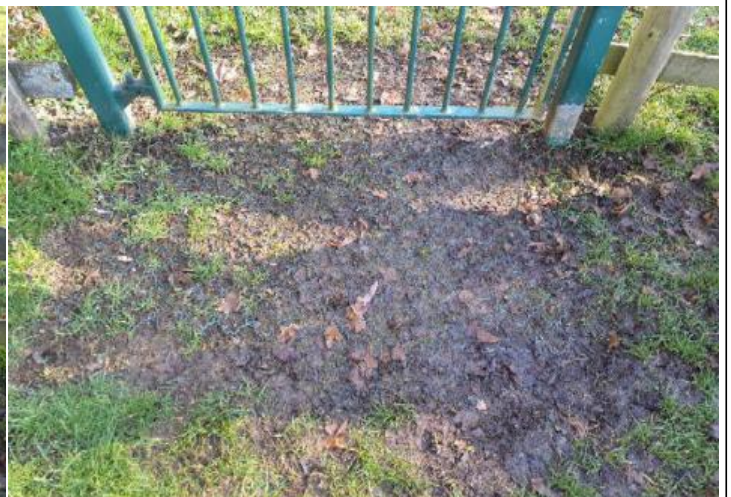
Item: Gates - Gate - Self Closing
Manufacturer: Not Identified

Finding: The area around the item has eroded and may become slippery

Action: Reinstate eroded area

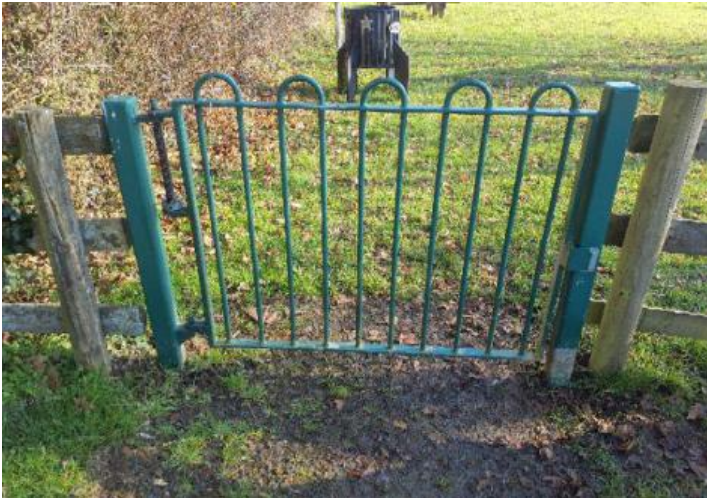
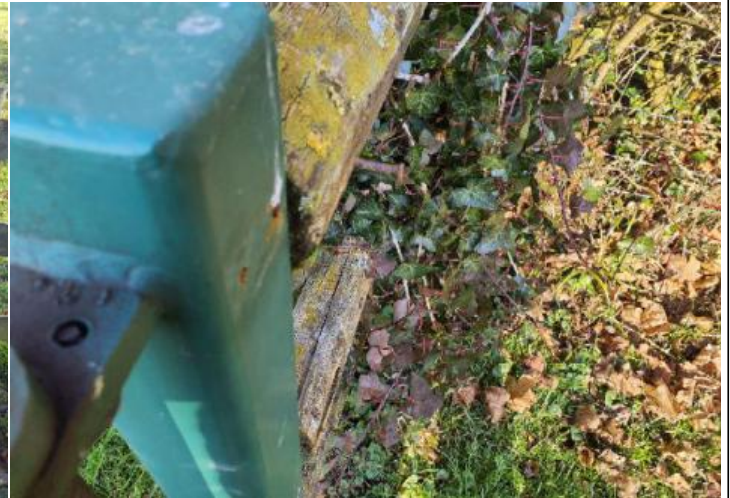
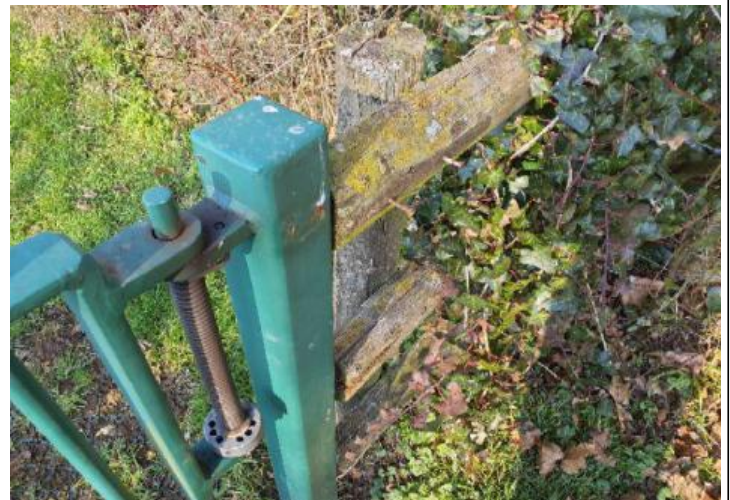
Item: Gates - Gate - Self Closing
Manufacturer: Not Identified

Finding: There are projecting nail ends present

Action: Remove and provide more appropriate fixings if required

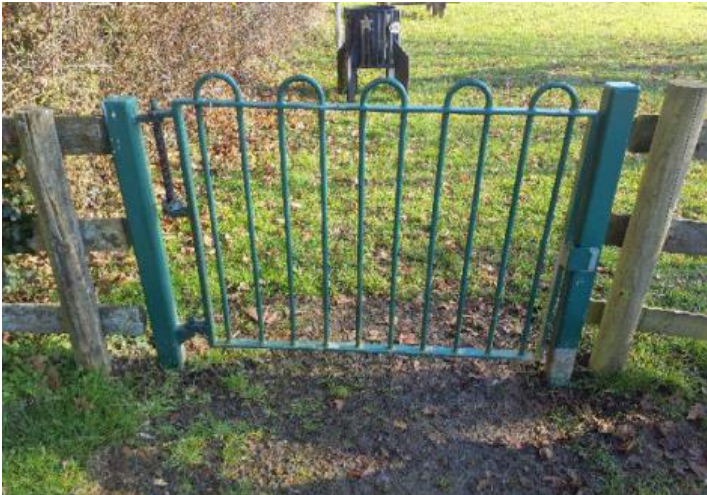
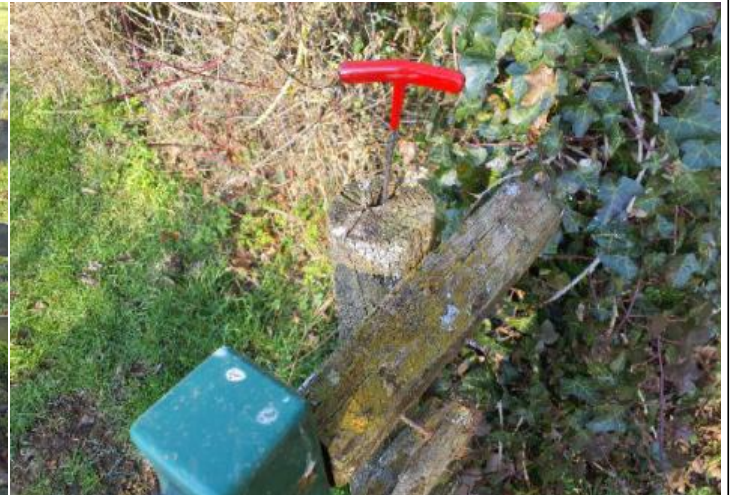
Item: Gates - Gate - Self Closing
Manufacturer: Not Identified

Finding: There is some evidence of rot in the timber

Action: Monitor for any further deterioration and replace as required

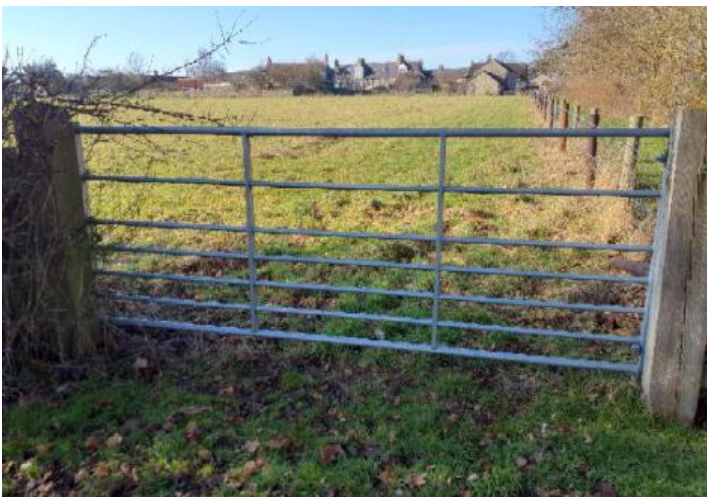
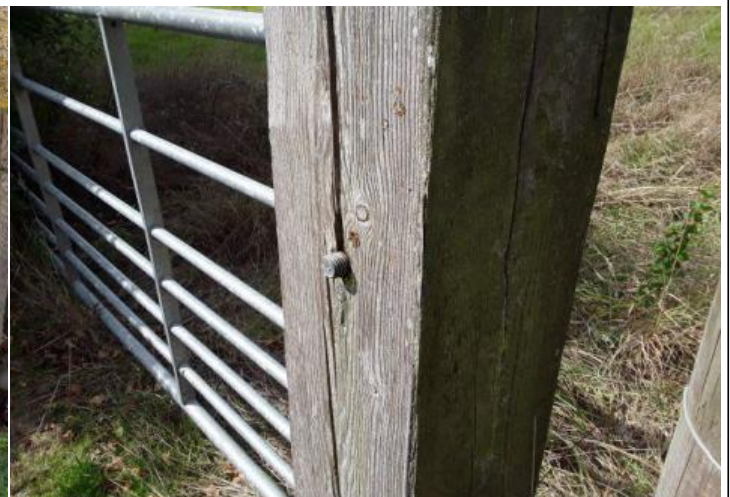
Item: Gates - Gate - Maintenance
Manufacturer: Not Identified

Finding: There are projecting bolt thread(s) present

Action: Remove excess thread length and deburr or provide cap

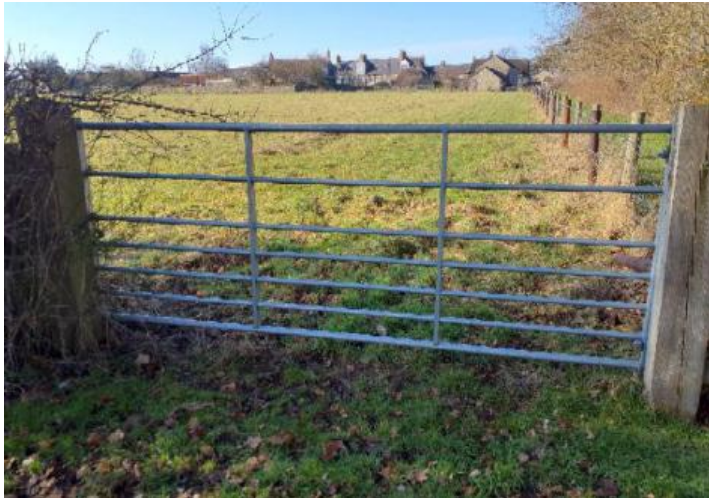
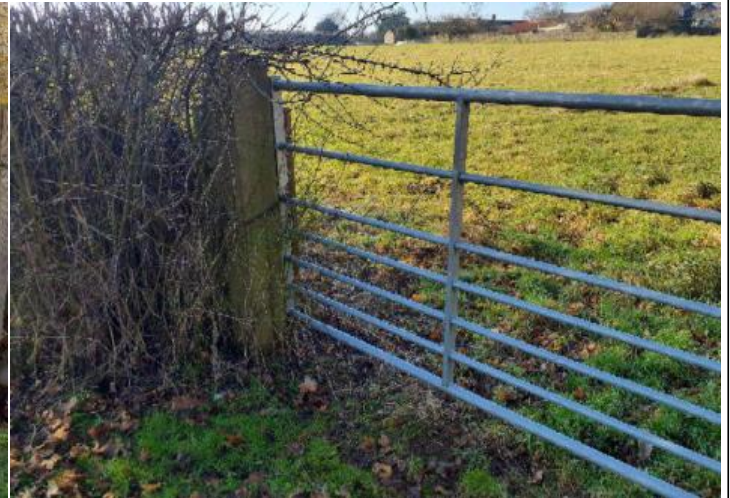
Item: Gates - Gate - Maintenance
Manufacturer: Not Identified

Finding: The adjacent foliage is overhanging

Action: Cut back and maintain

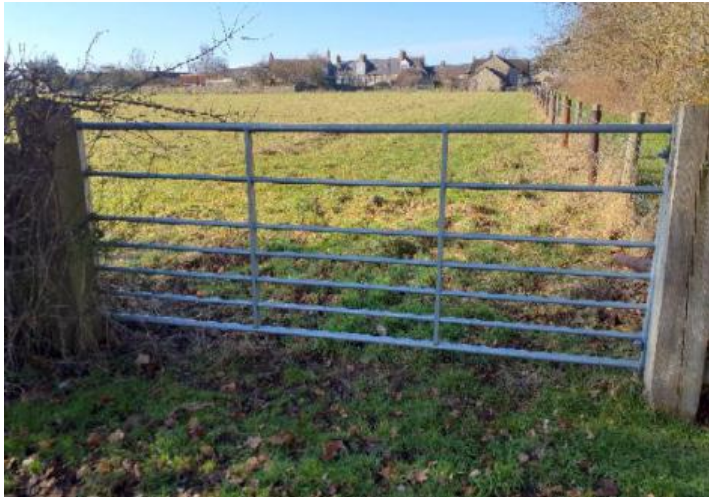
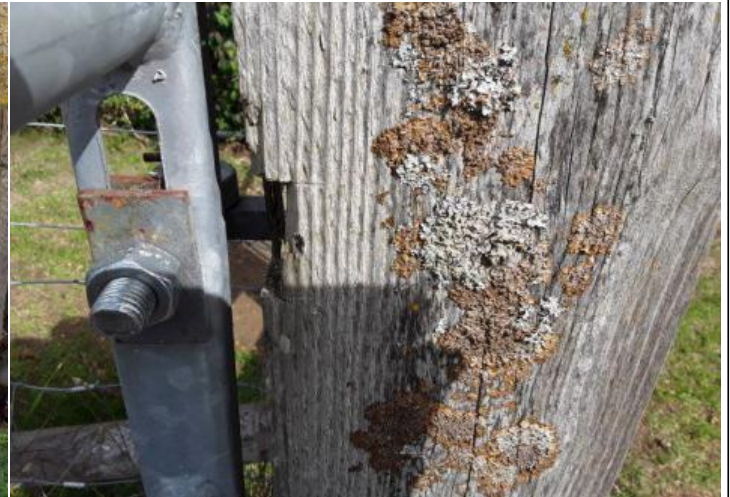
Item: Gates - Gate - Maintenance
Manufacturer: Not Identified

Finding: Parts of the timber are rough or splintered

Action: Remove all rough or sharp edges

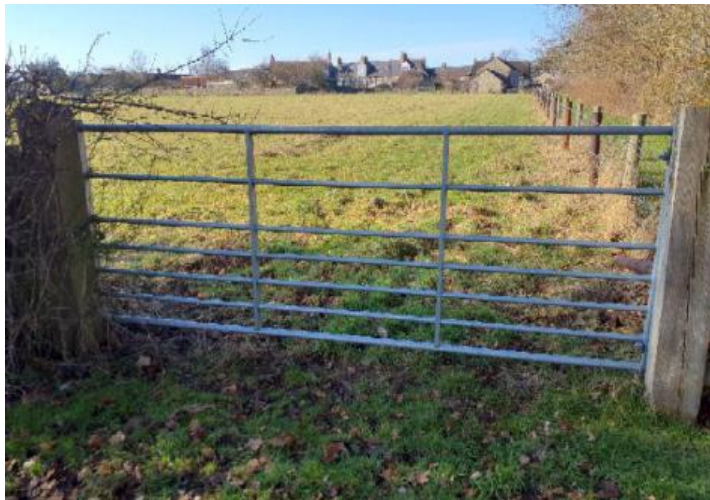
i 6 - Low Risk (Finding 4)

Item: Gates - Gate - Maintenance
Manufacturer: Not Identified
Risk Level: L - Low Risk
Surface: Grass

Finding: There is some strimmer / machinery damage apparent on the posts, this can penetrate the preservative applied to the timber and accelerate the rotting process
Action: Monitor for any deterioration (rot) and replace as required

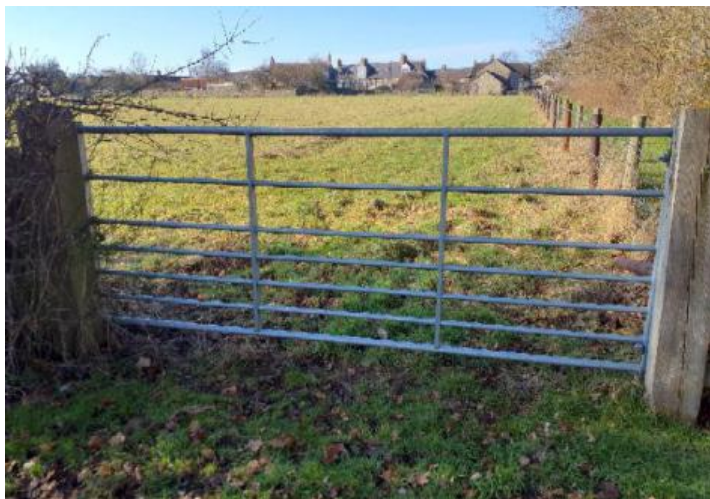
i 6 - Low Risk (Finding 5)

Item: Gates - Gate - Maintenance
Manufacturer: Not Identified
Risk Level: L - Low Risk
Surface: Grass

Finding: There is some evidence of rot in the timber
Action: Monitor for any further deterioration and replace as required

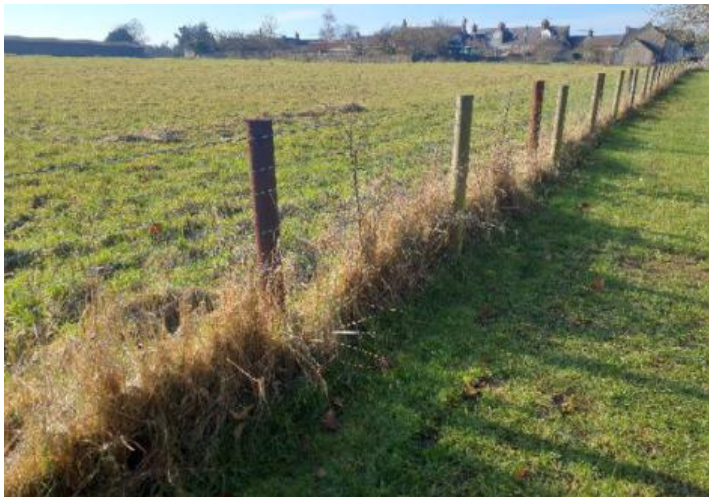
Item: Fences - Fence - Timber & Mesh Infill
Manufacturer: Not Identified

Finding: There are areas or parts of the timber on the structure that have rotted
Action: Replace all affected timbers

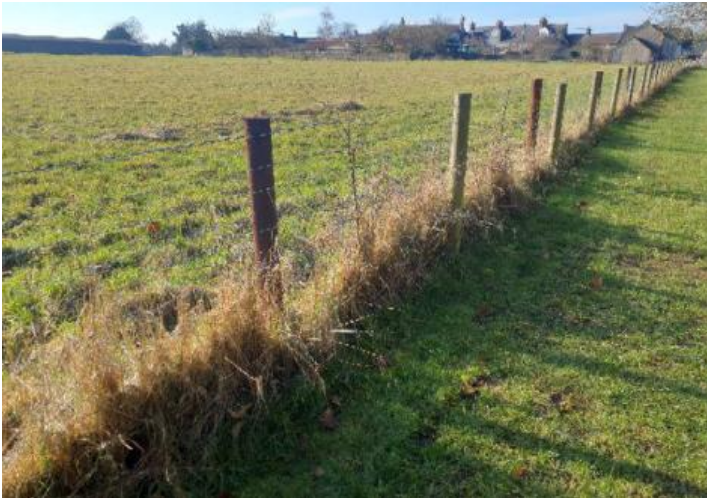
i 6 - Low Risk (Finding 2)

Item: Fences - Fence - Timber & Mesh Infill
Manufacturer: Not Identified

Finding: The timber has a number of splits/shakes or air cracks and this may affect the stability or allow water ingress which will accelerate the rotting process
Action: Monitor to ensure the splits do not cross through fixing points of the structure and/or cause any instability

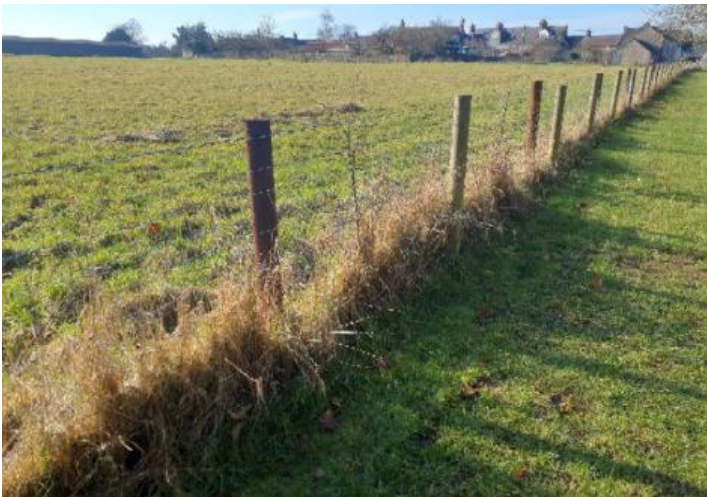
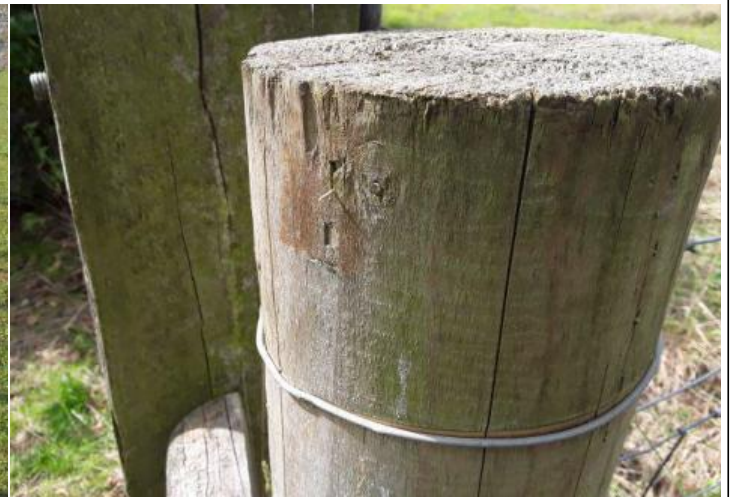
i 6 - Low Risk (Finding 3)

Item: Fences - Fence - Timber & Mesh Infill
Manufacturer: Not Identified

Finding: Parts of the timber are rough or splintered
Action: Remove all rough or sharp edges

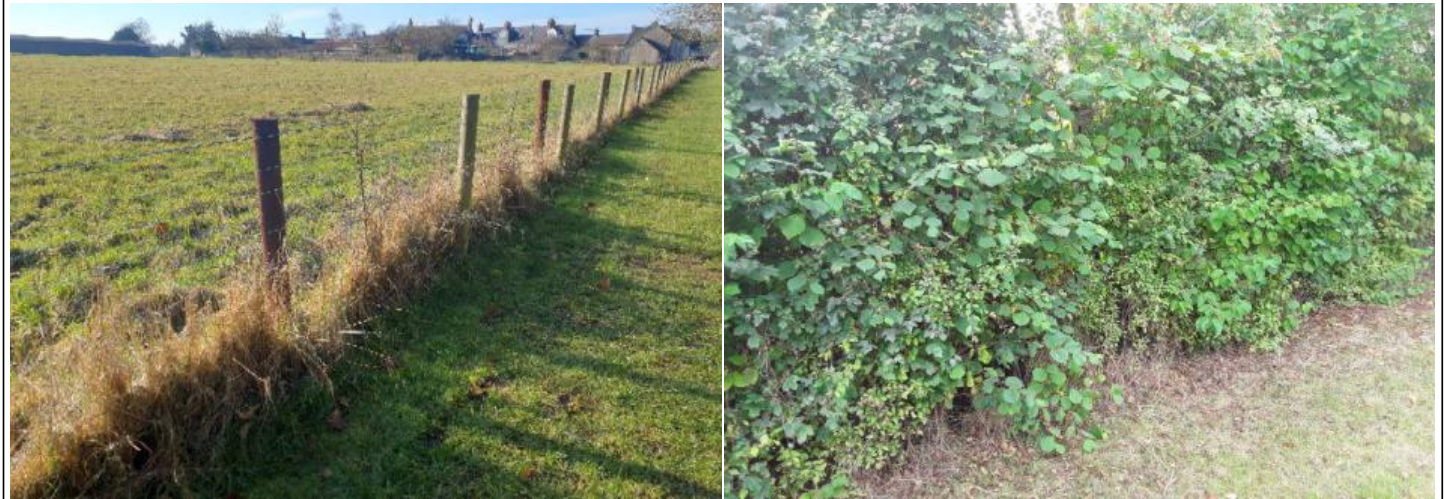
i 6 - Low Risk (Finding 5)

Item:	Fences - Fence - Timber & Mesh Infill	Risk Level:	L - Low Risk
Manufacturer:	Not Identified	Surface:	Grass

Finding: The adjacent foliage is overhanging	Action: Cut back and maintain
---	--------------------------------------

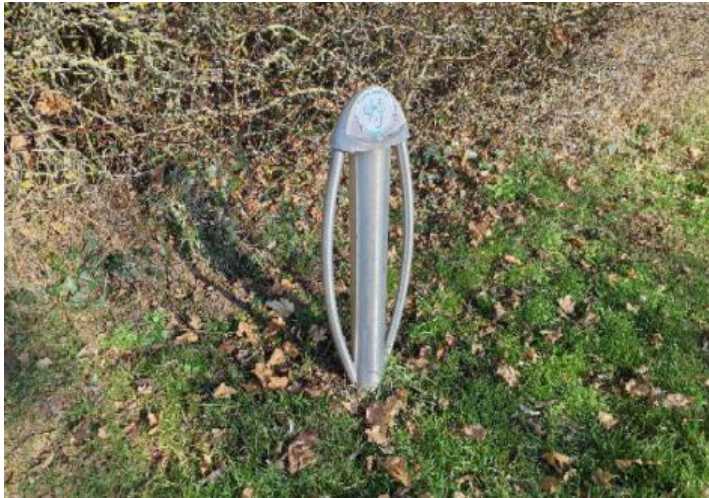
i 6 - Low Risk (Finding 1)

Item: Ancillary Items - Cycle Rack
Manufacturer: Husson UK

Finding: There is some minor damage to the item

Action: Monitor for any further deterioration and remove any rough or sharp edges

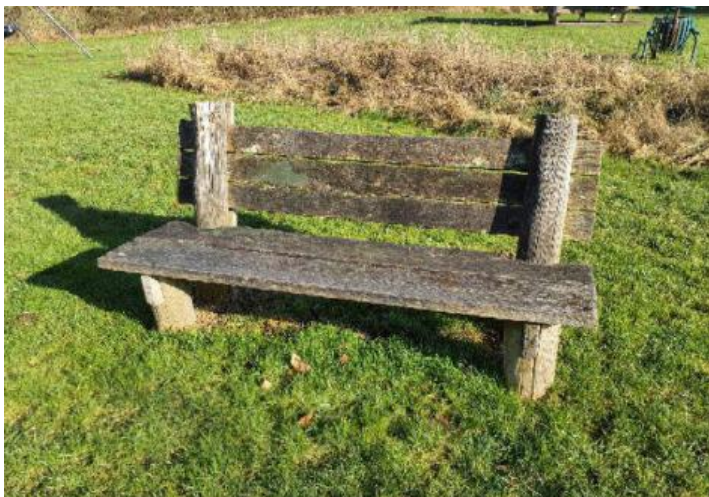
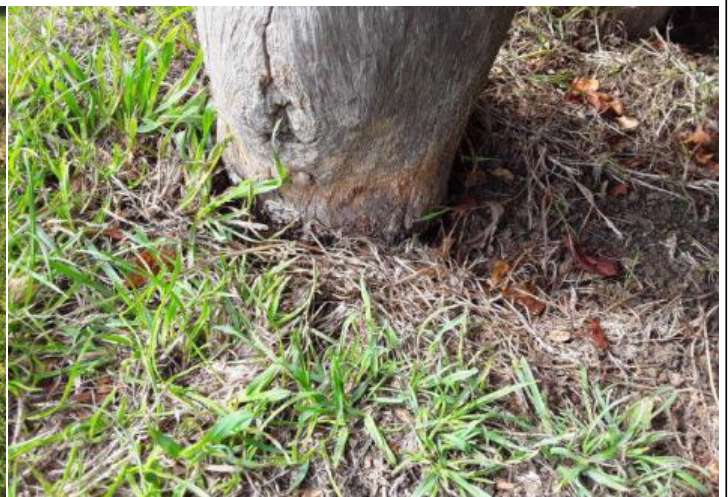
Item: Ancillary Items - Bench
Manufacturer: Not Identified

Finding: There is some strimmer / machinery damage apparent on the posts, this can penetrate the preservative applied to the timber and accelerate the rotting process

Action: Monitor for any deterioration (rot) and replace as required

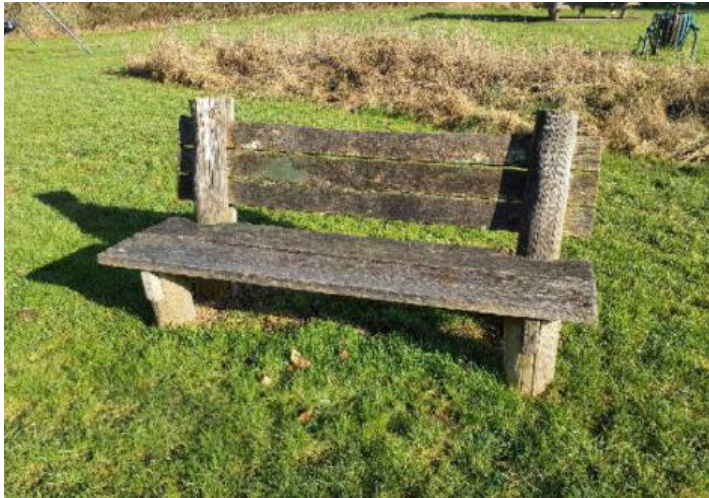
Item: Ancillary Items - Bench
Manufacturer: Not Identified

Finding: There is some evidence of rot in the timber

Action: Monitor for any further deterioration and replace as required

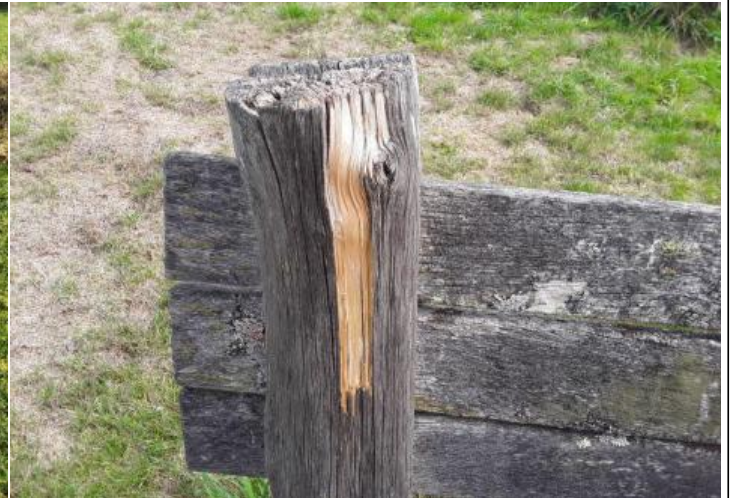
Item: Ancillary Items - Bench
Manufacturer: Not Identified

Finding: Parts of the timber are rough or splintered

Action: Remove all rough or sharp edges

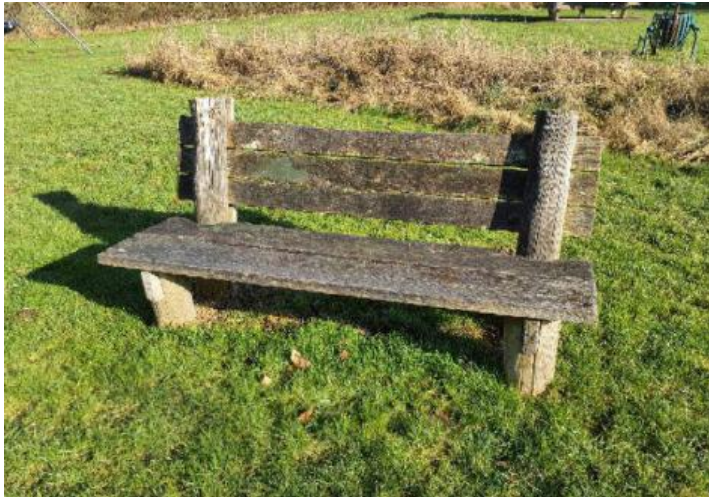
Item: Ancillary Items - Bench
Manufacturer: Not Identified

Finding: The timber has a number of splits/shakes or air cracks and this may affect the stability or allow water ingress which will accelerate the rotting process

Action: Monitor to ensure the splits do not cross through fixing points of the structure and/or cause any instability

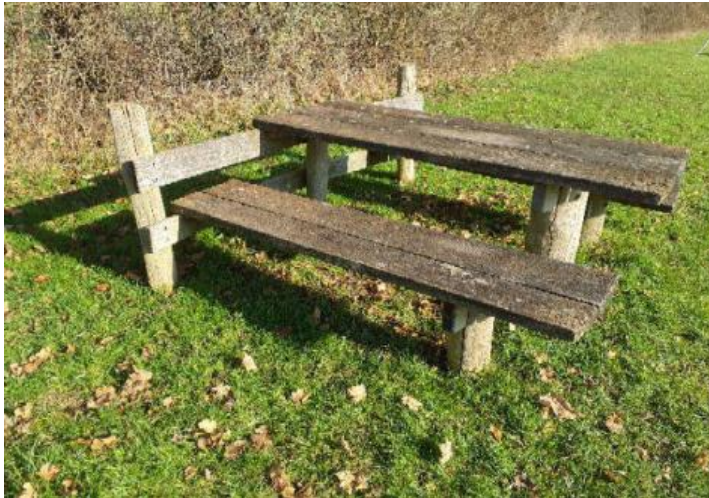
Item: Ancillary Items - Picnic Table
Manufacturer: Not Identified

Finding: There is some strimmer / machinery damage apparent on the posts, this can penetrate the preservative applied to the timber and accelerate the rotting process

Action: Monitor for any deterioration (rot) and replace as required

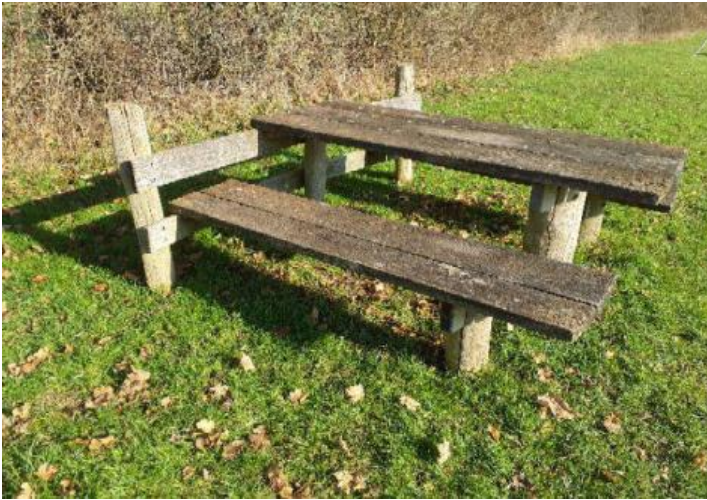
Item: Ancillary Items - Picnic Table
Manufacturer: Not Identified

Finding: There is some evidence of rot in the timber

Action: Monitor for any further deterioration and replace as required

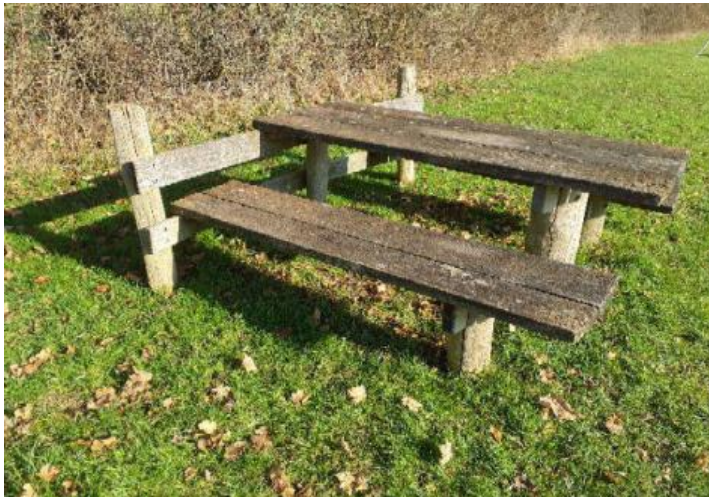
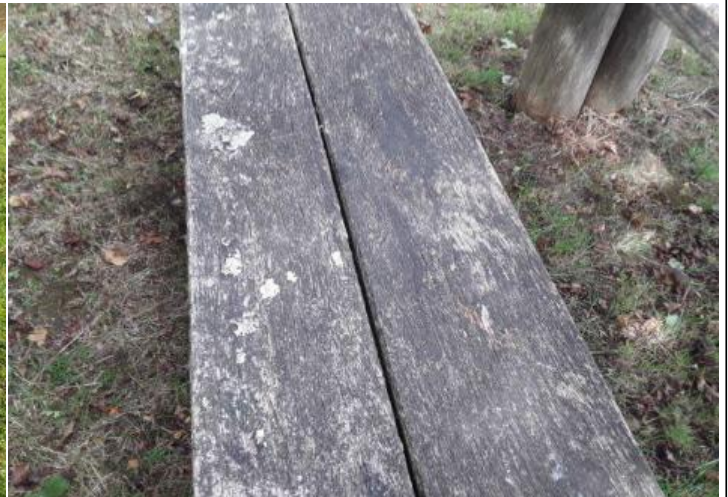
Item: Ancillary Items - Picnic Table
Manufacturer: Not Identified

Finding: There is algae or moss on the surface of the equipment **Action:** Clean and treat appropriately
