Operational Inspection

Thornhackett Parish Council

Thornford Play Area

adj The Village Hall, Blacksmiths Lane, Thornford,
Dorset, DT9 6PH

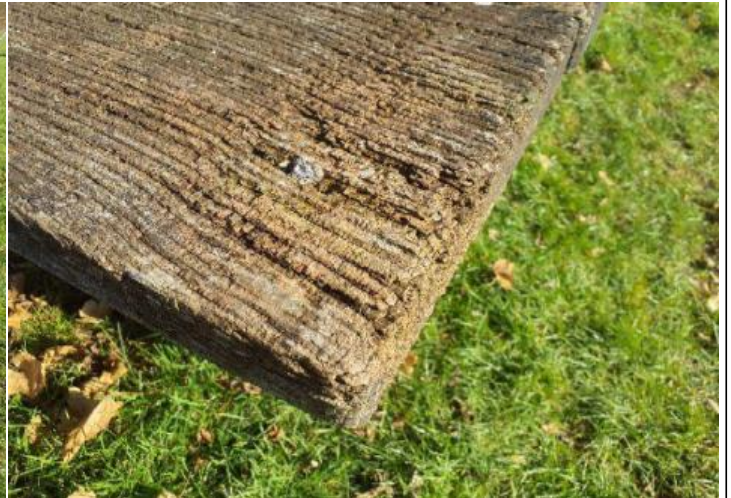
i 6 - Low Risk (Finding 5)

Item: Ancillary Items - Picnic Table
Manufacturer: Not Identified

Finding: Parts of the timber are rough or splintered

Action: Remove all rough or sharp edges

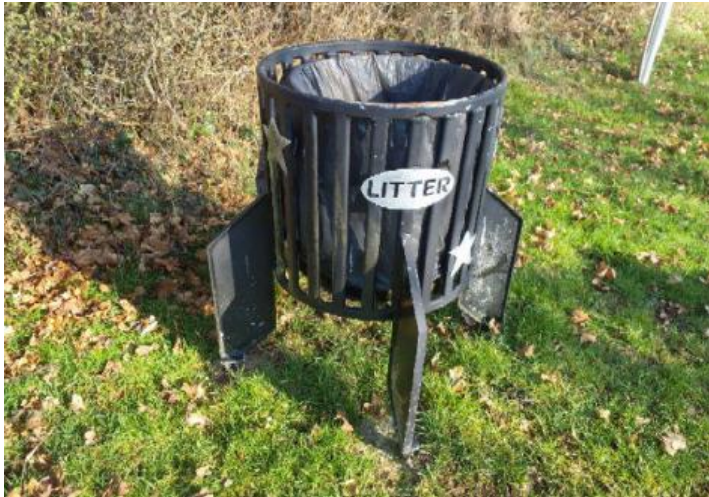
Item: Ancillary Items - Litter Bin
Manufacturer: Not Identified

Finding: The paintwork on this item has been damaged or worn exposing the metal underneath which is rusting

Action: Treat any rusting components and repaint

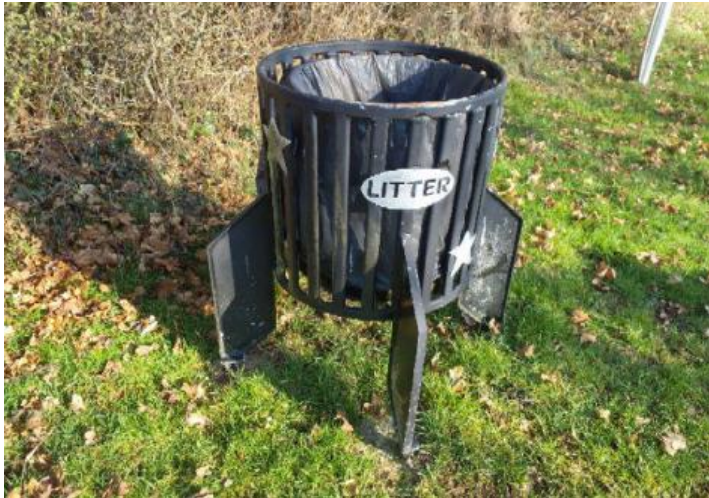
Item: Ancillary Items - Litter Bin
Manufacturer: Not Identified

Finding: The bin lid is missing

Action: Replace

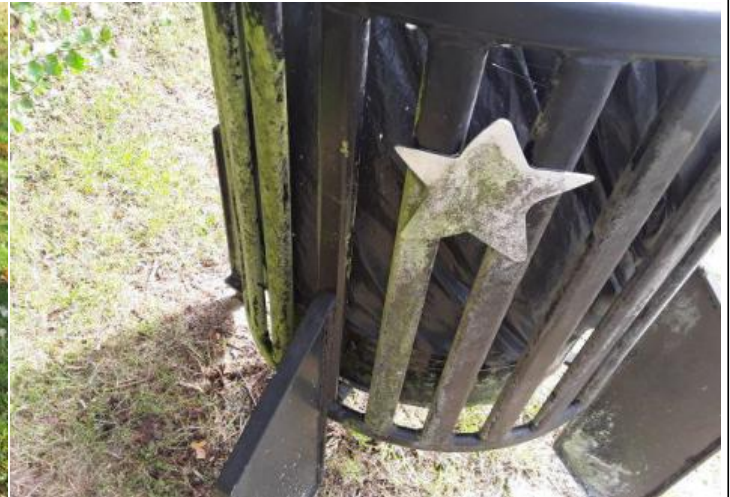
Item: Ancillary Items - Litter Bin
Manufacturer: Not Identified

Finding: There is algae or moss on the surface of the bin

Action: Clean and treat appropriately

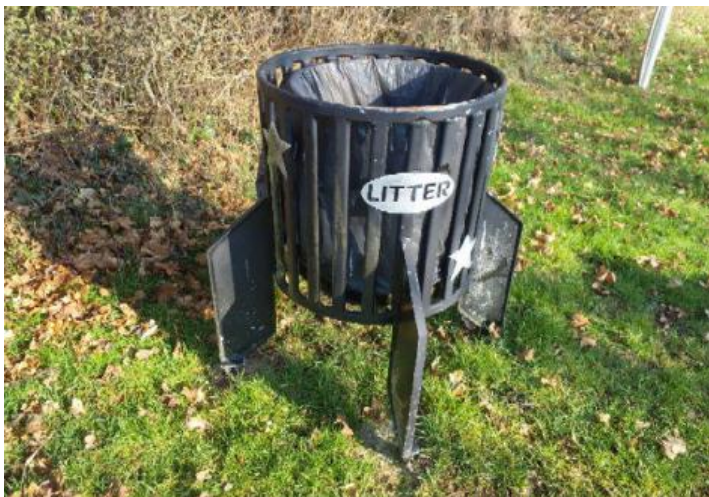
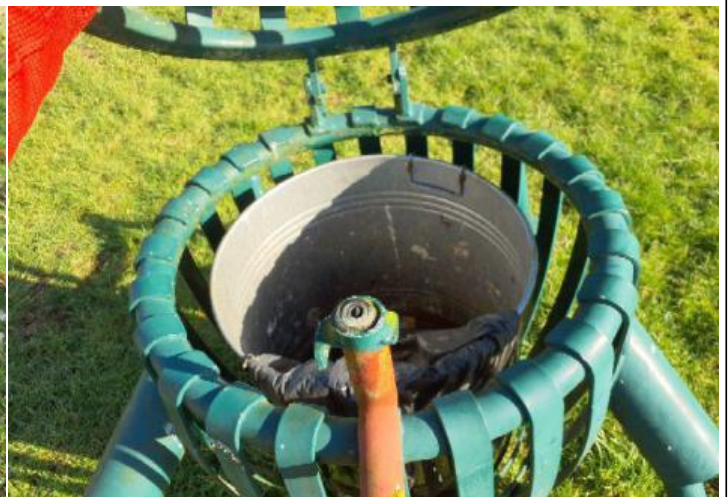
Item: Ancillary Items - Litter Bin
Manufacturer: Not Identified

Finding: The lid or door of the litter bin is not secured

Action: Ensure the lid or door is kept locked

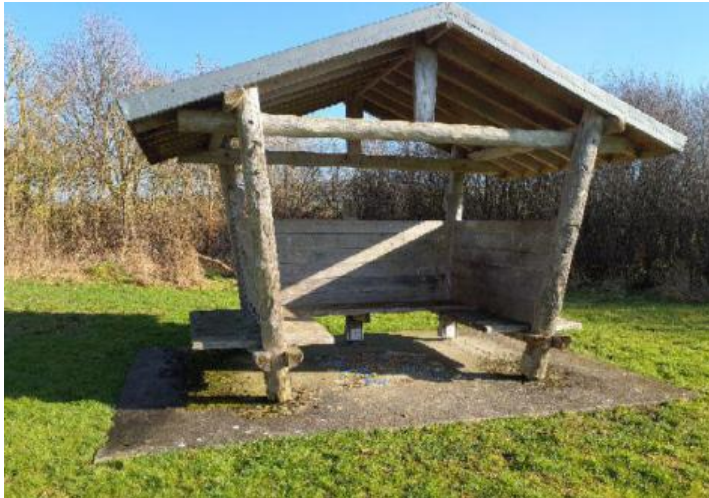
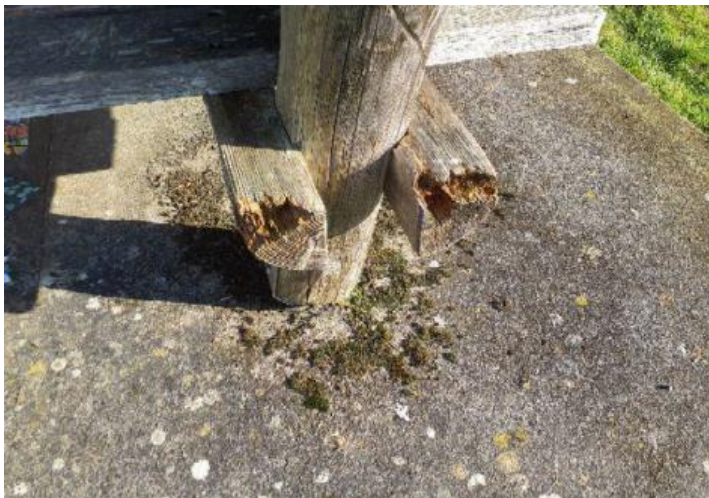
Item: Ancillary Items - Shelter
Manufacturer: Not Identified

Finding: There are areas or parts of the timber on the structure that have rotted

Action: Replace all affected timbers

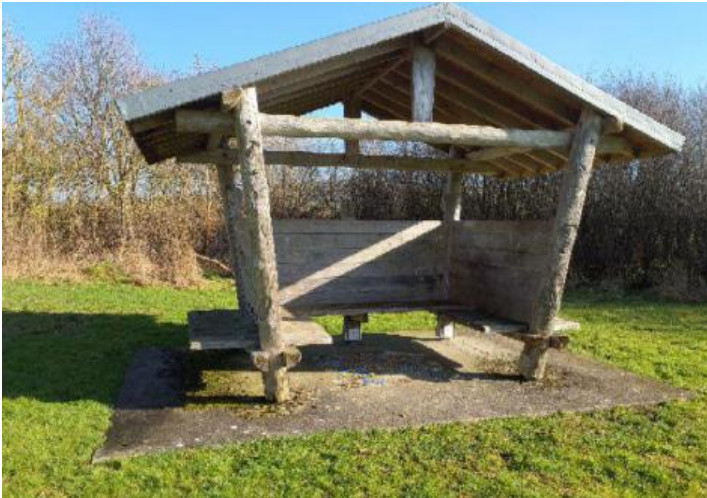
Item: Ancillary Items - Shelter
Manufacturer: Not Identified

Finding: There are trip hazards at the edges of the concrete pad
Action: Reinstate surrounding surface levels to remove the trip points

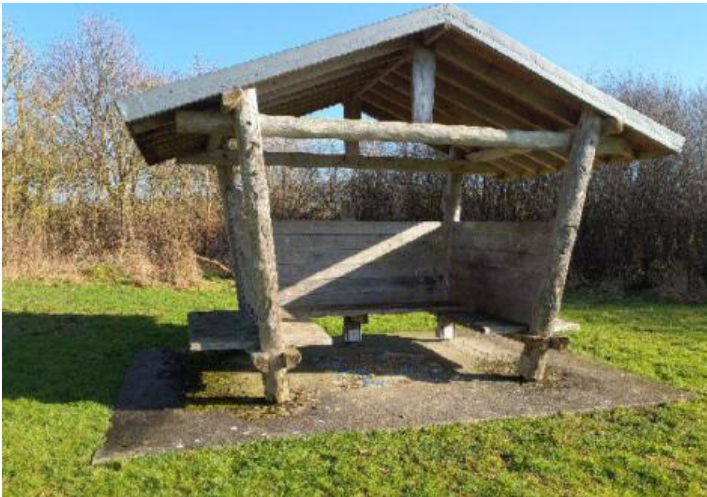
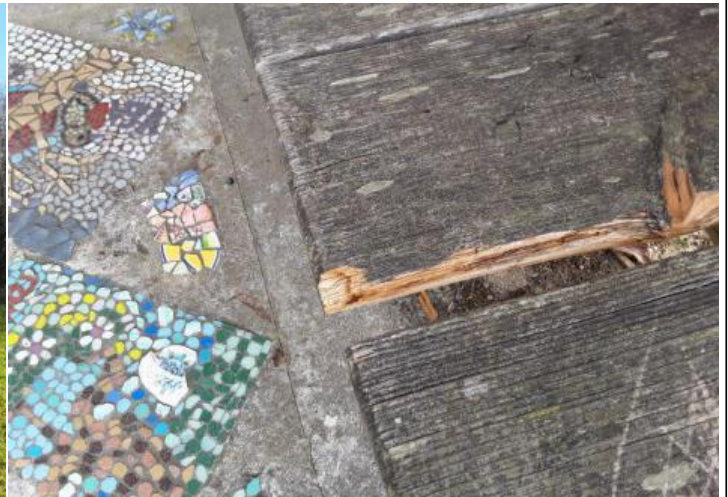
i 6 - Low Risk (Finding 3)

Item: Ancillary Items - Shelter
Manufacturer: Not Identified

Finding: Parts of the timber are rough or splintered
Action: Remove all rough or sharp edges

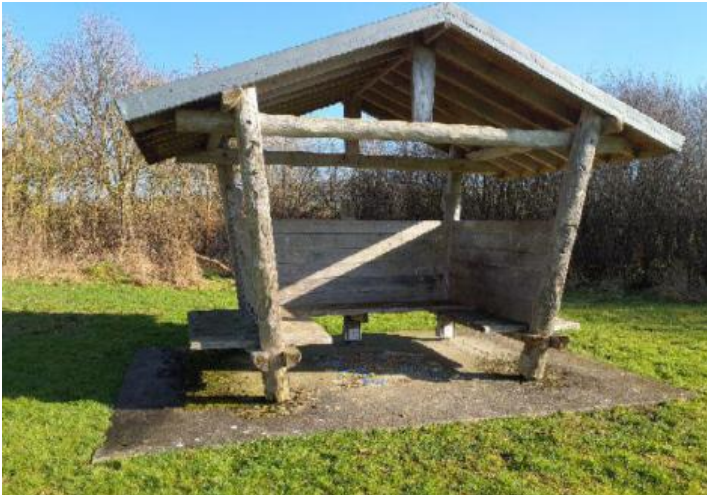
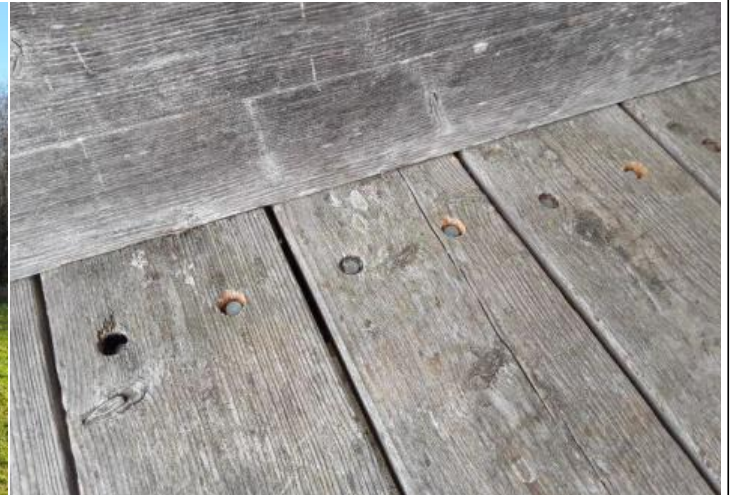
Item: Ancillary Items - Shelter
Manufacturer: Not Identified

Finding: A number of fixing(s) have worked loose

Action: Secure all loose fixings

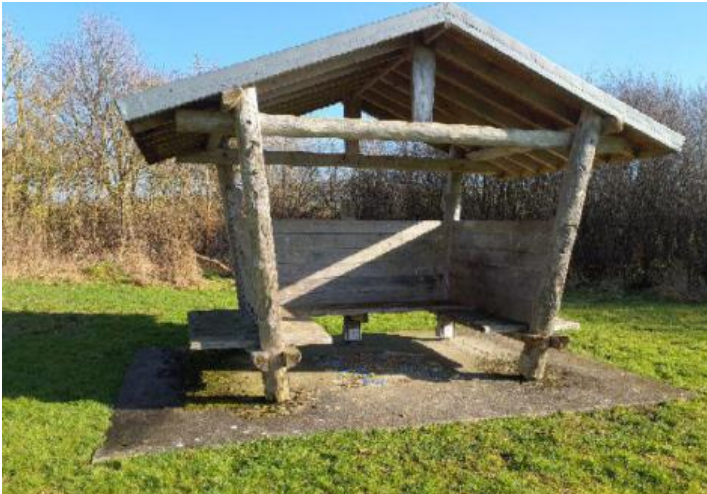
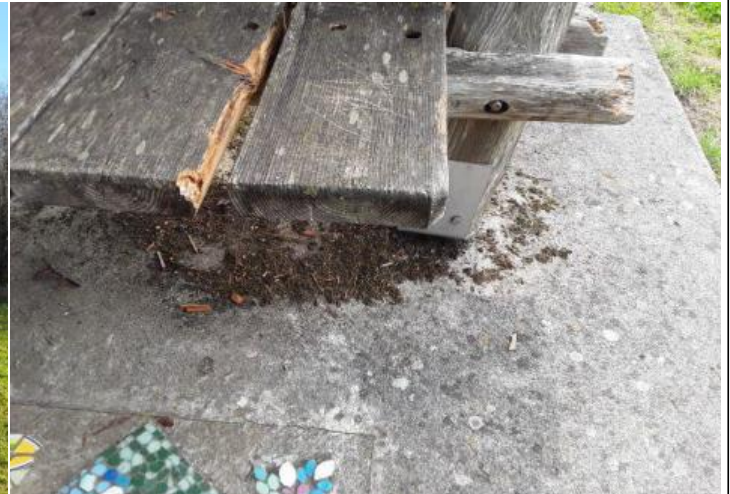
Item: Ancillary Items - Shelter
Manufacturer: Not Identified

Finding: There is algae or moss growth on the surface resulting in slippery conditions

Action: Clean and treat appropriately

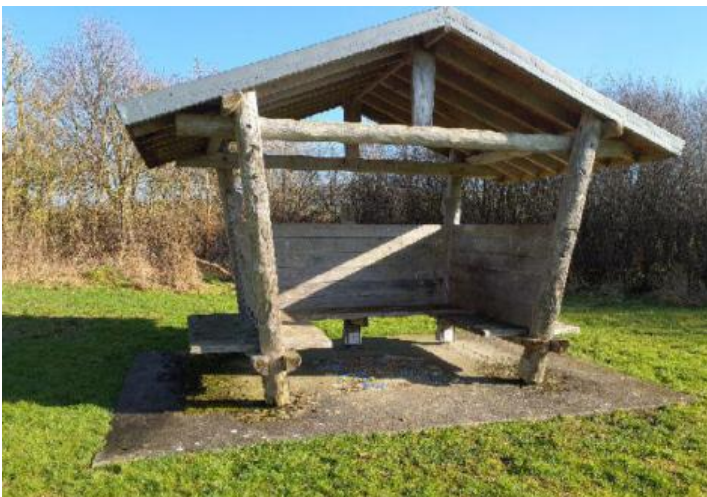
Item: Ancillary Items - Shelter
Manufacturer: Not Identified

Finding: There is or are fixings missing on the item

Action: Replace all missing fixings

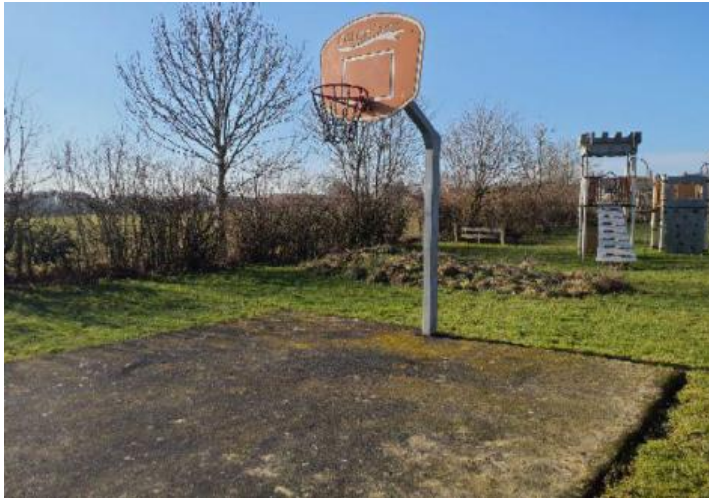
Item: Multi Use Games Area - Basketball Post
Manufacturer: Husson UK

Finding: There are trip hazards at the edges of the wet pour surfacing
Action: Reinstate surrounding surface levels to remove the trip points

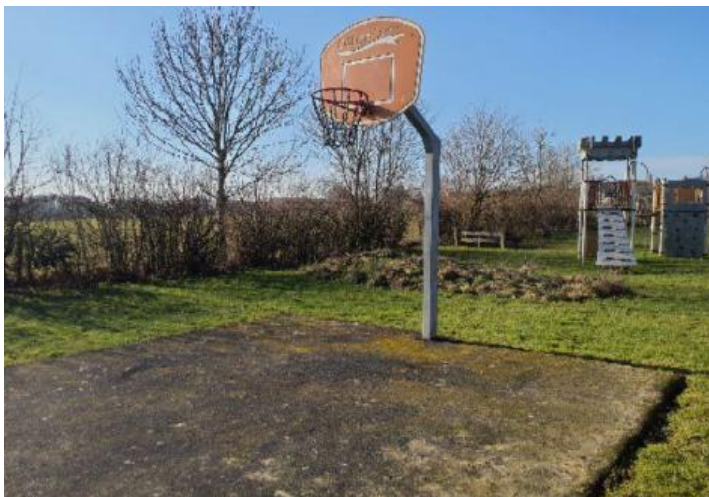
Item: Multi Use Games Area - Basketball Post
Manufacturer: Husson UK

Finding: There is or are fixings missing on the backboard
Action: Replace all missing fixings

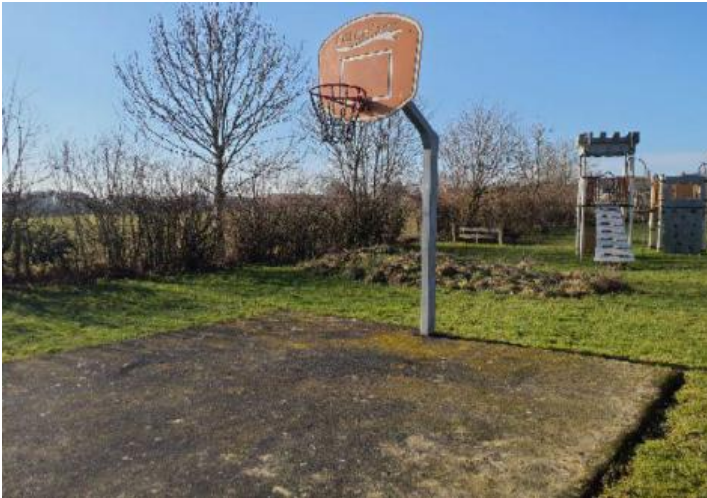
Item: Multi Use Games Area - Basketball Post
Manufacturer: Husson UK

Finding: There are significant gaps (over 30mm) between the surface and the edging or between the joints in the surface; these are large enough for a small foot to enter

Action: Repair surfacing

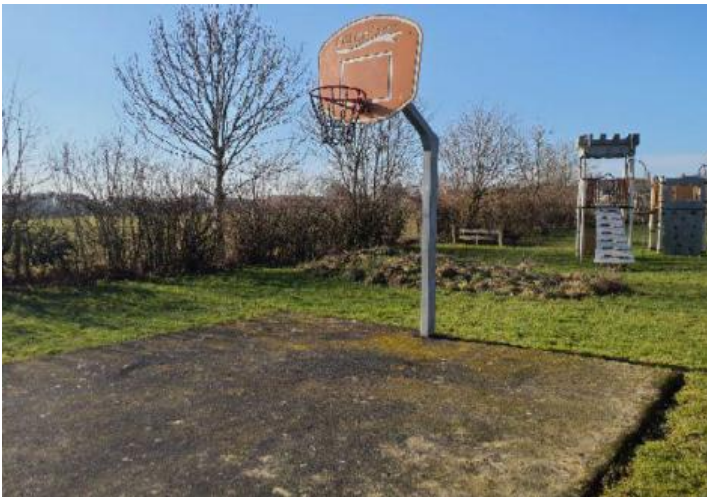
Item: Multi Use Games Area - Basketball Post
Manufacturer: Husson UK

Finding: There is algae or moss growth on the surface resulting in slippery conditions

Action: Clean and treat appropriately

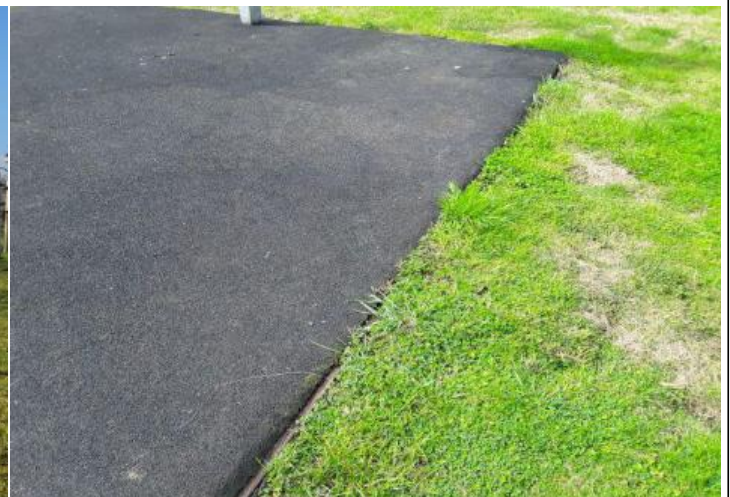
Item: Multi Use Games Area - Basketball Post
Manufacturer: Husson UK

Finding: There are weeds/vegetation growth between or around the edges of the surfacing

Action: Remove weeds/vegetation growth

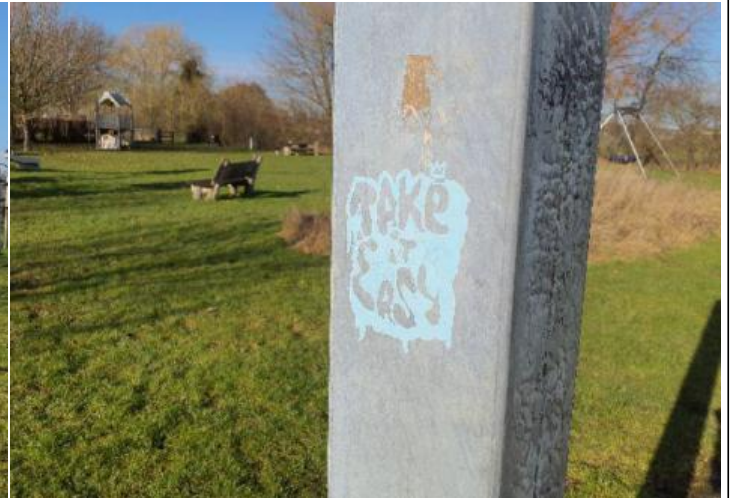
Item: Multi Use Games Area - Basketball Post
Manufacturer: Husson UK

Finding: There is some graffiti present

Action: Remove the graffiti

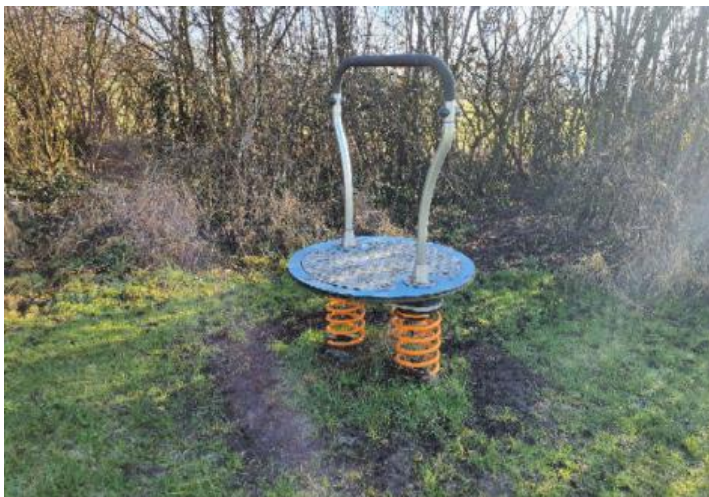
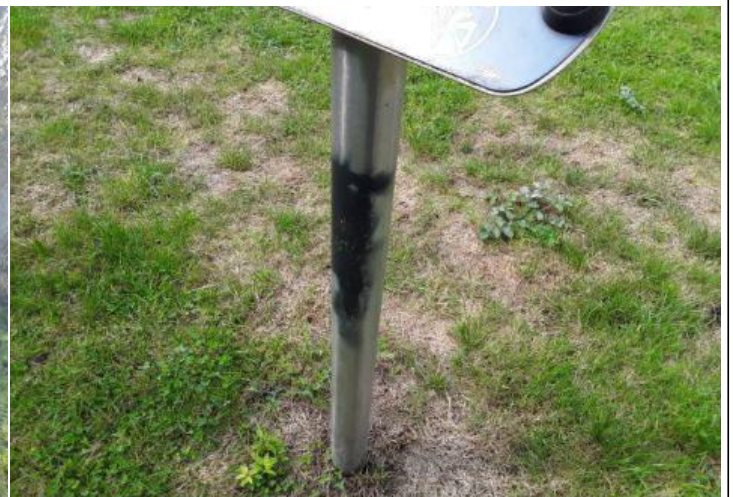
Item: Rocking Equipment - Rotating Spring Board
Manufacturer: Proludic

Finding: There is some graffiti present

Action: Remove the graffiti

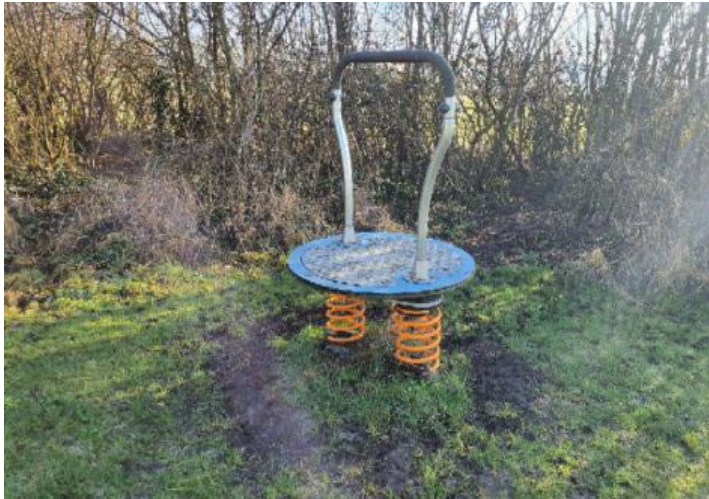
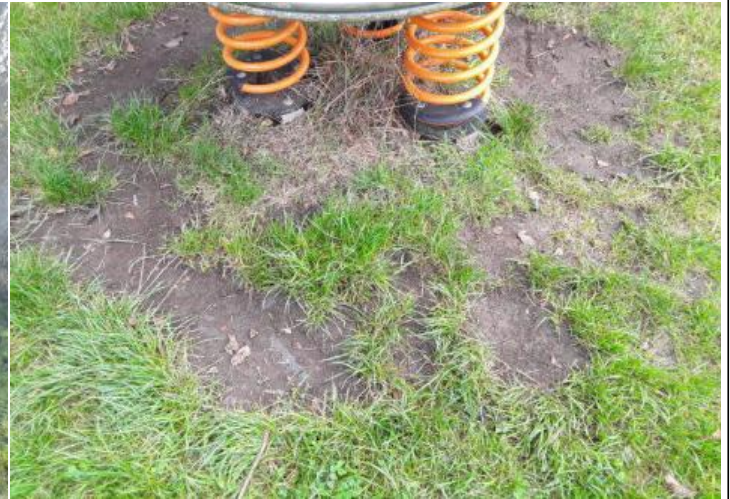
Item: Rocking Equipment - Rotating Spring Board
Manufacturer: Proludic

Finding: The grass mats are silted up, the soil is compacted and the area will become very slippery when the soil is wet. **Action:** Reinstate as required

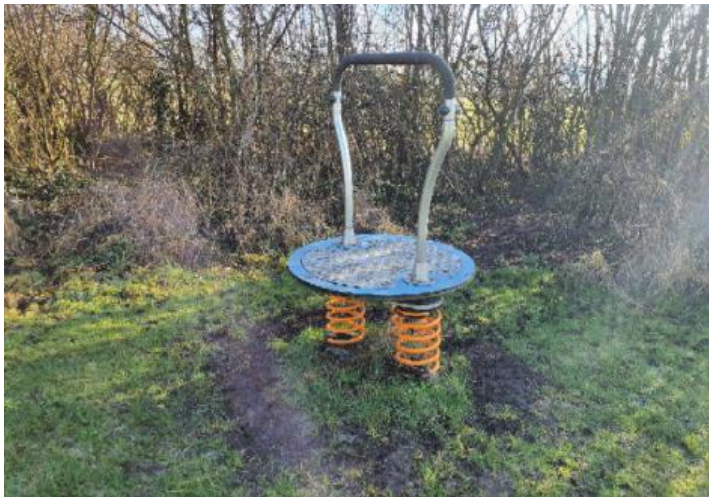
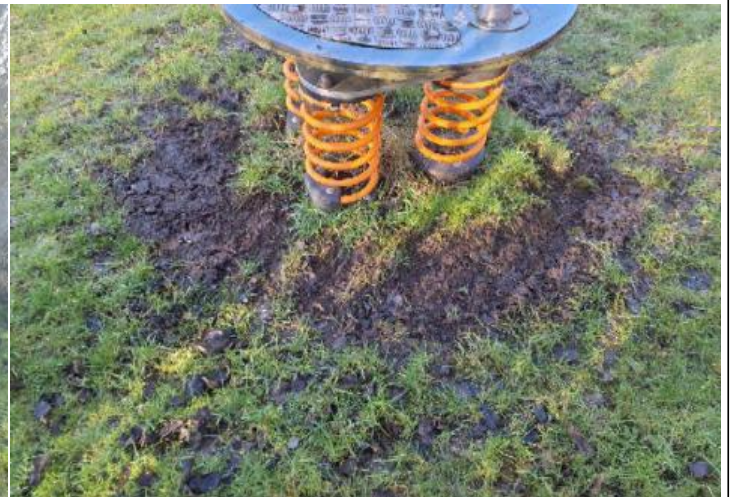
Item: Rocking Equipment - Rotating Spring Board
Manufacturer: Proludic

Finding: The area around the item has eroded and may become slippery **Action:** Reinstate eroded area

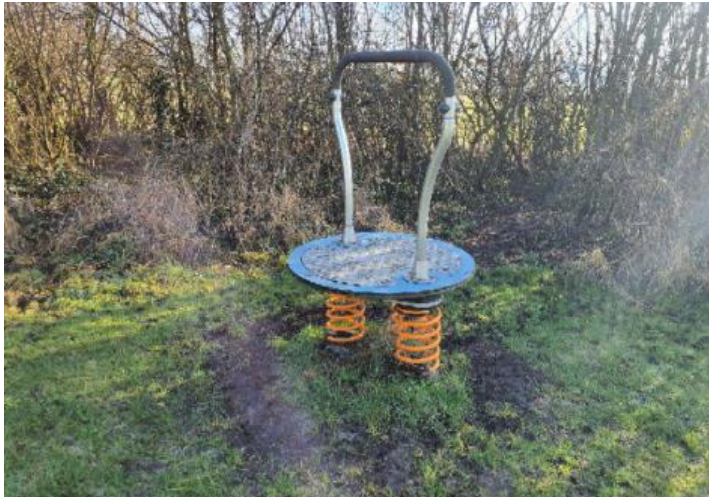
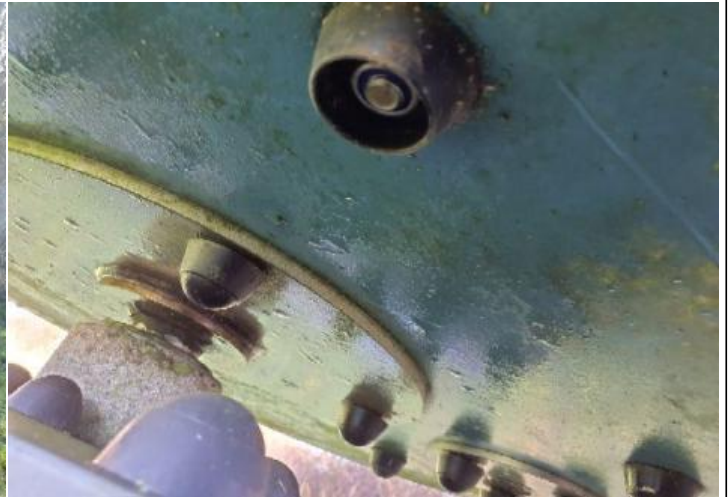
Item: Rocking Equipment - Rotating Spring Board
Manufacturer: Proludic

Finding: There is/are bolt cap covers missing or damaged on the item

Action: Replace missing or damaged bolt cap covers

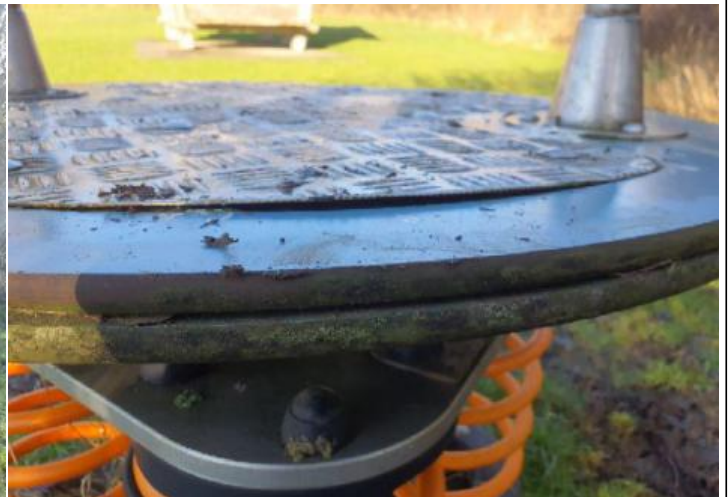
Item: Rocking Equipment - Rotating Spring Board
Manufacturer: Proludic

Finding: The edge of the steel plate is lifting in places

Action: Monitor for any further deterioration and repair as required

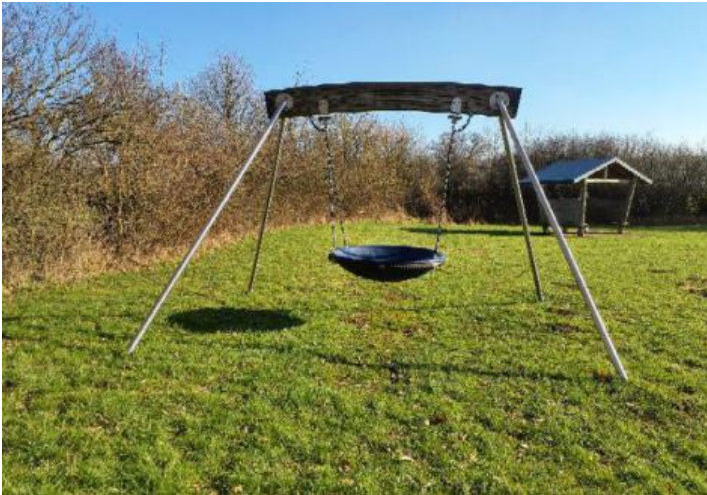
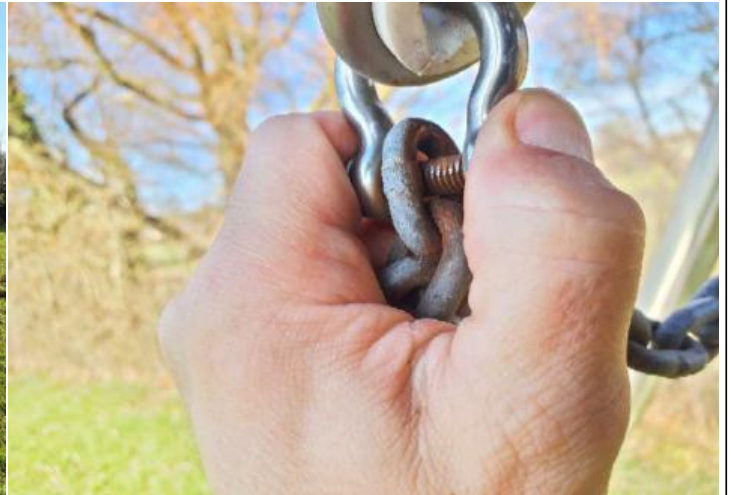
Item: Swings - Basket Swing - Type 1
Manufacturer: Proludic

Finding: There is some notable evidence of chain wear

Action: Monitor for any further deterioration and replace when 40% worn

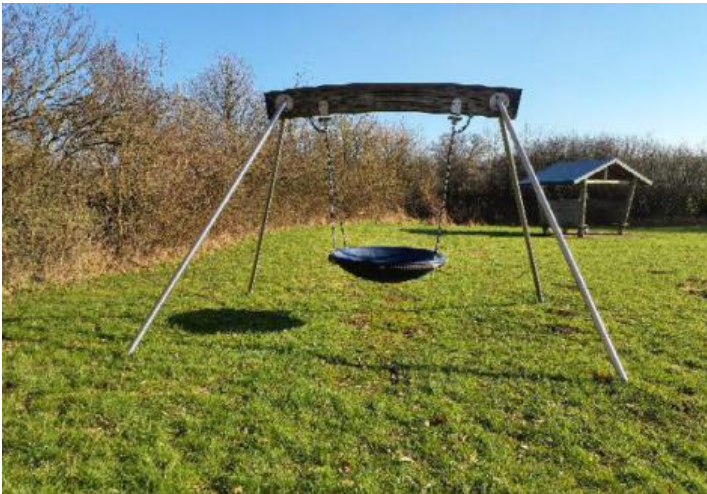
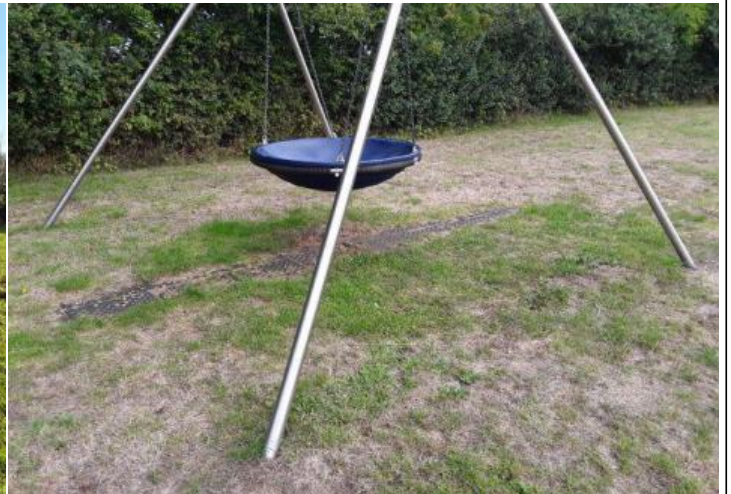
Item: Swings - Basket Swing - Type 1
Manufacturer: Proludic

Finding: The posts are slightly loose in the ground

Action: Monitor for any further deterioration and repair as required

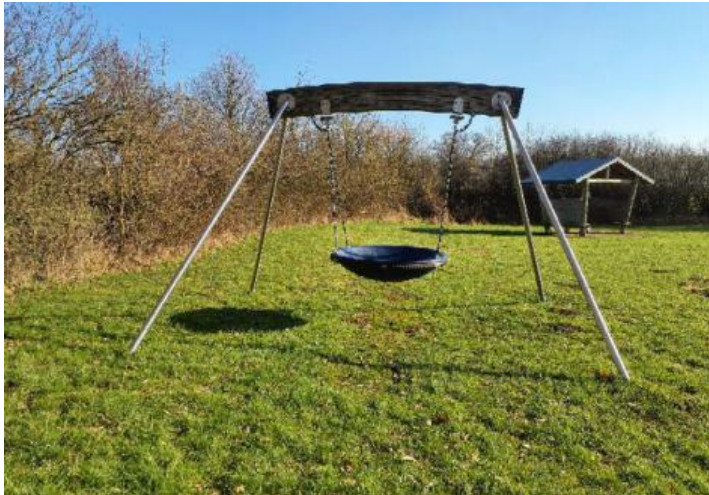
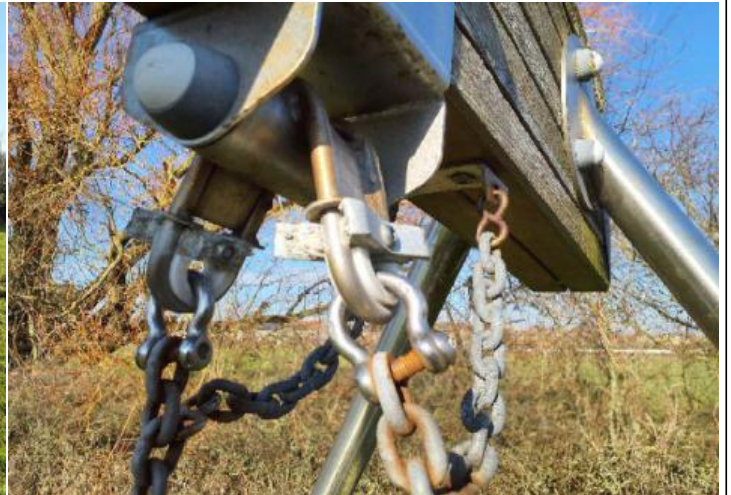
Item: Swings - Basket Swing - Type 1
Manufacturer: Proludic

Finding: The pivot mechanism fixings are corroded

Action: Replace

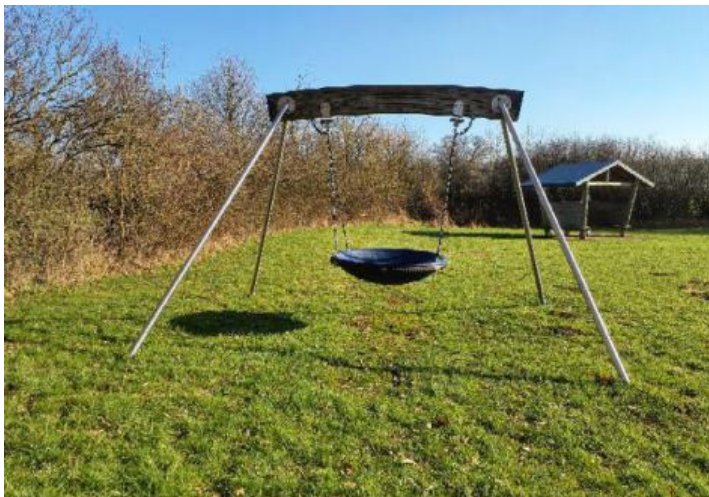
Item: Swings - Basket Swing - Type 1
Manufacturer: Proludic

Finding: There is/are bolt cap covers missing or damaged on the item

Action: Replace missing or damaged bolt cap covers

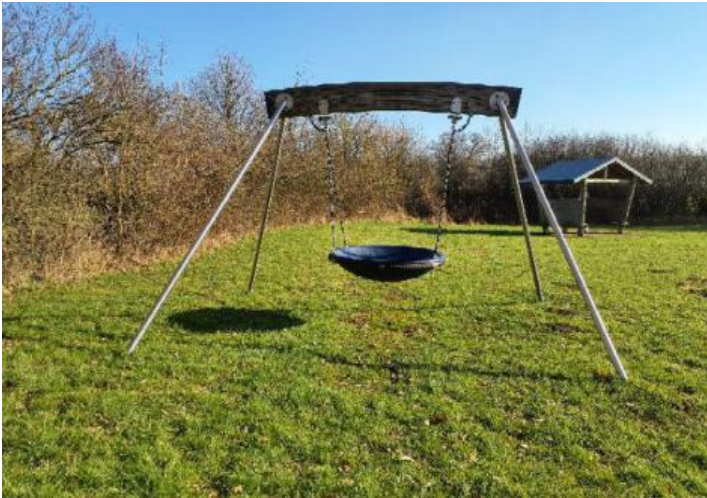
Item: Swings - Basket Swing - Type 1
Manufacturer: Proludic
Risk Level: L - Low Risk
Surface: Grass Matrix Tiles

Finding: There is some evidence of rot in the crossbeam
Action: Monitor for any further deterioration and replace as required

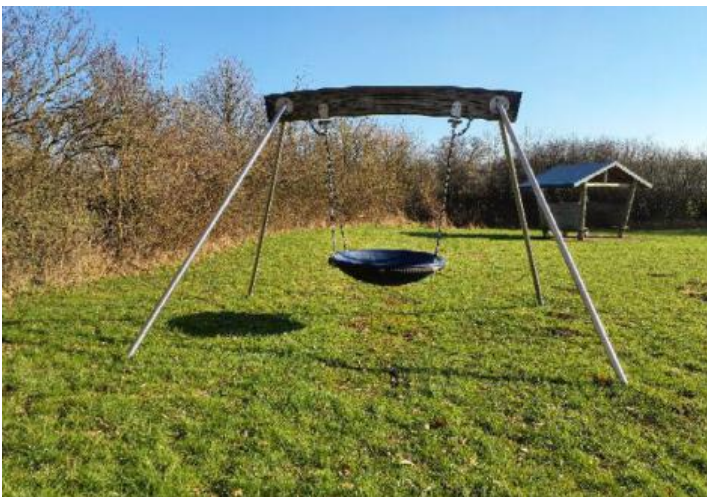
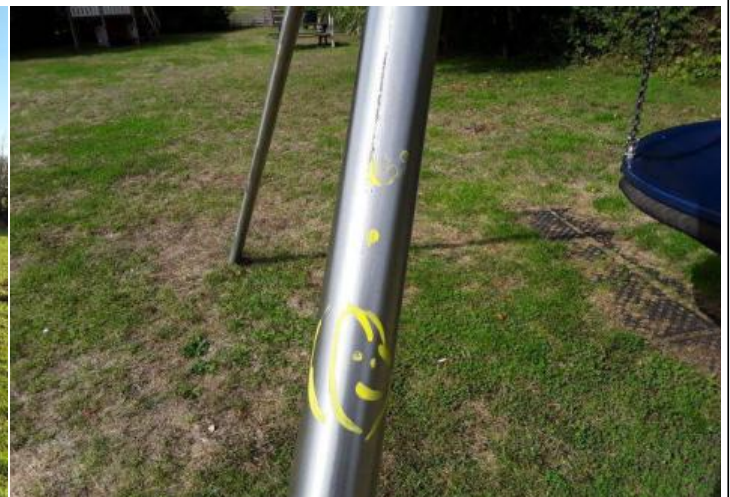
Item: Swings - Basket Swing - Type 1
Manufacturer: Proludic
Risk Level: N - Risk Assessment not Undertaken
Surface: Grass Matrix Tiles

Finding: There is some graffiti present
Action: Remove the graffiti

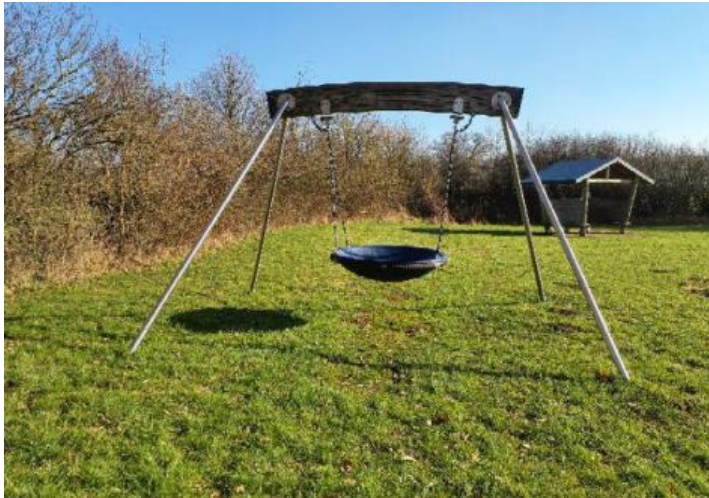
Item: Swings - Basket Swing - Type 1
Manufacturer: Proludic

Finding: There is algae or moss on the surface of the equipment that can lead to the onset of rot

Action: Monitor condition of the timbers (rot), clean and treat appropriately

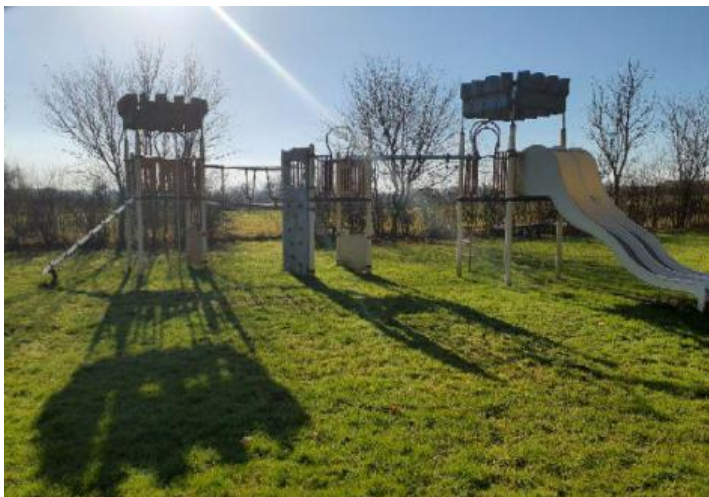
Item: Activity Equipment - Multi Play (Junior)
Manufacturer: Husson UK

Finding: There is some notable evidence of chain wear

Action: Monitor for any further deterioration and replace when 40% worn

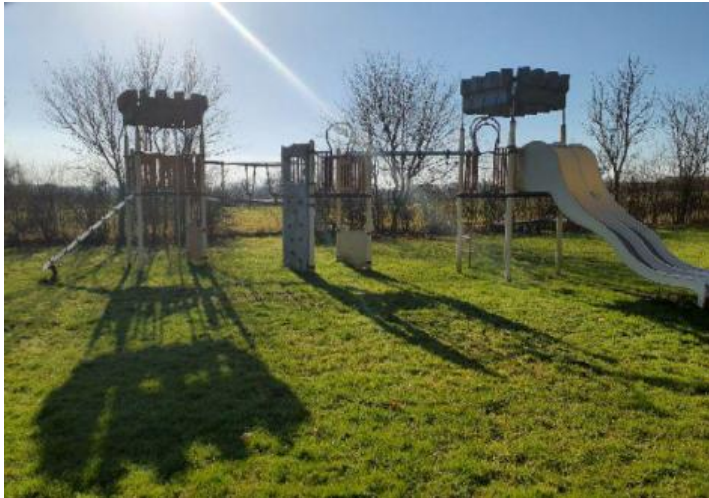
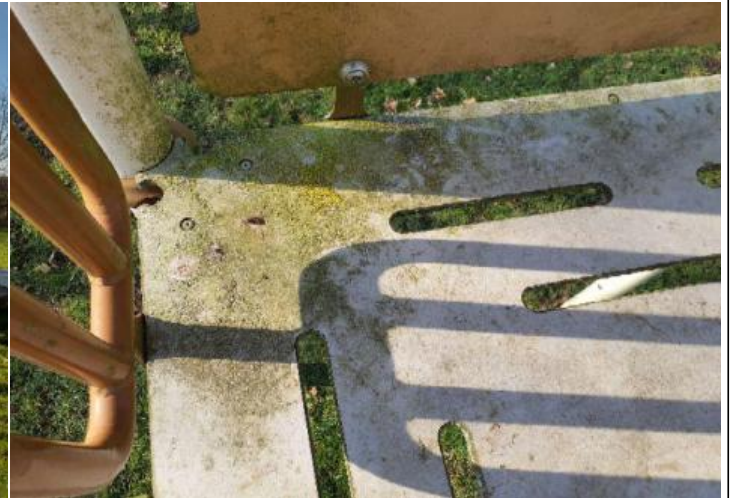
Item: Activity Equipment - Multi Play (Junior)
Manufacturer: Husson UK

Finding: There is algae or moss on the surface of the equipment

Action: Clean and treat appropriately

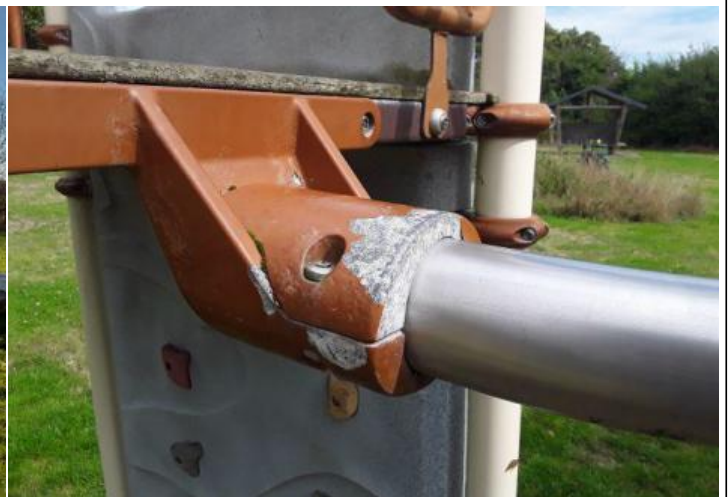
Item: Activity Equipment - Multi Play (Junior)
Manufacturer: Husson UK

Finding: The paint is flaking off the metalwork

Action: Rub down and re-paint

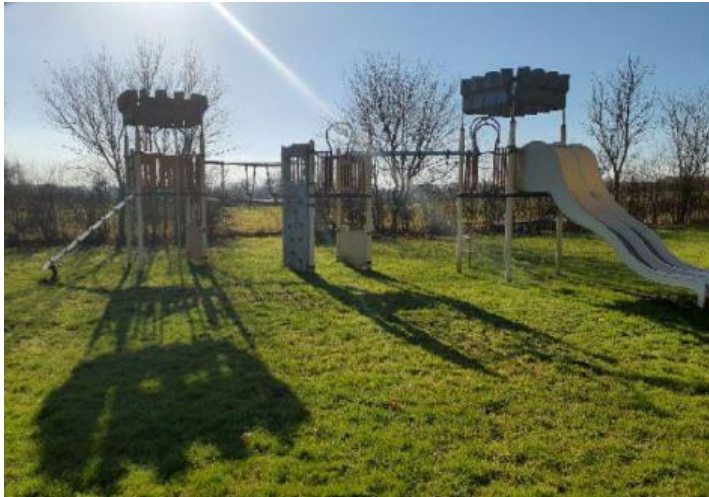
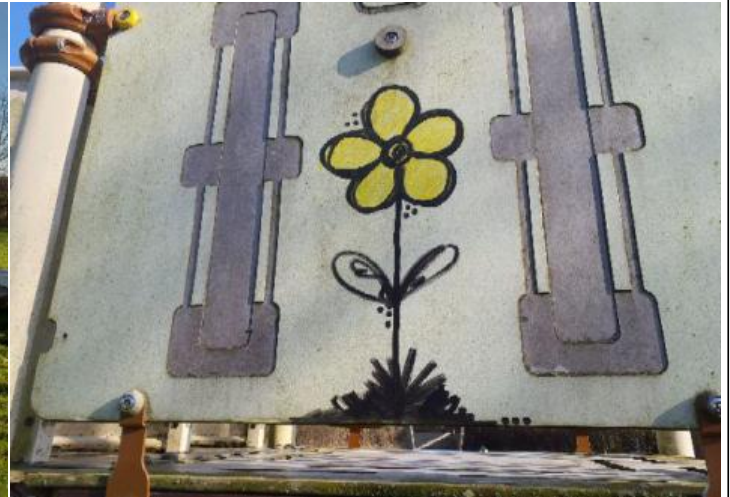
Item: Activity Equipment - Multi Play (Junior)
Manufacturer: Husson UK

Finding: There is some graffiti present

Action: Remove the graffiti

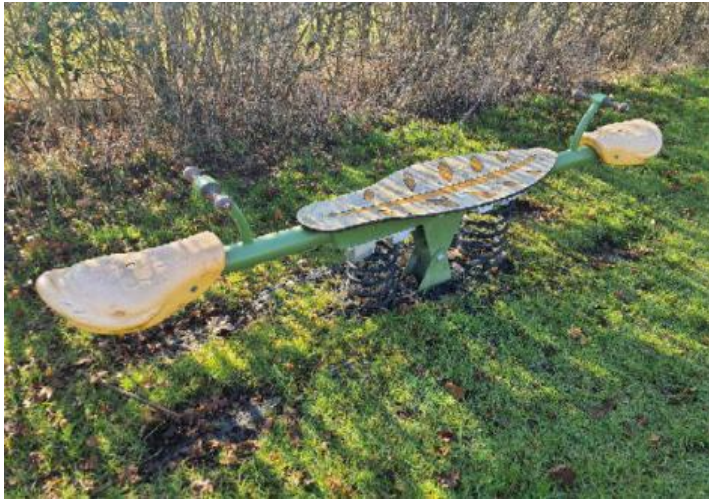
Item: Rocking Equipment - See Saw
Manufacturer: Husson UK

Finding: The pivot mechanism is showing signs of wear

Action: Monitor for any further deterioration and repair as required

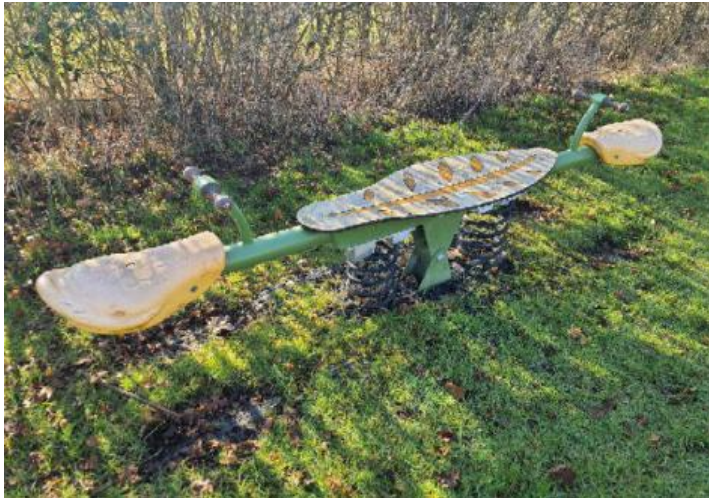
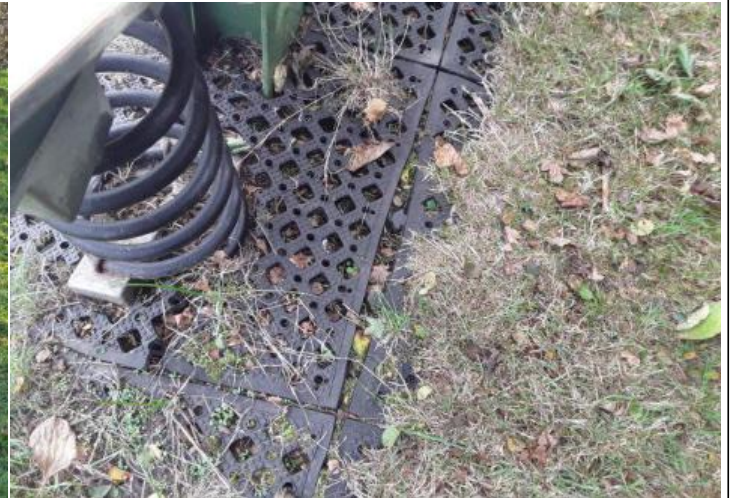
Item: Rocking Equipment - See Saw
Manufacturer: Husson UK

Finding: There are gaps opening between the grass mat tiles

Action: Provide additional ties or secure / reinstate surface tiles

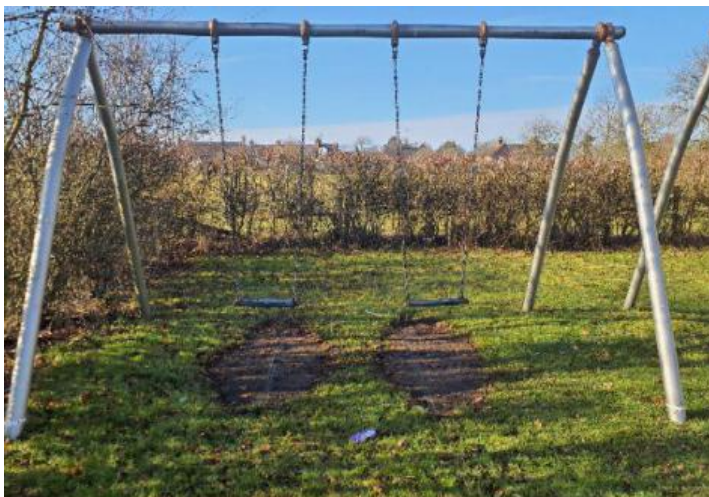
Item: Swings - 1 Bay 2 Seat (Flat)
Manufacturer: Husson UK

Finding: There is some notable evidence of chain wear

Action: Monitor for any further deterioration and replace when 40% worn

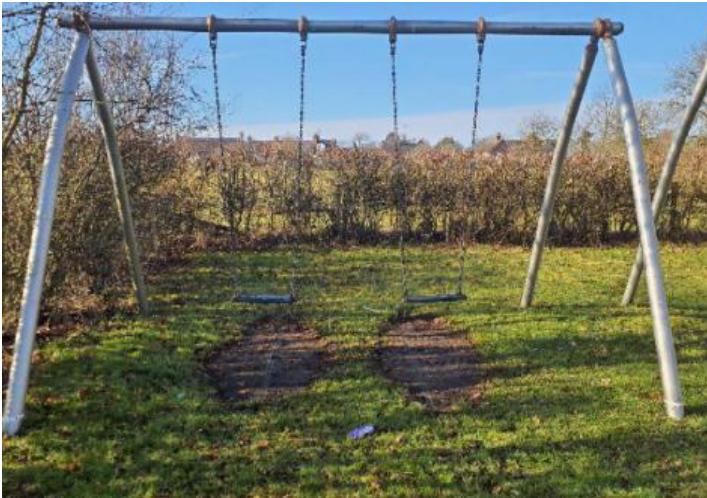
Item: Swings - 1 Bay 2 Seat (Flat)
Manufacturer: Husson UK

Finding: The seat has minor damage or wear

Action: Monitor for any further deterioration and replace as required

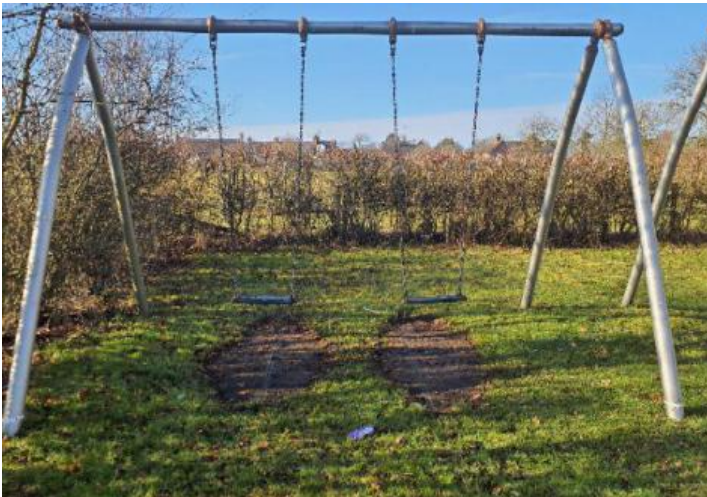
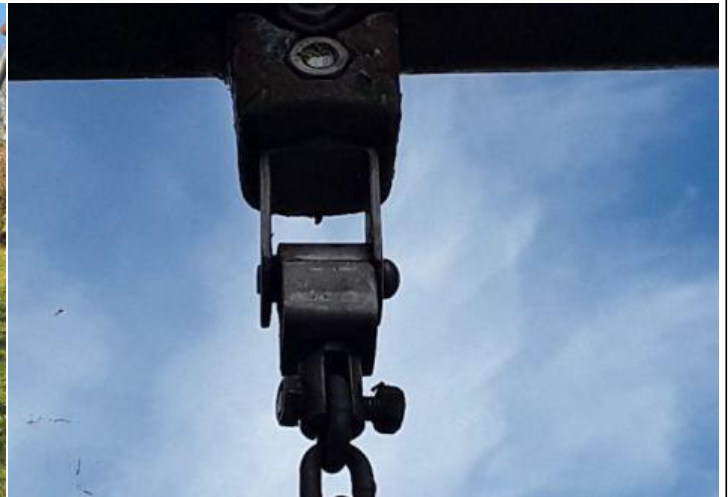
Item: Swings - 1 Bay 2 Seat (Flat)
Manufacturer: Husson UK

Finding: The bushes are showing signs of wear

Action: Monitor for any further deterioration and replace as required

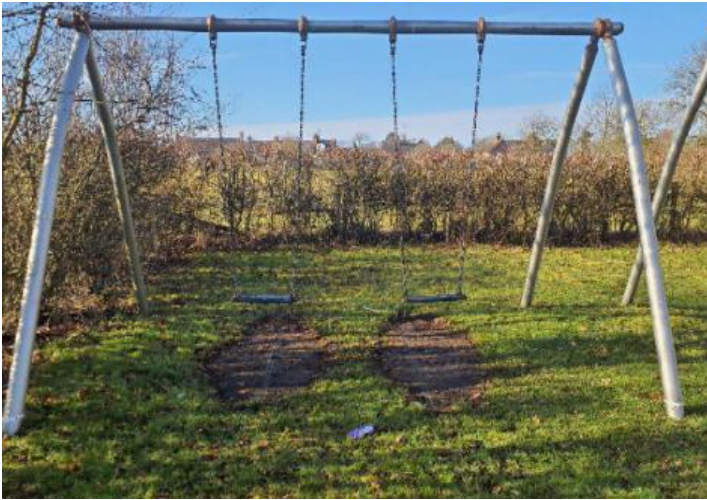
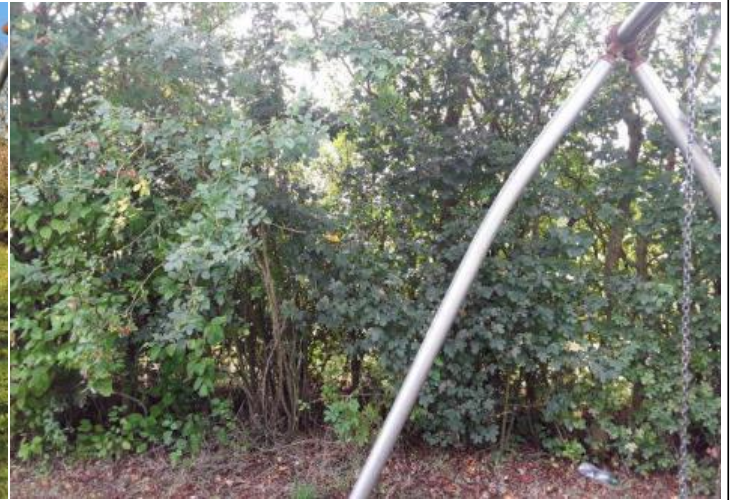
Item: Swings - 1 Bay 2 Seat (Flat)
Manufacturer: Husson UK

Finding: The tree canopy overhangs the equipment and is less than 2.0m away

Action: Lift tree canopy to ensure a minimum clearance of 2.0m from the equipment

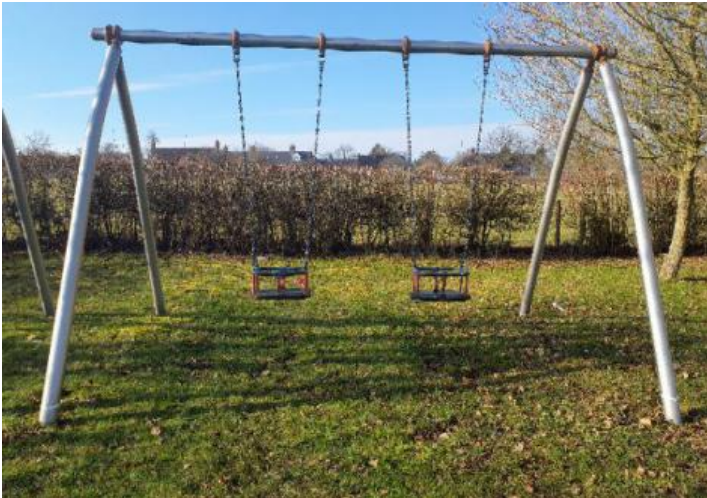
Item: Swings - 1 Bay 2 Seat (Cradle)
Manufacturer: Husson UK

Finding: The seat has minor damage or wear

Action: Monitor for any further deterioration and replace as required

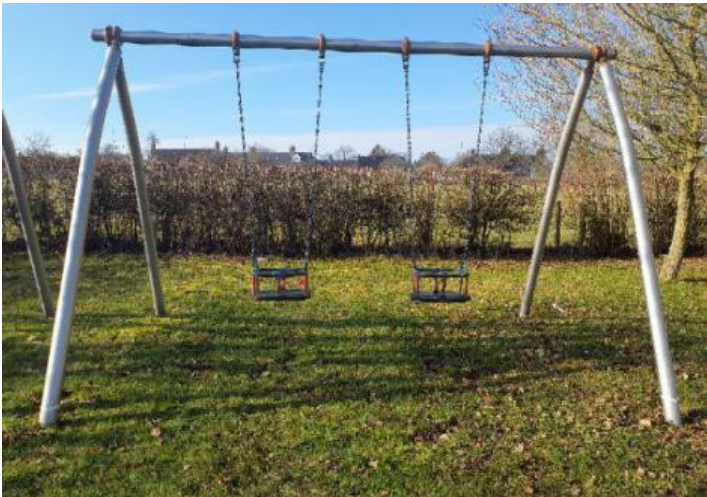
Item: Swings - 1 Bay 2 Seat (Cradle)
Manufacturer: Husson UK

Finding: The swing seat connectors are loose

Action: Tighten to secure
