Operational Inspection

Thornhackett Parish Council

Thornford Play Area

adj The Village Hall, Blacksmiths Lane, Thornford,
Dorset, DT9 6PH

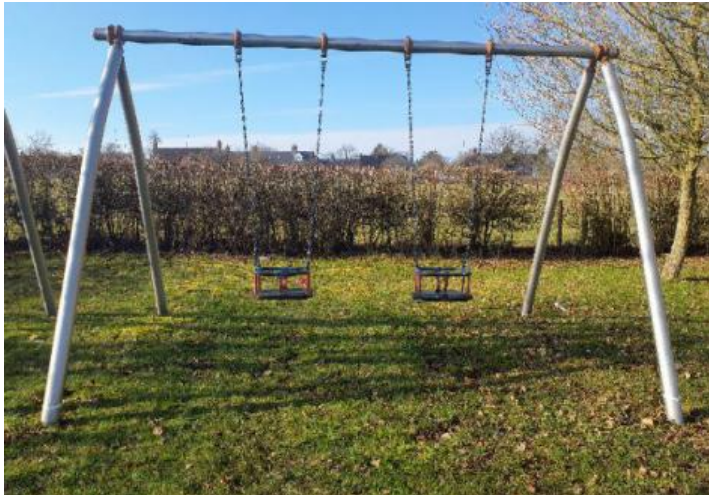
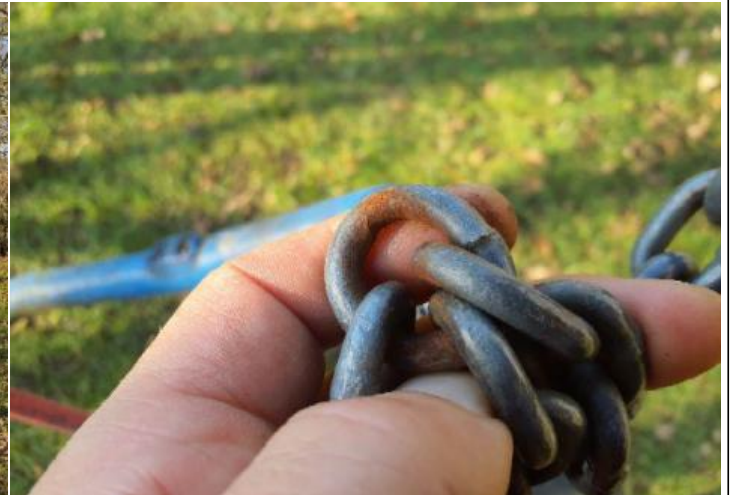
Item: Swings - 1 Bay 2 Seat (Cradle)
Manufacturer: Husson UK

Finding: There is some notable evidence of chain wear

Action: Monitor for any further deterioration and replace when 40% worn

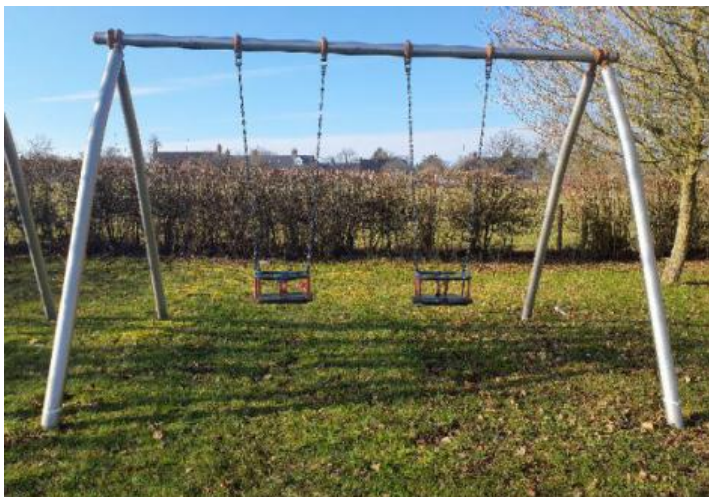
Item: Swings - 1 Bay 2 Seat (Cradle)
Manufacturer: Husson UK

Finding: Fungus or algae was found on the equipment

Action: Remove fungi or algae from the equipment

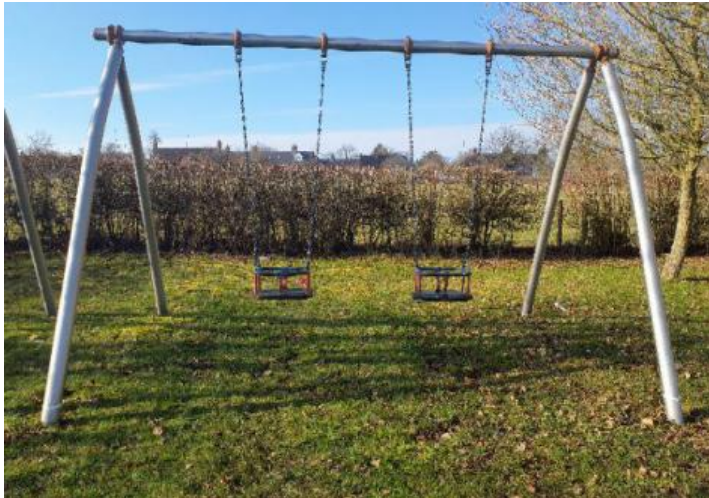
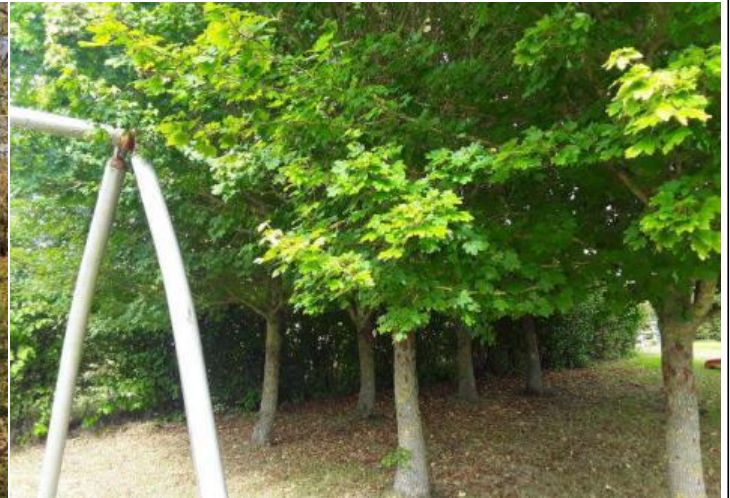
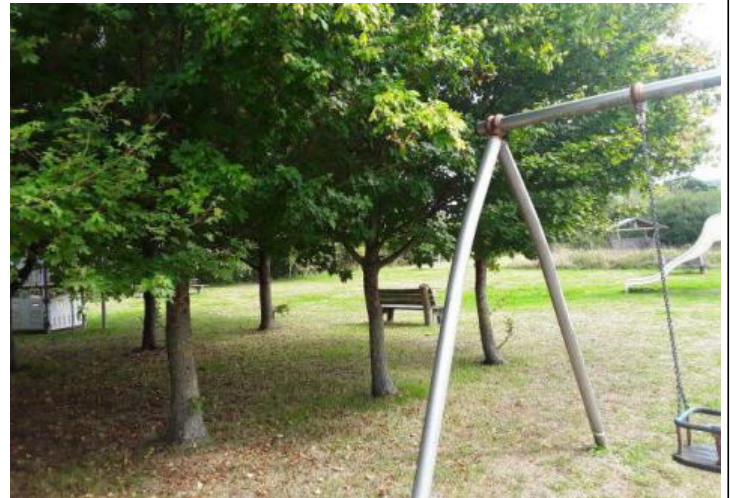
Item: Swings - 1 Bay 2 Seat (Cradle)
Manufacturer: Husson UK

Finding: The tree canopy overhangs the equipment and is less than 2.0m away

Action: Lift tree canopy to ensure a minimum clearance of 2.0m from the equipment

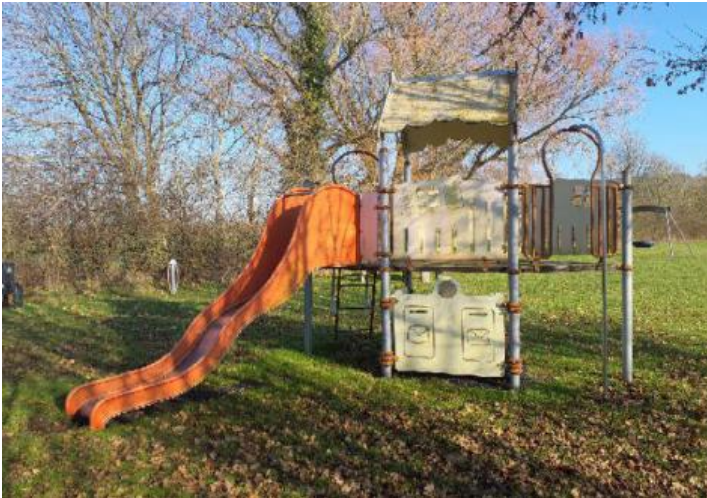
Item: Activity Equipment - Multi Play (Toddler)
Manufacturer: Husson UK

Finding: A number of fixing(s) have worked loose beneath the platforms

Action: Secure all loose fixings

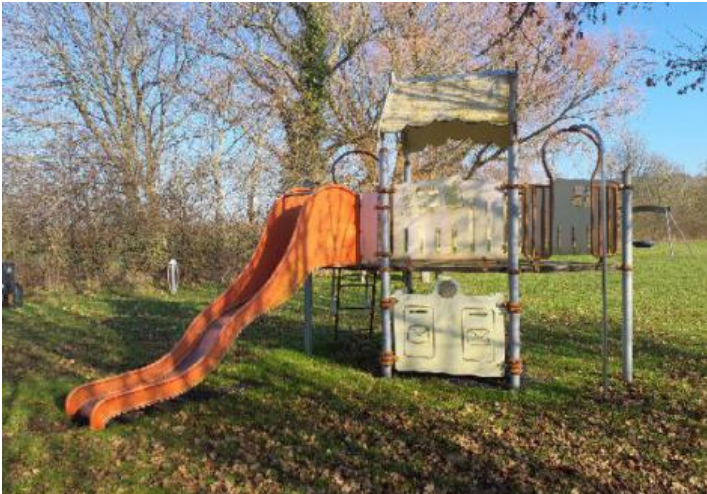
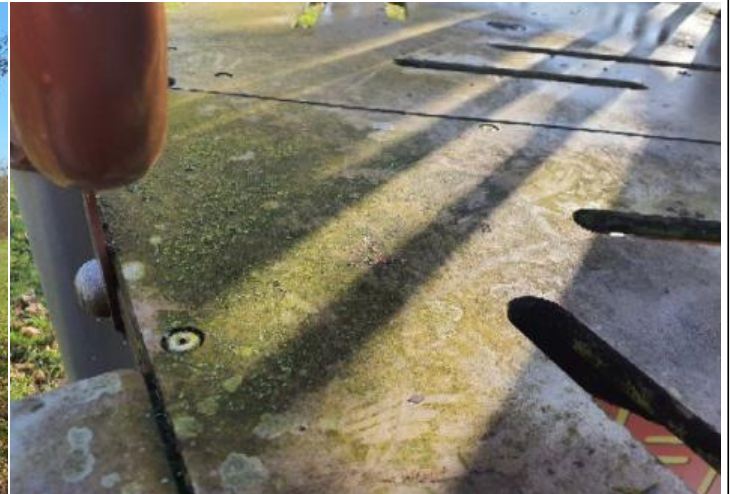
Item: Activity Equipment - Multi Play (Toddler)
Manufacturer: Husson UK

Finding: There is algae or moss on the surface of the equipment

Action: Clean and treat appropriately

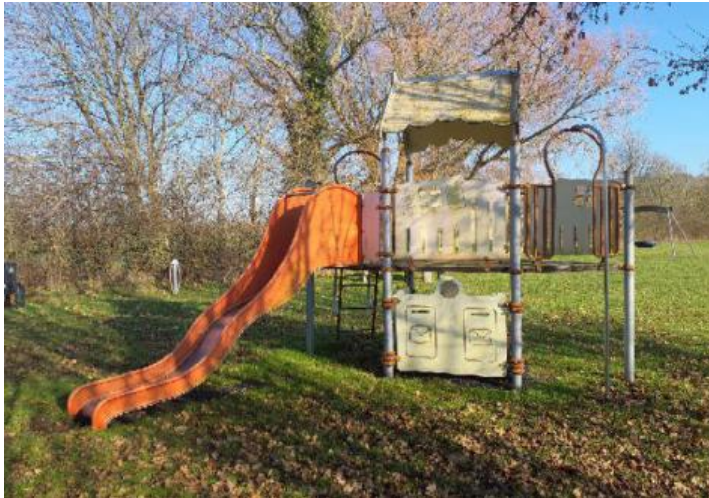
Item: Activity Equipment - Multi Play (Toddler)
Manufacturer: Husson UK

Finding: There is or are fixings missing on the item

Action: Replace all missing fixings

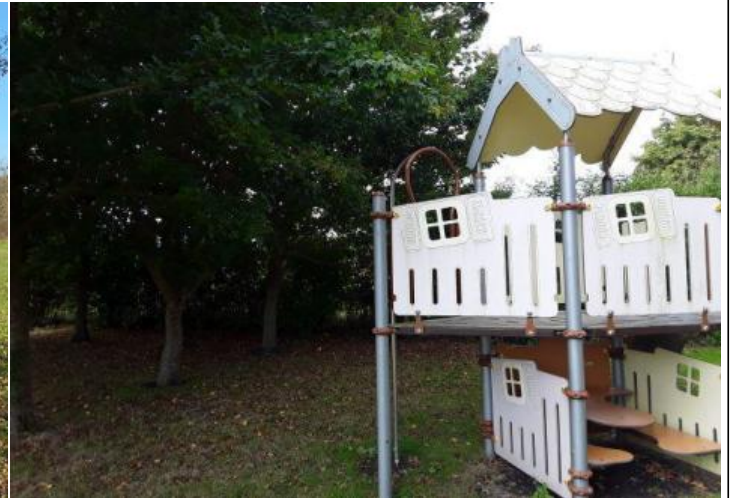
Item: Activity Equipment - Multi Play (Toddler)
Manufacturer: Husson UK

Finding: The tree canopy overhangs the equipment and is less than 2.0m away

Action: Lift tree canopy to ensure a minimum clearance of 2.0m from the equipment

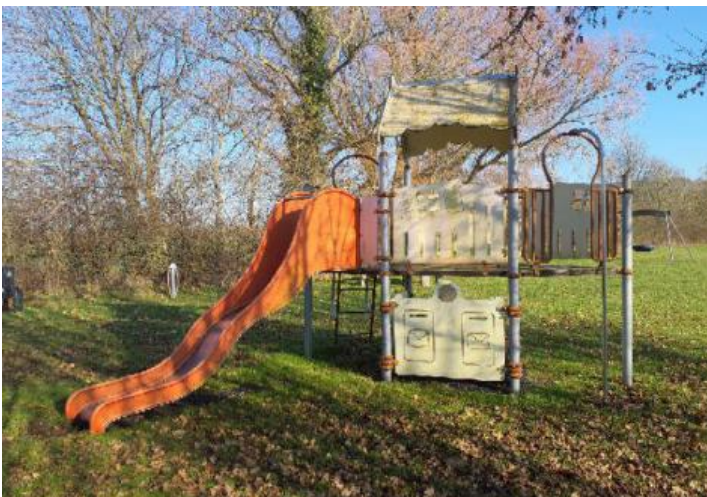
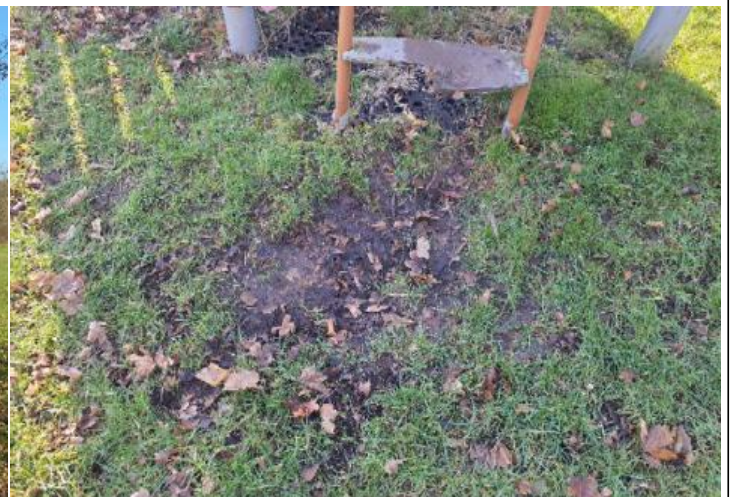
Item: Activity Equipment - Multi Play (Toddler)
Manufacturer: Husson UK

Finding: The area around the item has eroded and may become slippery

Action: Reinstate eroded area

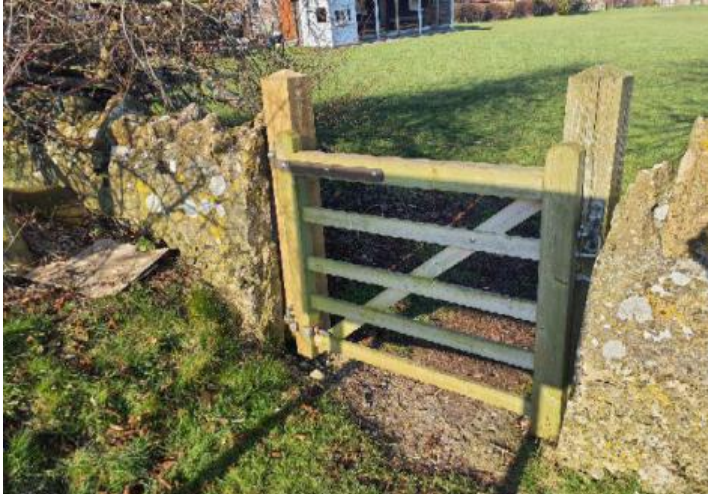
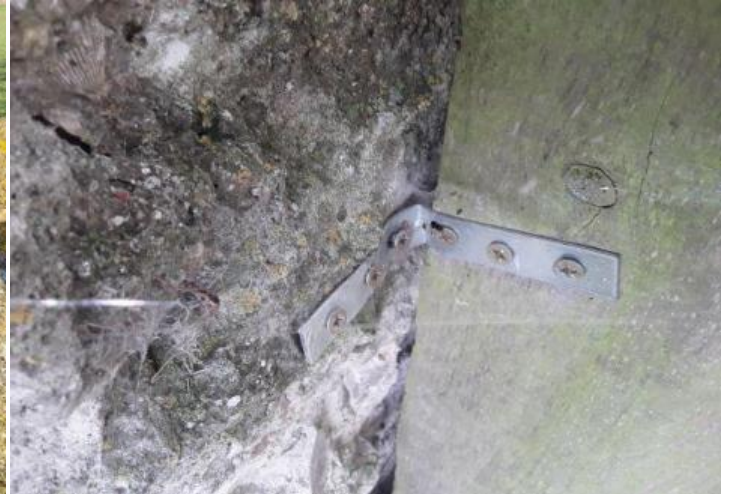
Item: Gates - Gate - Pedestrian
Manufacturer: Not Identified

Finding: A number of fixing(s) have worked loose

Action: Secure all loose fixings

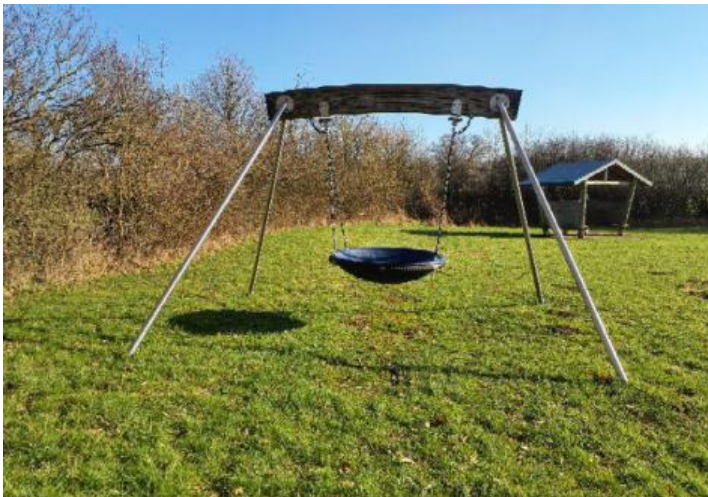
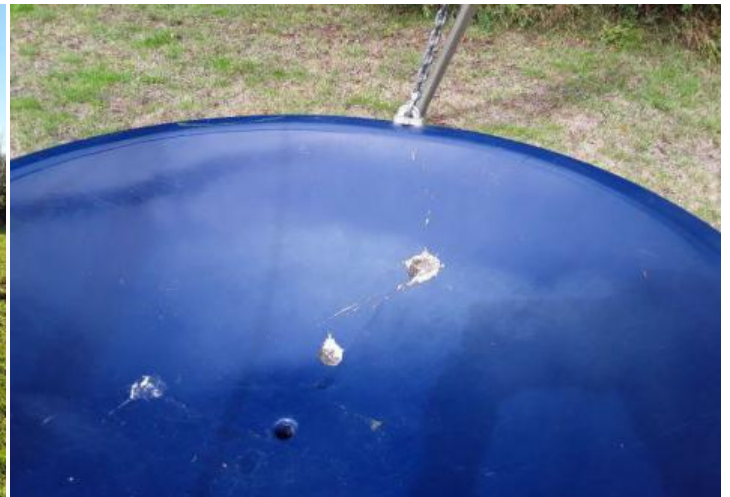
Item: Swings - Basket Swing - Type 1
Manufacturer: Proludic

Finding: There is bird excrement on the seat

Action: Clean and maintain area
