the **play inspection** company

Annual Inspection

Shoreham Parish Council

Shoreham Playground

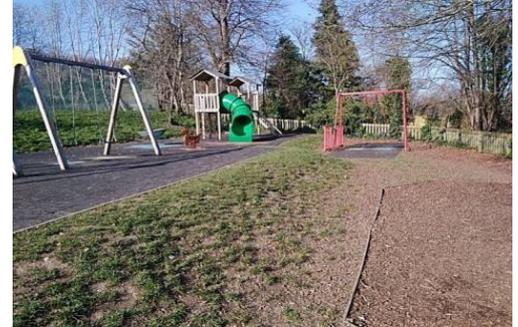
Item: Site General
Manufacturer: Owner/Operator
Surface Type: N/A
Item Quantity: 1
Equipment Compliance: N/A
Surface Area Compliance: N/A

There are trip hazards at the edges of the surface - Reinstate surrounding surface levels to remove the trip points

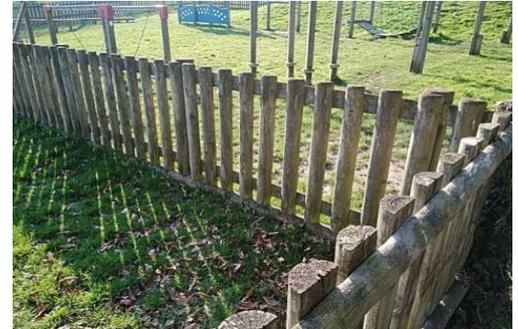
Item: Fencing - Timber
Manufacturer: Not Identified
Surface Type: Grass
Item Quantity: 1
Equipment Compliance: N/A
Surface Area Compliance: N/A

A number of posts have rotted - Replace all affected timber

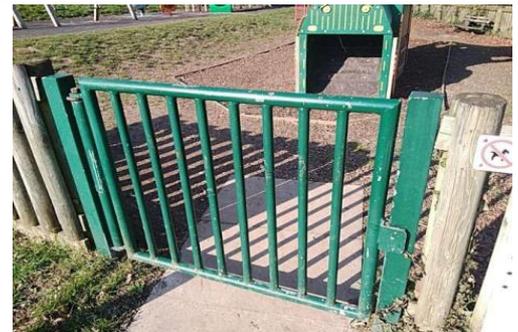
Item: Gate - Self Closing
Manufacturer: Not Identified
Surface Type: Paving Slabs
Item Quantity: 1
Equipment Compliance: N/A
Surface Area Compliance: N/A

The area under the gate has eroded leaving uneven areas, or the concrete foundations exposed, resulting in trip hazards at the entrance/exit to the playground - Reinstate to level with surrounding surfaces

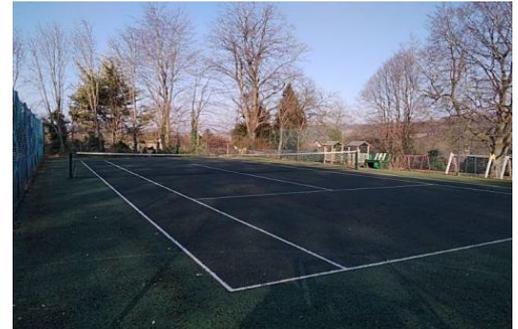
Item: Tennis Court
Manufacturer: Not Identified
Surface Type: Tarmac
Item Quantity: 1
Equipment Compliance: N/A
Surface Area Compliance: N/A

There is some damage to the fence sections - Monitor for any further deterioration and repair as required

The rubber buffer is missing from the latch plate - Replace rubber buffer

There is algae or moss growth on the surface resulting in slippery conditions - Clean and treat appropriately

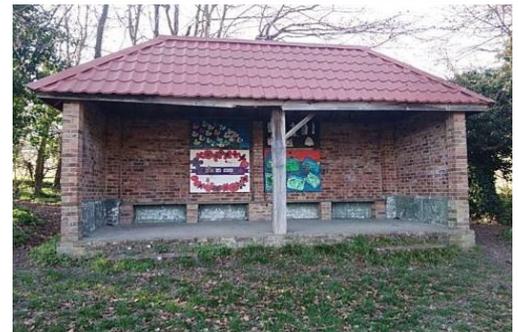
Item: Shelter
Manufacturer: Not Identified
Surface Type: N/A
Item Quantity: 1
Equipment Compliance: N/A
Surface Area Compliance: N/A

There is some evidence of fire damage to the item - Monitor for any further deterioration and repair as required

The art panels has been severely damaged - Repair or replace the item

There is some minor damage to the surface - Monitor for any further deterioration and repair as required

The roof timber has been damaged - Monitor for any further deterioration and replace as required

There are areas or parts of the timber on the structure that have rotted - Replace all affected timbers

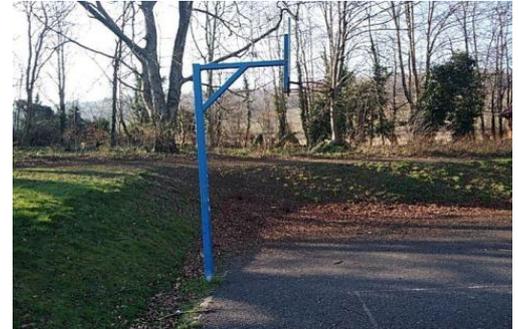
Item: Basketball Post
Manufacturer: Not Identified
Surface Type: Tarmac
Item Quantity: 1
Equipment Compliance: Yes
Surface Area Compliance: N/A

The net has been damaged - Replace the item

The surface is crumbling in areas creating slippery conditions - Sweep and clear all loose debris and monitor

The basketball hoops are damaged - Replace all affected components

The paintwork on this item has been damaged or worn exposing the metal underneath which is rusting - Treat any rusting components and repaint

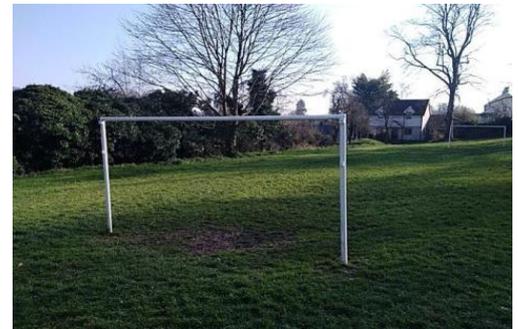
Item: 5 a side Goals
Manufacturer: Not Identified
Surface Type: Grass
Item Quantity: 2
Equipment Compliance: N/A
Surface Area Compliance: N/A

The item is slightly loose in its foundations - Monitor for any further deterioration and repair as required

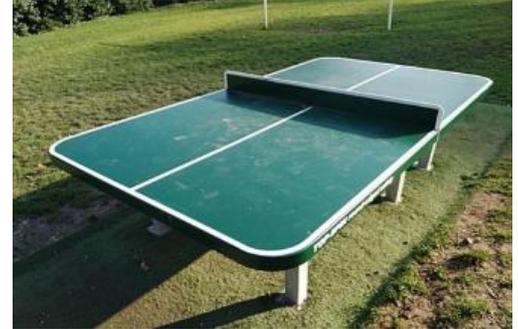
Item: Table Tennis
Manufacturer: Not Identified
Surface Type: Artificial Grass
Item Quantity: 1
Equipment Compliance: N/A
Surface Area Compliance: N/A

This item is satisfactory - no work required -

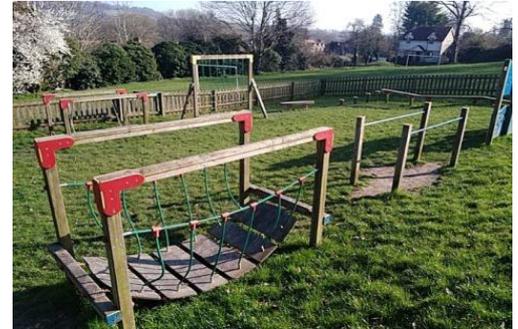
Item: Activity Trail
Manufacturer: Creative Play
Surface Type: Grass
Item Quantity: 1
Equipment Compliance: No
Surface Area Compliance: Yes

There is some wear to the shackles - Monitor for any further deterioration and replace when 40% worn

A number of eyebolt fixing(s) have worked loose - Secure all loose fixings

The step between the items is quite large and users may not be able to complete the step without touching ground, the items could therefore be considered to be within the falling space of each other, however the intention of the play activity continuity is easily apparent and foreseeable to the user - Monitor - No remedial work recommended

The connecting lugs are showing signs of wear - Monitor for any further deterioration and repair as required

There is some strimmer / machinery damage apparent on the posts, this can penetrate the preservative applied to the timber and accelerate the rotting process - Monitor for any deterioration (rot) and replace as required

There is some evidence of rot in the timber - Monitor for any further deterioration and replace as required

A number of fixing(s) have worked loose - Secure all loose fixings

There is some notable evidence of chain wear - Monitor for any further deterioration and replace when 40% worn

The item is slightly loose in its foundations - Monitor for any further deterioration and repair as required

The paintwork on the spring has been damaged or worn exposing the metal underneath which is rusting - Treat any rusting components and repaint

The connecting links are in excess of 8.6mm and less than 12mm and fail the requirements of BS EN 1176 Part 1; clause 4.2.13, Chains - Monitor use and replace with compliant links at the next maintenance cycle

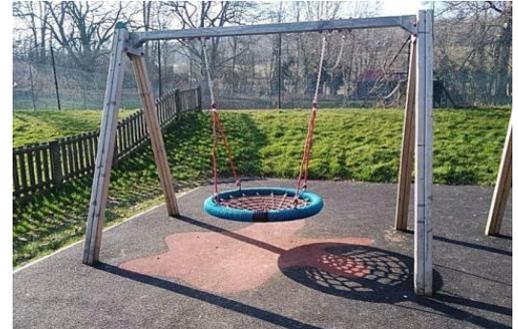
Item: Basket Swing - Type 1
Manufacturer: Creative Play
Surface Type: Wet Pour
Item Quantity: 1
Equipment Compliance: No
Surface Area Compliance: Yes

The seat clearance from finished surface level to the underside of the seat is too low when measured in its most onerous position and does not meet the requirements of BS EN 1176 Part 2 - Install seats to a minimum height of 400mm for Group Swing Seats

The connecting links are in excess of 8.6mm and less than 12mm and fail the requirements of BS EN 1176 Part 1; clause 4.2.13, Chains - Monitor use and replace with compliant links at the next maintenance cycle

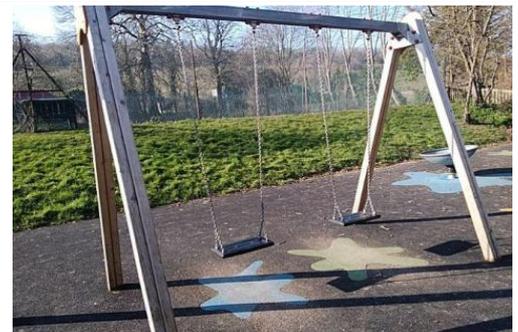
Item: 1 Bay 2 Seat (Flat)
Manufacturer: Creative Play
Surface Type: Wet Pour
Item Quantity: 1
Equipment Compliance: No
Surface Area Compliance: Yes

The seats are too close to the frame as defined in BS EN 1176 Part 2; this is a low risk failure and no remedial action is required - Monitor - No remedial work recommended

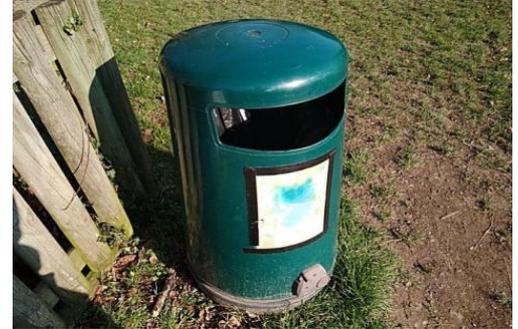
Item: Litter Bin
Manufacturer: Not Identified
Surface Type: Grass
Item Quantity: 1
Equipment Compliance: N/A
Surface Area Compliance: N/A

The lid or door of the litter bin is not secured - Ensure the lid or door is kept locked

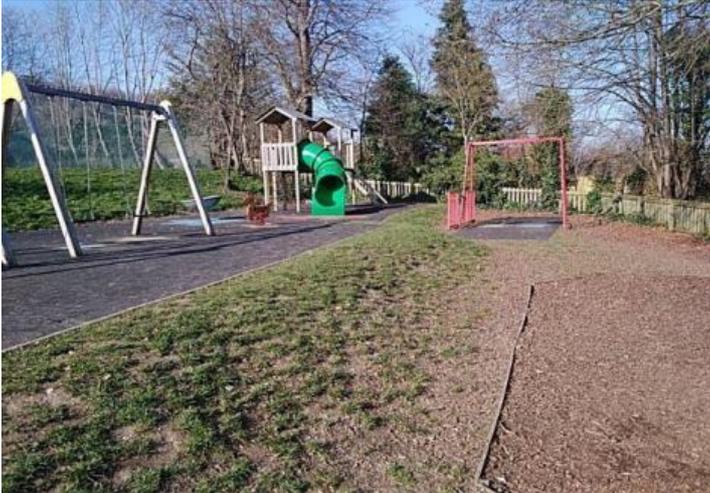
Item: Ancillary Items - Site General
Manufacturer: Owner/Operator

Finding: There are trip hazards at the edges of the surface

Action: Reinstate surrounding surface levels to remove the trip points

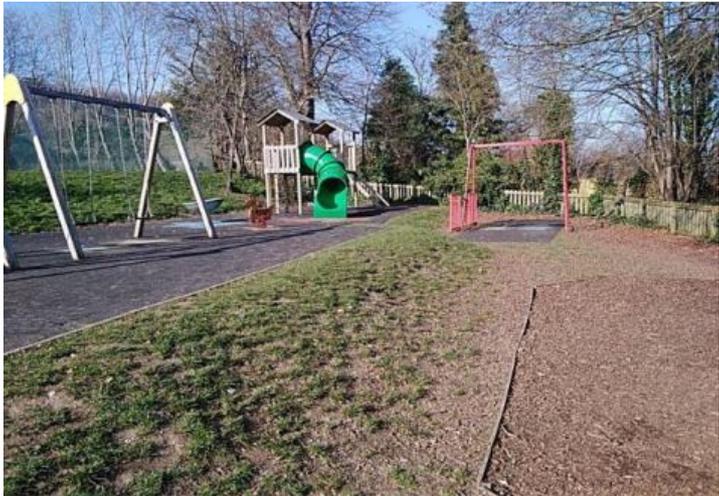
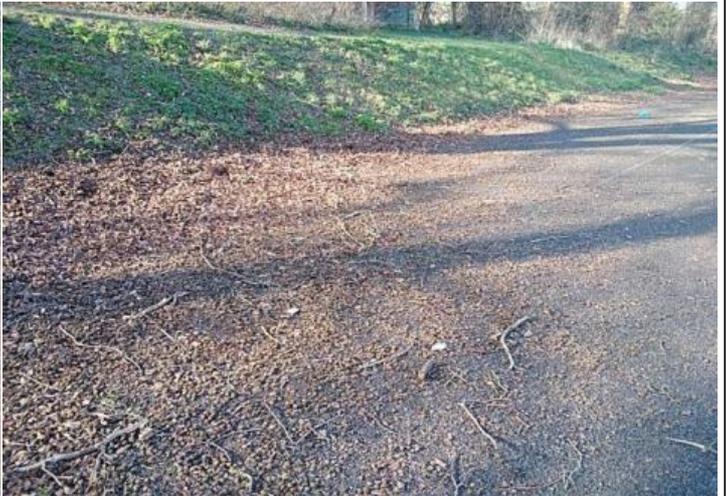
Item: Ancillary Items - Site General
Manufacturer: Owner/Operator

Finding: There is some tree debris on the surfacing

Action: Remove and maintain

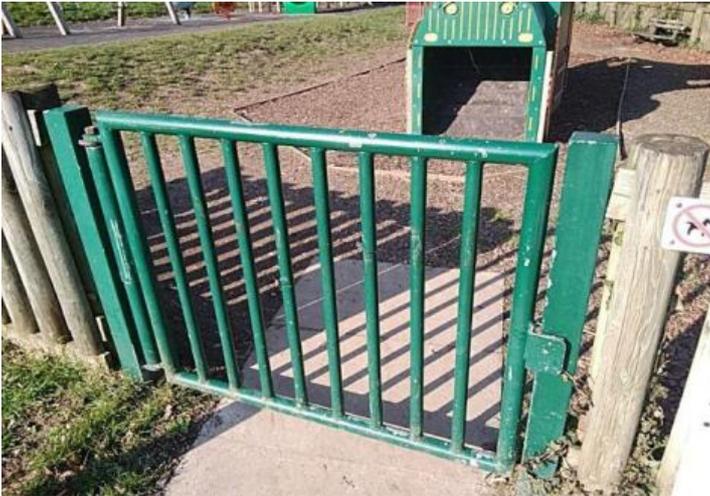
Item: Gates - Gate - Self Closing
Manufacturer: Not Identified

Finding: The area under the gate has eroded leaving uneven areas, or the concrete foundations exposed, resulting in trip hazards at the entrance/exit to the playground

Action: Reinststate to level with surrounding surfaces

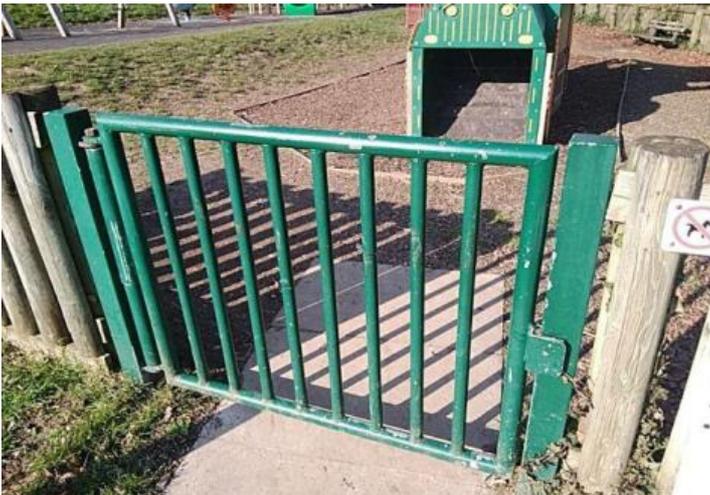
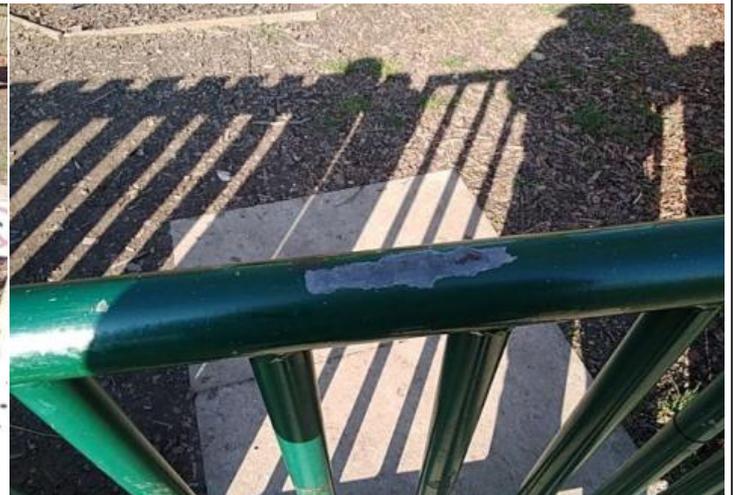
Item: Gates - Gate - Self Closing
Manufacturer: Not Identified

Finding: The paint is flaking off the metalwork

Action: Rub down and re-paint

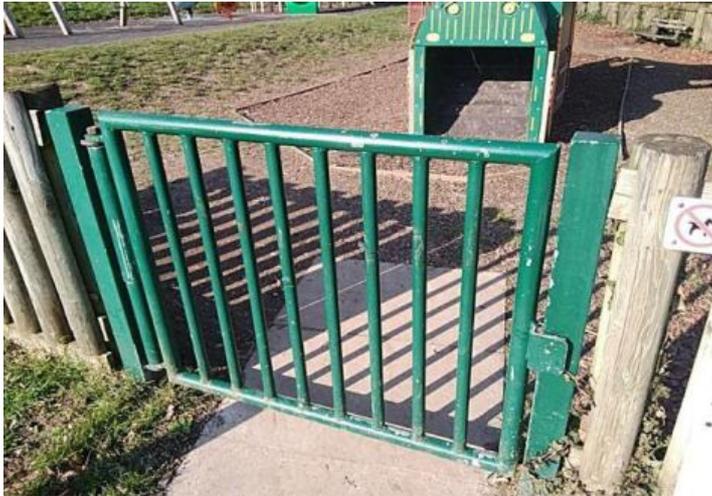
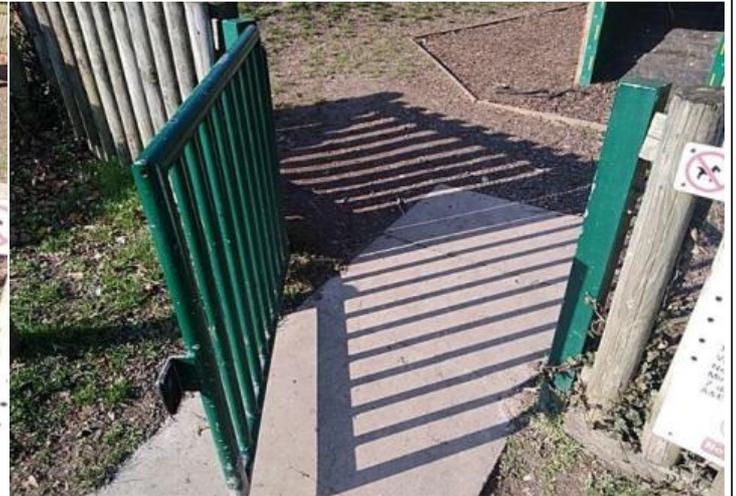
Item: Gates - Gate - Self Closing
Manufacturer: Not Identified

Finding: The gate is closing too quickly (less than 4 seconds)

Action: Take corrective action to ensure that the gate closes in 4-8 seconds

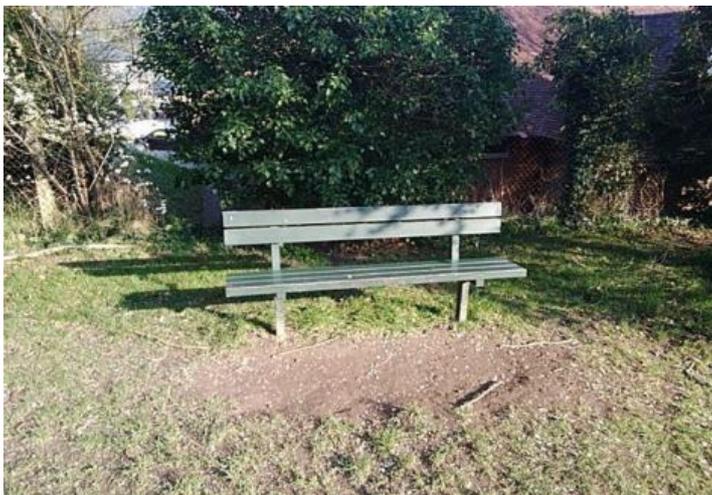
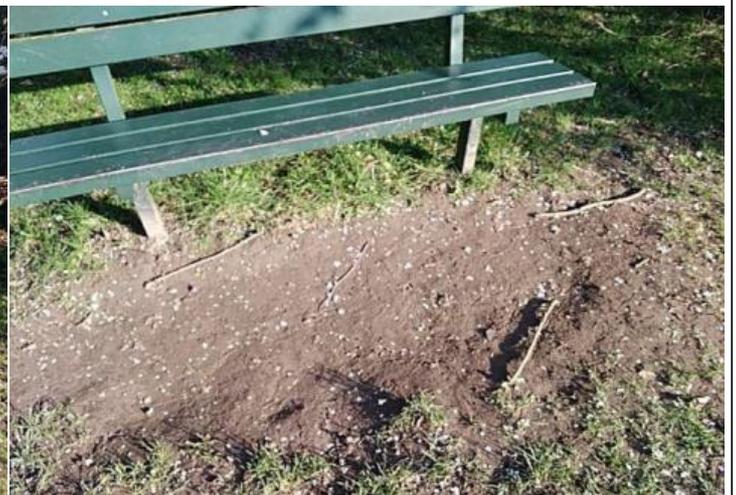
Item: Ancillary Items - Bench
Manufacturer: Not Identified

Finding: The surface has eroded in some areas

Action: Reinstate the surface

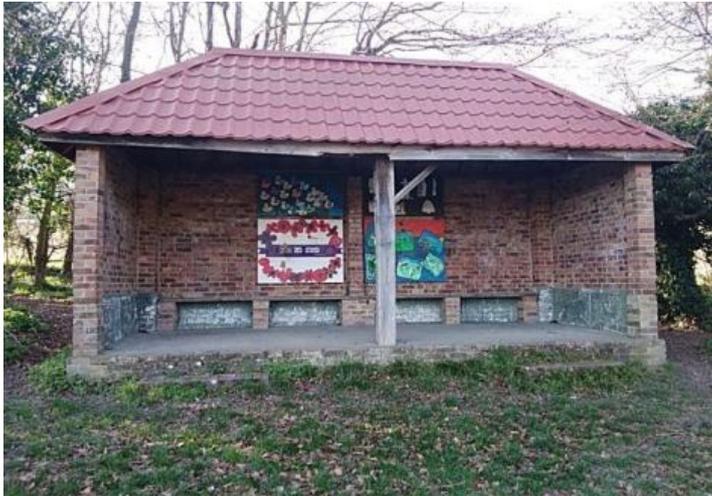
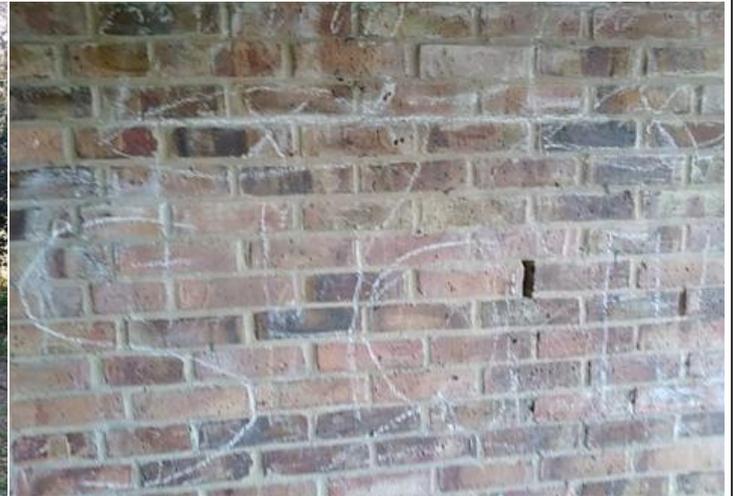
Item: Ancillary Items - Shelter
Manufacturer: Not Identified
Risk Level: N - Risk Assessment not Undertaken
Surface: N/A

Finding: There is some graffiti present

Action: Remove the graffiti

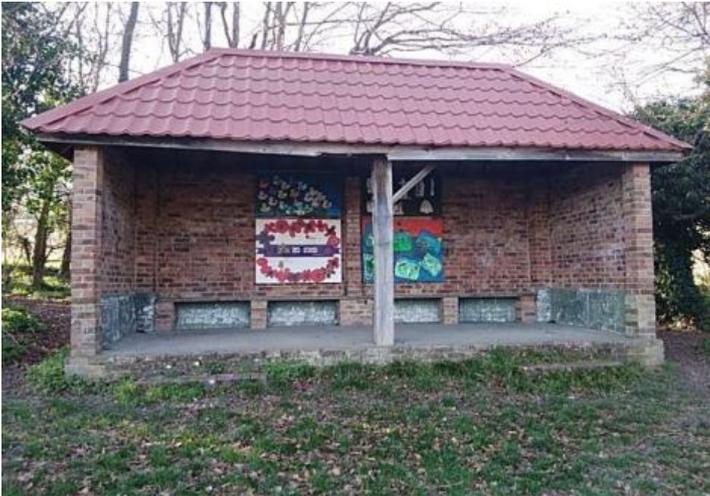
Item: Ancillary Items - Shelter
Manufacturer: Not Identified

Finding: The roof timber has been damaged

Action: Monitor for any further deterioration and replace as required

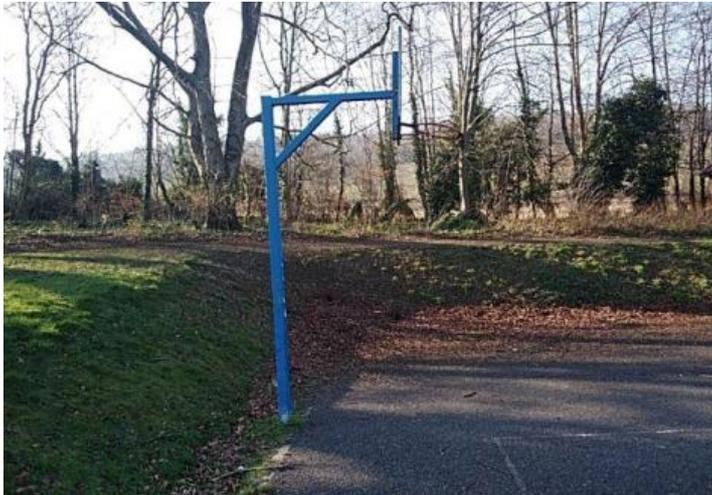
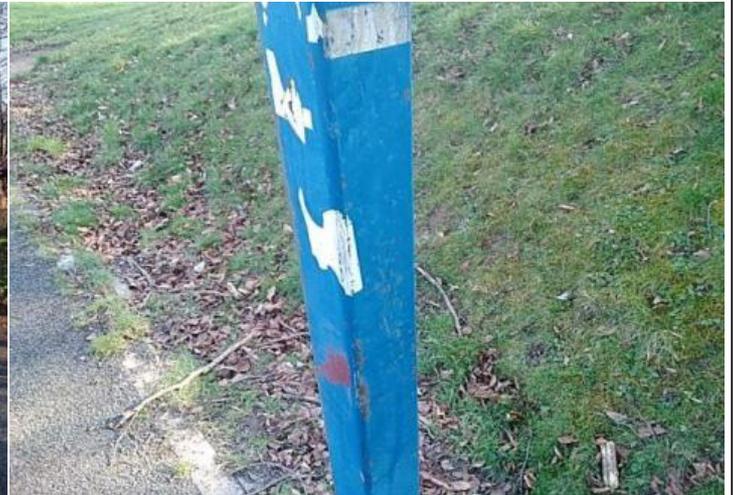
Item: Multi Use Games Area - Basketball Post **Risk Level:** N - Risk Assessment not Undertaken
Manufacturer: Not Identified **Surface:** Tarmac

Finding: There is some graffiti present

Action: Remove the graffiti

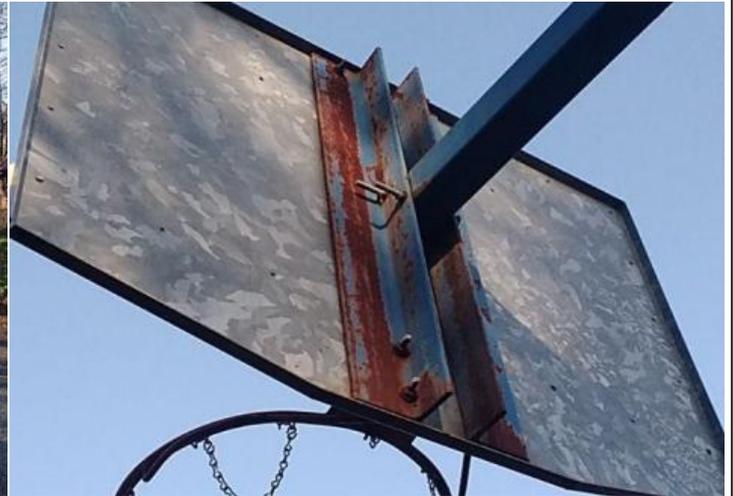
Item: Multi Use Games Area - Basketball Post **Risk Level:** L - Low Risk
Manufacturer: Not Identified **Surface:** Tarmac

Finding: There are projecting bolt thread(s) present

Action: Remove excess thread length and deburr or provide cap

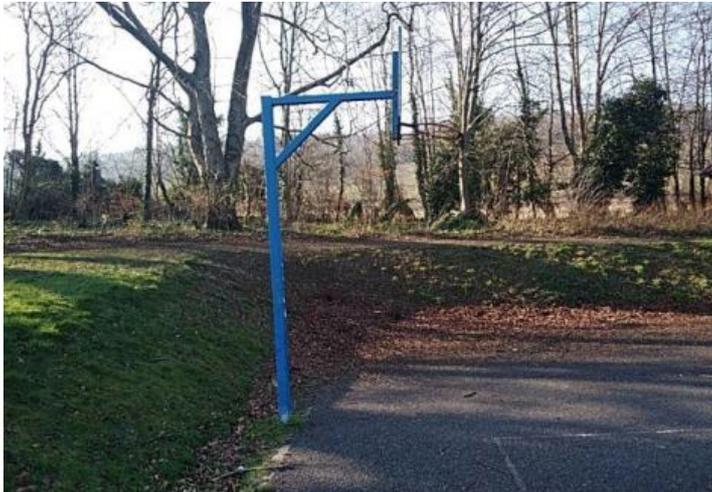
Item: Multi Use Games Area - Basketball Post **Risk Level:** L - Low Risk
Manufacturer: Not Identified **Surface:** Tarmac

Finding: The paintwork on this item has been damaged or worn exposing the metal underneath which is rusting

Action: Treat any rusting components and repaint

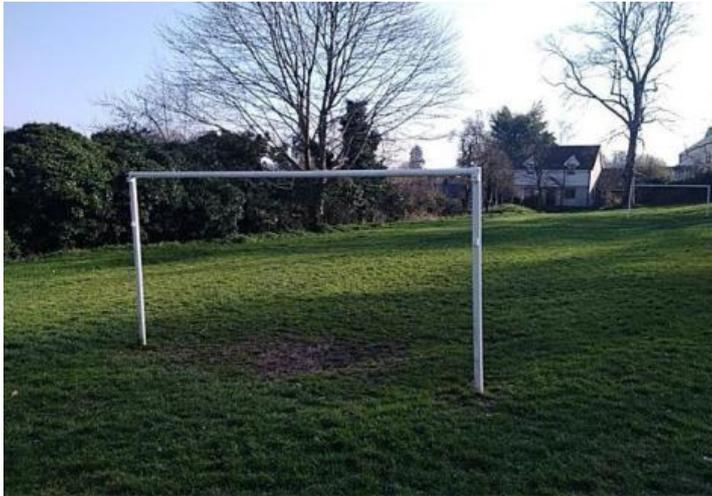
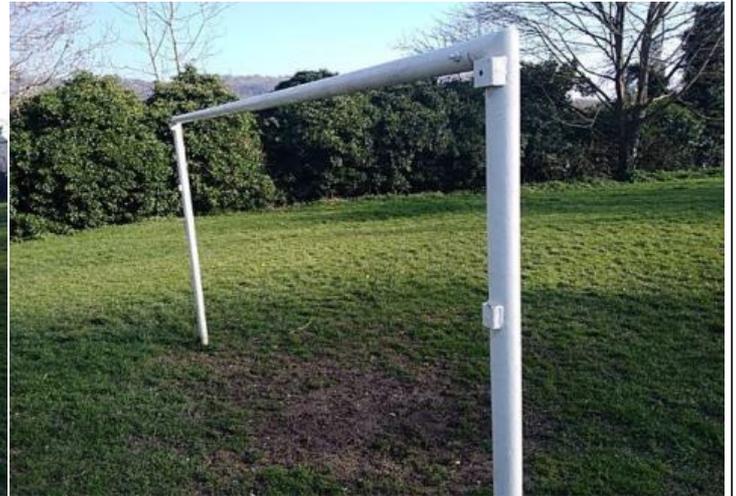
Item: Multi Use Games Area - 5 a side Goals
Manufacturer: Not Identified

Finding: NB: We have undertaken a maintenance inspection only of the football goal(s); full load testing falls outside the scope of our inspection.

Action: Implement load testing as required

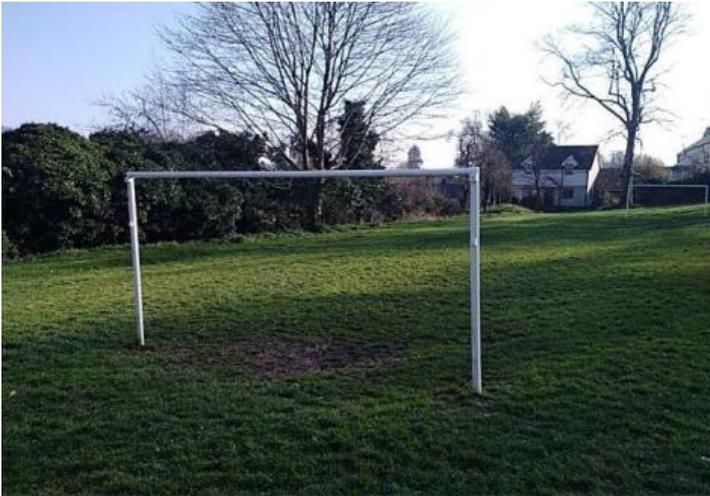
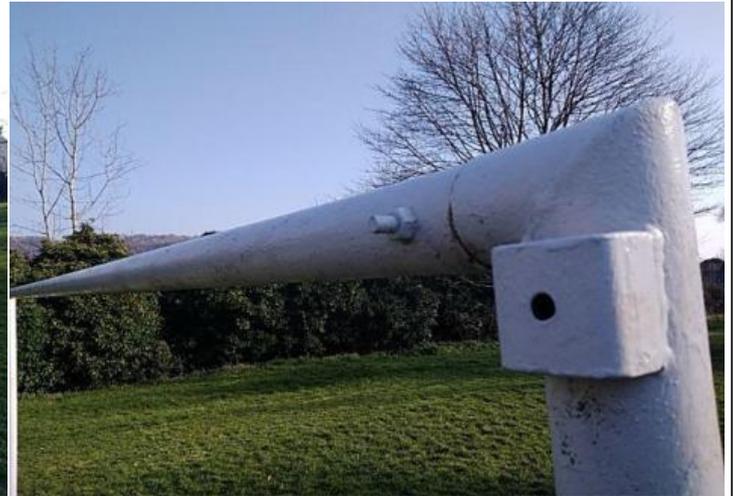
Item: Multi Use Games Area - 5 a side Goals
Manufacturer: Not Identified

Finding: There are projecting bolt thread(s) present

Action: Remove excess thread length and deburr or provide cap

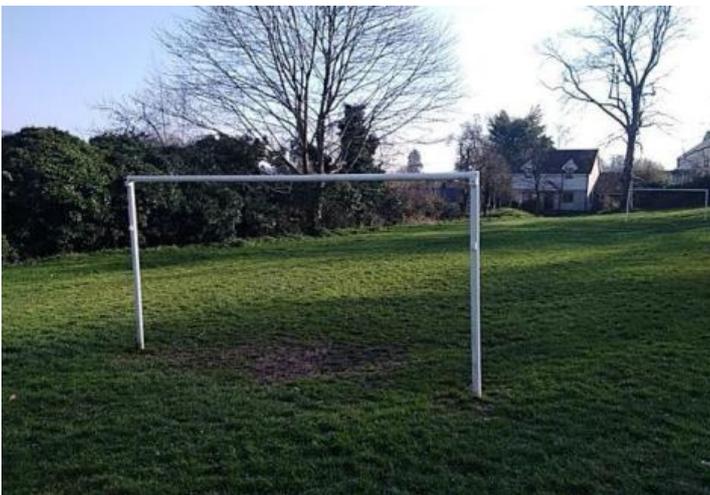
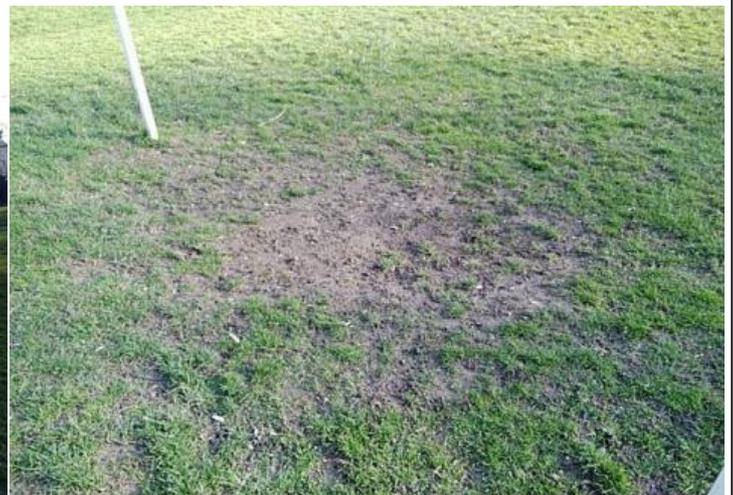
Item: Multi Use Games Area - 5 a side Goals
Manufacturer: Not Identified

Finding: The surface has eroded in some areas

Action: Reinstate the surface

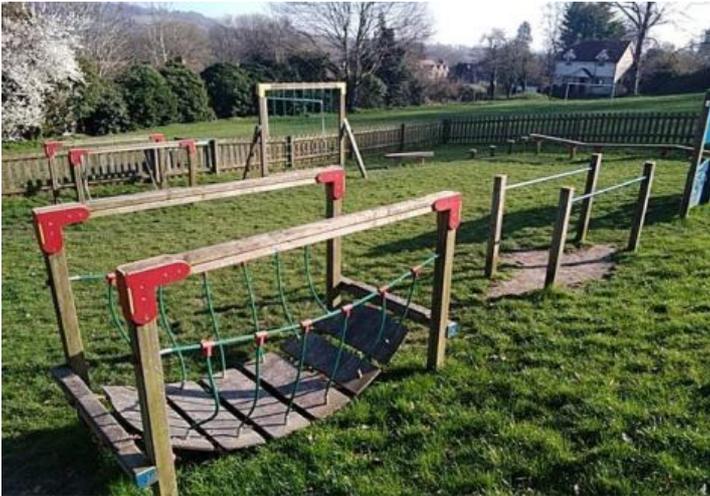
Item: Activity Equipment - Activity Trail
Manufacturer: Creative Play

Finding: There is some wear to the shackles

Action: Monitor for any further deterioration and replace when 40% worn

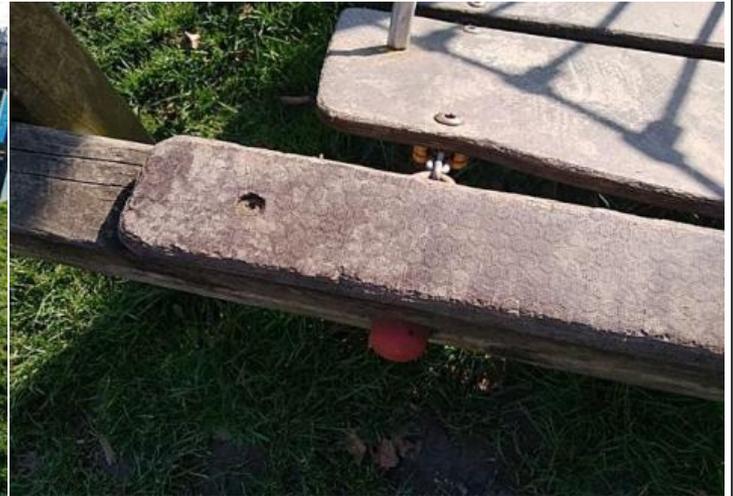
Item: Activity Equipment - Activity Trail
Manufacturer: Creative Play

Finding: Parts of the timber are rough or splintered

Action: Remove all rough or sharp edges

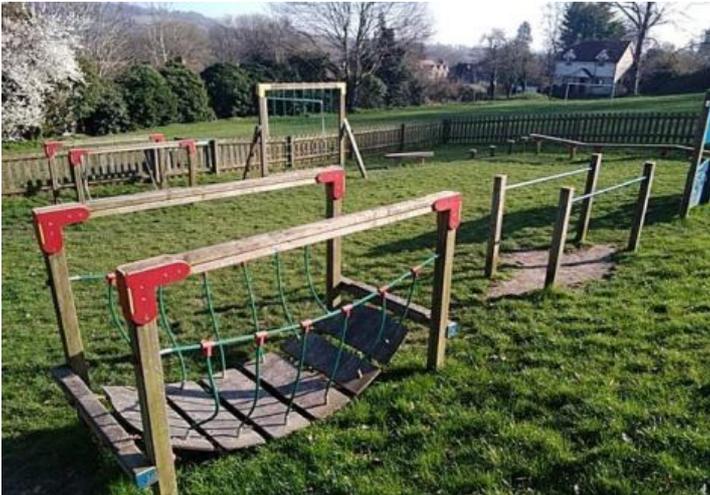
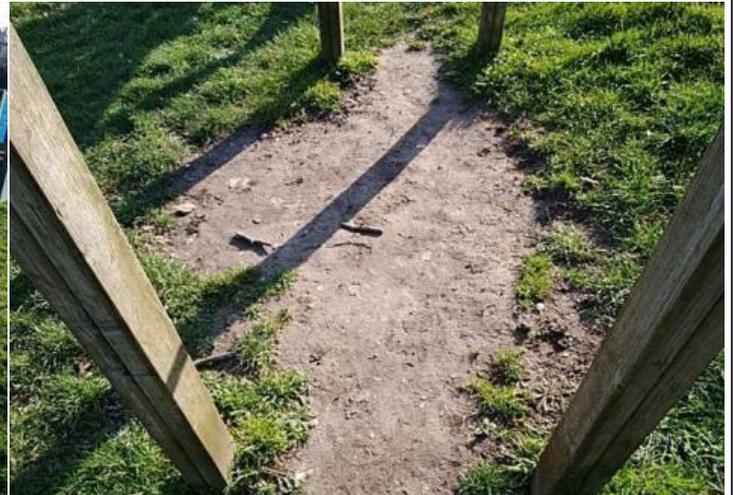
Item: Activity Equipment - Activity Trail
Manufacturer: Creative Play

Finding: The area around the item has eroded and may become slippery

Action: Reinstate eroded area

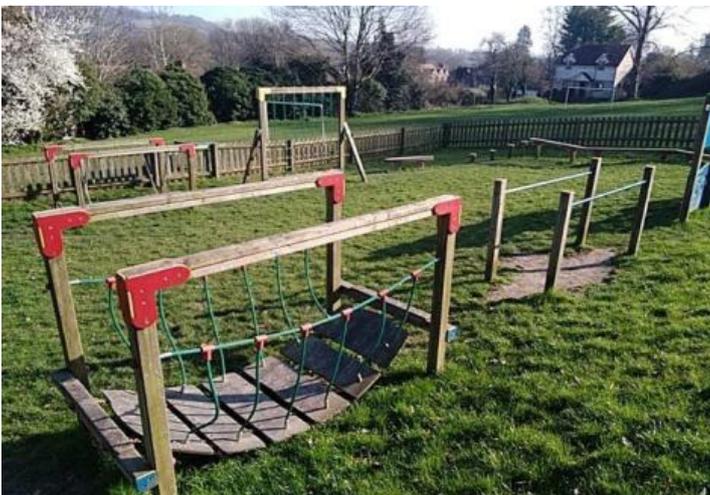
Item: Activity Equipment - Activity Trail
Manufacturer: Creative Play

Finding: The item is slightly loose in its foundations

Action: Monitor for any further deterioration and repair as required

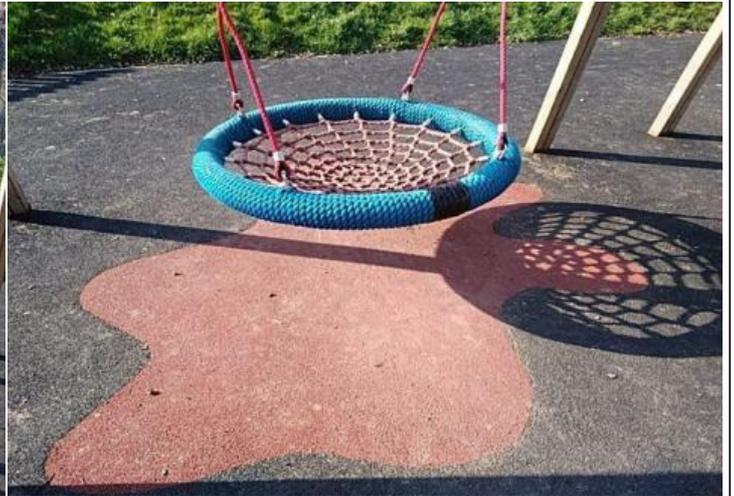
Item: Swings - Basket Swing - Type 1
Manufacturer: Creative Play

Finding: The seat clearance from finished surface level to the underside of the seat is too low when measured in its most onerous position and does not meet the requirements of BS EN 1176 Part 2

Action: Install seats to a minimum height of 400mm for Group Swing Seats

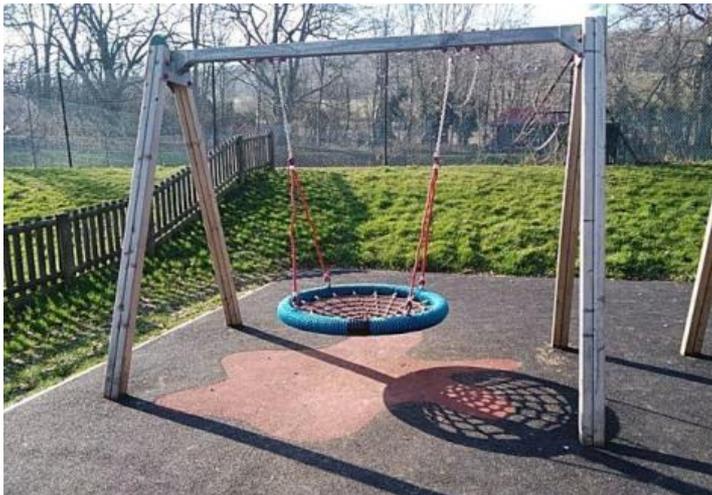
Item: Swings - Basket Swing - Type 1
Manufacturer: Creative Play

Finding: The connecting links are in excess of 8.6mm and less than 12mm and fail the requirements of BS EN 1176 Part 1; clause 4.2.13, Chains

Action: Monitor use and replace with compliant links at the next maintenance cycle

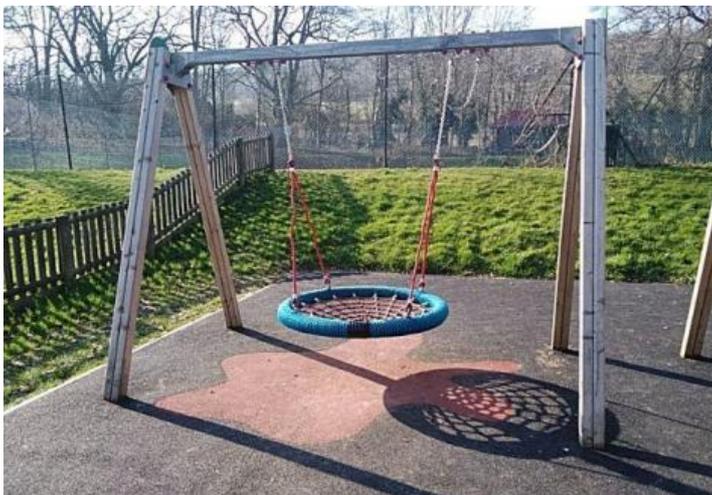
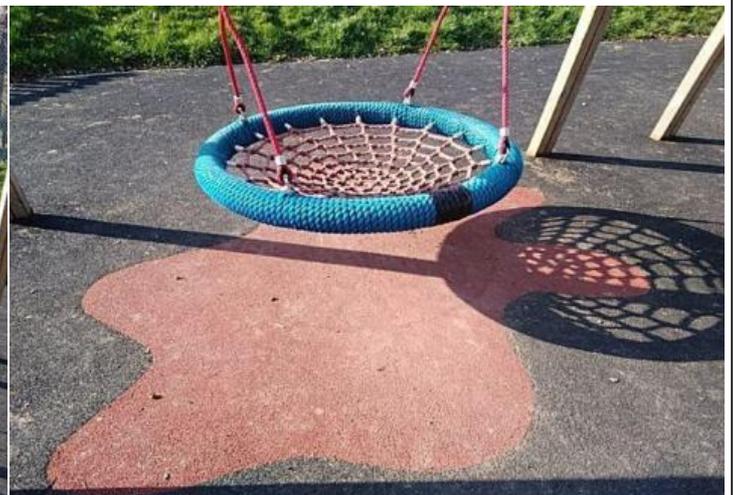
Item: Swings - Basket Swing - Type 1
Manufacturer: Creative Play

Finding: The seat has been installed incorrectly and needs rotating by 90 degrees to ensure that the eyelets are at the same angle as the suspension; these swing seats have less impact attenuating properties to the sides of the seat than to the leading edges

Action: Reinstall the seat in the correct orientation

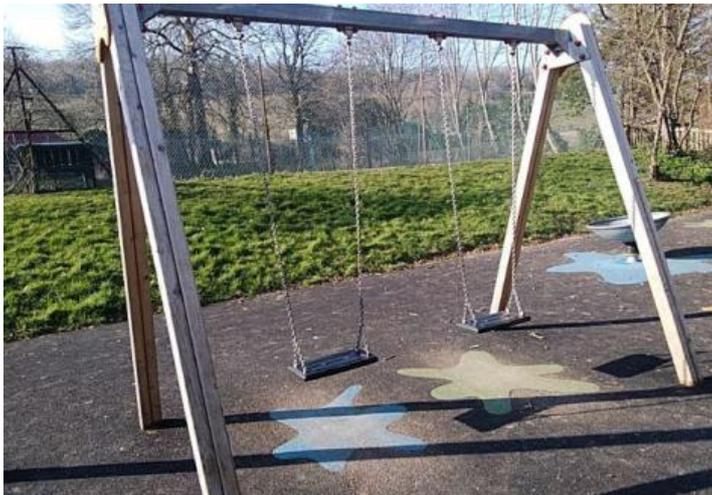
Item: Swings - 1 Bay 2 Seat (Flat)
Manufacturer: Creative Play

Finding: There is some notable evidence of chain wear

Action: Monitor for any further deterioration and replace when 40% worn

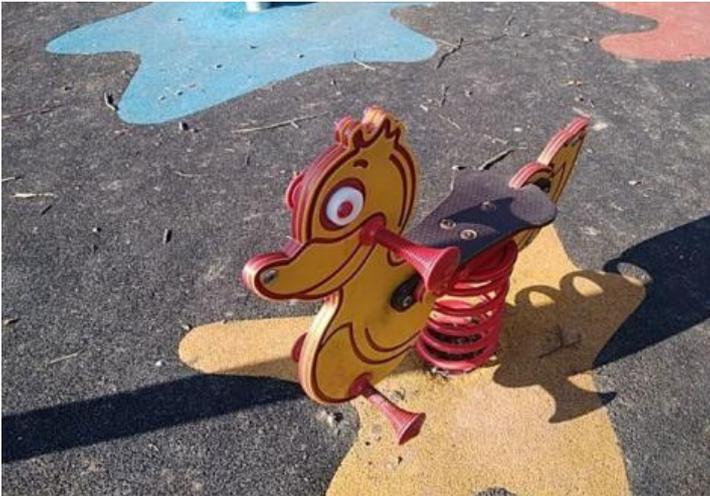
Item: Rocking Equipment - Spring Duck
Manufacturer: Creative Play

The main body profile has a radius of less than 20mm in places - Monitor - No remedial work recommended

Finding: The main body profile has a radius of less than 20mm in places

Action: Monitor - No remedial work recommended

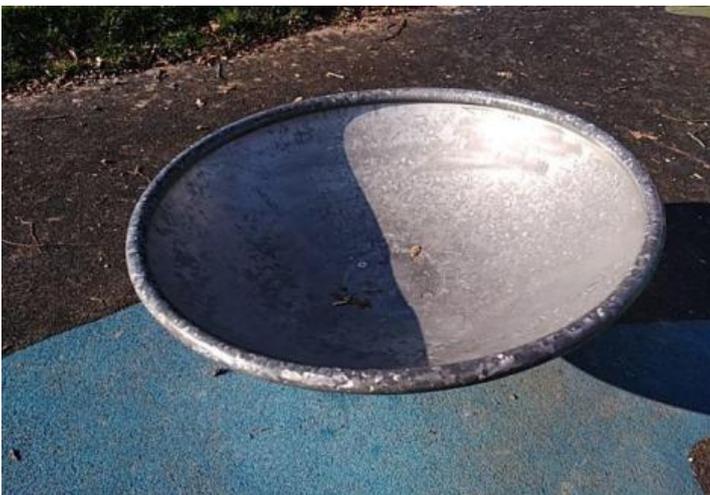
Item: Rotor Play - Dish Roundabout
Manufacturer: Not Identified

The falling space overlaps the free space between the dish roundabout and the slide in contravention of the requirements of BS EN 1176:2017 Part 1 - Monitor - No remedial work recommended

Finding: The falling space overlaps the free space between the dish roundabout and the slide in contravention of the requirements of BS EN 1176:2017 Part 1

Action: Monitor - No remedial work recommended

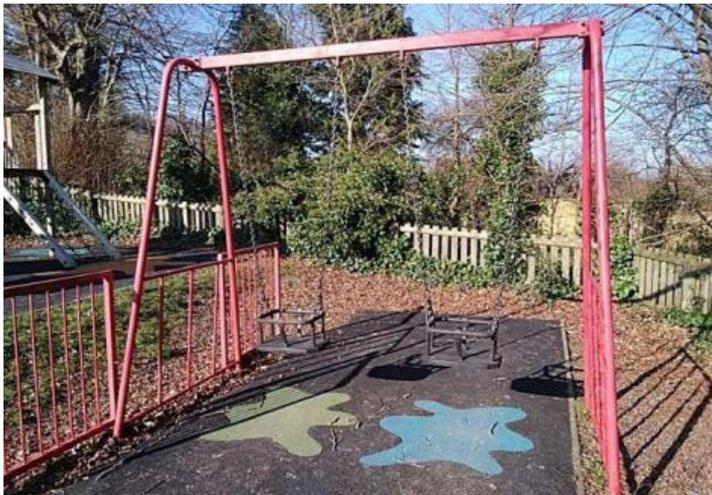
Item: Swings - 1 Bay 2 Seat (Cradle)
Manufacturer: Not Identified

There is some notable evidence of chain wear - Monitor for any further deterioration and replace when 40% worn

Finding: There is some notable evidence of chain wear
Action: Monitor for any further deterioration and replace when 40% worn

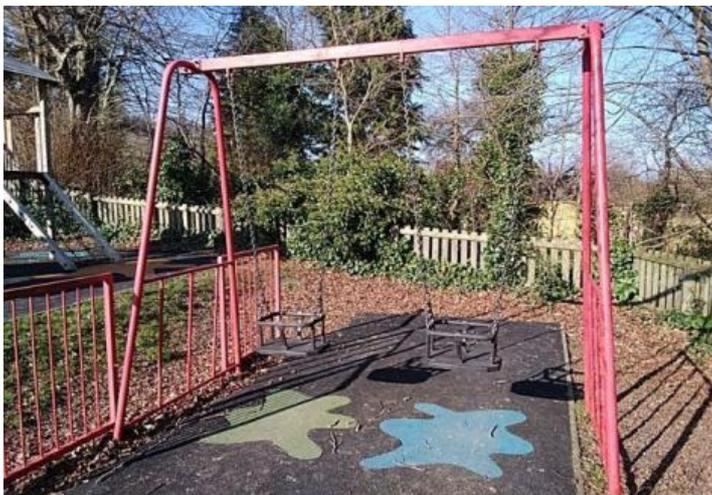
Item: Swings - 1 Bay 2 Seat (Cradle)
Manufacturer: Not Identified

There is some wear to the shackles - Monitor for any further deterioration and replace when 40% worn

Finding: There is some wear to the shackles

Action: Monitor for any further deterioration and replace when 40% worn

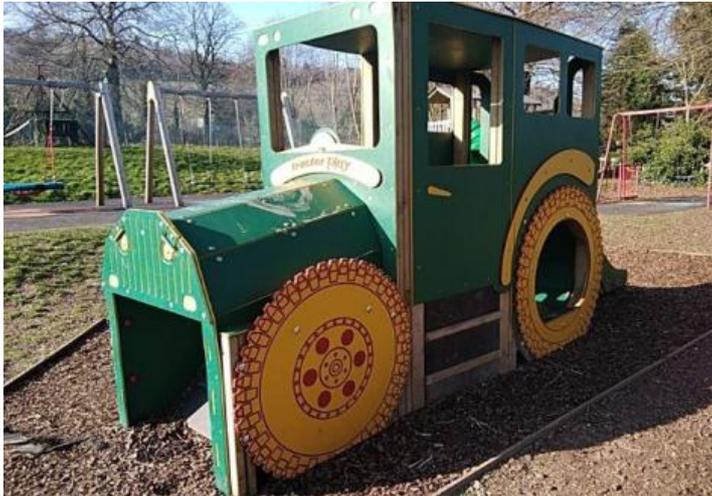
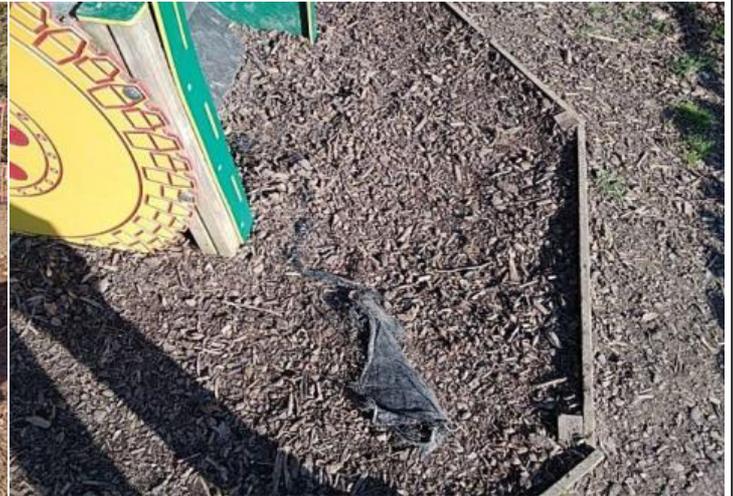
Item: Activity Equipment - Tractor
Manufacturer: Creative Play

Finding: The safety surface is low and the membrane is exposed creating trip points

Action: Remove or resecure the exposed membrane and top up the surface to the correct level

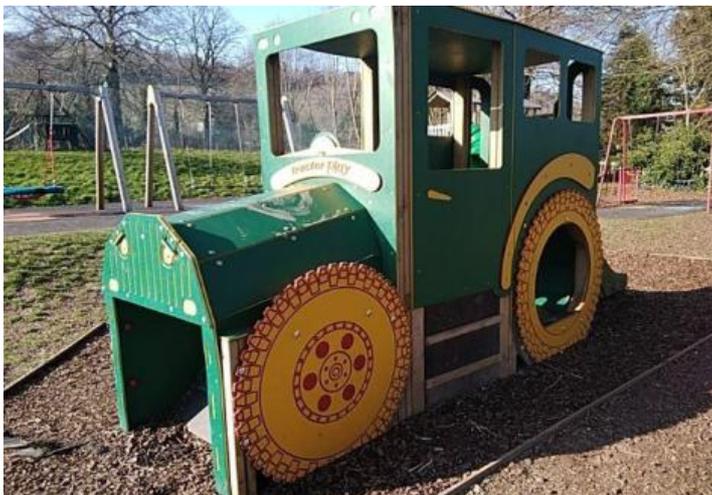
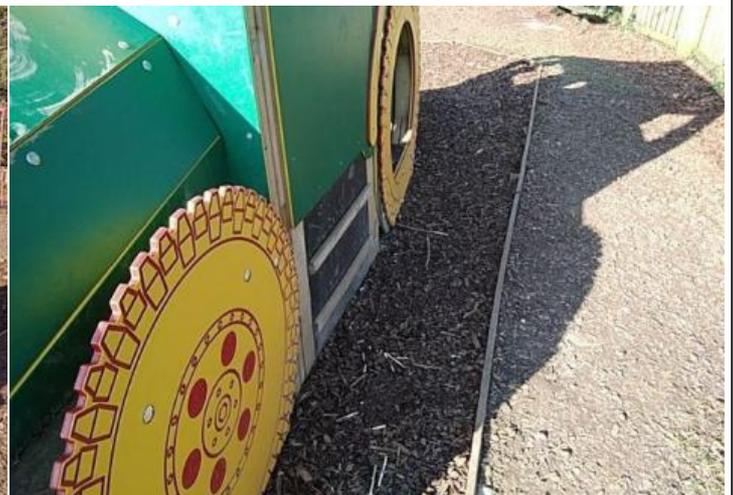
Item: Activity Equipment - Tractor
Manufacturer: Creative Play

Finding: The timber edging forms a hard object within the falling space of the equipment in contravention of the requirements of BS EN 1176 Part 1

Action: Remove the timber edging

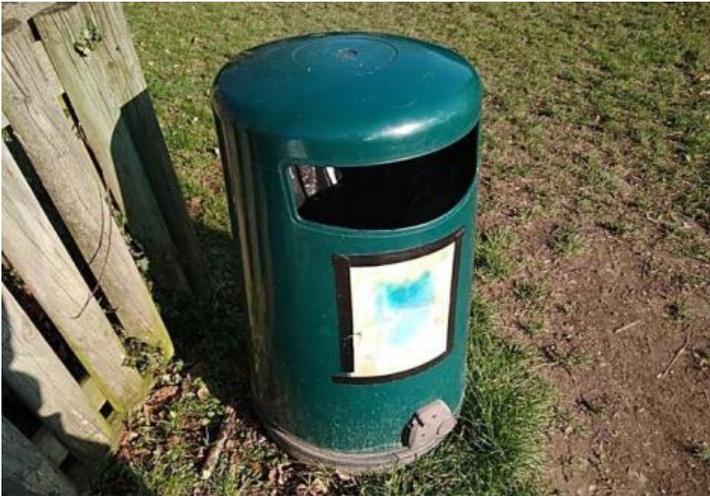
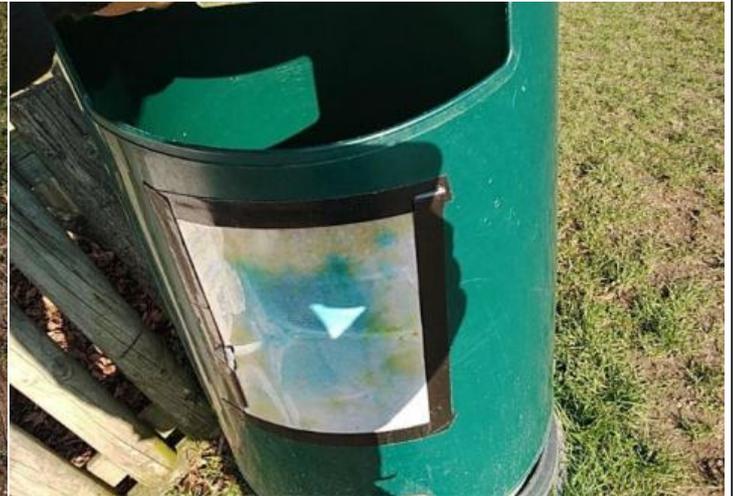
Item: Ancillary Items - Litter Bin
Manufacturer: Not Identified

Finding: The lid or door of the litter bin is not secured

Action: Ensure the lid or door is kept locked
