# Safety Inspection Report

## St Mary Bourne Play Area

St Mary Bourne Parish Council

14 May 2026

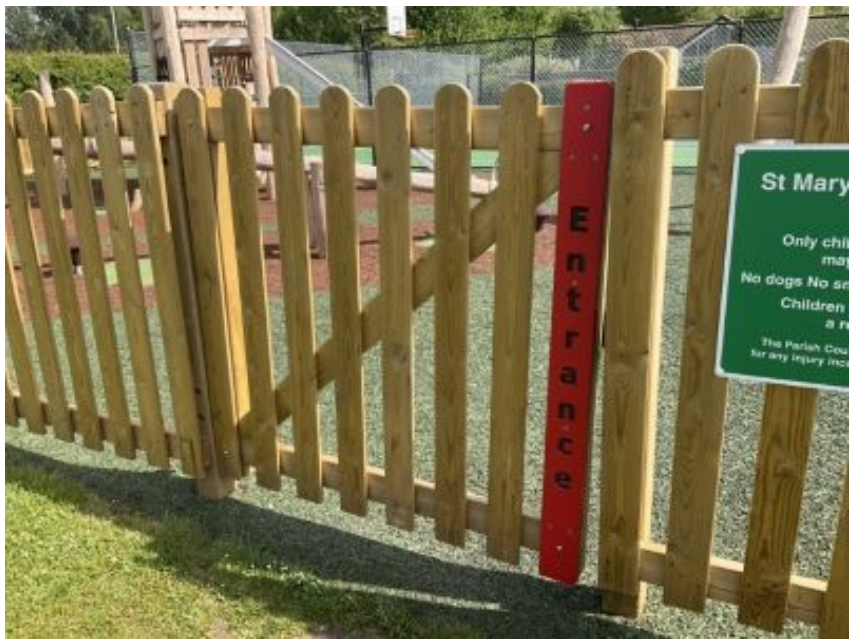
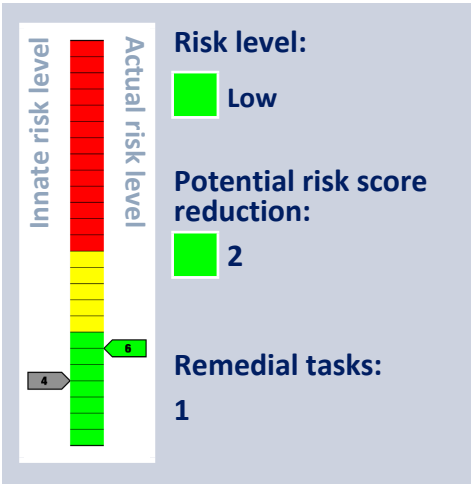
# Gates - Pedestrian

There is a crushing or shearing point on the side of the gate. Where the gaps reduce to less than 12 mm these have been known to cause serious, permanent injury to children, especially on the hinge side where the leverage forces are significant.

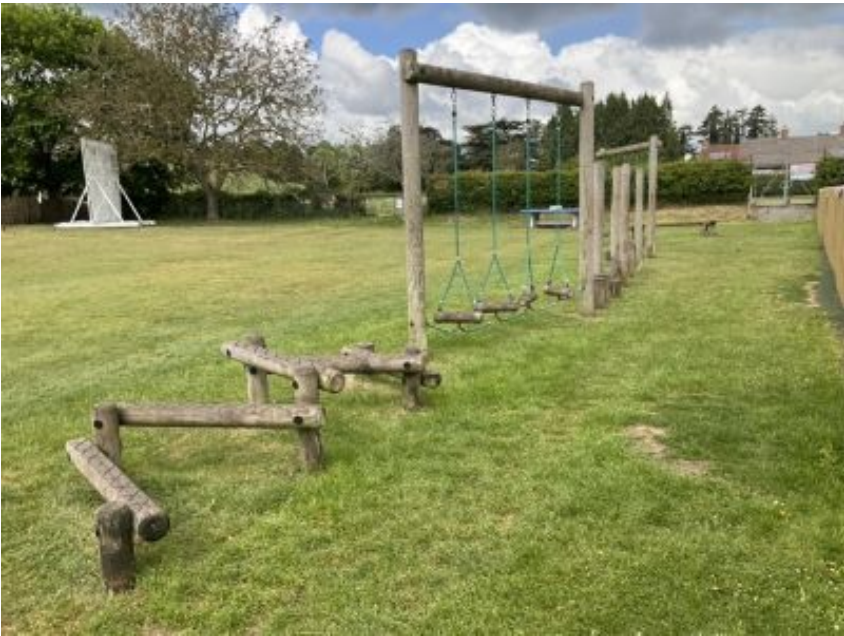
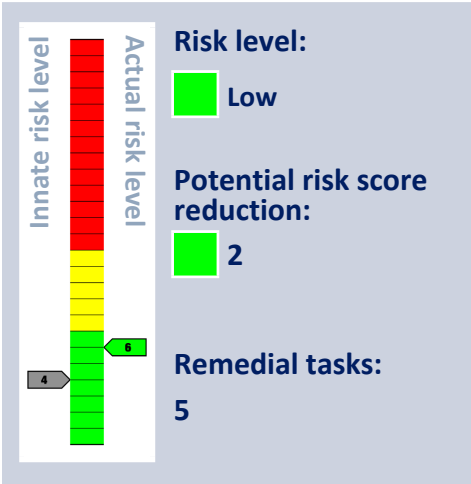
# Agility Trail - Balance Beams, Stepping Logs, Suspended Log Walk & Rope Walk

This equipment relies on one post for its stability. Special attention should be paid to maintenance (e.g. by monitoring degradation) and if necessary decommissioning the item before the end of its operating life. This is a requirement of the British Standard.

Timber is not in good condition.

Bolt(s) loose.

Cap missing.

Replace.

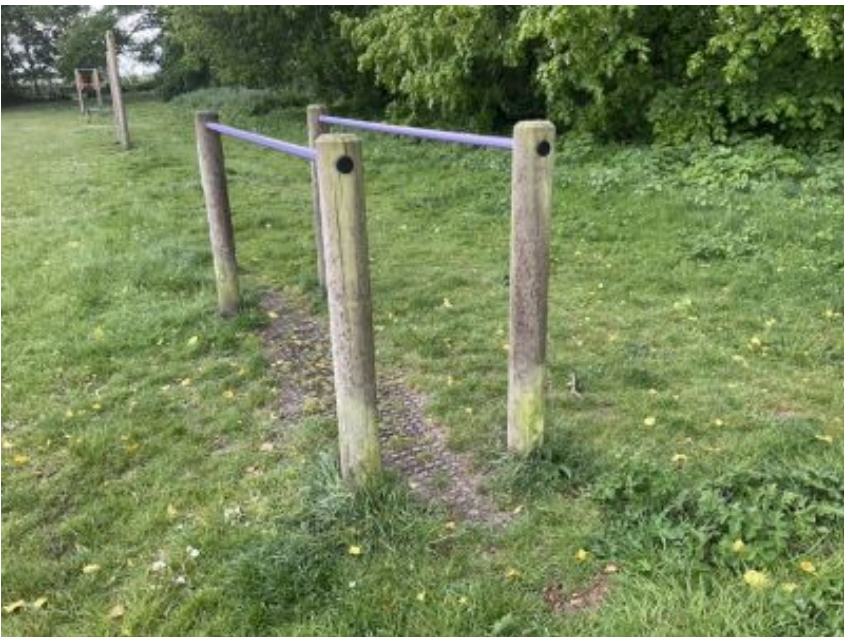
# Adult Fitness - Parallel Bars

Surface is wearing.

Monitor for significant deterioration and rectify when necessary.

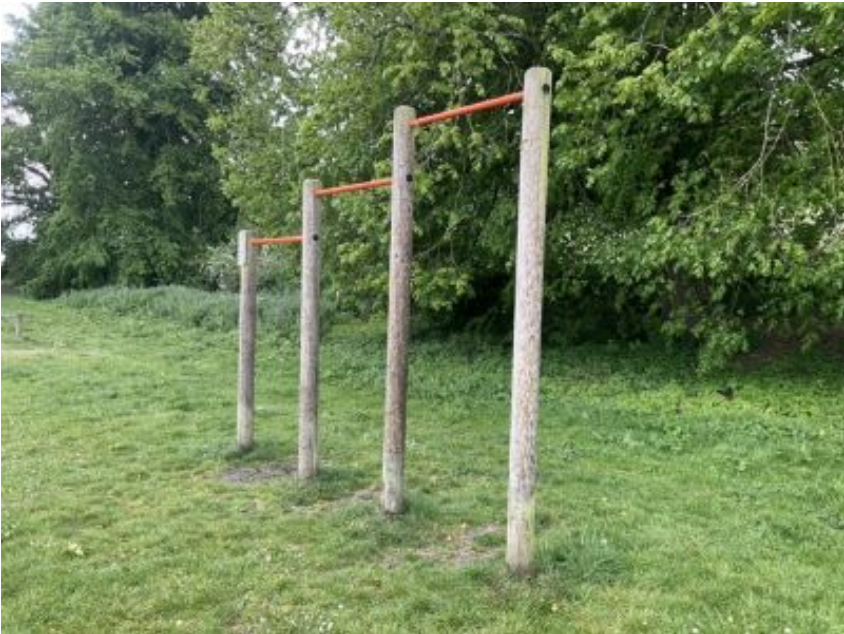
# Adult Fitness - Pull Ups - 3 Heights

Surface is wearing.

Monitor for significant deterioration and rectify when necessary.

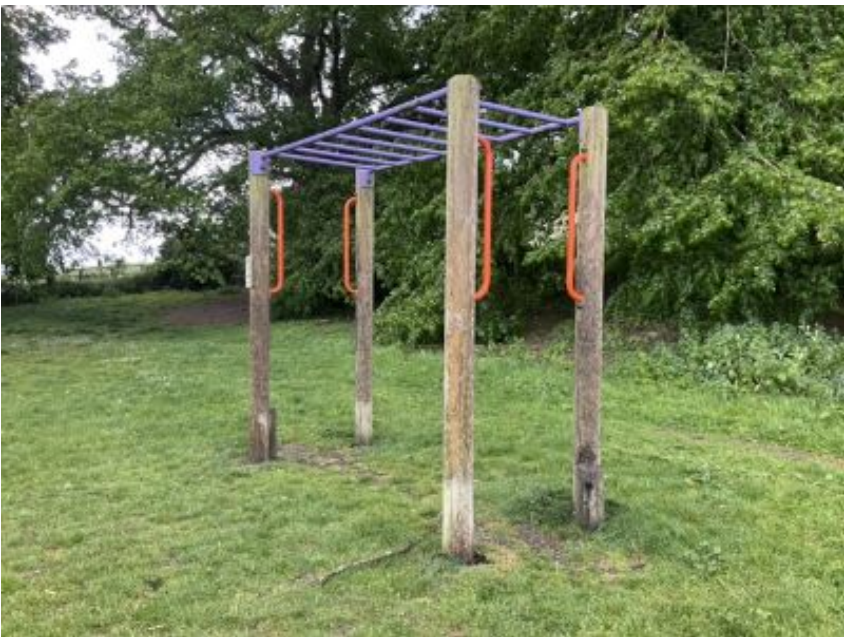
# Adult Fitness - Monkey Bars

Overhead ladders and rings provide significant play value and benefits to children, and with it the risk of falling. Ensuring the surface remains in good condition will help to keep the correct balance between benefits and risk.

The protective surface under all bars and rings must be kept in good condition.

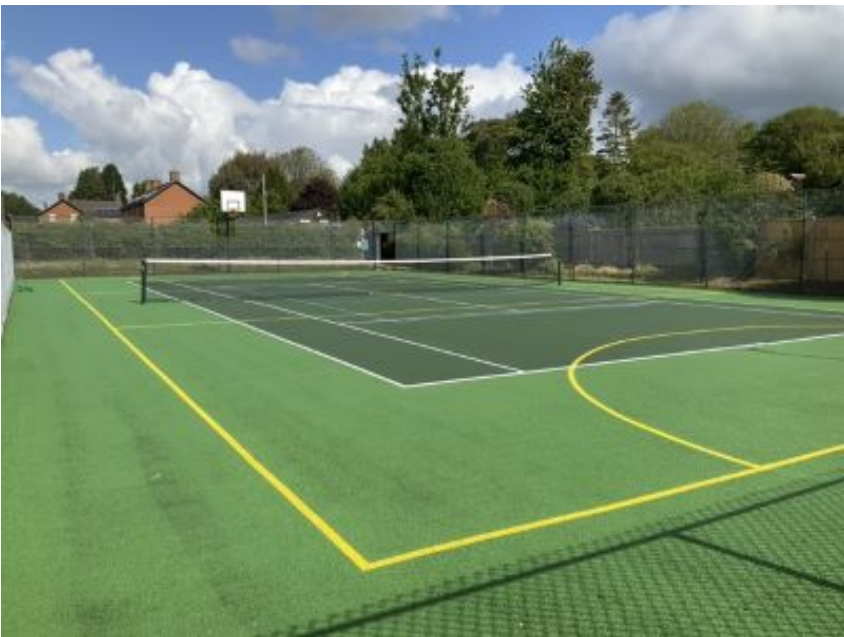
# MUGA

1. Additional comments are noted below.
2. Item is cracked.

Item is cracked.

Replace.
