PLAY AREA SAFETY INSPECTION REPORT

Chideock Parish Council

Inspection undertaken September 2022
This report issued October 16th 2022

Park Name: Mill Lane
Location: Mill Lane, Chideock. DT6 6JS

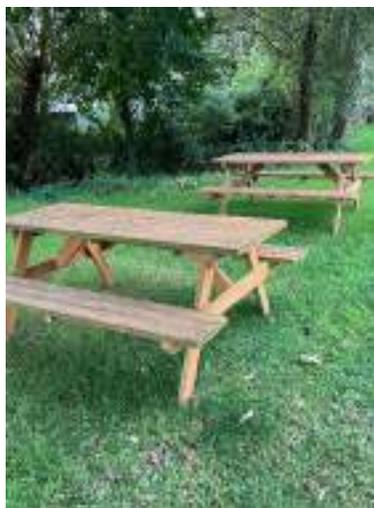
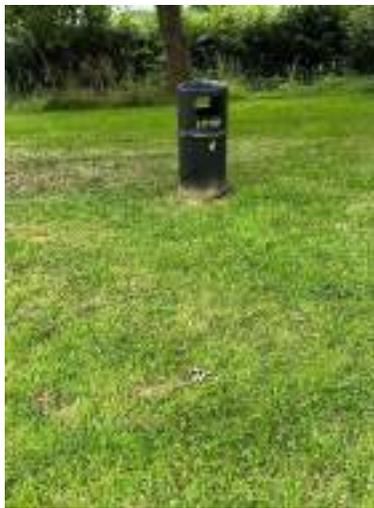
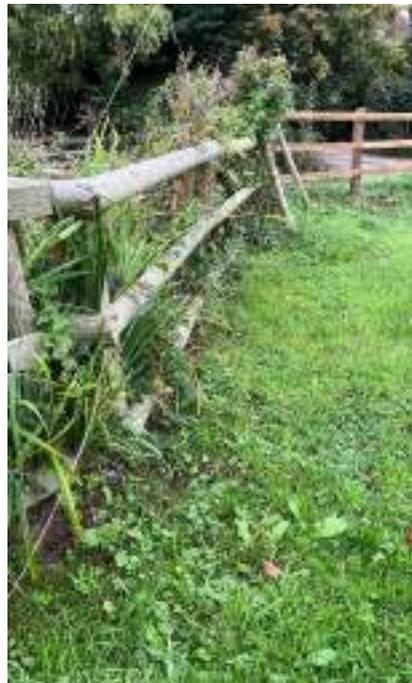
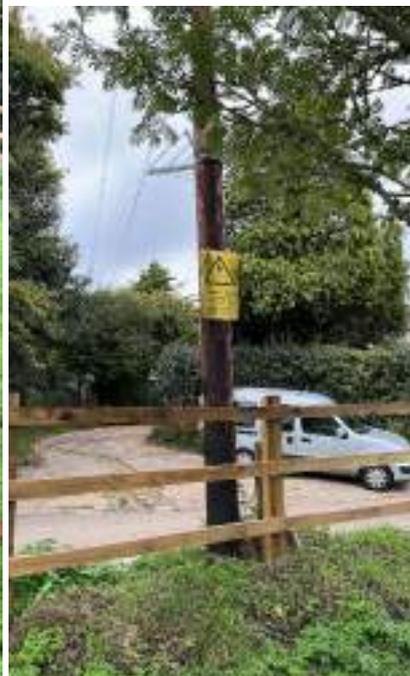
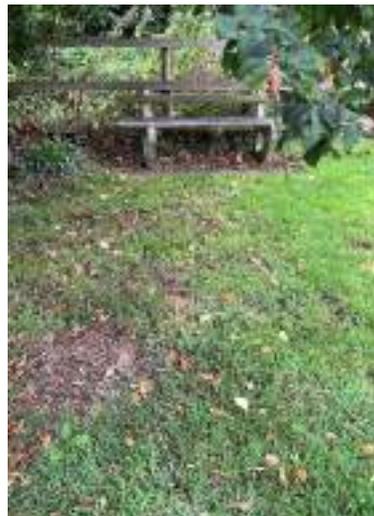
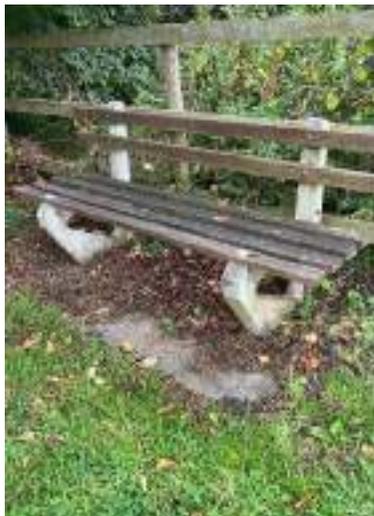
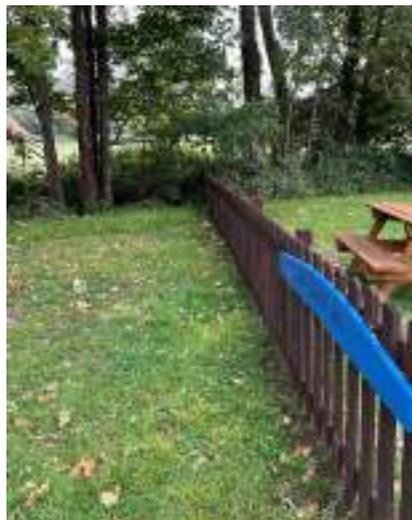
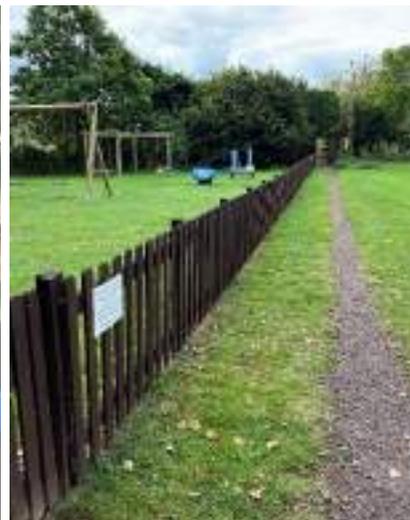
Fencing and gates are in reasonable condition and are being well maintained.

There are several nearby bins and a variety of benches around the site in reasonable condition. There is some decay in the seat of one of the picnic tables. It should also be noted that if picnic tables are going to be positioned inside the play area they must be fixed to prevent them being placed in the fall area of swings or climbing equipment where they could cause injury.
