PLAY AREA SAFETY INSPECTION REPORT

Chideock Parish Council

Inspection undertaken April 26th 2021

Park Name: Mill Lane

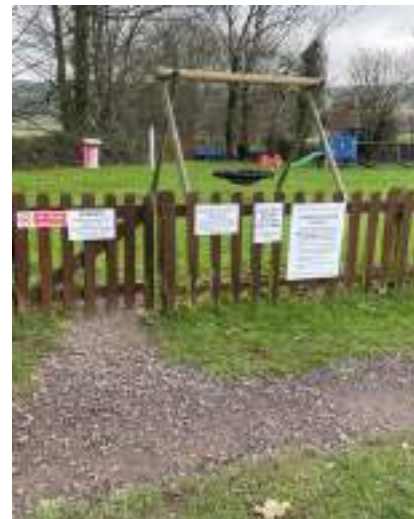
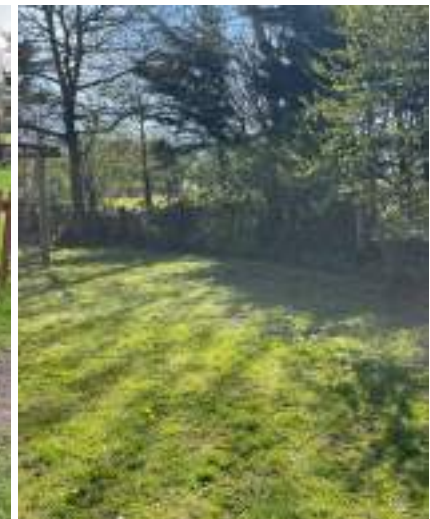
The fencing in the corner with the bench closest to the road is in need of repair. The bench is too close to the fence, but the risk is lower here outside the main play area.
