## Annual Inspection

Winchester City Council

West Meon Village Hall RG (West Meon PC)

Headon View, West Meon, Hampshire, GU32 1LH

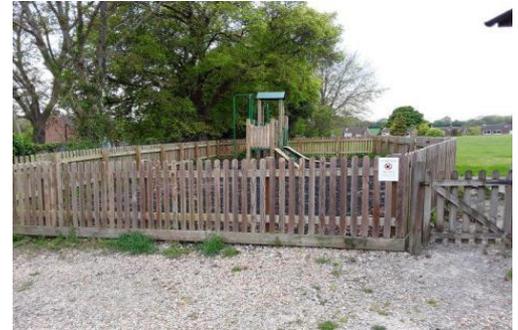
**Item:** Site General  
**Manufacturer:** Owner/Operator  
**Surface Type:** N/A  
**Item Quantity:** 1  
**Equipment Compliance:** N/A  
**Surface Area Compliance:** N/A

There is some tree debris on the surfacing - Remove and maintain

There is algae or moss growth on the safety surfacing resulting in slippery conditions - Clean and treat appropriately

The grass is overgrown within the play area and may hide hazards - Reduce the length of grass to an acceptable height and maintain

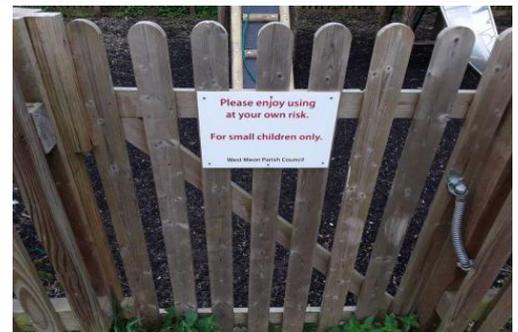
**Item:** Sign  
**Manufacturer:** Owner/Operator  
**Surface Type:** N/A  
**Item Quantity:** 1  
**Equipment Compliance:** N/A  
**Surface Area Compliance:** N/A

BS EN 1176 recommends that signage, with information including the site address, contact information for maintenance issues and emergency contact details are provided on the playground - Provide in accordance with the recommendations set out in BS EN 1176 Part 7

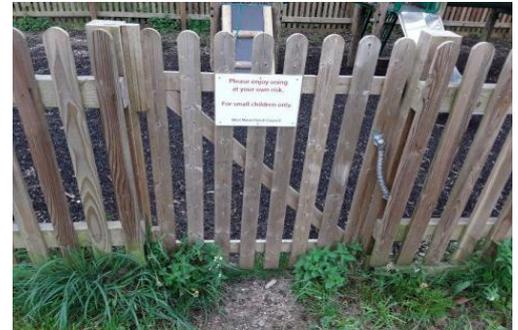
**Item:** Gate - Self Closing  
**Manufacturer:** Owner/Operator  
**Surface Type:** Grass  
**Item Quantity:** 1  
**Equipment Compliance:** N/A  
**Surface Area Compliance:** N/A

There is or are fixings missing on the item - Replace all missing fixings

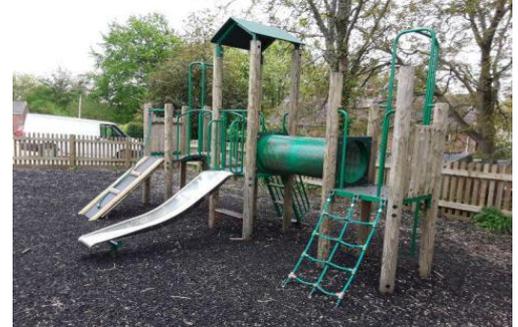
**Item:** Multi Play (Junior)  
**Manufacturer:** A.E.Evans  
**Surface Type:** Loose Rubber Mulch  
**Item Quantity:** 1  
**Equipment Compliance:** No  
**Surface Area Compliance:** Yes

The paintwork on this item has been damaged or worn exposing the metal underneath which is rusting - Treat any rusting components and repaint

A number of tread fixing(s) have worked loose - Secure all loose fixings

The timber has a number of splits/shakes or air cracks and this may affect the stability or allow water ingress which will accelerate the rotting process - Monitor to ensure the splits do not cross through fixing points of the structure and/or cause any instability

There is/are bolt cap covers missing or damaged on the item - Replace missing or damaged bolt cap covers

A number of barrier fixing(s) have worked loose - Secure all loose fixings

The item fails to meet the requirements of BS EN 1176 Part 1 4.2.7.2 head and neck entrapment in the barriers and/or steps - Monitor - No remedial work recommended

The unit is easily accessible and should have the appropriate barriers installed to meet the requirements of BS EN 1176 Part 1 as the height of the unit exceeds 600mm - Monitor - No remedial work recommended

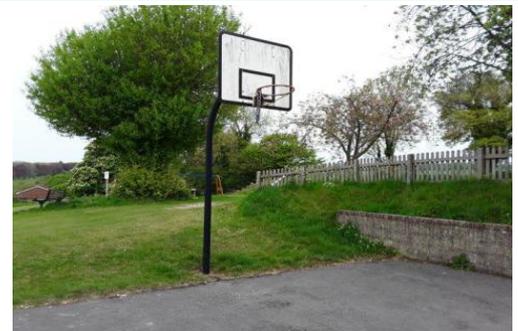
**Item:** Basketball Post  
**Manufacturer:** Not Identified  
**Surface Type:** Bitmac  
**Item Quantity:** 1  
**Equipment Compliance:** Yes  
**Surface Area Compliance:** N/A

The net is damaged - Replace / remove net

The paintwork on this item has been damaged or worn exposing the metal underneath which is rusting - Treat any rusting components and repaint

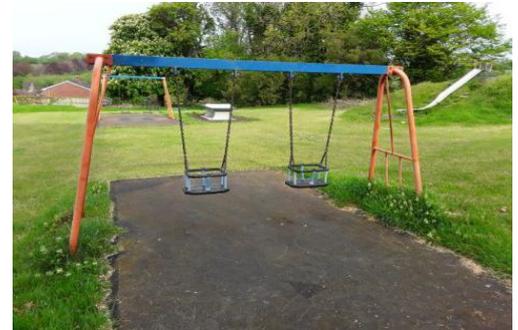
**Item:** 1 Bay 2 Seat (Cradle)  
**Manufacturer:** Wicksteed Playgrounds  
**Surface Type:** Wet Pour  
**Item Quantity:** 1  
**Equipment Compliance:** No  
**Surface Area Compliance:** Yes

The paintwork on this item has been damaged or worn exposing the metal underneath which is rusting - Treat any rusting components and repaint

There is some notable evidence of chain wear - Monitor for any further deterioration and replace when 40% worn

The seat has minor damage or wear - Monitor for any further deterioration and replace as required

The chain openings are in excess of the 8.6mm as recommended by BS EN 1176 - Monitor - No remedial work recommended

The safety surface under or around this unit has been damaged - Monitor for any further deterioration and repair as required

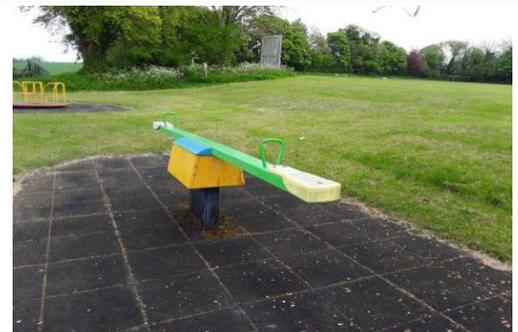
**Item:** See Saw  
**Manufacturer:** Wicksteed Playgrounds  
**Surface Type:** Rubber Tiles  
**Item Quantity:** 1  
**Equipment Compliance:** Yes  
**Surface Area Compliance:** Yes

There are gaps opening in between the tiles - Monitor for any further deterioration and repair as required

The seat has minor damage or wear - Monitor for any further deterioration and replace as required

The paintwork on this item has been damaged or worn exposing the metal underneath which is rusting - Treat any rusting components and repaint

Parts of the steel on this item have corroded excessively and the metal has perforated in places - Ensure all affected areas are treated and repaired

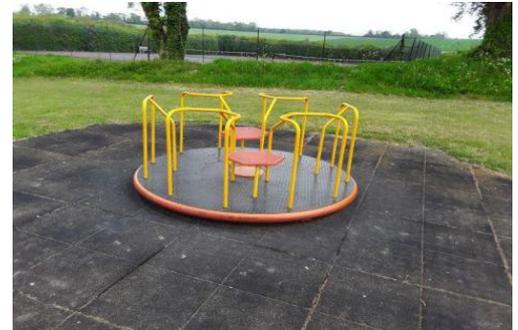
**Item:** Roundabout  
**Manufacturer:** Wicksteed Playgrounds  
**Surface Type:** Rubber Tiles  
**Item Quantity:** 1  
**Equipment Compliance:** Yes  
**Surface Area Compliance:** Yes

There are gaps opening in between the tiles - Monitor for any further deterioration and repair as required

The safety surface under or around this unit has been damaged - Monitor for any further deterioration and repair as required

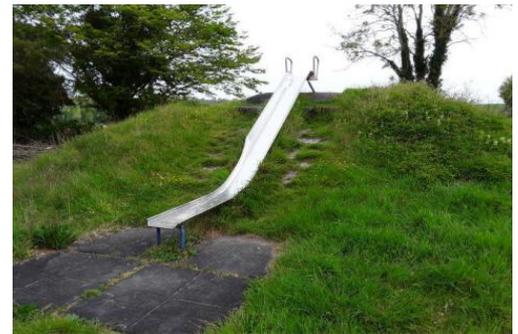
**Item:** Embankment Slide  
**Manufacturer:** Not Identified  
**Surface Type:** Rubber Tiles  
**Item Quantity:** 1  
**Equipment Compliance:** No  
**Surface Area Compliance:** Yes

The grass is overgrown within the play area and may hide hazards - Reduce the length of grass to an acceptable height and maintain

There are gaps opening in between the tiles - Monitor for any further deterioration and repair as required

The safety surface under or around this unit has been damaged - Monitor for any further deterioration and repair as required

The paintwork on this item has been damaged or worn exposing the metal underneath which is rusting - Treat any rusting components and repaint

There is some evidence of rot in the timber sleeper - Monitor for any further deterioration and replace as required

The slide start section incline is not in the direction of travel; it should slope towards the direction of the sliding surface to meet the requirements of BS EN 1176 Part 3 - Monitor - No remedial work recommended

There is / are toggle entrapment/s present in contravention of the recommendations set out in BS EN 1176 Part 3 - Monitor - no remedial work recommended

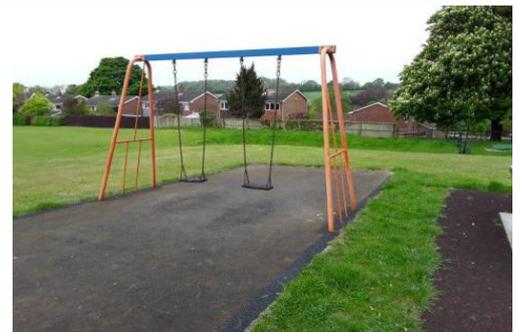
**Item:** 1 Bay 2 Seat (Flat)  
**Manufacturer:** Wicksteed Playgrounds  
**Surface Type:** Wet Pour  
**Item Quantity:** 1  
**Equipment Compliance:** No  
**Surface Area Compliance:** Yes

There is some notable evidence of chain wear - Monitor for any further deterioration and replace when 40% worn

The bushes are showing signs of wear - Monitor for any further deterioration and replace as required

The chain openings are in excess of the 8.6mm as recommended by BS EN 1176 - Monitor - No remedial work recommended

The swing seat connectors are loose - Tighten to secure

There is some wear to the shackles. - Monitor for any further deterioration and replace when 40% worn

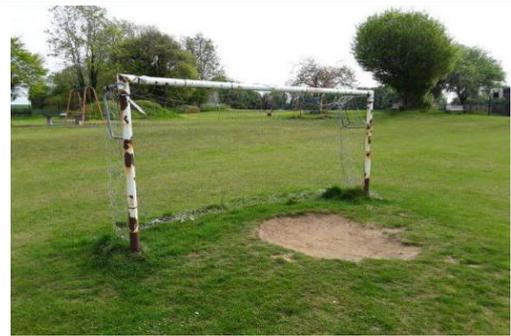
**Item:** Football Goal  
**Manufacturer:** Not Identified  
**Surface Type:** Grass  
**Item Quantity:** 2  
**Equipment Compliance:** N/A  
**Surface Area Compliance:** N/A

NB: We have undertaken a maintenance inspection only of the football goal(s); full load testing falls outside the scope of our inspection. - Implement load testing as required

The nets are damaged - Repair / replace as required

The paintwork on this item has been damaged or worn exposing the metal underneath which is rusting - Treat any rusting components and repaint

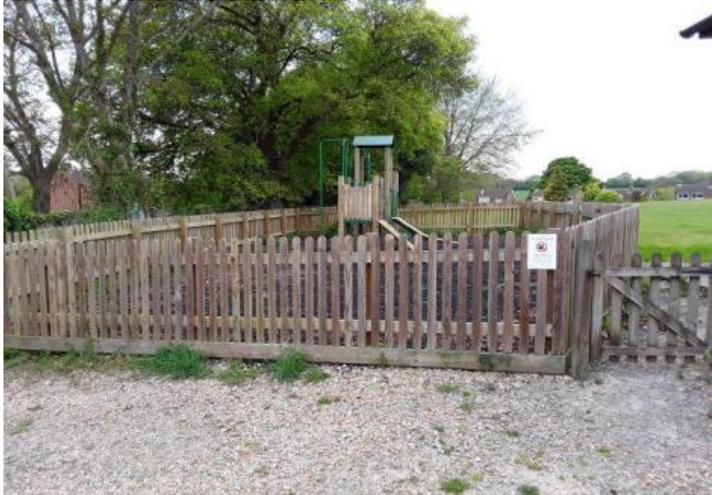
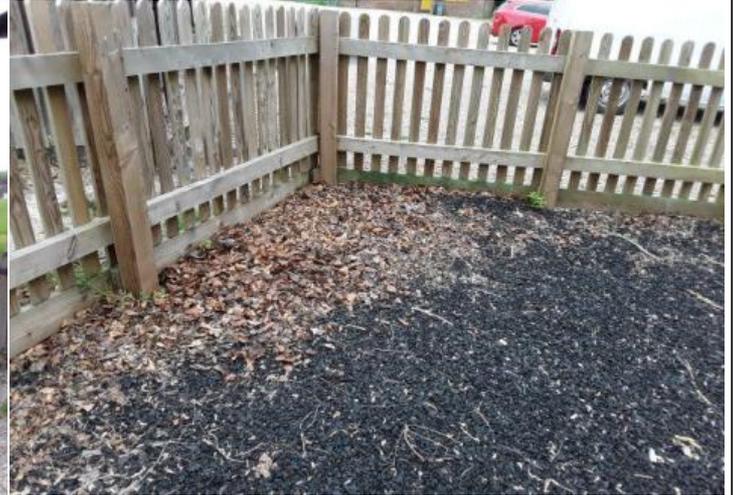
**Item:** Ancillary Items - Site General  
**Manufacturer:** Owner/Operator

**Finding:** There is some tree debris on the surfacing

**Action:** Remove and maintain

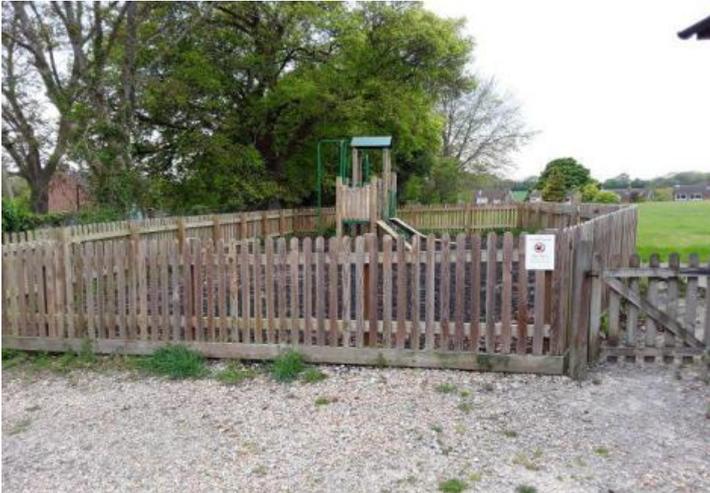
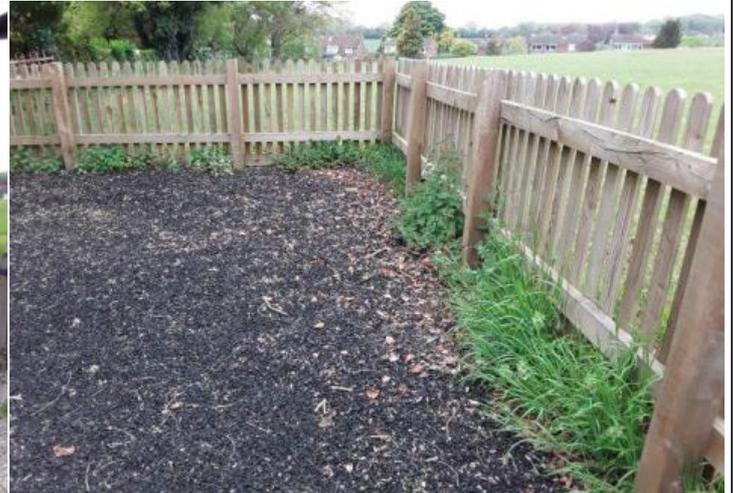
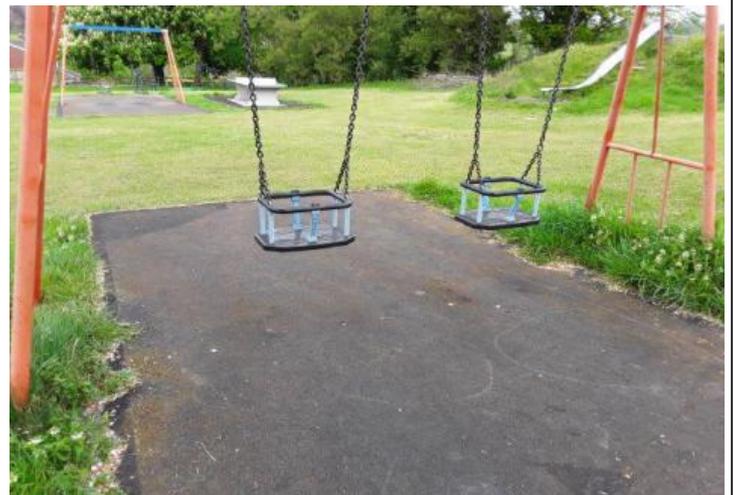
**Item:** Ancillary Items - Site General  
**Manufacturer:** Owner/Operator

**Finding:** There are weeds/vegetation growth between or around the edges of the surfacing

**Action:** Remove weeds/vegetation growth

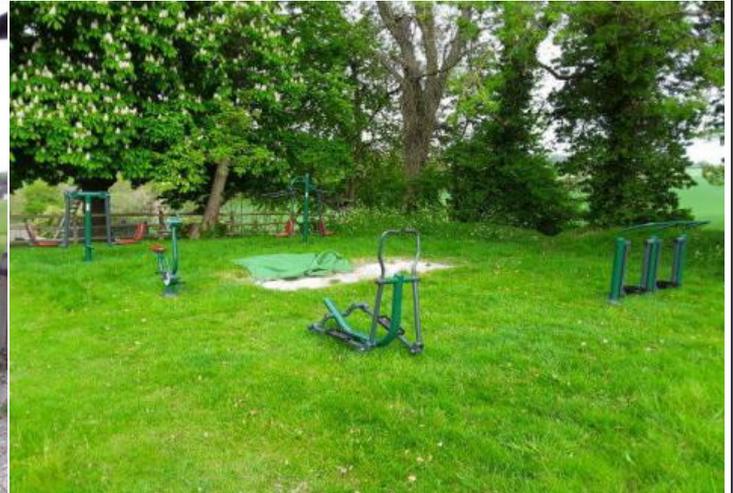
**Item:** Ancillary Items - Site General  
**Manufacturer:** Owner/Operator

**Finding:** Signage should be provided for the outdoor fitness equipment in accordance with the requirements of BS EN 16630, key requirements of the sign include, but are not limited to, intended users, medical safety and emergency contact details  
**Action:** Provide appropriate signage

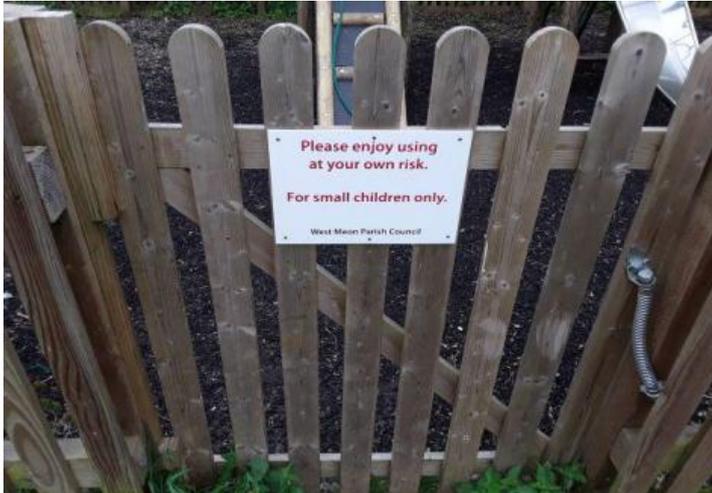
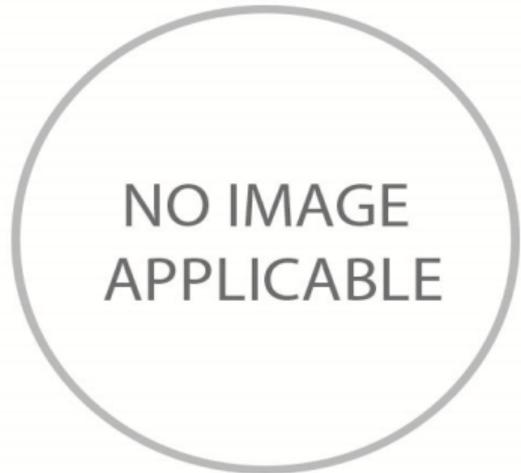
**Item:** Ancillary Items - Sign  
**Manufacturer:** Owner/Operator

**Finding:** There is no COVID19 entry prohibition sign visible on the site  
**Action:** Fit sign as directed

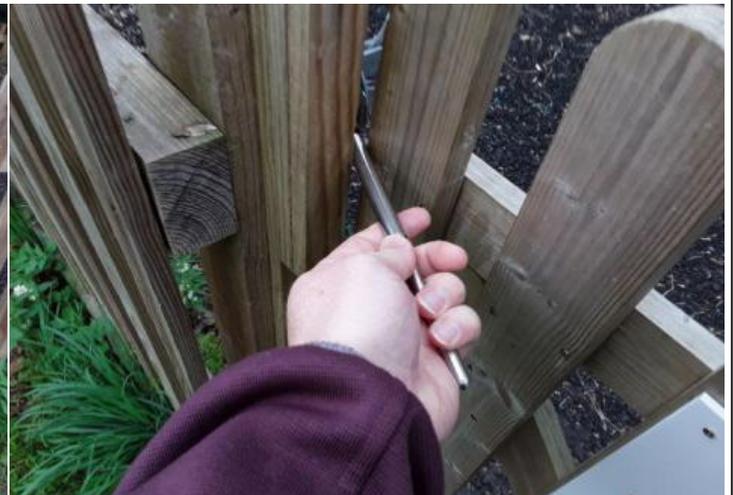
**Item:** Ancillary Items - Gate - Self Closing  
**Manufacturer:** Owner/Operator

**Finding:** There are openings that are less than 12mm that could trap or crush fingers  
**Action:** Where possible a 12mm gap should be maintained on both sides or between the gate leaves

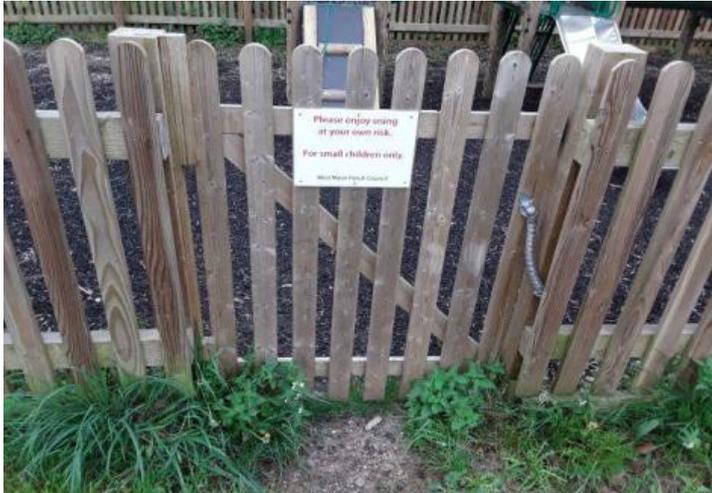
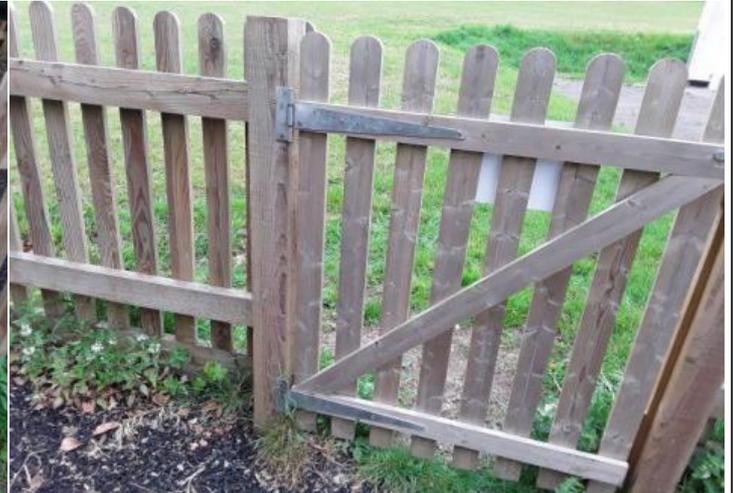
**Item:** Ancillary Items - Gate - Self Closing  
**Manufacturer:** Owner/Operator

**Finding:** The gate is closing too quickly (less than 4 seconds)

**Action:** Take corrective action to ensure that the gate closes in 4-8 seconds

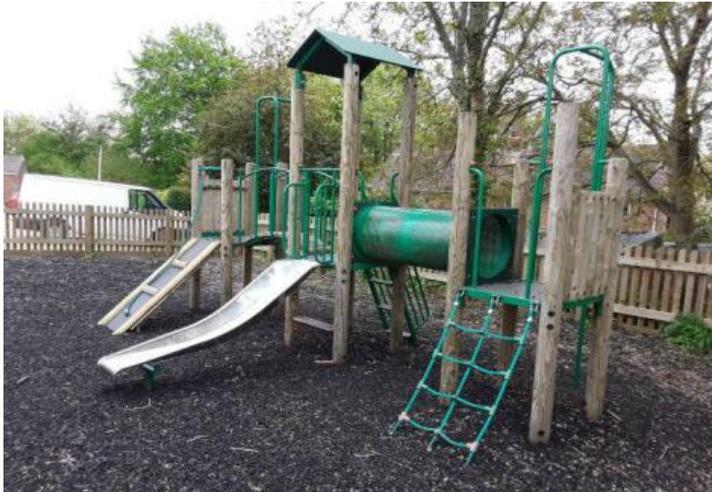
**Item:** Activity Equipment - Multi Play (Junior)  
**Manufacturer:** A.E.Evans

**Finding:** There is/are bolt cap covers missing or damaged on the item  
**Action:** Replace missing or damaged bolt cap covers

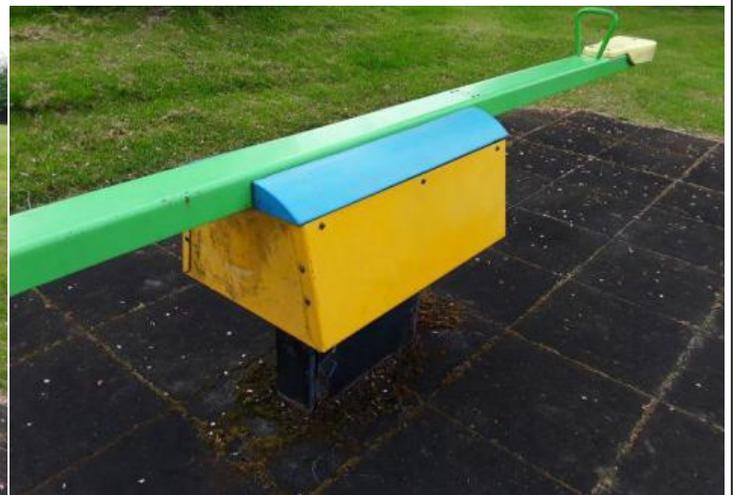
**Item:** Rocking Equipment - See Saw  
**Manufacturer:** Wicksteed Playgrounds

**Finding:** The item is noisy during operation

**Action:** Service and lubricate as required

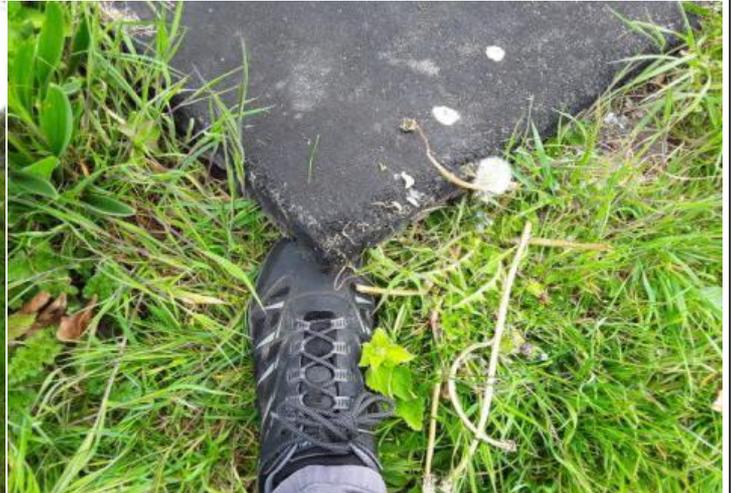
**Item:** Other - Embankment Slide  
**Manufacturer:** Not Identified

**Finding:** The tiles can easily be lifted or are lifting along the edges of the area  
**Action:** Lift and re-glue tiles to secure

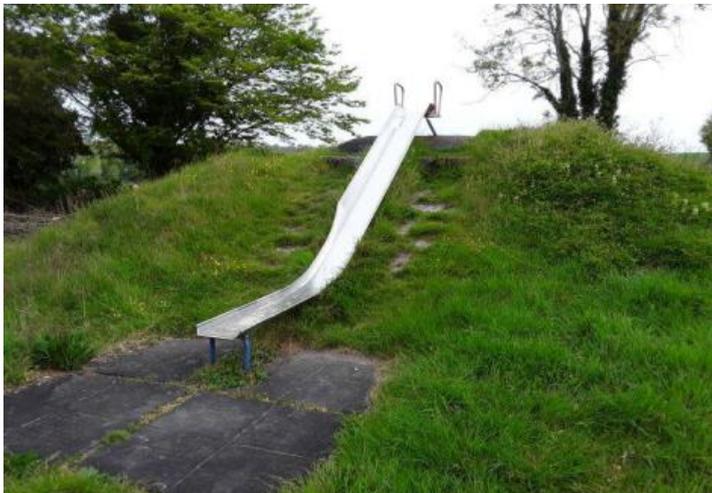
**Item:** Other - Embankment Slide  
**Manufacturer:** Not Identified

**Finding:** The safety surface under or around this unit has been damaged  
**Action:** Monitor for any further deterioration and repair as required

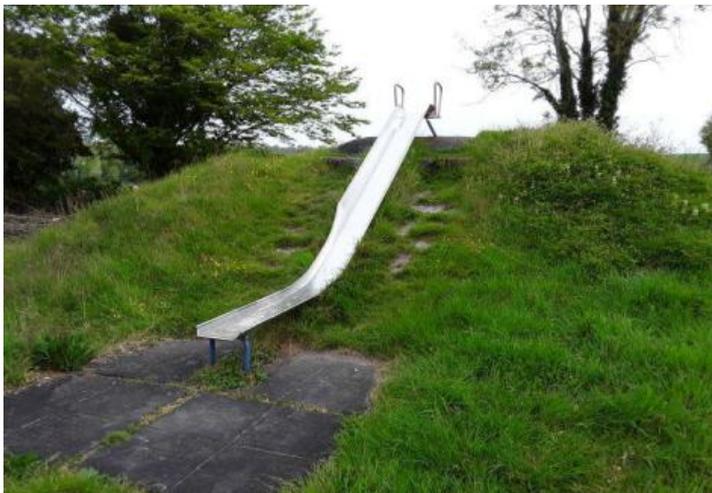
**Item:** Other - Embankment Slide  
**Manufacturer:** Not Identified

**Finding:** There is / are toggle entrapment/s present in contravention of the recommendations set out in BS EN 1176 Part 3  
**Action:** Monitor - no remedial work recommended

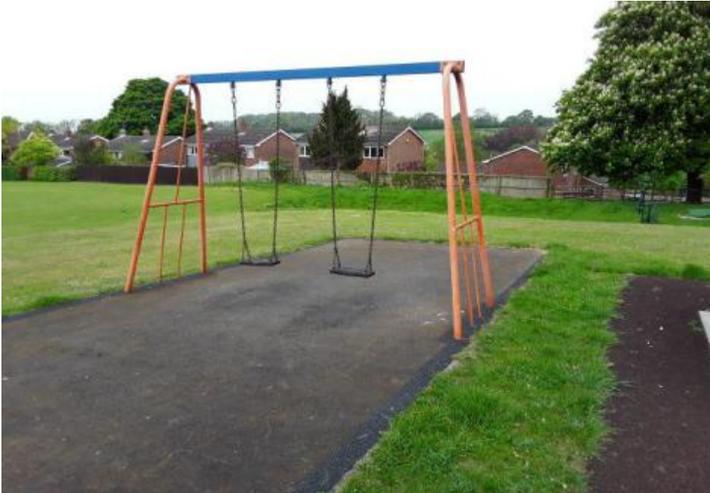
**Item:** Swings - 1 Bay 2 Seat (Flat)  
**Manufacturer:** Wicksteed Playgrounds

**Finding:** There is some notable evidence of chain wear

**Action:** Monitor for any further deterioration and replace when 40% worn

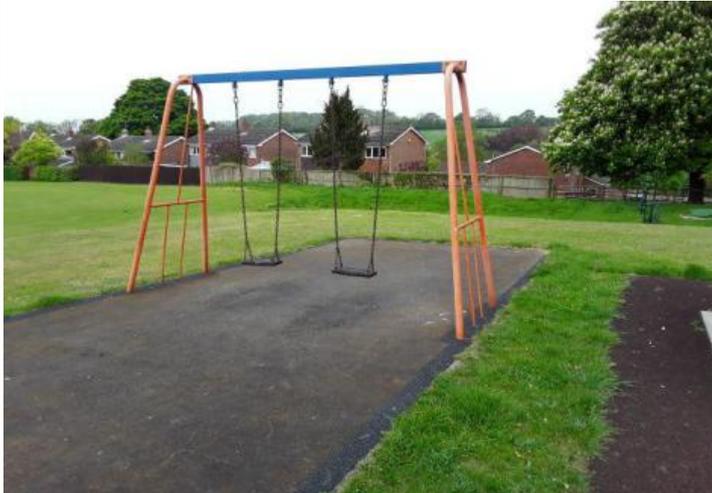
**Item:** Swings - 1 Bay 2 Seat (Flat)  
**Manufacturer:** Wicksteed Playgrounds

**Finding:** The bushes are showing signs of wear

**Action:** Monitor for any further deterioration and replace as required

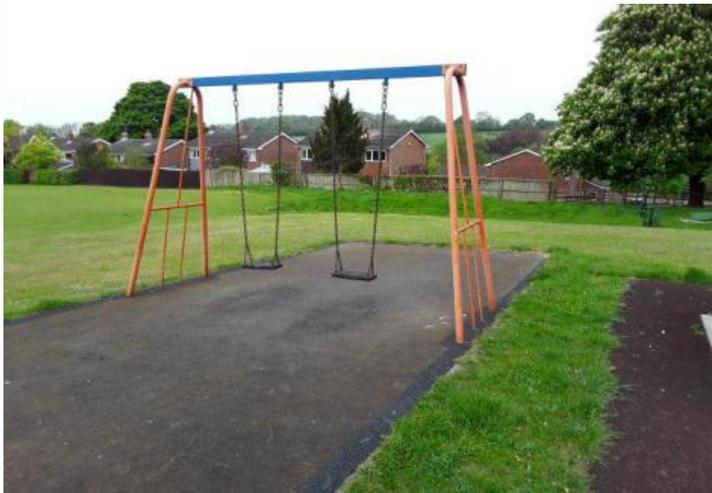
**Item:** Swings - 1 Bay 2 Seat (Flat)  
**Manufacturer:** Wicksteed Playgrounds

**Finding:** There is some wear to the shackles.

**Action:** Monitor for any further deterioration and replace when 40% worn

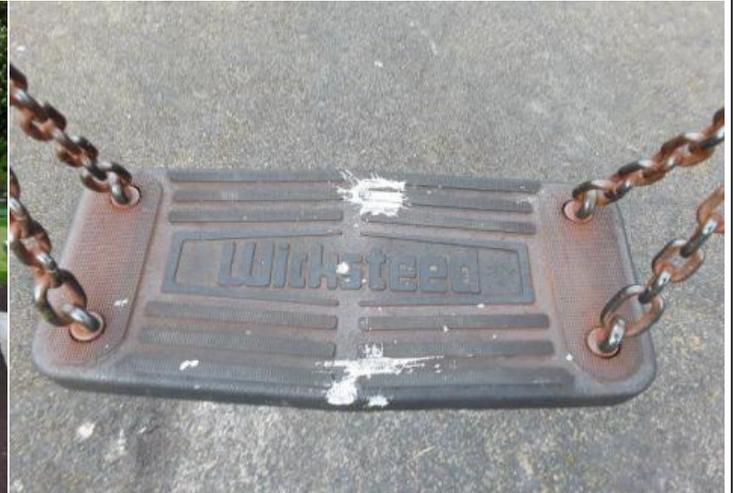
**Item:** Swings - 1 Bay 2 Seat (Flat)  
**Manufacturer:** Wicksteed Playgrounds

**Risk Level:** V - Very Low Risk  
**Surface:** Wet Pour

**Finding:** There is bird excrement on the seats

**Action:** Clean and maintain area

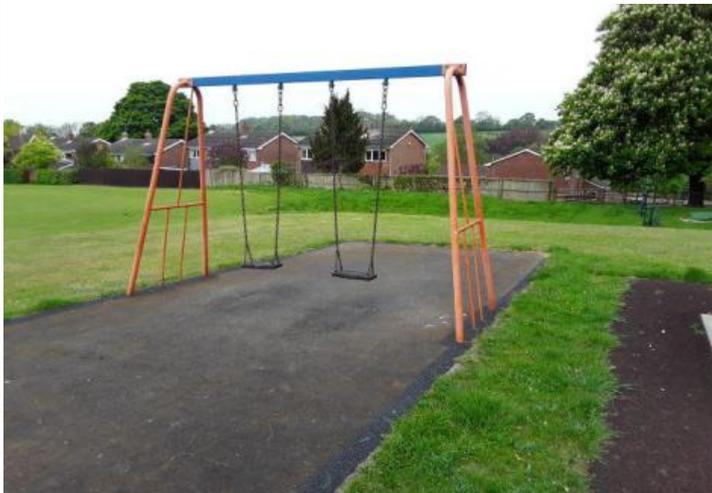
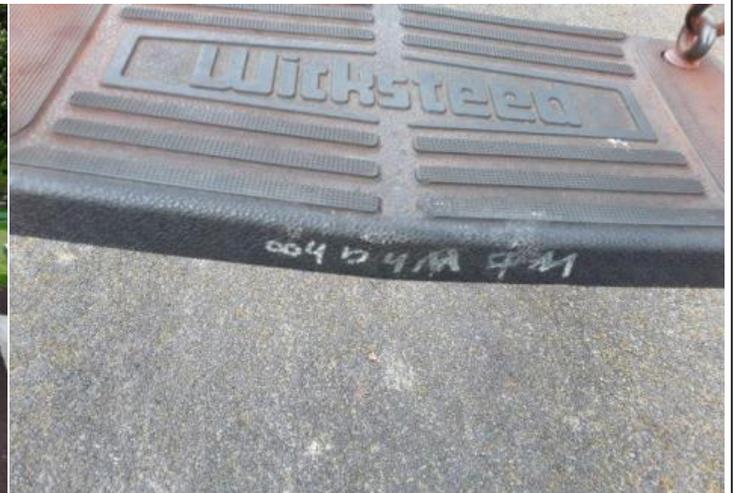
**Item:** Swings - 1 Bay 2 Seat (Flat)  
**Manufacturer:** Wicksteed Playgrounds

**Risk Level:** N - Risk Assessment not Undertaken  
**Surface:** Wet Pour

**Finding:** There is some graffiti present

**Action:** Remove the graffiti

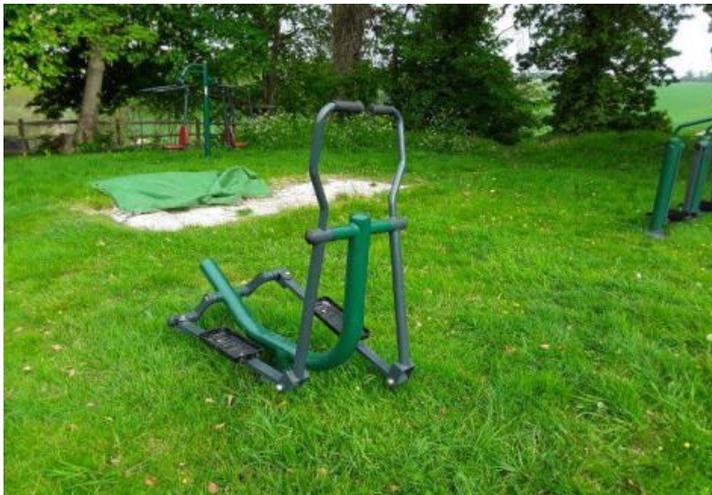
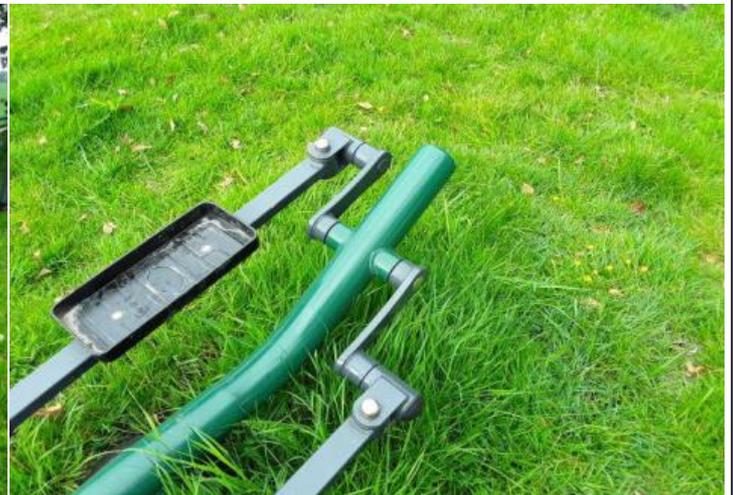
**Item:** Outdoor Fitness Equipment - Skier  
**Manufacturer:** Sunshine Gym

**Risk Level:** V - Very Low Risk  
**Surface:** Grass Matrix Tiles

**Finding:** The item is noisy during operation

**Action:** Service and lubricate as required

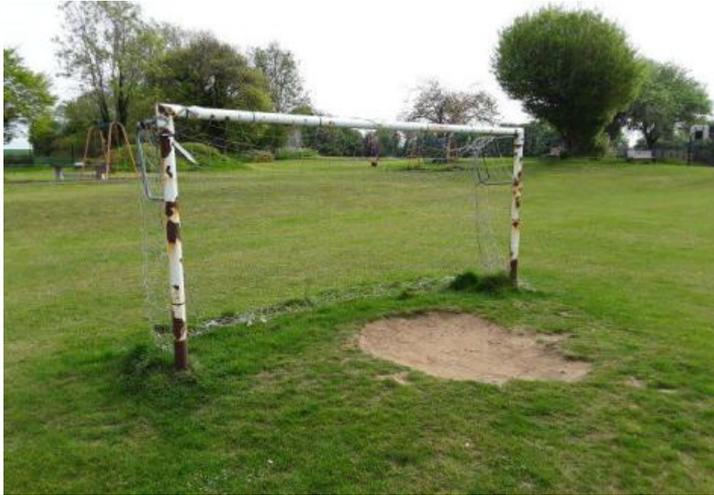
**Item:** Multi Use Games Area - Football Goal  
**Manufacturer:** Not Identified

**Risk Level:** N - Risk Assessment not Undertaken  
**Surface:** Grass

**Finding:** NB: We have undertaken a maintenance inspection only of the football goal(s); full load testing falls outside the scope of our inspection.

**Action:** Implement load testing as required

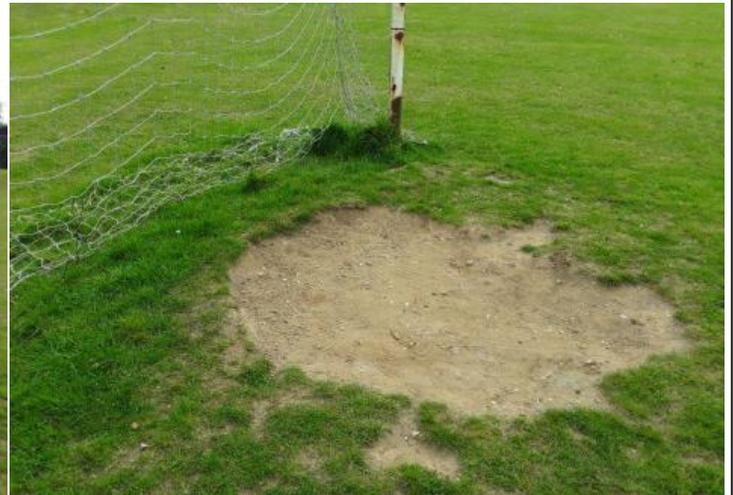
**Item:** Multi Use Games Area - Football Goal  
**Manufacturer:** Not Identified

**Risk Level:** L - Low Risk  
**Surface:** Grass

**Finding:** The surface has eroded in some areas

**Action:** Reinststate the surface

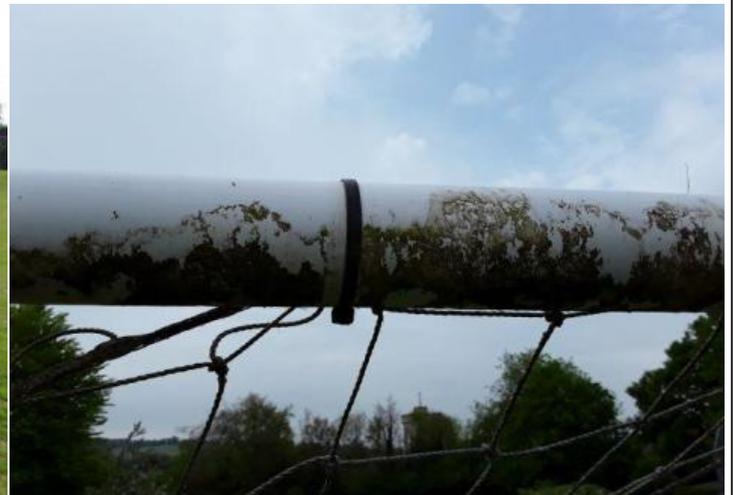
**Item:** Multi Use Games Area - Football Goal  
**Manufacturer:** Not Identified

**Risk Level:** L - Low Risk  
**Surface:** Grass

**Finding:** There is algae or moss on the surface of the equipment

**Action:** Clean and treat appropriately
