# Safety Inspection Report

Annual Inspection

## Jubilee Field

Matching Parish Council

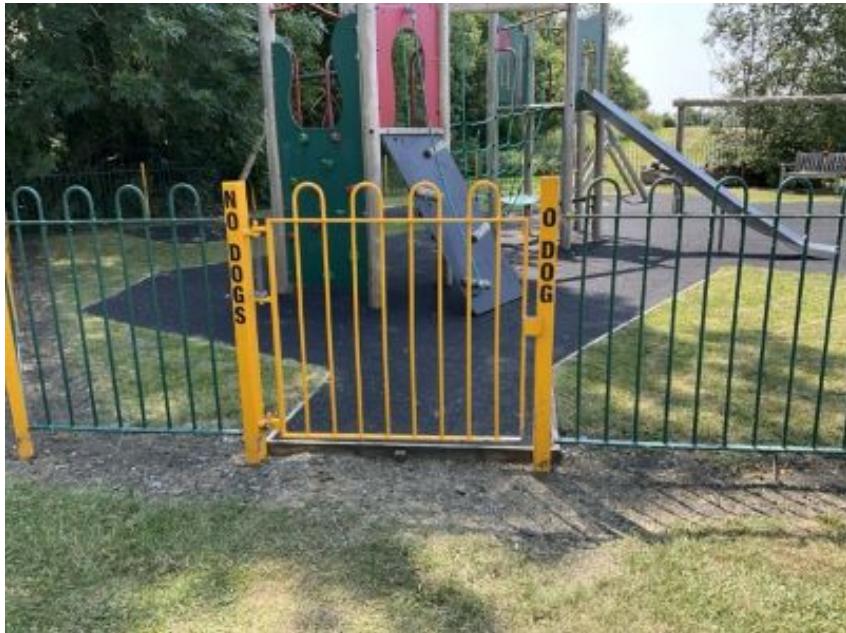
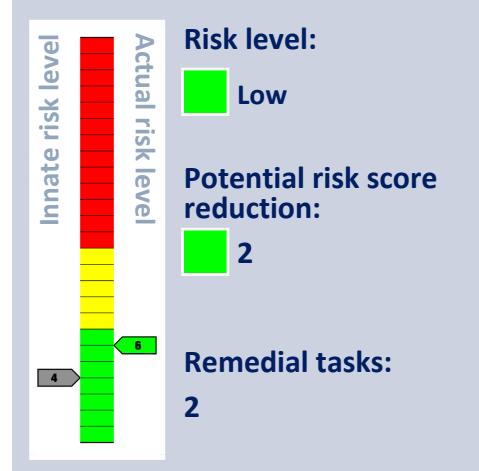
## Gates x 2

Description	Tasks	Risk score
The gate's closing mechanism does not work correctly.	Adjust to allow gate to self close. Ideally gate from open should not close in less than 5 seconds.

6
Trip points on the surface.	Remove trip points.

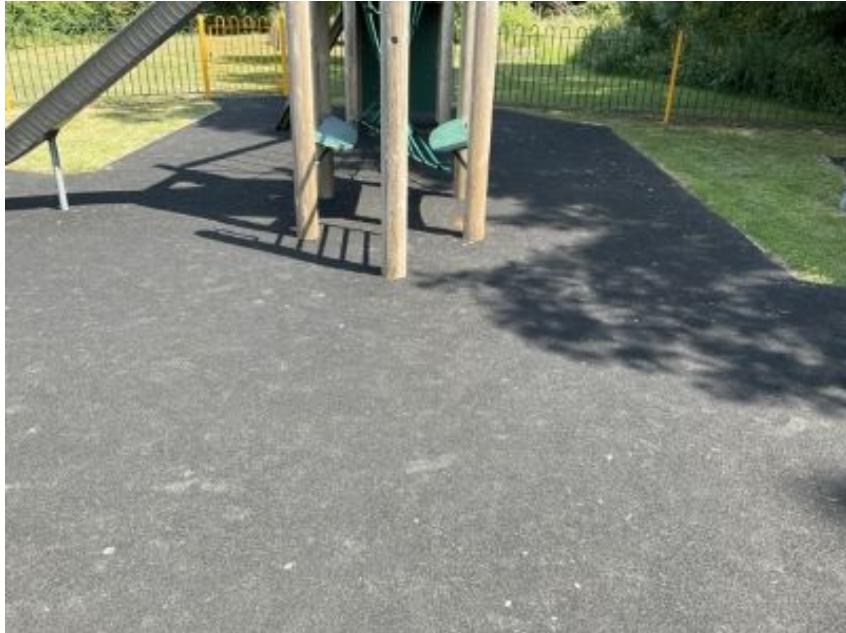
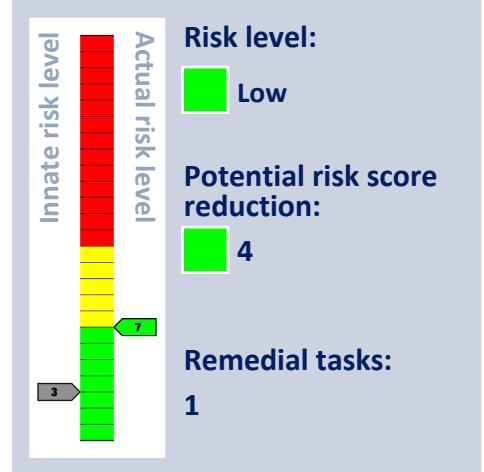
# General Surface - Wet Pour

Surface needs repair.

Timber edging is rotting in areas, causing wet pour to lift/have separation. Repair.

Repair.

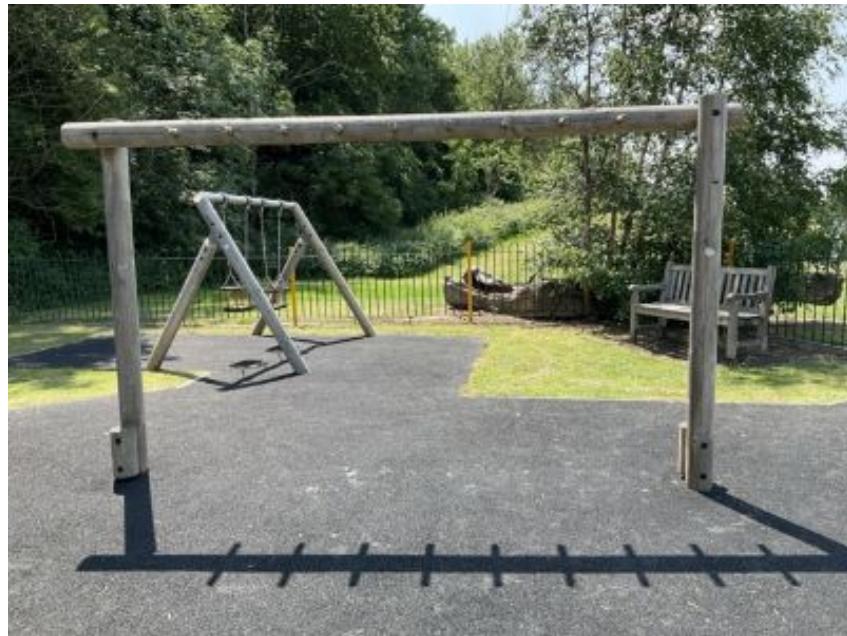
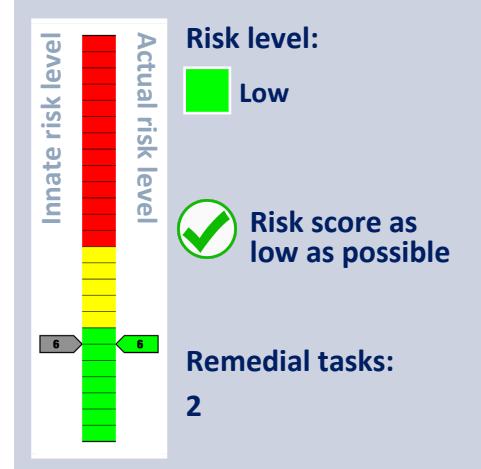
# Climber - Overhead - Rungs

Overhead ladders and rings provide significant play value and benefits to children, and with it the risk of falling. Ensuring the surface remains in good condition will help to keep the correct balance between benefits and risk.

The protective surface under all bars and rings must be kept in good condition.

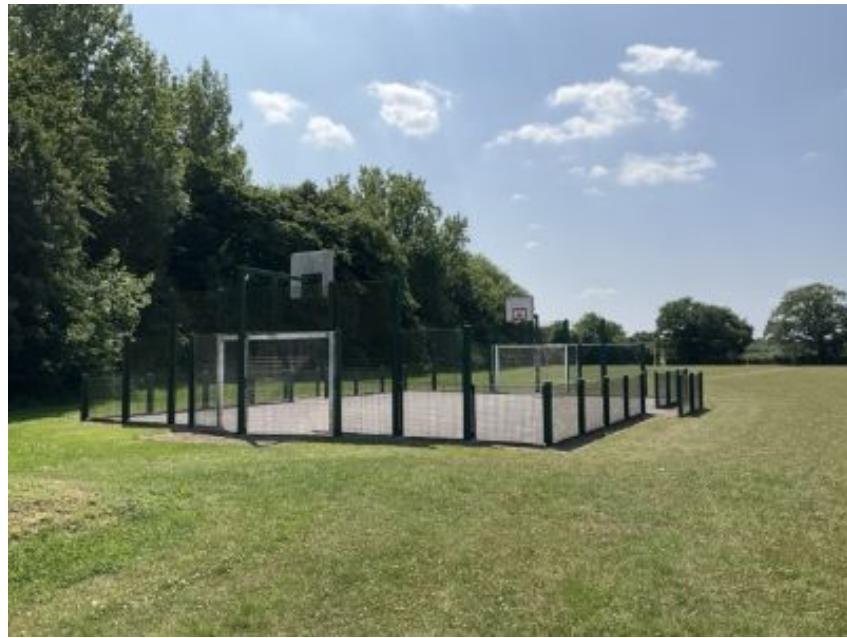
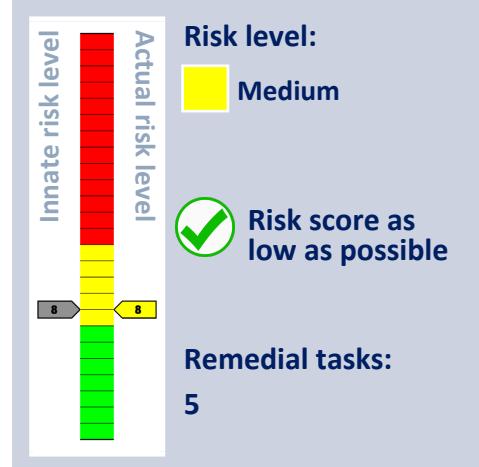
# MUGA - Double End

Cap missing.

Various caps missing.

Minor repairs are needed.

Replace.

De-scale back to good base material and coat with lead free paint, using appropriate precautions. Repairs may be necessary where corrosion is severe., Touch up the paint.

Repair.

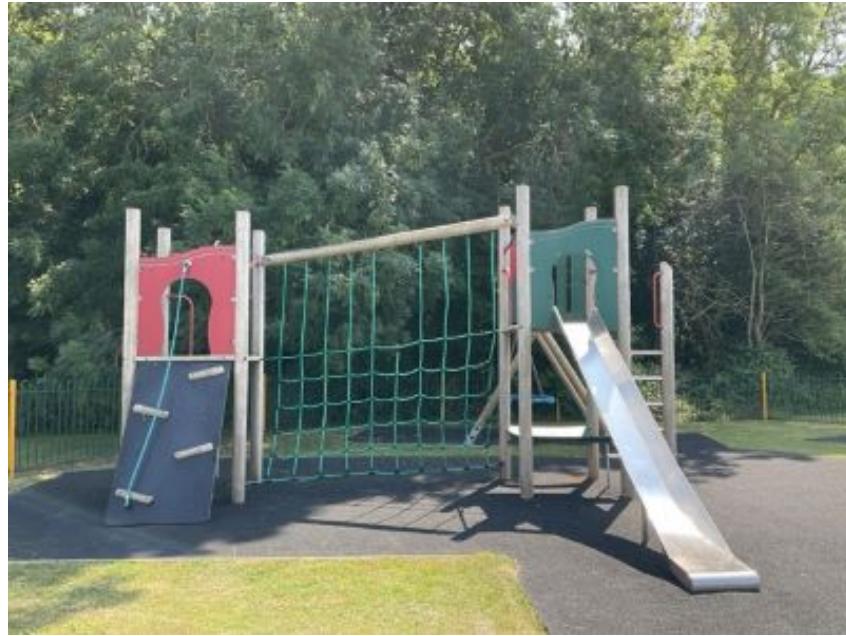
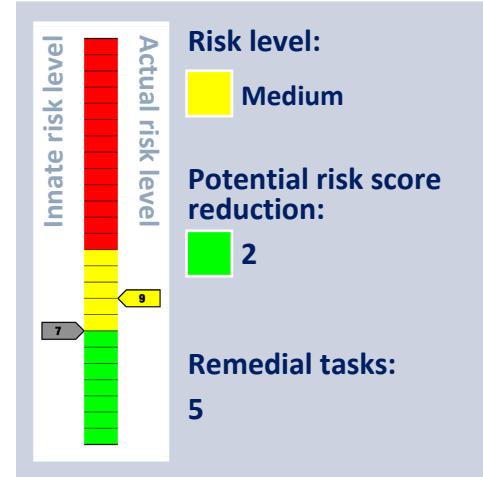
# Multiplay

Monitor rot and structural stability on cross beam of netting. Replace when necessary.

Rope connections are enclosed with no access for inspection. Ensure these are dismantled and inspected for internal rust/corrosion as the external parts are rusting/corroding.

The surface is cracking.

Cap missing.

Various caps are missing. Replace.

Repair.

Replace.

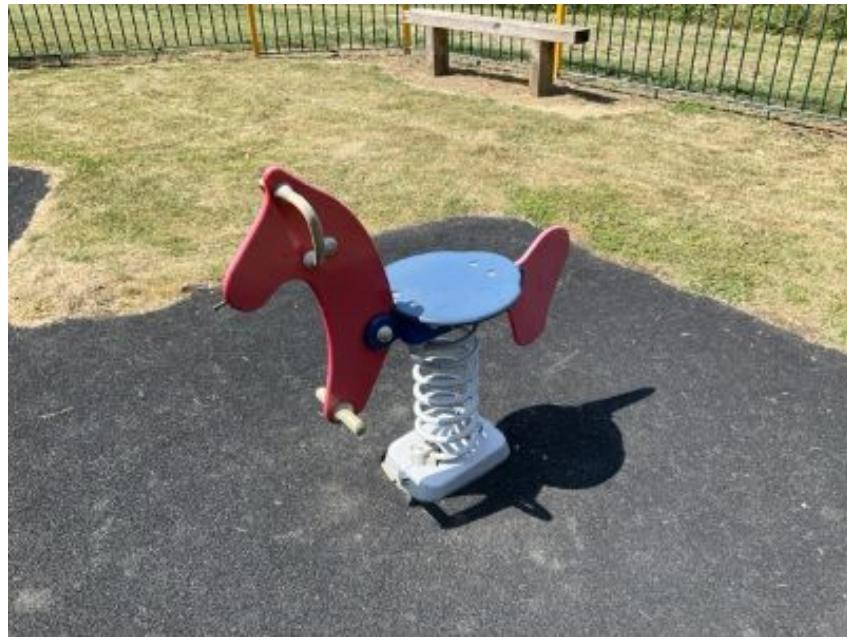
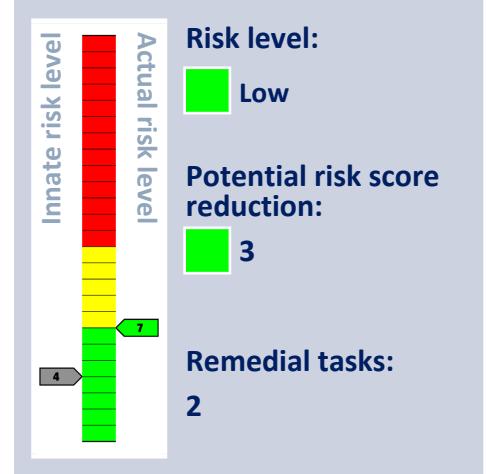
# Rocker - Horse

1. Bolt(s) loose.

Bolt(s) loose.

The spring is loose.

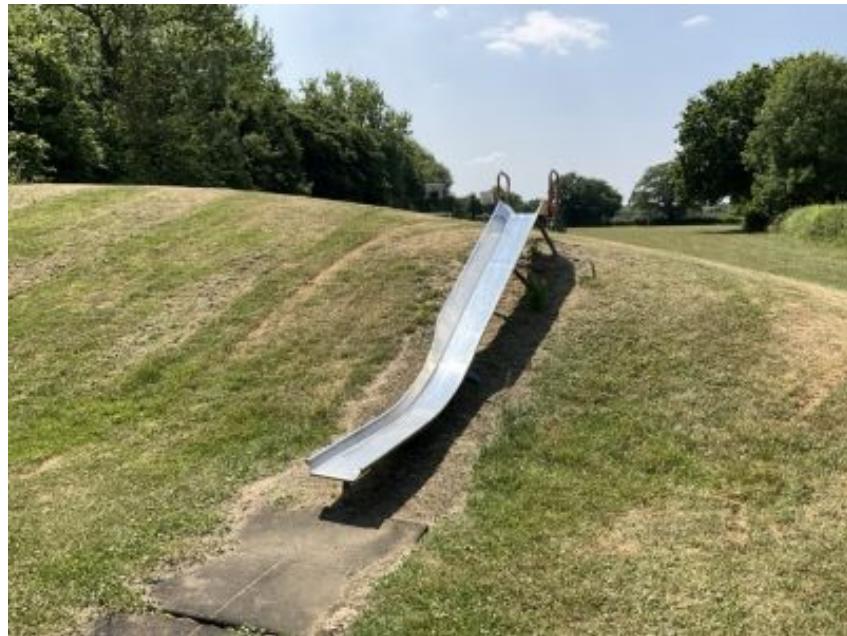
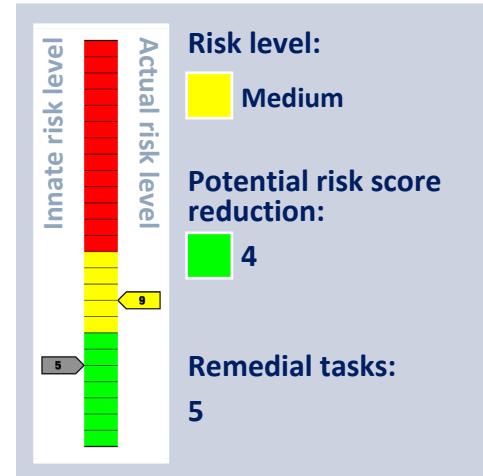
# Slide - Embankment

There is significant corrosion on this item.

The foundations should be designed such that they do not present a hazard (tripping, impact). Care should be taken to ensure that foundations are not exposed as a result of erosion.

Gaps have opened up between tiles causing trip hazard.

Paintwork is in poor condition.

De-scale back to good metal and coat with lead free paint, using appropriate precautions. Repairs may be necessary where corrosion is severe.

Eliminate the hazard.

De-scale back to good base material and coat with lead free paint, using appropriate precautions. Repairs may be necessary where corrosion is severe.

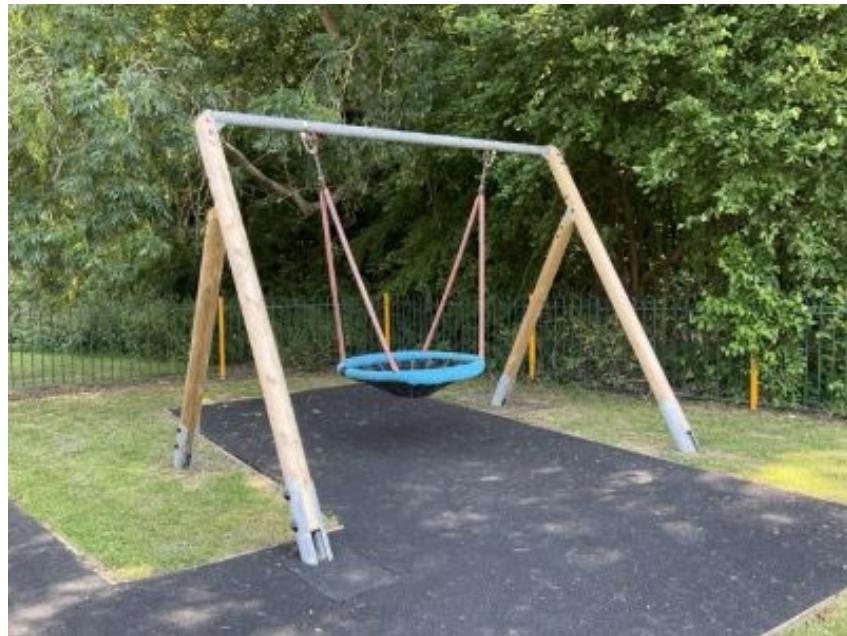
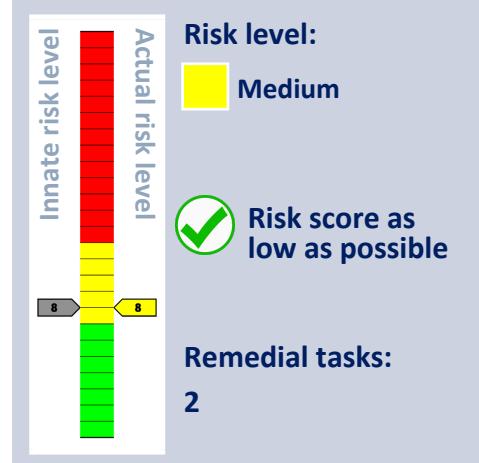
# Swing - Nest

Shrinkage / separation of the surface. This may give a trip hazard.

Repair.

Also repair damaged wooden edging.

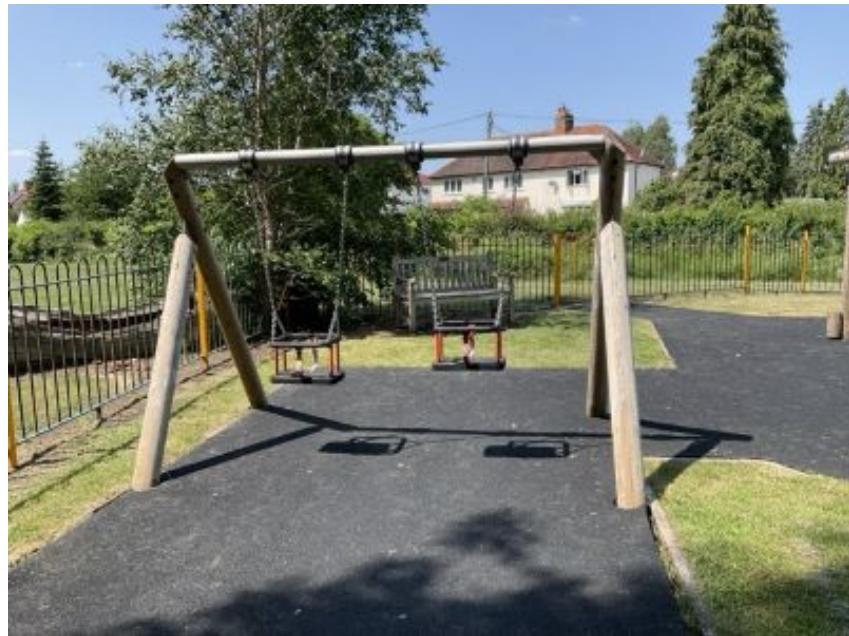
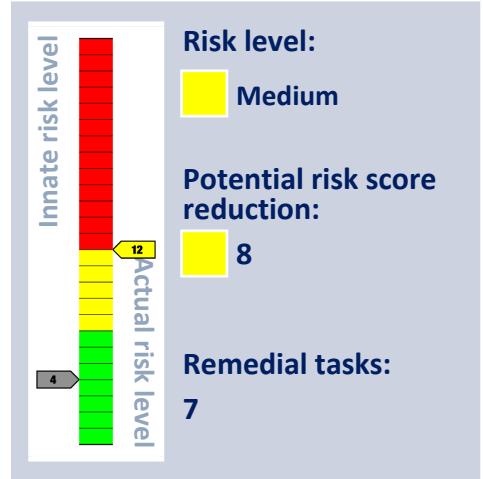
# Swing - Toddler - 1 Bay 2 Seat

Timber is decayed.

Older timbers are soft below wet pour level and can be probed easily in areas, Resistance testing is advised. Monitor and replace accordingly.

Minor rot to support leg x 1, 500 mm up from surface.
