# Oakley Traffic Information Survey

Sponsored by Bakers Recovery

Report number 5  
Survey location - Fox Lane  
August 2019  
Revision number 1

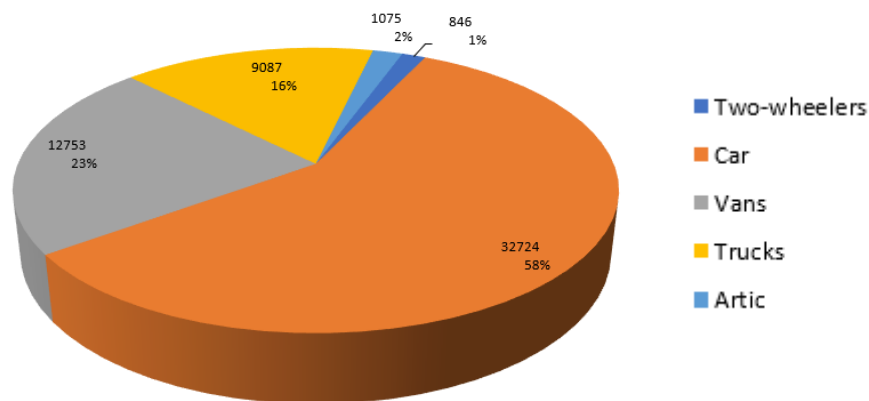
Fox Lane is one of the major routes into and out of the village and is heavily used by all types of traffic but with private cars making up just over 50% of the traffic as shown in figure 1.

Figure 1: typical vehicle distribution by type

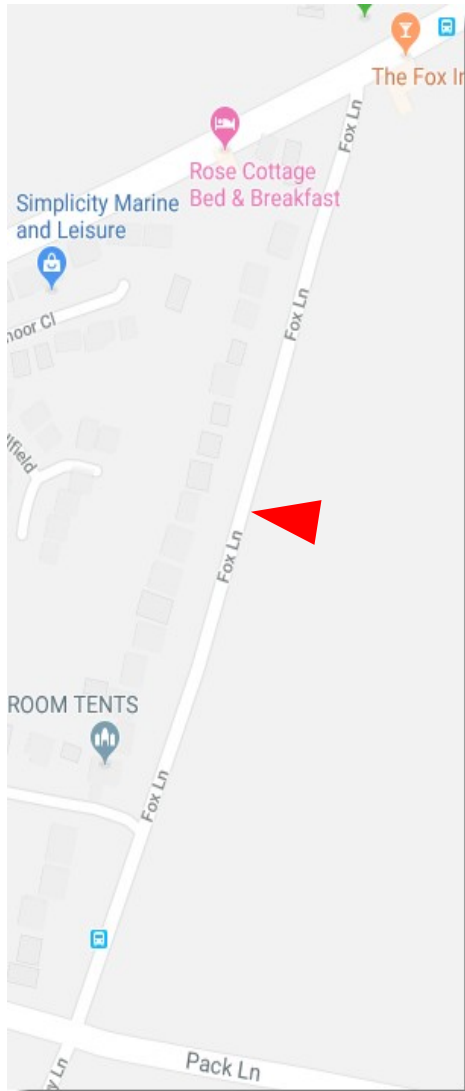
This survey was made using an MSID Counter device, known as OTIS (Oakley Traffic Information Surveyor), mounted on lamp post no 5 (GPS 51° 15.300' N, 001° 10.587' W) in Fox Lane, Oakley.

Figure 3: showing OTIS' position in Fox Lane

Figures 3 and 4 are derived from Google Maps.

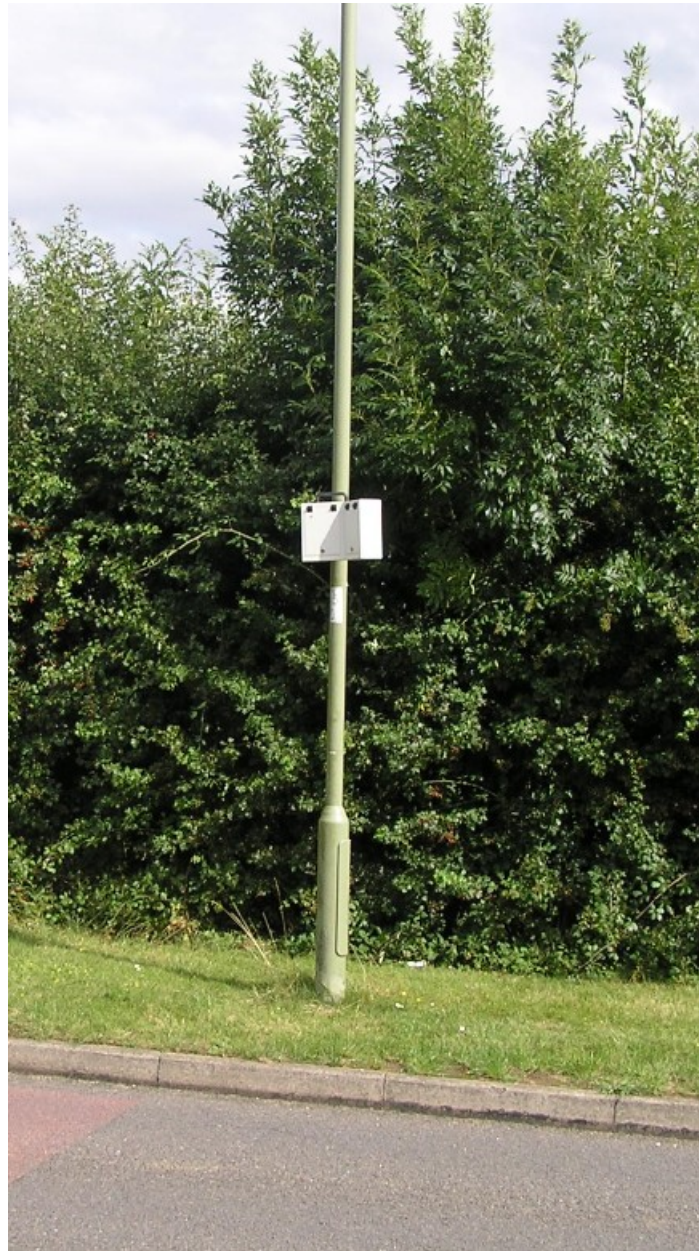
The MSID Counter uses a radar beam to detect and measure the vehicle's speed, length (which is used to determine vehicle type), direction of travel and separation gap between vehicles. A date/time stamp is added to each vehicle record. Every vehicle passing the survey point is recorded.

*Figure 5: OTIS on lamp post no 5 in Fox Lane*
