Oakley Traffic Information Survey

Report number 4
Survey location - The Drive
July 2019
Revision number

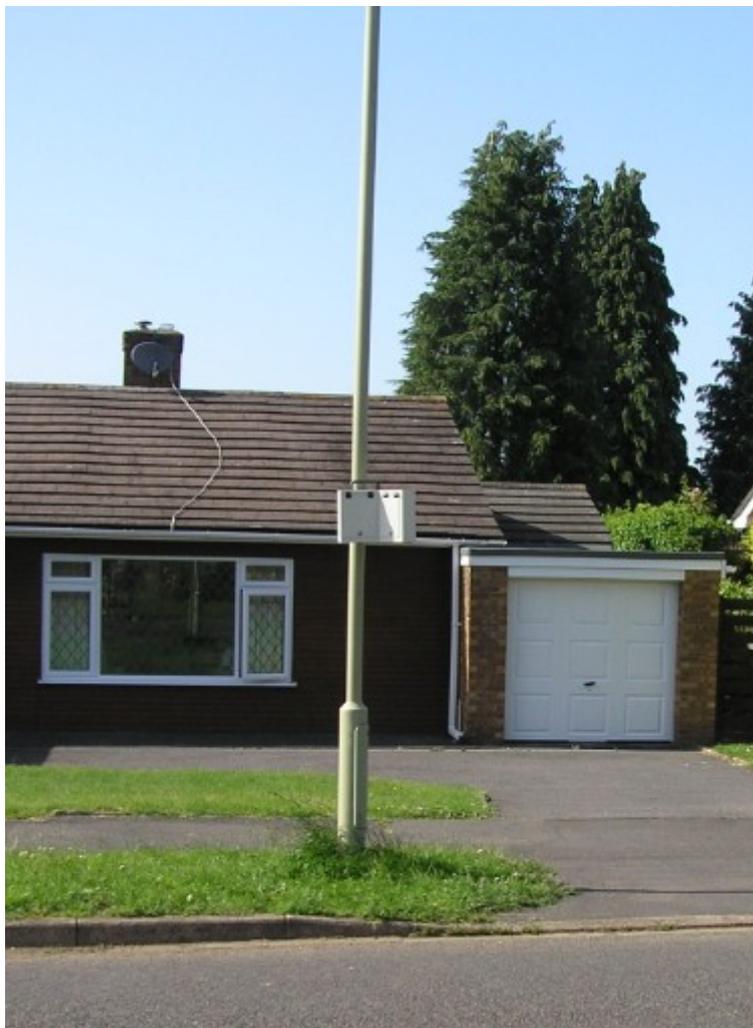
This survey was made using an MSID Counter device, known as OTIS (Oakley Traffic Information Surveyor), mounted on lamp post no 7 (GPS 51°14.634' N, 001° 10.693' W) near the junction of Oak Close and The Drive in Oakley.

Figure 1: showing OTIS on lamp post number xx

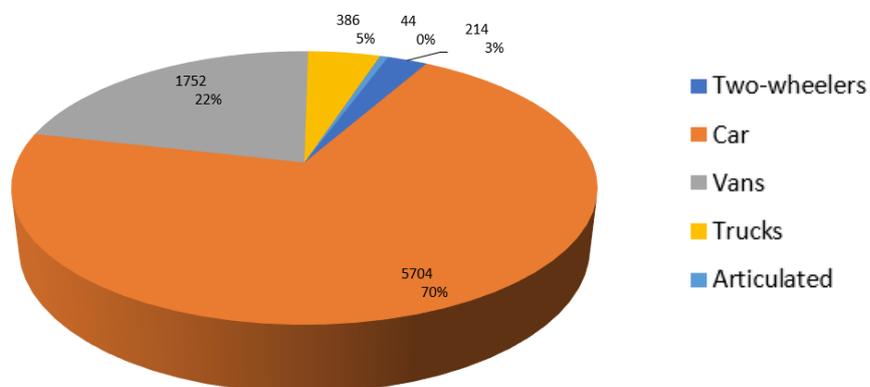
As expected, the majority of the traffic using the drive is cars and vans with a combined total of just over 90% of the traffic as shown in figure 3.

Figure 3: typical vehicle distribution by type
