Elite Playground Inspections

Inspection Report

| Site Name | Cerne Abbas Play Area | |
| Inspection Type | Playground-Operational | |

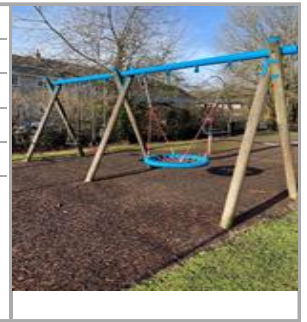
| Asset Name | Basket, Cradle & Flat Seat Swing |

| Finding Title | Item - Loose in Ground | <p>Asset Photo</p> |
| Finding Notes | Swing leg appears to be slightly loose in the ground - monitor condition | |

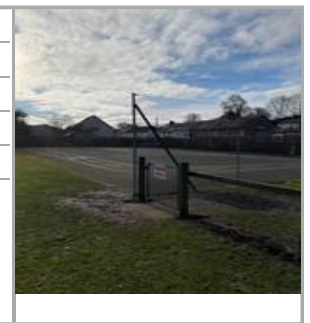
| Asset Name | Outside Area - MUGA |

| Finding Title | Item - Damaged |
| Finding Notes | Net is damaged in places |

| Task Title | Replace item |

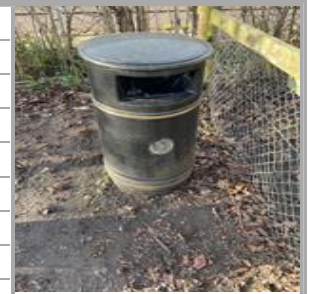
Asset Photo

| Finding Title | Bin - Not locked |
| Finding Notes | Lock bin to help stop contents being emptied out in the play area |

| Task Title | Lock Bin |
