Elite Playground Inspections

Inspection Report

Inspection - Cerne Abbas Play Area - 03/02/2023 14:18:09

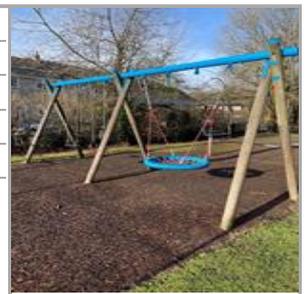
Asset Name	Basket, Cradle & Flat Seat Swing
Asset Sub Type	Type 1 - Traditional (Other)
Asset Type	Swing
Asset Category	Equipment (Outdoor Play)
Manufacturer

Asset	Basket, Cradle & Flat Seat Swing	
Cause	Unknown	
Finding Creation Date	02/02/2022 10:08:29	
Finding Group	Maintenance	
Finding Notes	Swing leg appears to be slightly loose in the ground - monitor condition	
Finding Resolved Date		
Finding Status	Open	
Location		
Resolve By Date		
Risk Level	Low	Asset Photo

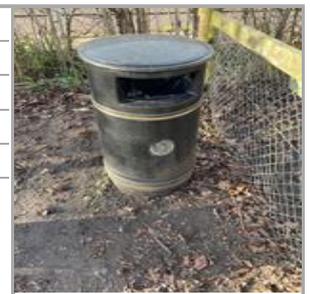
Asset Name	Litter Bin
Asset Sub Type	Bin
Asset Type	Bins
Asset Category	Facilities
Manufacturer

Finding Title	Bin - Not locked
Asset	Litter Bin
Cause	Operator Error
Finding Creation Date	02/02/2022 09:53:57
Finding Group	Maintenance
Finding Notes	Lock bin to help stop contents being emptied out in the play area
Finding Resolved Date	
Finding Status	Open
Location	
Resolve By Date	
Risk Level	Low

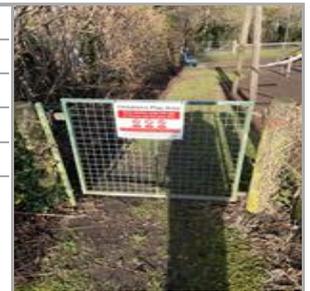
Asset Name	Pedestrian Gates
Asset Sub Type	Pedestrian Gate
Asset Type	Entrance
Asset Category	Perimeter
Manufacturer

Asset	Pedestrian Gates	
Cause	Other - See Finding Notes	
Finding Creation Date	02/02/2022 10:20:19	
Finding Group	Maintenance	
Finding Notes	Gates do not self close. It is recommended that they close between 4-8 seconds	
Finding Resolved Date		
Finding Status	Open	
Location		
Resolve By Date		
Risk Level	Low	Asset Photo
