Milborne St Andrew Conservation Area Appraisal

Edition for public consultation May 2021

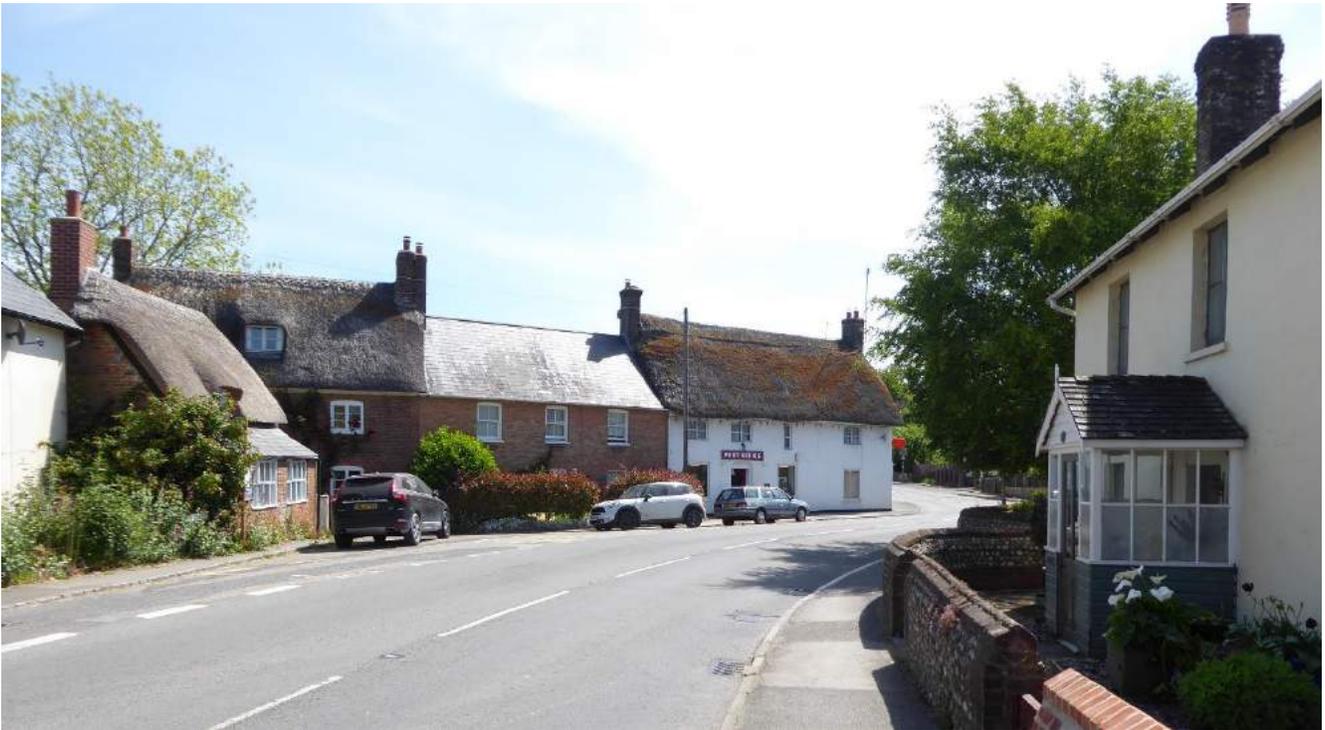
Figure 1: 'The Square' group of buildings

- 5.5 This part of the conservation area has groups of relatively high-density development but with space between. Buildings are generally set to the back of pavement and face onto the street. They are set in groups of two or more houses often linked (such as The Square grouping) (**Figure 1 HSE43**) but with some semi-detached pairs (Nos. 6 and 7 Dorchester Hill) and individual houses (such as the Grade II Listed Heathcote and its separately listed front boundary wall) (**Figure 2 HSE3**). Almost all development is a traditional two storey with only two notable exceptions; Crown House and the recent addition of Nos.1 to 3 Crown Court. Buildings are of a narrow traditional depth with outshuts (pent roofed ground floor extensions) or other extensions to the rear or side which are modest in scale and utilitarian in character. The Royal Oak Public House (**Figure 3 HSE4**) is notable for its local landmark qualities as a former coaching inn which has the survival of a projecting bay at ground floor for travellers from which to view the approaching coaches. There is also the characteristic fireplace by the entrance for the convenience of the coachmen. Of further note is the presence of a painted plaster stag (**Figure 4 HSE16**). The stag is thought to have been given to a previous owner of the house, a Mr Cole, by a recently elected MP, Earl Drax with gratitude for aiding his election to the Houses of Parliament¹.

- 5.6 There are some very strongly defined groups of buildings to this part of the conservation area emphasised by the strong building line and linking of varied buildings forming rows (rather than uniform terraces). The well-defined group to The Square (as named in examples of historic postcards from the late 19th/early 20th century) (**Figure 5** – historic postcard) is a good example of this varied character but consistent form, scale and orientation (**Figure 6 HSE22**). There is a further, more loosely defined group but nonetheless of high architectural and historic significance to Blandford Hill where traditional form and the back of pavement building line are very apparent. Where buildings are set slightly back from the roadside or offset from the road, boundary walls often continue the strongly defined building line.

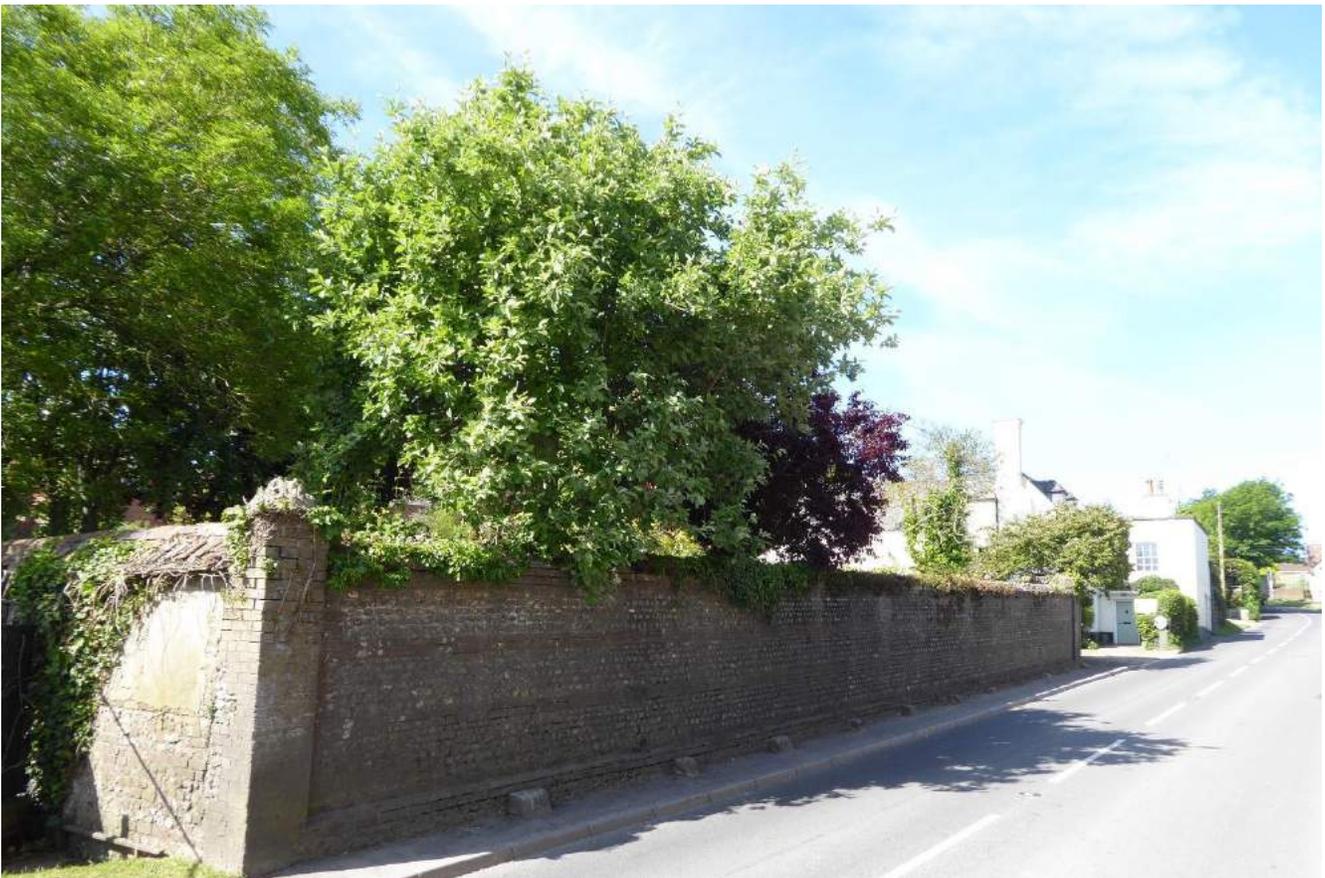
Figure 2: Grade II Listed boundary wall to Heathcote, Dorchester Hill

- 5.7 For walls, there is a mix of exposed brick which is generally of a deep red/orange colour and in Flemish bond (sometimes with flared or vitrified headers) and painted render. This is sometimes over brick and sometimes over cob. Roofs are a mix of thatch (generally wheat straw – combed wheat reed) and natural slate, with some clay tile though this is not predominant in this part of the conservation area. Thatch roofs have a mix of raised and flush block cut ridges but they are generally plain with cross liggers (an appropriate traditional finish). Boundary walls are brick and flint; generally flint with brick dressings with the notable use brick and flint banding to the Grade II listed boundary wall to Heathcote (**see figure 2**).

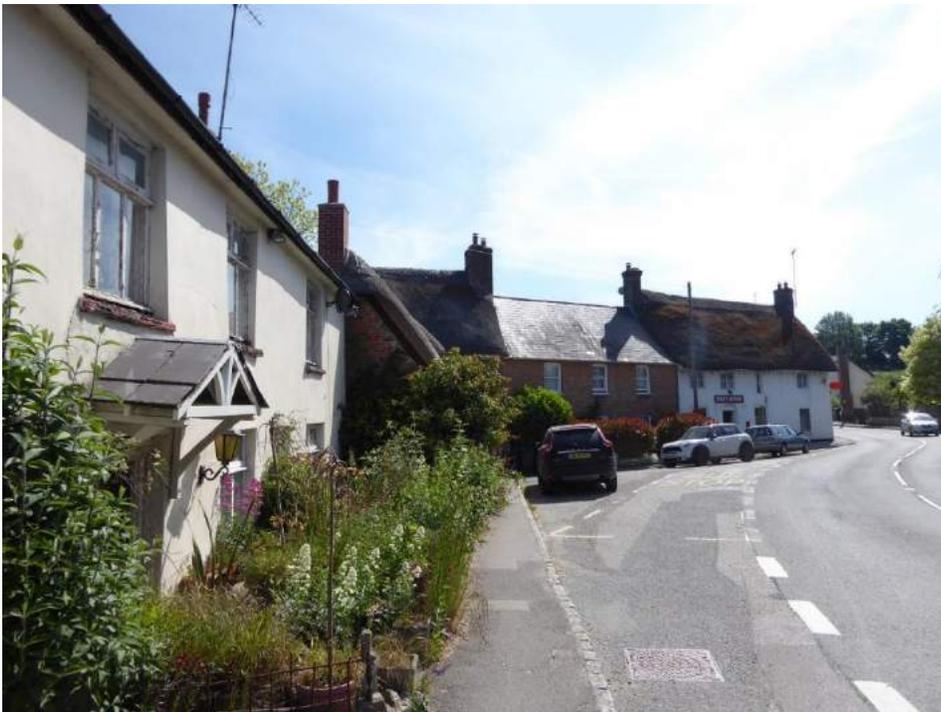
Figure 6: The well-defined group to The Square (as named in examples of historic postcards from the late 19th/early 20th century – see Figure 5)

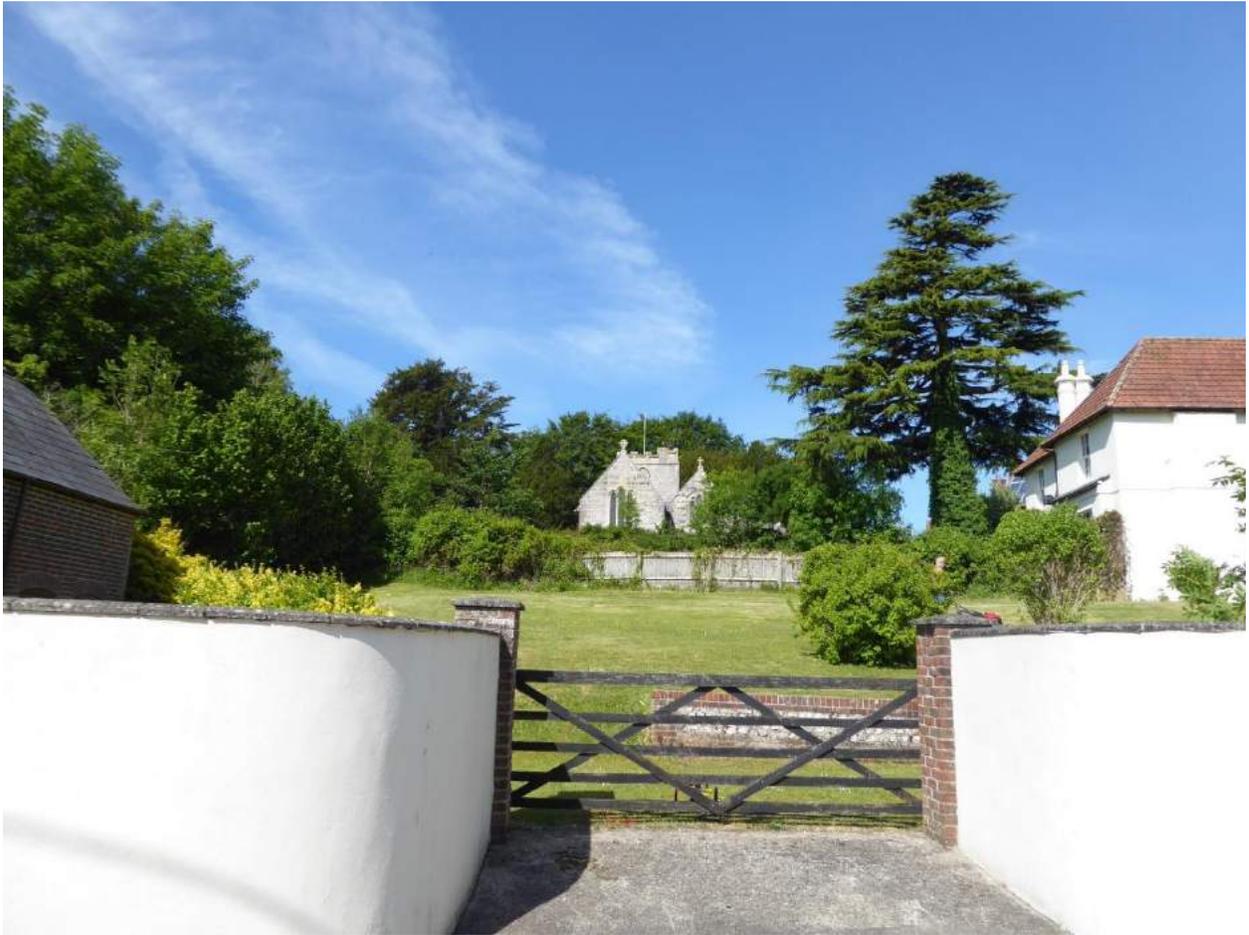
Figure 10: The Old Rectory - view from Chapel Street west up to St Andrew's Church

from Chapel Street west up to the east elevation of the Grade II* listed St Andrew's Church (Figure 10 CC4).

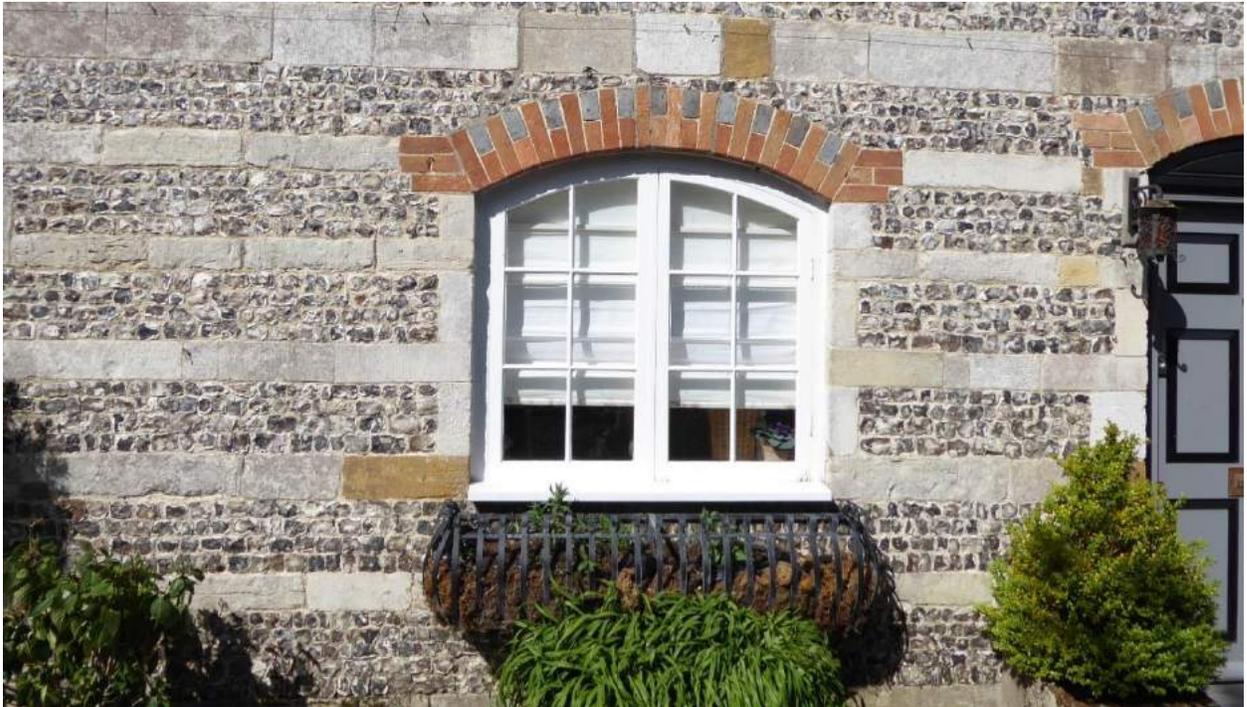
Figure 11: Flint with stone ashlar and brick dressings (Home Farm House)

5.12 There is some variation to materials with the unifying material being flint. Flint is seen with brick and (unusually for this conservation area) stone ashlar (Home Farm House) (Figure 11 CC17). The latter is alleged to have been built using demolished material from the former Milton House (RCHME). Brick is often seen for window and door dressings and is seen decoratively to the polychromatic brickwork of the windows to the former non-conformist (Weslyan) chapel. Elsewhere, there is rendered cob. Roofs are generally more varied to this part of the conservation area with some use of the clay tile (but generally to 20th century buildings), some combed wheat reed thatch and natural slate. There is also the limited but attractive use of Bridgewater pantiles (Figure 12 CC48).

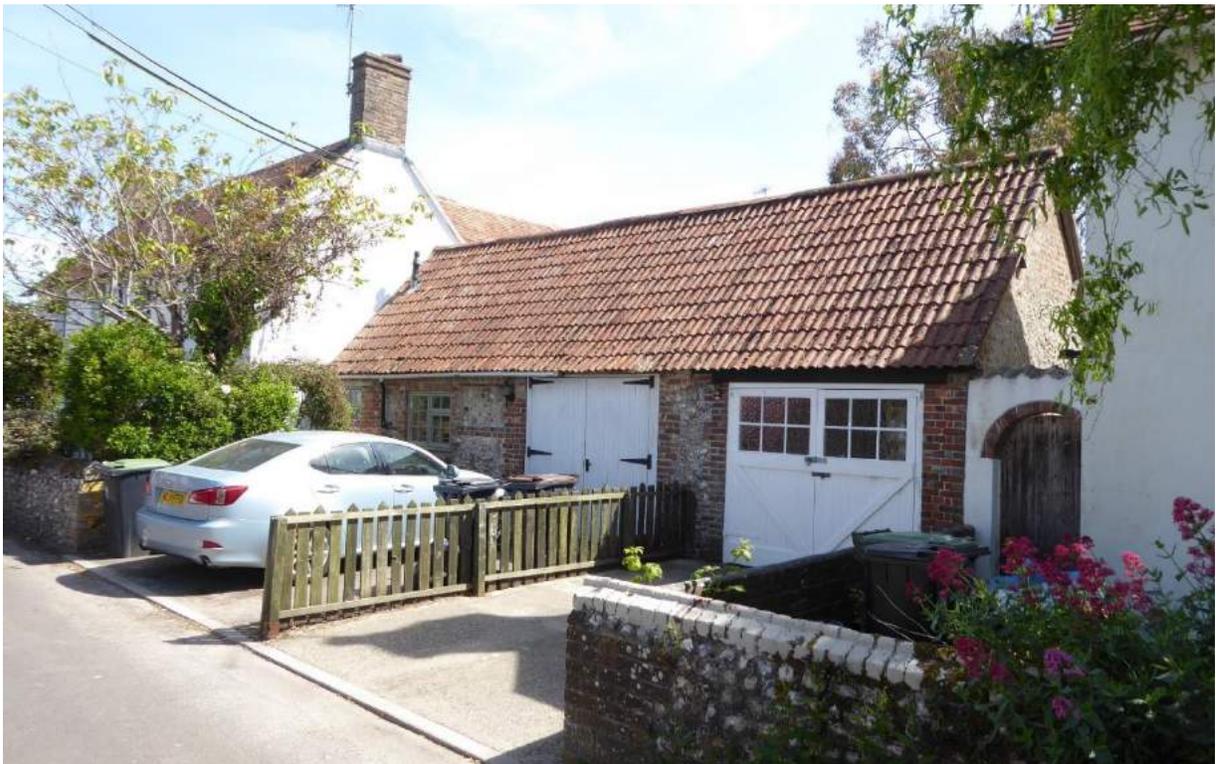
Figure 12: Bridgewater pantile, outbuildings to Chapel Street

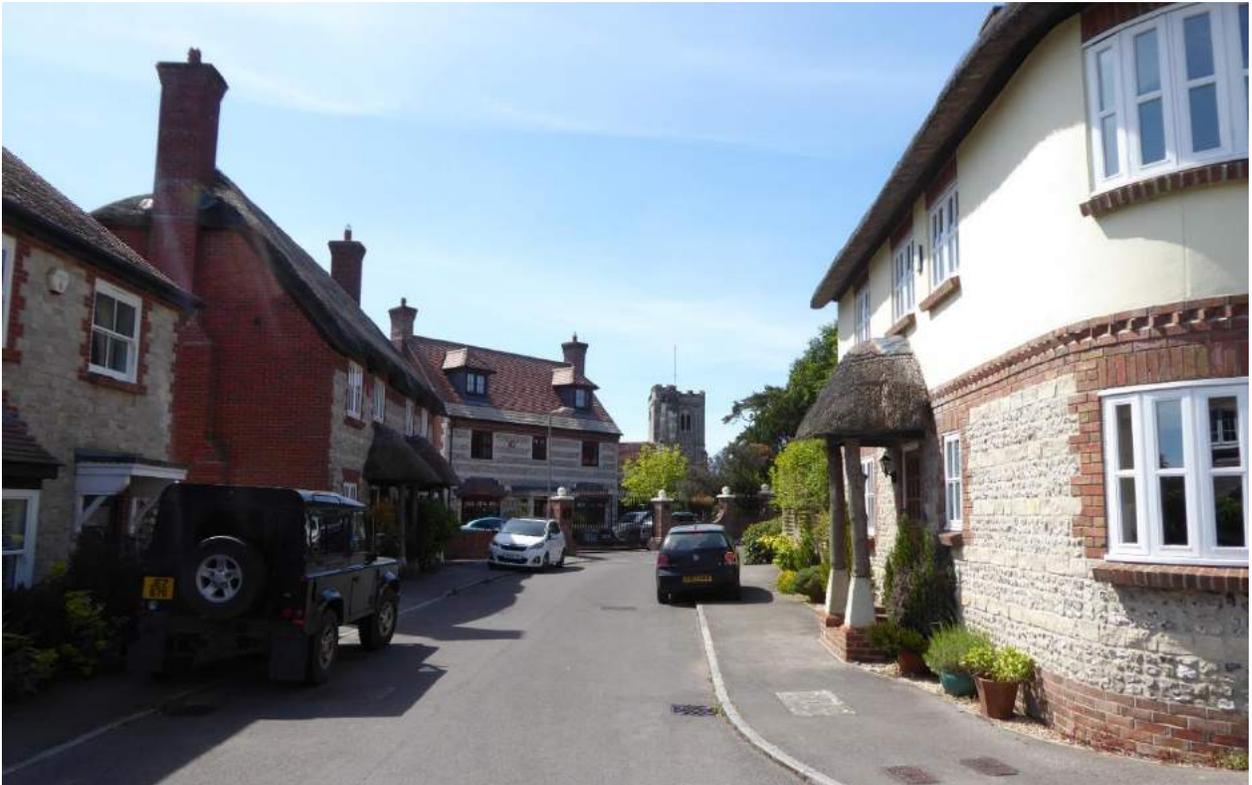
Figure 15: View to St Andrew's church (St Andrew's View)

- 5.17 To St Andrew's View the houses have taken on a 'traditional' character and have been set almost to back of pavement which has created some interesting townscape and juxtaposition of built form and has introduced, enclosed and defined a new view to the church tower to the south. There are no distinctive groups but there has been some attempt at the grouping of houses to accentuate corners and views to the church (**Figure 15 SAV4**).

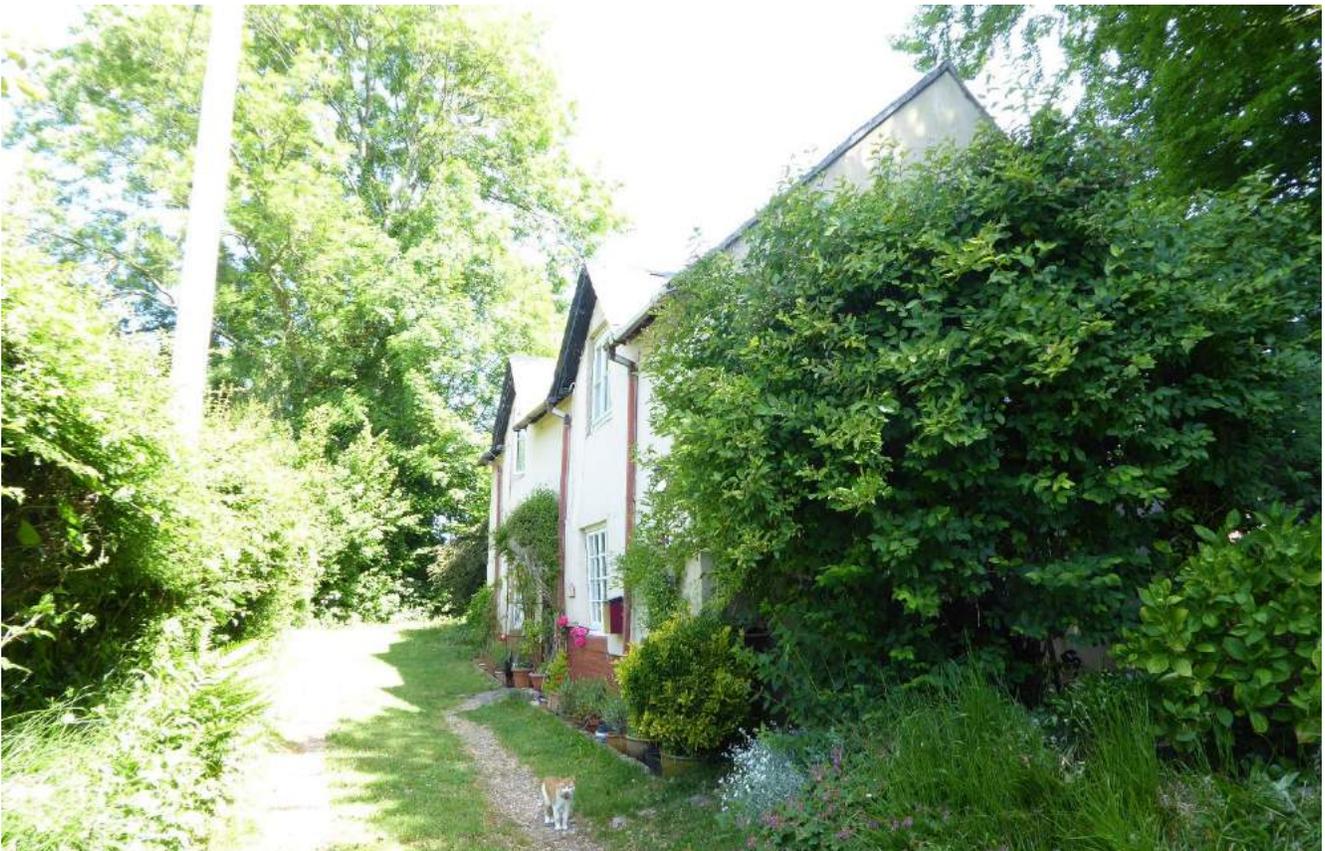
Figure 17: Church Hill Cottage which fronts onto a public footpath to the west of the church

- 5.21 Apart from the church there are only two further buildings to this part of the conservation area. These are both attractive, modest-scaled 19th century cottages; The Grove which sits to the south of the church almost to the prow of the hillside (**Figure 16 VI44**) and Church Hill Cottage which fronts onto a public footpath to the west of the church (**Figure 17 SAV1**).

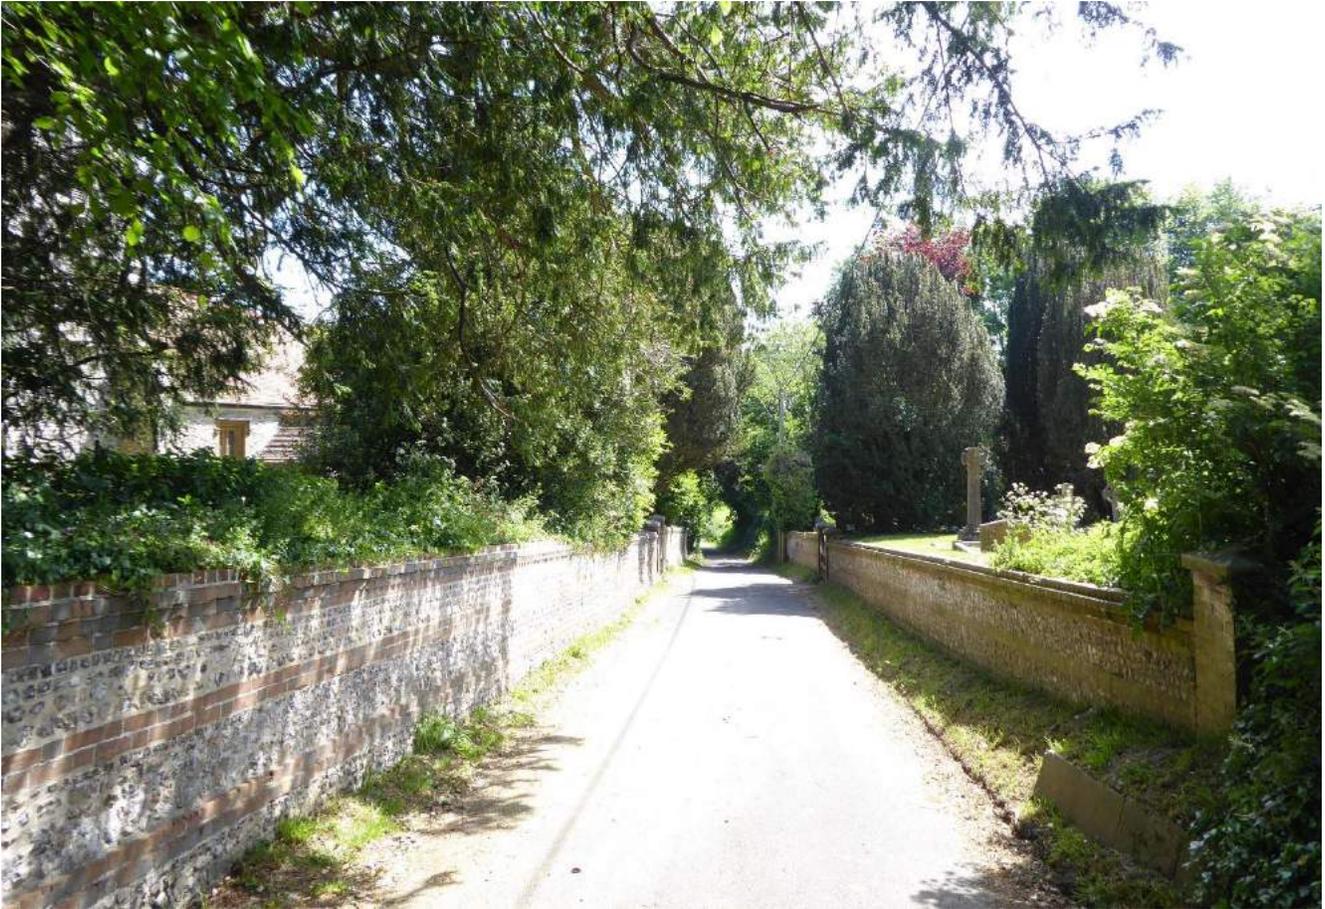
Figure 18: Walls to church and churchyard to the south form an important enclosure to the lane-side

- 5.23 Built form comprises the church itself, of rubble stone and flint with Ham stone windows and dressings and plain clay tile roof, sitting set back and up from the lane side with banded brick and flint retaining walls with a dentil course of brick to the coping to both sides of the lane. These walls to church and churchyard to the south form an important enclosure to the lane-side and attractive setting to the church and churchyard (**Figure 18 GCE41**). The Grove cottage can be glimpsed from the lane and comprises render walls (or cob or brick) and a low pitched hipped natural slate roof.

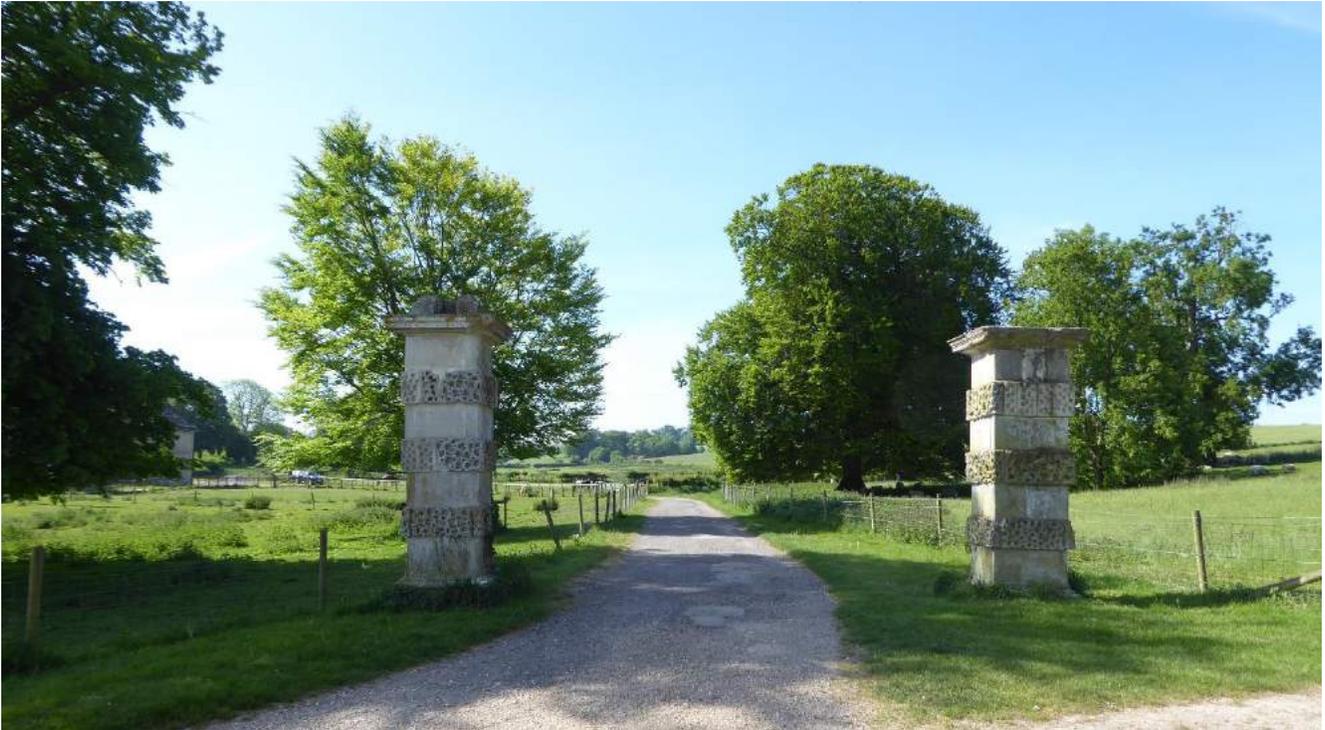
Figure 19: The Grade II listed gate piers, The Grove

5.24 An unusual feature, but notable local landmark, within the character area are 17th century (Grade II listed) stone gate piers (rusticated stone with moulded caps but missing their finials and armorial trophies²) to the former Milborne House (demolished and replaced by Milborne Manor Farm House). The gate piers sit somewhat isolated from other built or landscape features but are nonetheless a poignant and important reminder of the former grandeur of the Morton-Pleydell estate (**Figure 19 GCE4**).

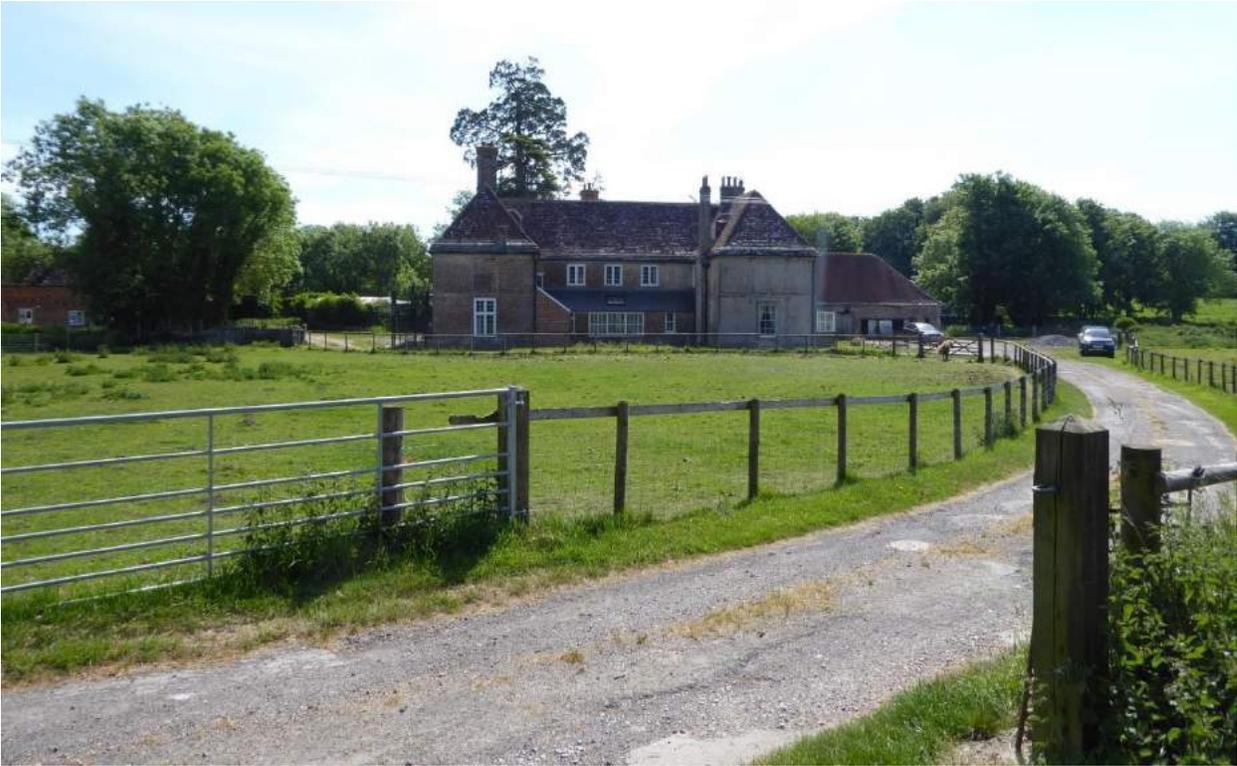
Figure 20: Manor Farm House

- 5.27 Manor Farm House is on the grander scale of a higher status farm house and appears to, at least in part have accommodation in the attic storey (**Figure 20 GCE17**). Large, substantial brick chimneys accentuate the height and scale of this building especially in extended and multiple views from the west. The farm house appears to be orientated to the south with its most formal and composed elevation facing out south to the open countryside. The farm buildings are set out in a large courtyard group and are essentially inward-looking. They are 1.5 to 2 storeys in height and have the traditional 19th century massing produced by a broader plan and relatively low pitched natural slate roofs but are nonetheless in scale with the spaces which they are enclosing.

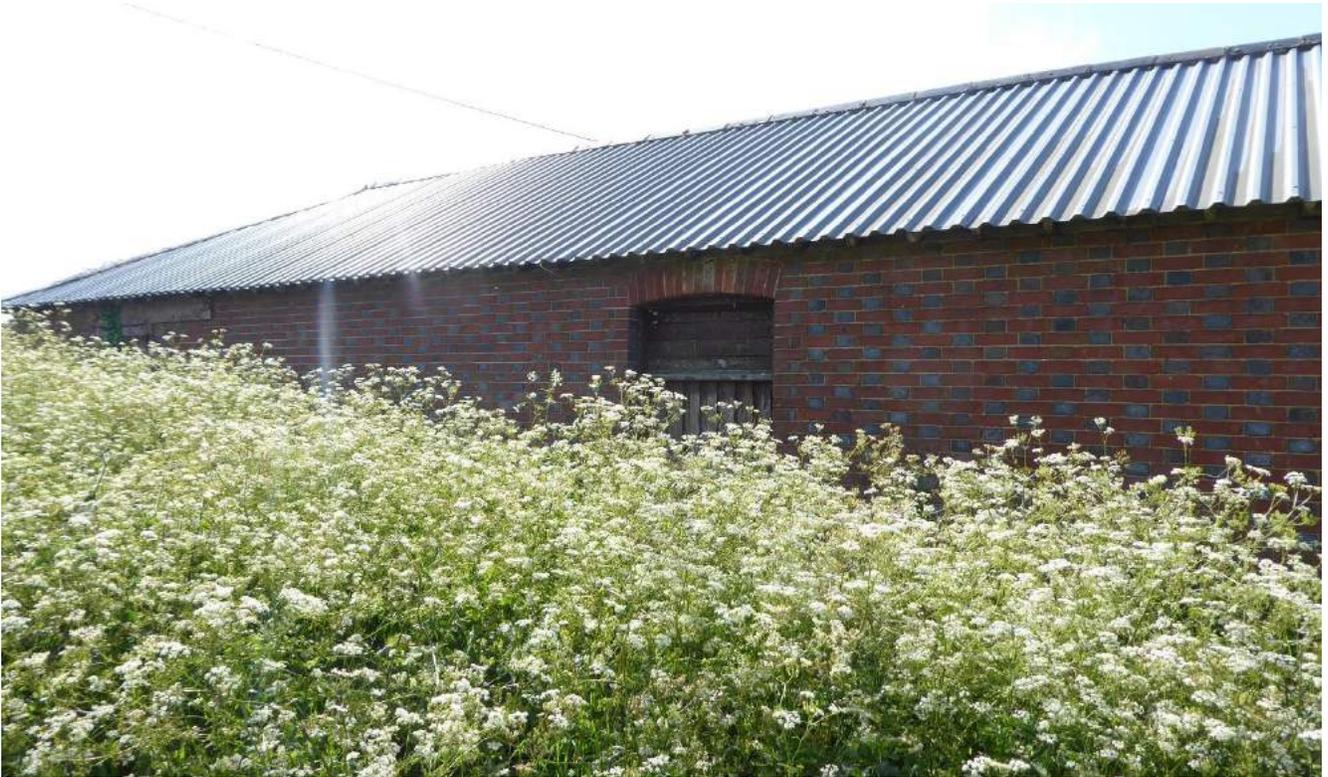
Figure 22: Manor Farm - Flemish bond with headers brought out in grey

5.29 To this part of the conservation area, brick is seen in Flemish bond with headers brought out in grey (**Figure 22 MHF1**). It is also seen with flint in bands to some of the farm buildings. Some of the brick to Manor Farm House has been rendered. There is some cob to buildings to the farm group. The farm group is exclusively natural slate roofs. The Manor Farm House has a prominent clay tile roof with Purbeck stone slips to the eaves. Similarly, its barn to the south has a clay tile roof with stone slates to the eaves. The use of red brick in traditional bonds (English and Flemish) is a unifying characteristic of the character area, seen as it is to the surviving sections of kitchen garden wall (**Figure 23 MHF37**) between farm house and farm group.

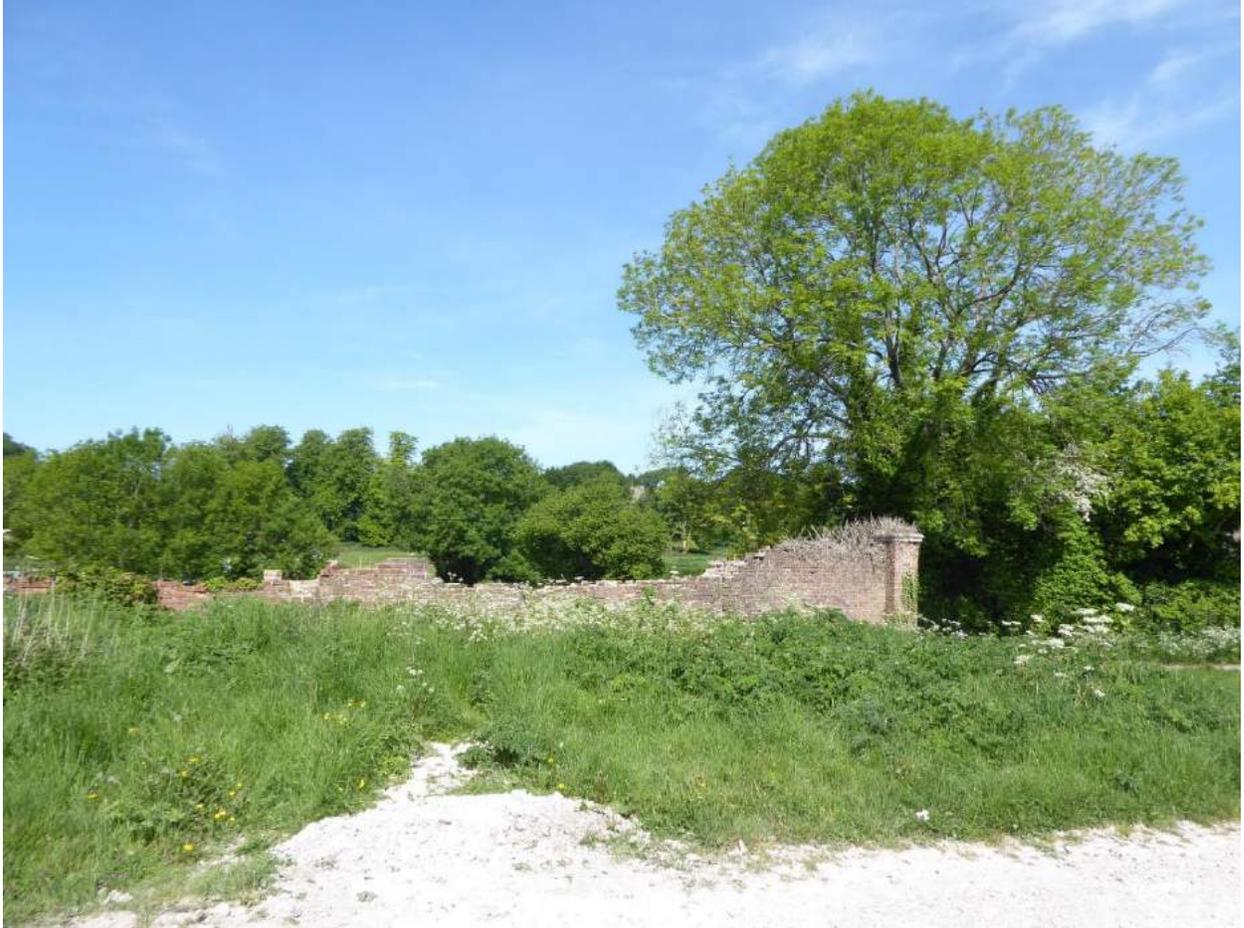
Figure 23: Surviving sections of kitchen garden wall

The wall to the former kitchen garden of the Manor Farm House group is curtilage listed by virtue of its historic relationship with the Grade II listed Manor Farm House. The wall is in a very poor state of repair and is partially collapsed in places. A section to the north-east

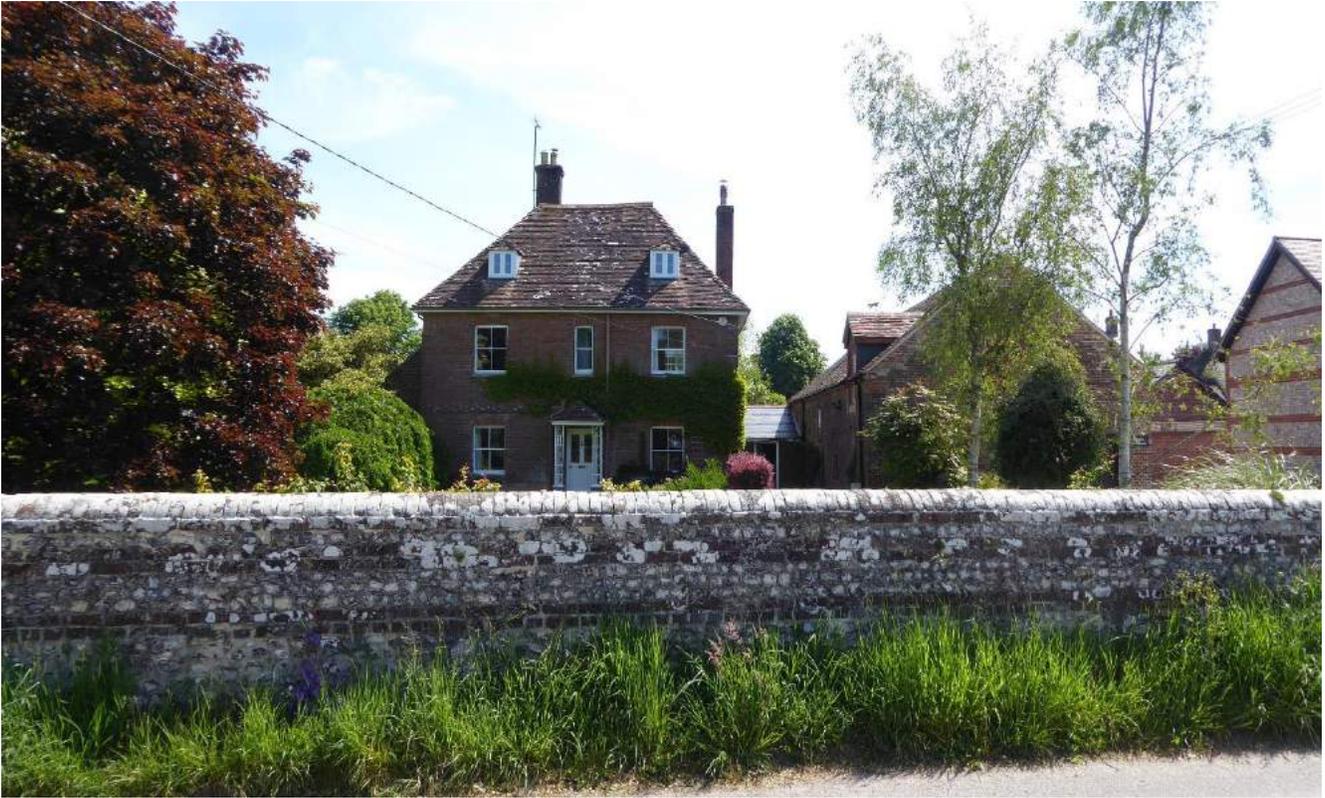
Figure 24: Gould's Farm house and its barn

- 5.32 Buildings are at a relatively low density in relation to the conservation area with most buildings semi-detached or detached and set on their own plot. Buildings generally face the street although perhaps more than anywhere else in the conservation area some residential buildings are side on or even back on to the roadside. Buildings are generally 1.5 to 2 storey with the exception being the grandly scaled Gould's farm with its steeply pitched clay tile roof with dormer windows. Gould's Farm house and its barn form a particularly attractive historic group in the street scene (**Figure 24 LE25**).

- 5.34 Gould's Farm, its outbuildings and its brick and flint boundary wall make a group of considerable architectural and historic quality. The new development to the south has attempted to pick some key features from the farm buildings to its north and the residential buildings to its south and could be good additions to the conservation area (once work is completed). There is a loose grouping of Little England Cottage (Grade II), No.31, Byways and Barton Hill Cottage and Saddlers Thatch (Grade II) perhaps best appreciated on approach from the east where these buildings are seen to define this historic grouping and put them in the context of the core of the village beyond by way of views towards the church and the old Rectory.

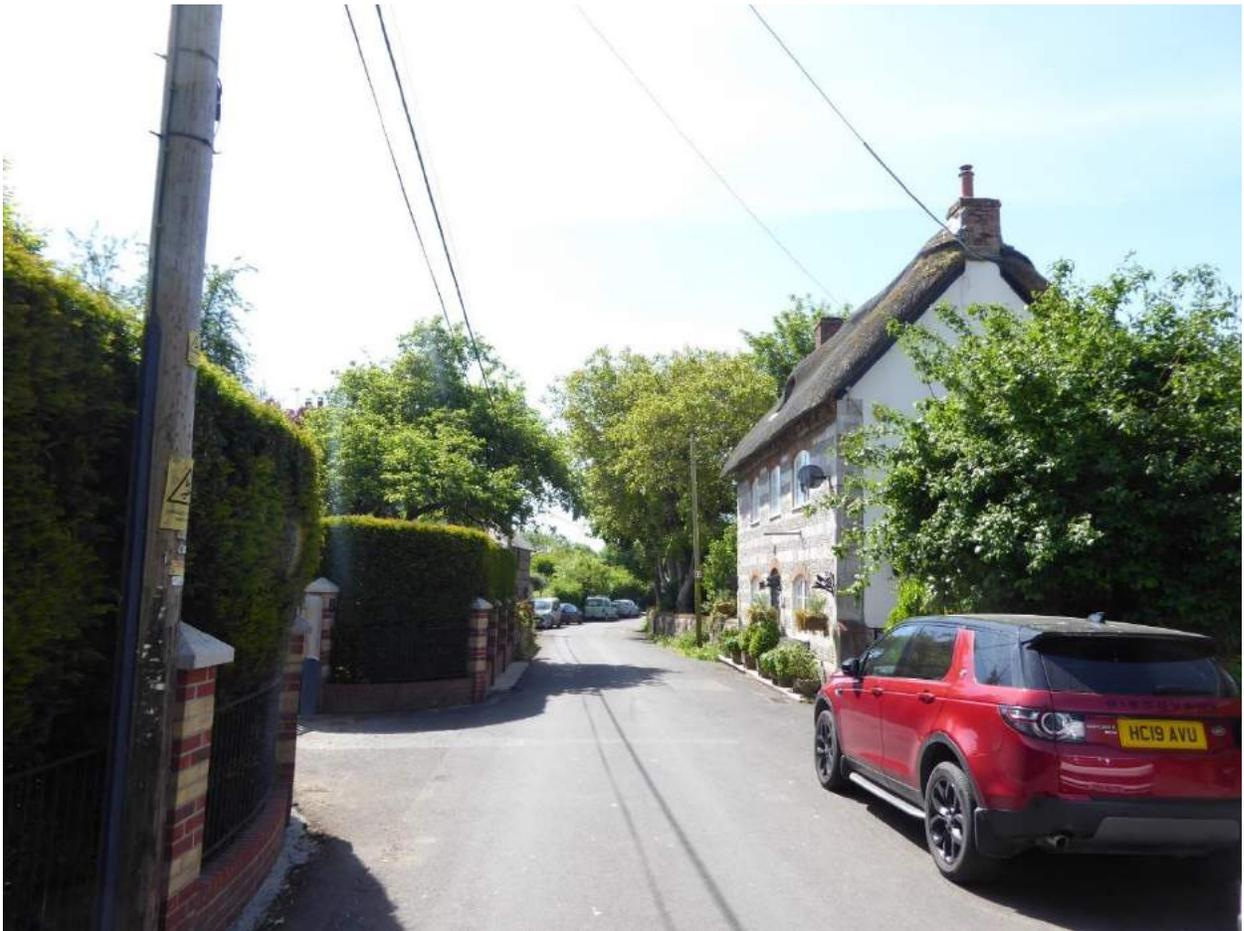
Figure 26: The use of stone ashlar to Home Farm House

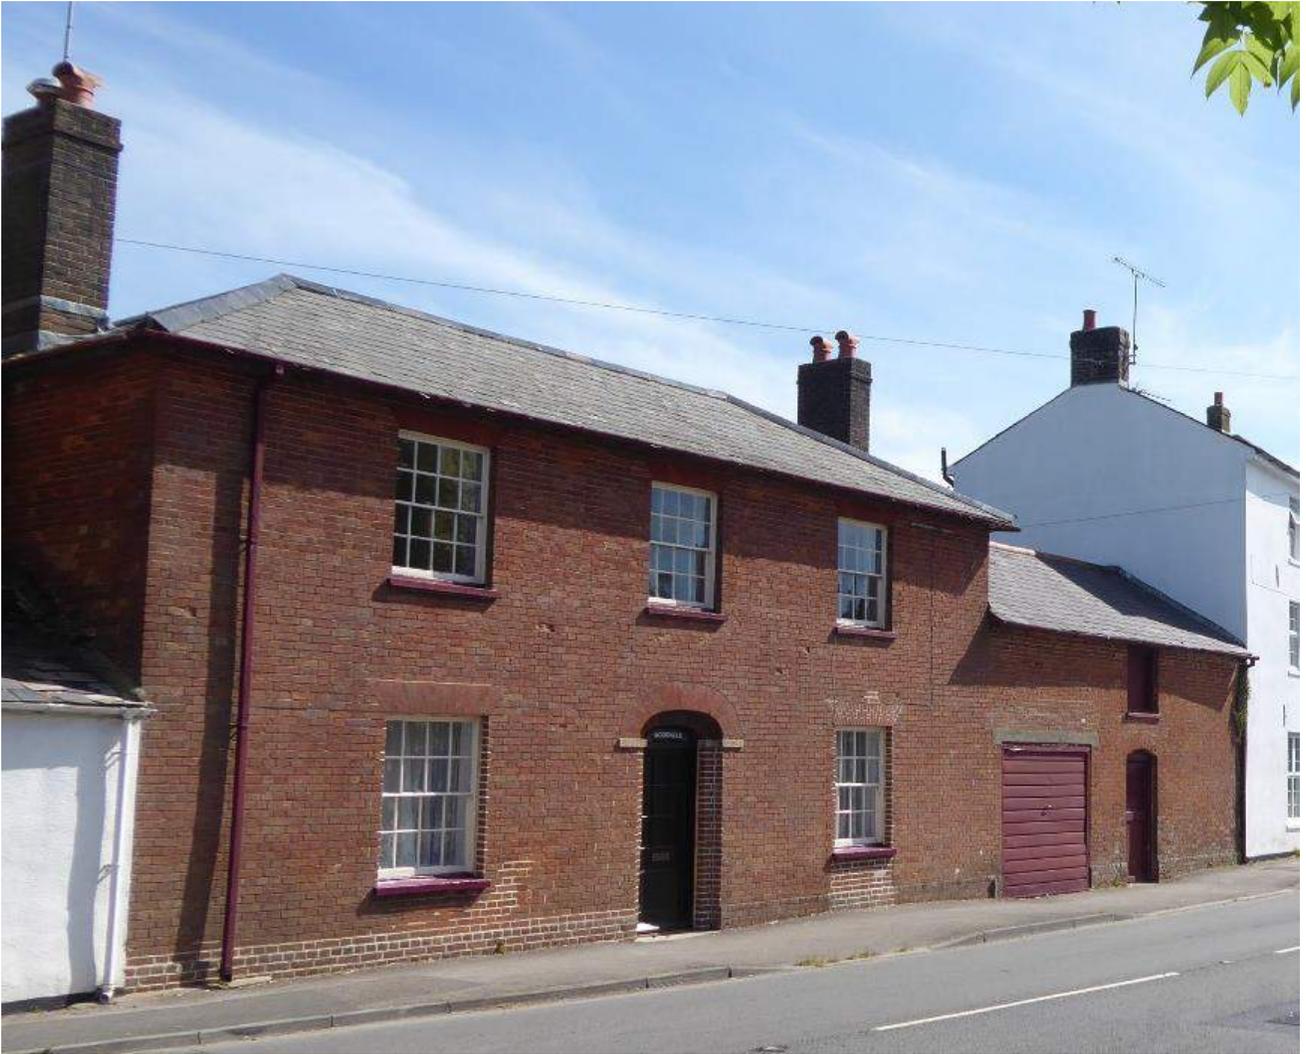
Figure 27: The use of segmental arches or flat gauged arches

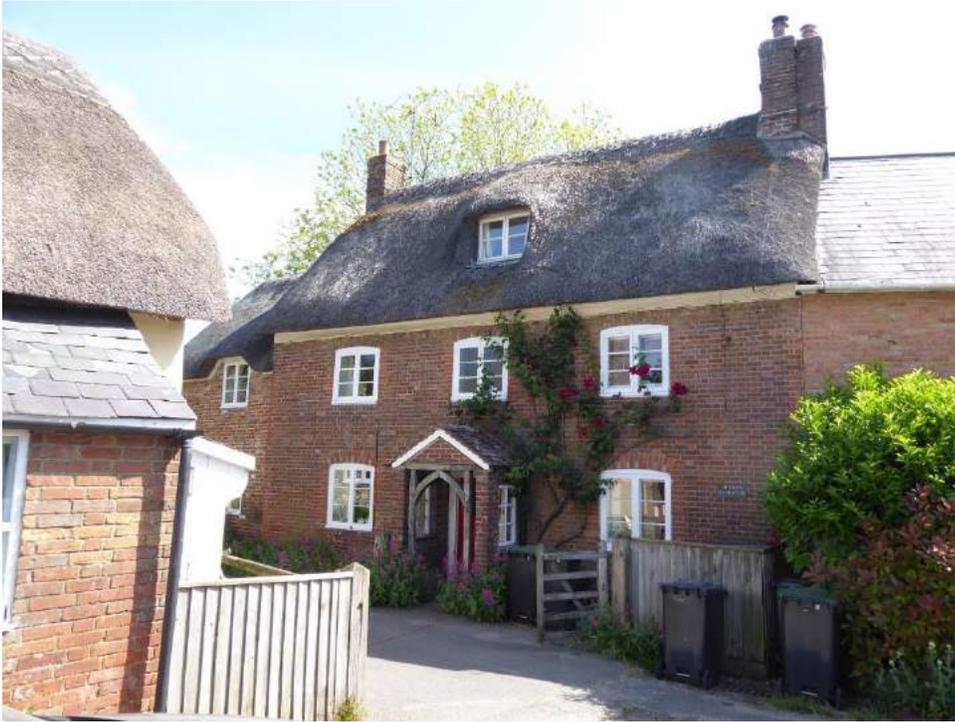
Figure 28: Casement windows of painted timber generally seen to more vernacular buildings

- 6.14 What would be considered more vernacular houses and cottage-scale houses generally have side hung timber casements; painted (usually white) and also set back with rebates into the wall face providing some animation and articulation to the façade (**Figure 36 HSE26**). There is some cross-over between the two groups but generally this is typical throughout the conservation area.

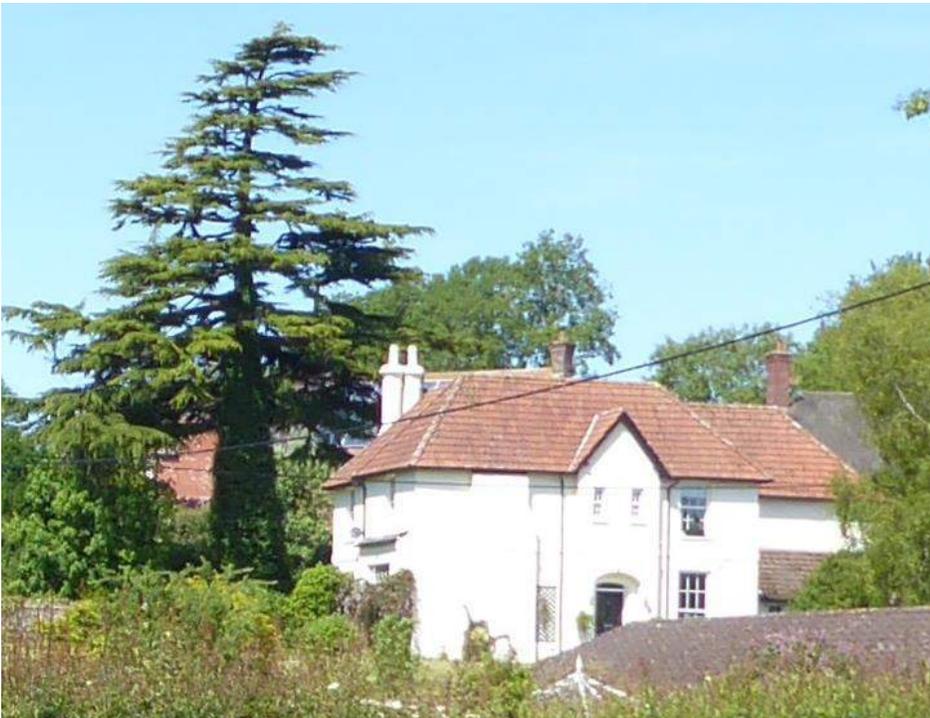
Figure 29: The (former) Rectory of a loose Tudor-Gothic style

- 6.1 The architectural style for Milborne St Andrew is generally of a local vernacular character despite aspirations for polite compositions with sash windows and some symmetry employed in the formation of principal facades (for example Manor Farm House and Gould's Farm). The aspirational features of the higher status houses might include the presence of stone (**Figure 26 CC46**) and the use of segmental arches or flat gauged arches (**Figure 27 HSE30**) for window heads. The larger, higher status houses generally use painted timber vertical sliding sashes (see **Figure 27**) and the more modest cottage scale houses are generally casement windows of painted timber (**Figure 28 HSE23**).
- 6.2 There are few pretensions to an architectural style with the (former) Rectory of a loose Tudor-Gothic style (but with much changes) (**Figure 29 LE23 -cropped**) being perhaps the

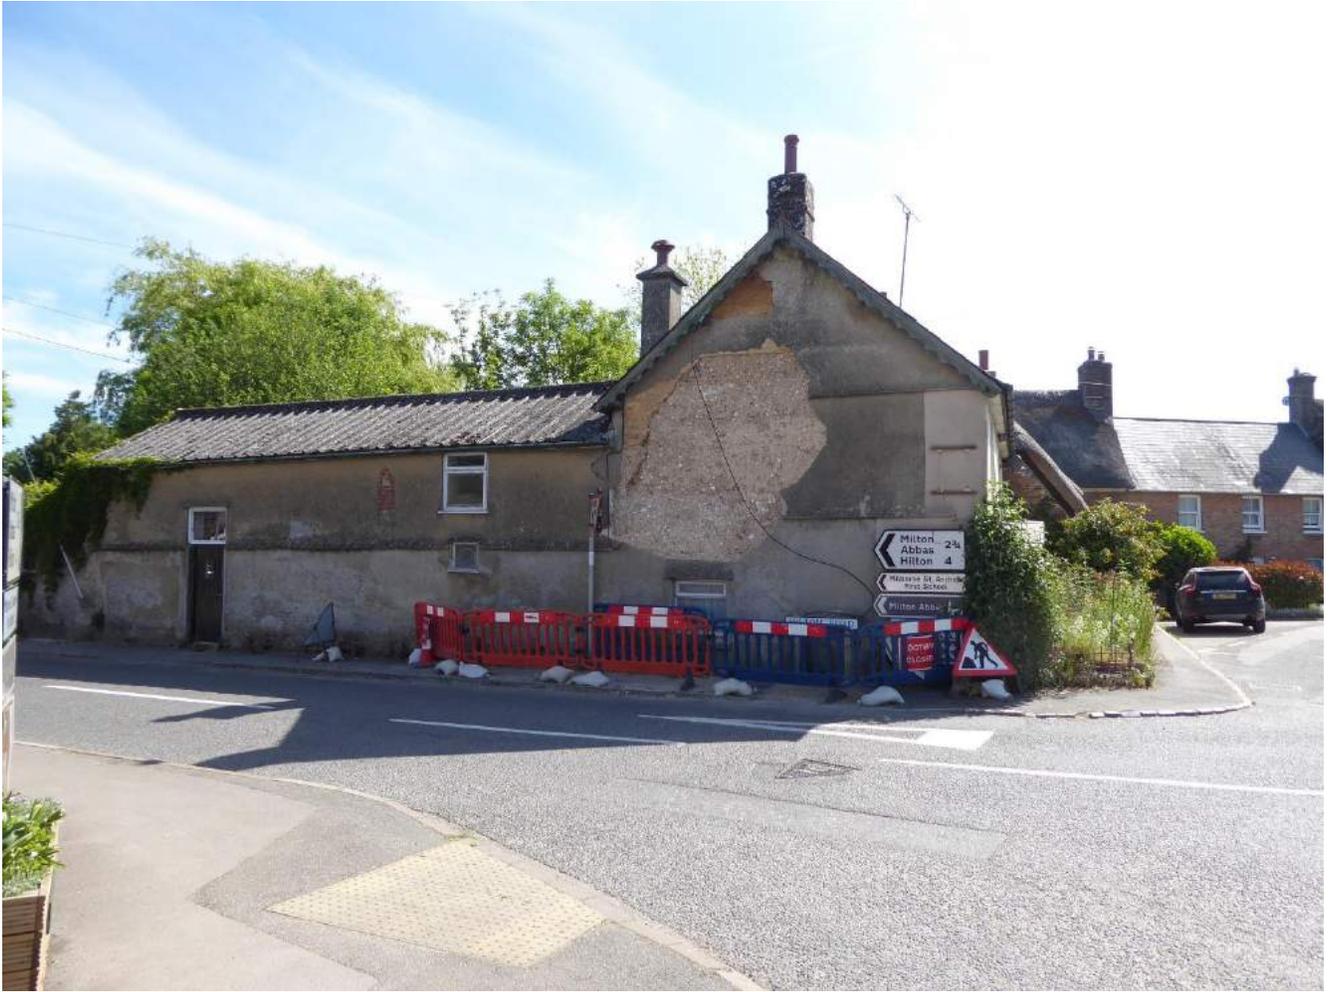
Figure 30: Decorative bargeboards to The Corner House, The Square

- 6.3 Residential houses generally present along the street frontage with ridges running parallel to the street and generally gabled roofs. There are some hipped roof examples but most are simple gables, sometimes with a plain narrow barge board (although there are some notable examples of decorative bargeboards – for example The Corner House, The Square) **(Figure 30 HSE17)** or occasionally exposed purlin ends.
- 6.4 Where dormer windows are found in traditional roofs they are generally small in comparison to the scale of the roof and set within the roof rather than to the eaves or forming part of the eaves line.
