Milborne St Andrew Conservation Area Appraisal

Edition for public consultation May 2021

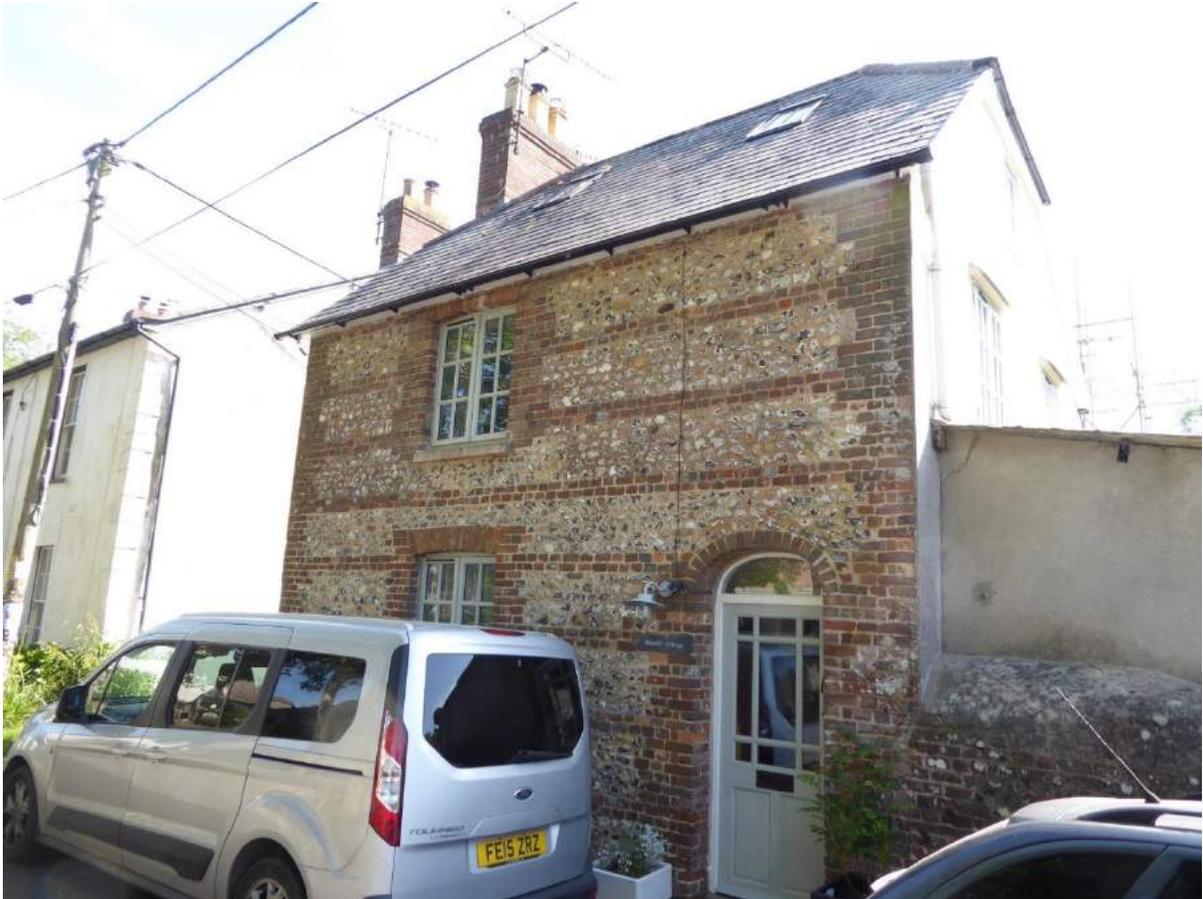
Figure 31: The use of flint and brick banding to walls

- 6.5 The most prevalent walling type to houses, agricultural buildings, but predominantly to boundary walls is the use of flint and brick banding (**Figure 31 CC10**). This tends to be approximately three or four courses of a deep red/orange brick to the equivalent in knapped flints. The flint work is generally coursed rather than laid randomly with the flint being the dominant material rather than the mortar joints.

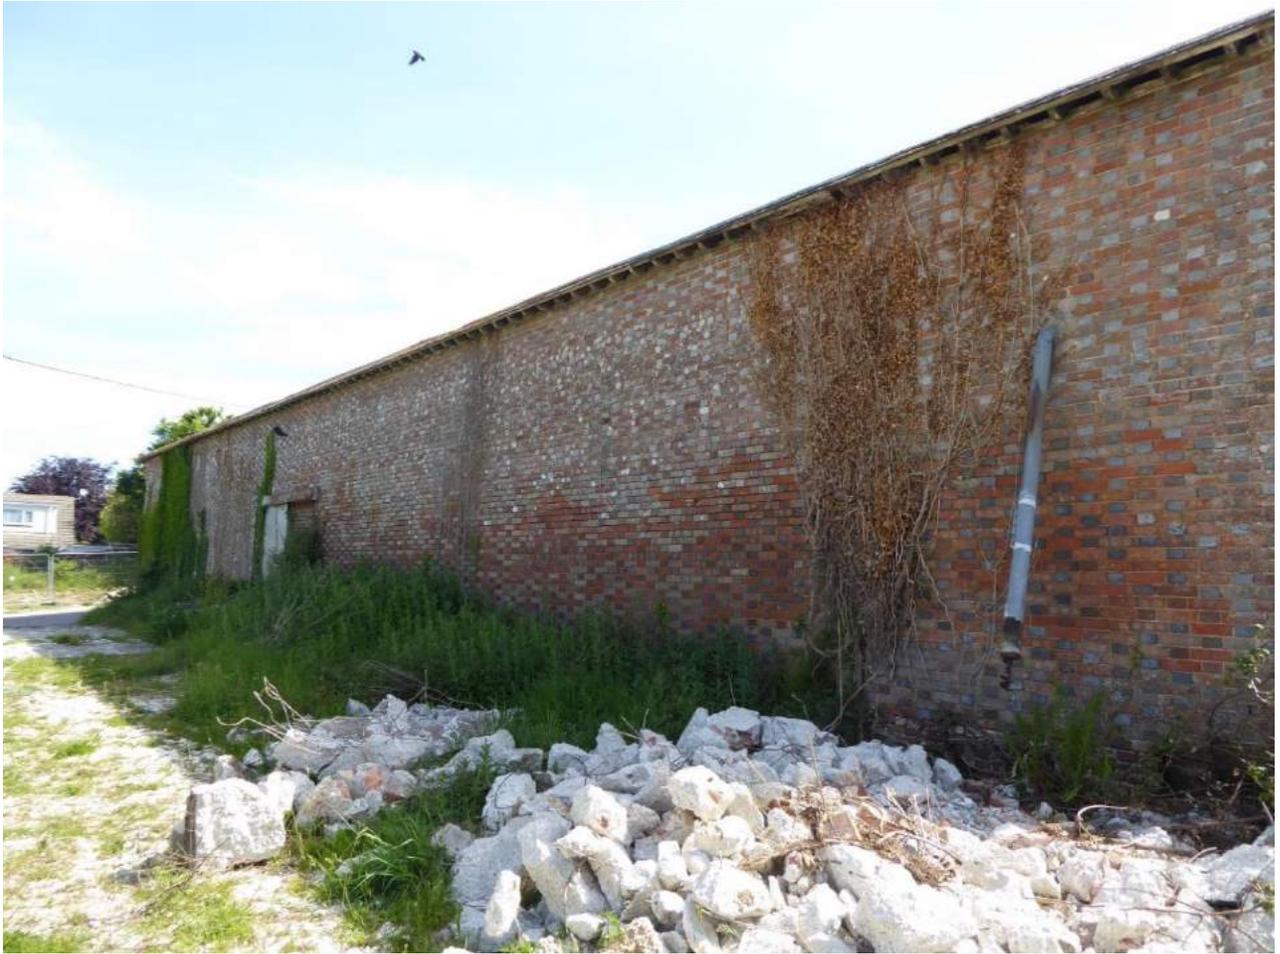
Figure 32: Flared headers used in Flemish bond to Manor Farm group

- 6.6 To higher status buildings (such as the Manor Farm House, Gould's Farm and Home Farm House) stone (ashlar) and flint (again in banding) and/or just red brick in Flemish bond or English bond (the latter is relatively rare) is seen. When brick is used it is often accentuated in its Flemish bond by the use of grey (sometimes also referred to flared, vitrified or burnt) headers in the bond making for a very attractive bonding pattern and commonly used through the 18th and into the early 19th century. Good examples of this are seen to the farm buildings of Manor Farm (**Figure 32 MHF36**).

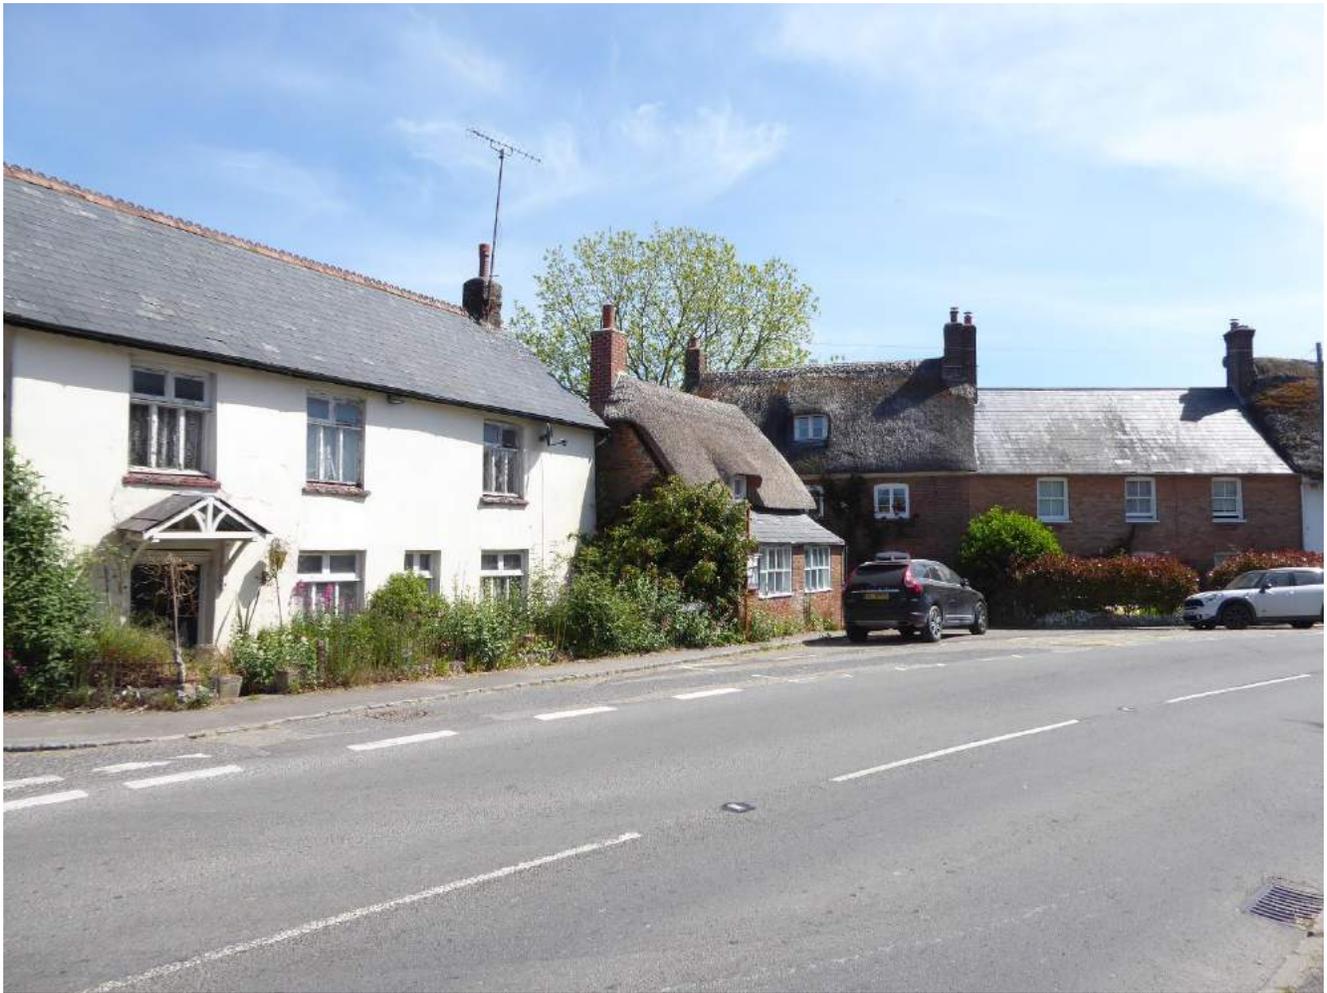
Figure 34: Survival of a once prevalent thatching tradition (The Square)

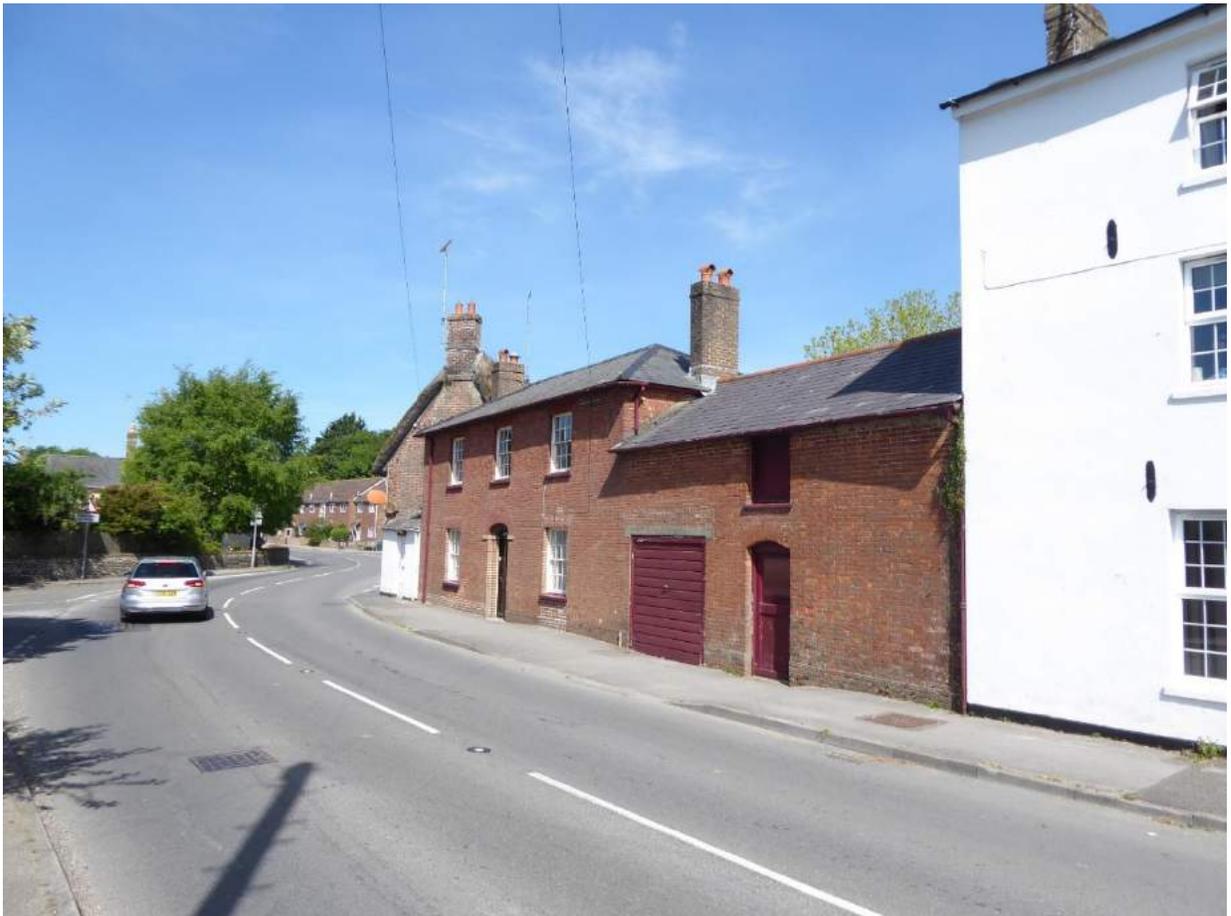
Figure 35: Vertical sliding sash windows to Woodville

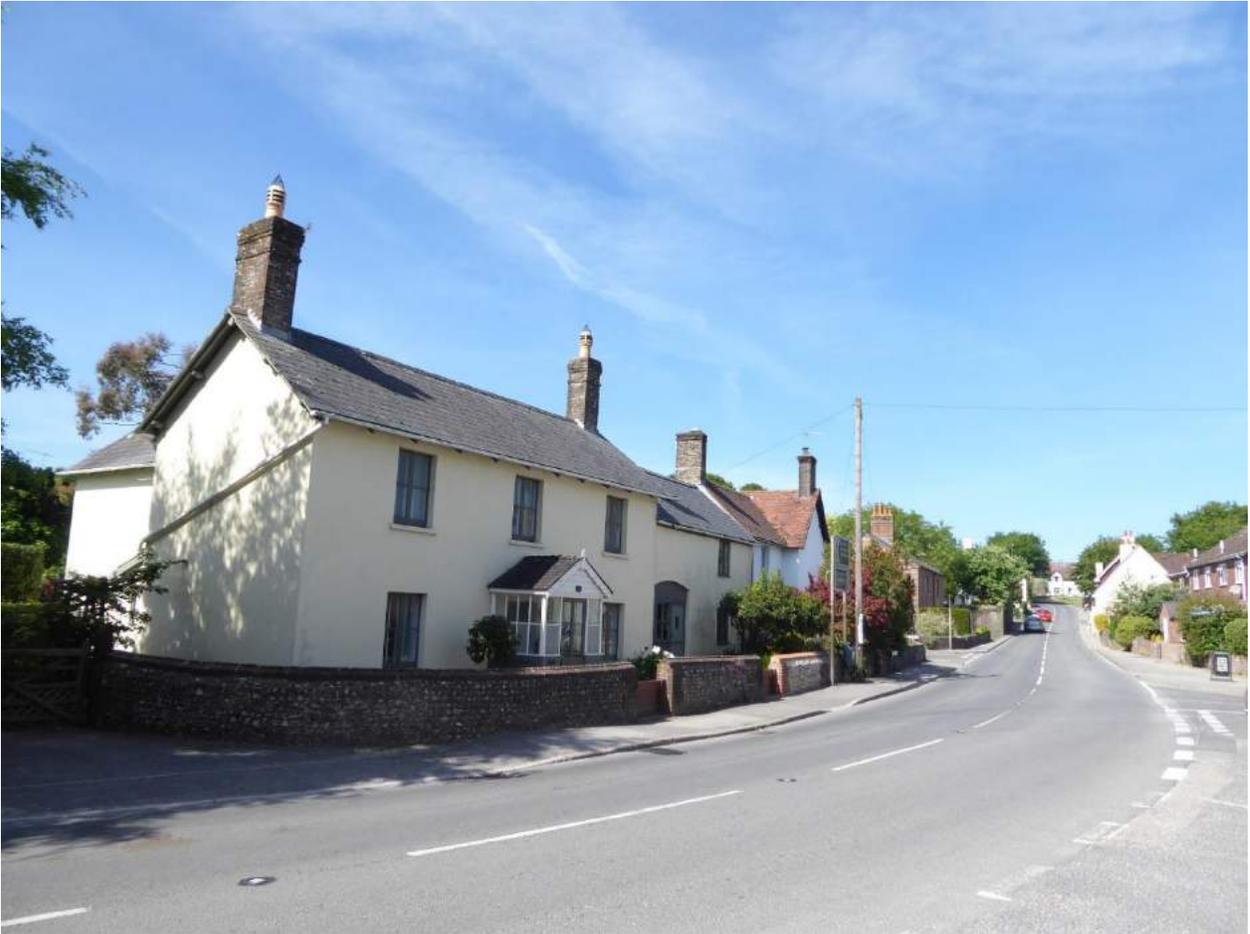
Figure 36: Widespread use of painted timber casements (south side of The Square)

- 6.14 What would be considered more vernacular houses and cottage-scale houses generally have side hung timber casements; painted (usually white) and also set back with rebates into the wall face providing some animation and articulation to the façade (**Figure 36 HSE26**). There is some cross-over between the two groups but generally this is typical throughout the conservation area.

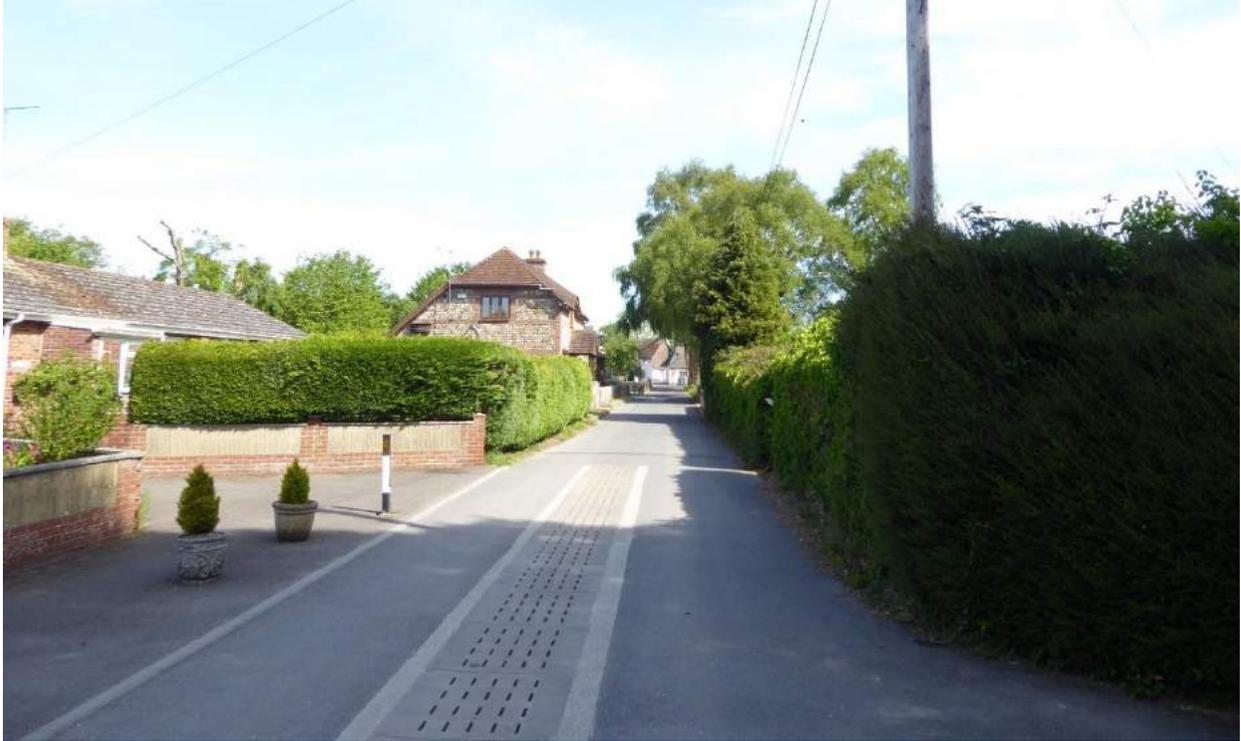
Figure 38: The flood prevention central drain to the road

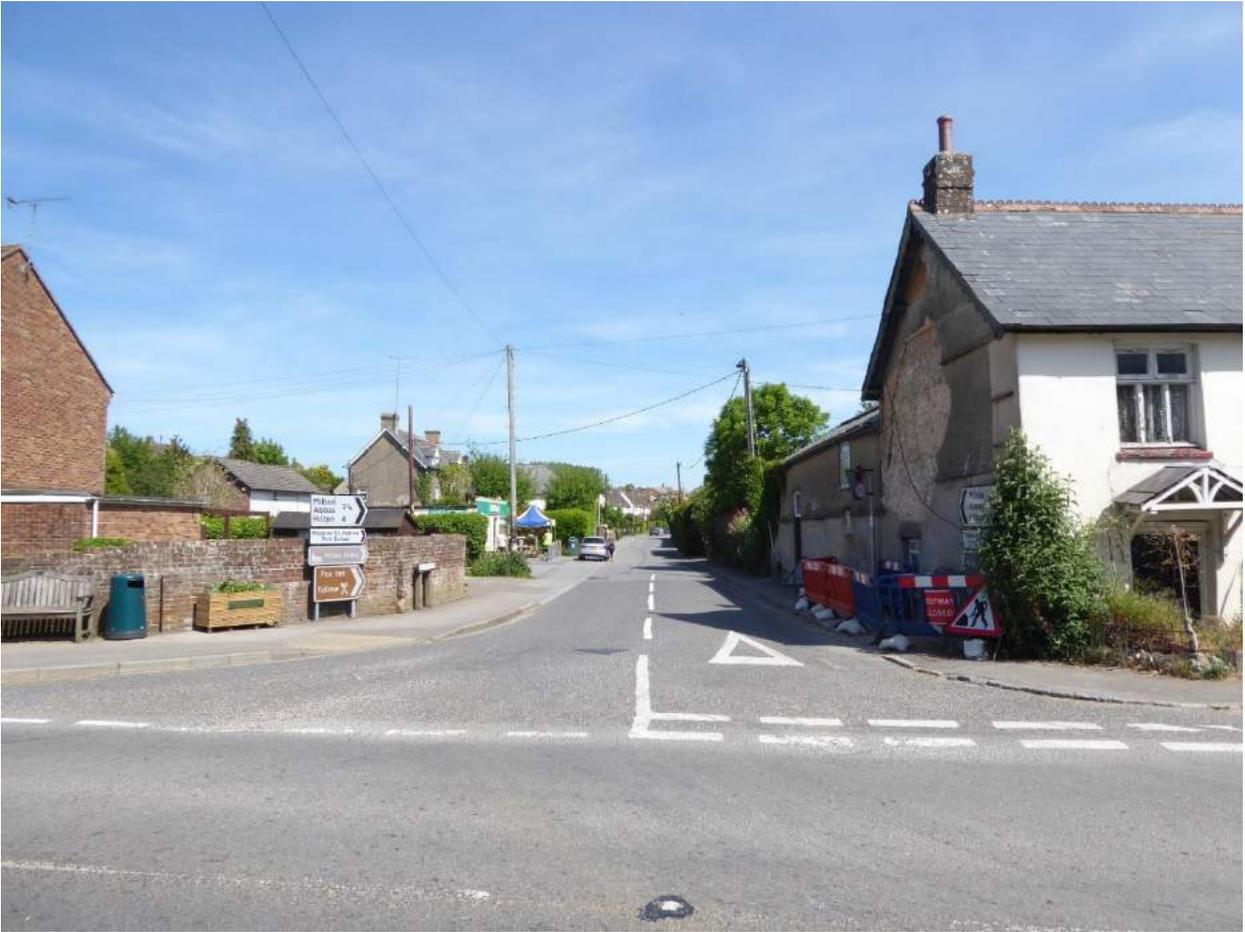
Figure 39: Standard design directional signage

- 7.5 There is very little by way of street furniture throughout the conservation area. Road and traffic signage is kept to a minimum but is of standard design and tends to be mounted on separate posts rather than wall mounted or integrated. Directional signage is of a standard design and in some places is intrusive and could be better designed or bespoke (**Figure 39 HSE44**).

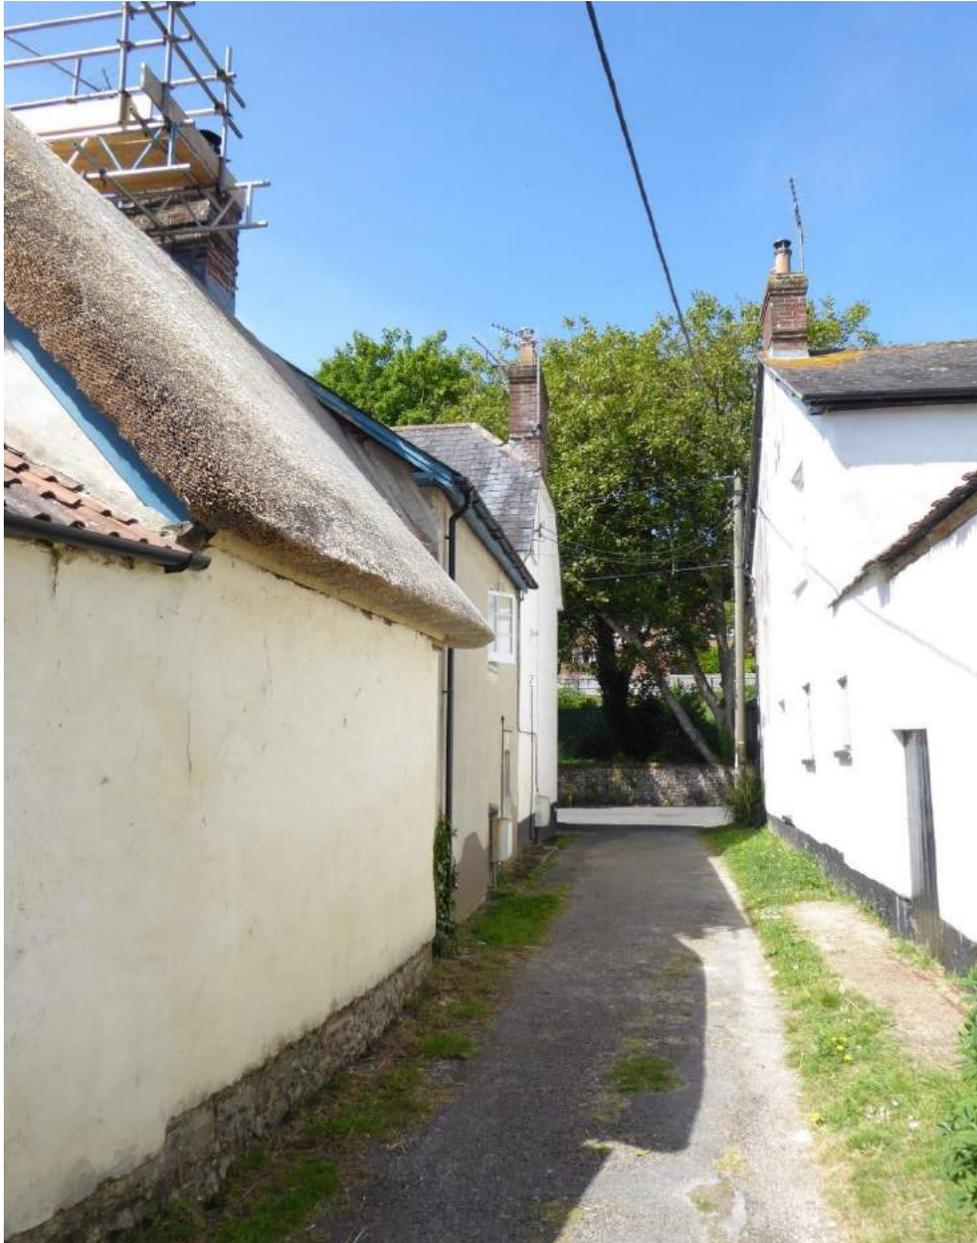
Figure 48: The footpath between Chapel Street and the Causeway

- 11.18 The footpath between Chapel Street and the Causeway (**Figure 48 CC60**) is a well-used pedestrian link between a series of historic buildings to the core of the conservation area and adjacent to the Bere Stream. The footpath would greatly benefit from a softening of its surface materials from tarmac to a resin-bonded gravel with crossover sections of stone setts to the entrances at each end. This would greatly enhance the visual appearance of the footpath and distinguish from the roads and lanes which are distinctly municipal in character particularly to Chapel Street.

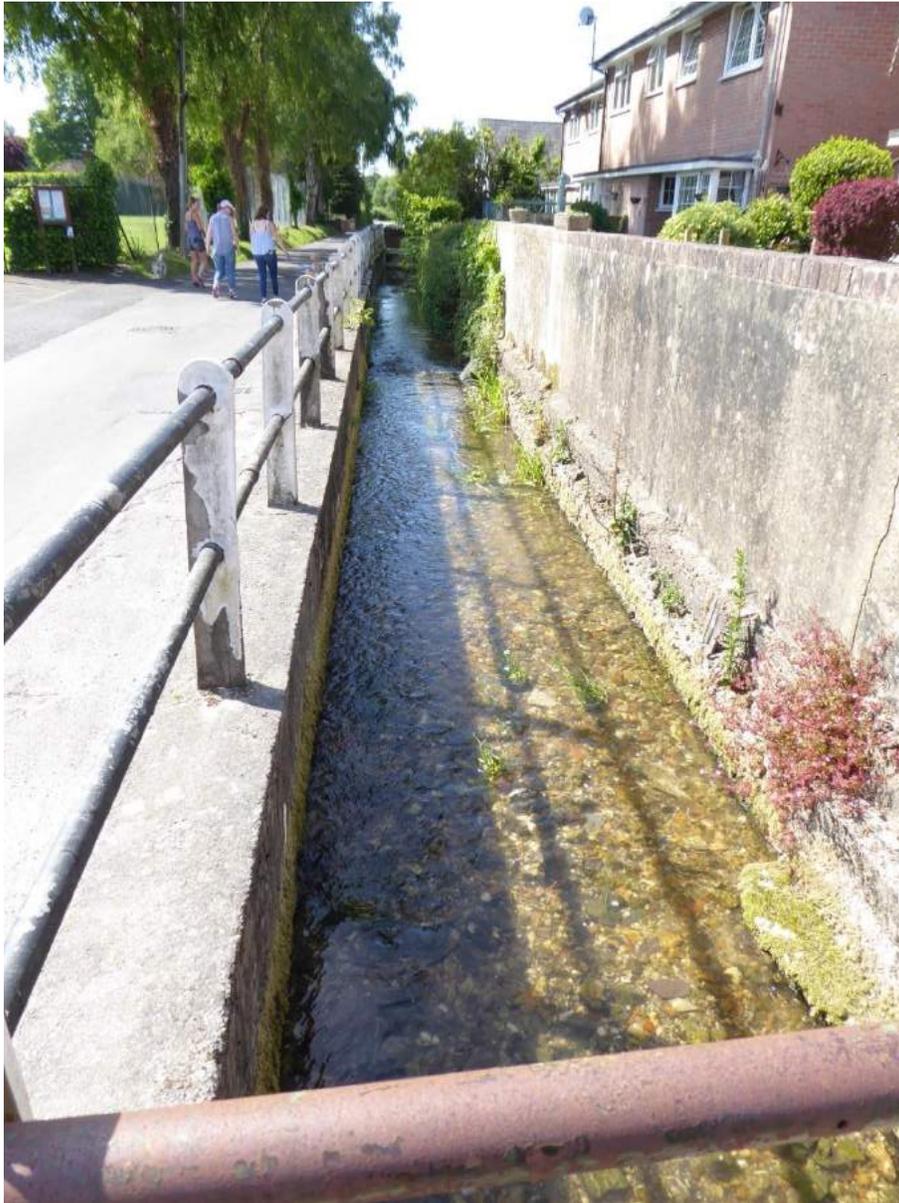
Figure 49: The present river enclosures to the northern section of the Causeway

11.19 The present river enclosures to the northern section of the Causeway (**Figure 49 CC27**) are function and utilitarian in their design and material finish. Their replacement with stone, flint and brick retaining elements would greatly improve the external appearance of these

features and the Causeway. In combination with this, consideration should be given to the replacement of pre-cast concrete posts with oak timber posts.

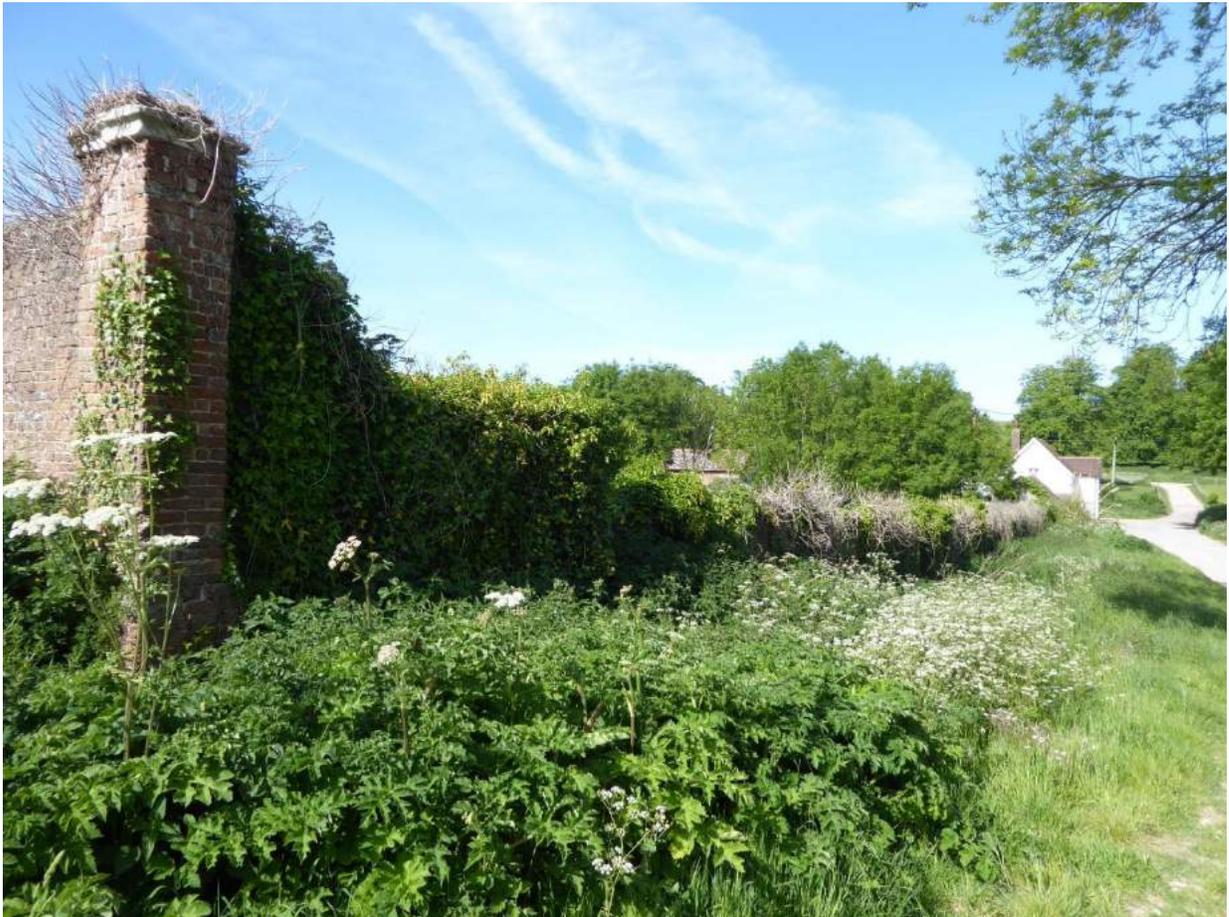
Figure 50: The kitchen garden wall - northern edge

- 11.21 The kitchen garden wall only survives in remnant sections or low sections of brickwork. Perhaps the best surviving sections are to the northern edge (**Figure 50 MHF22**) where it is most readily seen as forming the setting for the farm group and to outbuildings to the north of the Manor Farm (house). This section is perhaps the most vulnerable and susceptible to erosion and loss.
