Shipton Parish Council

Phone Box Triangle "The Land" (wall repair)

Brief to Structural Engineer (with appendix photos)

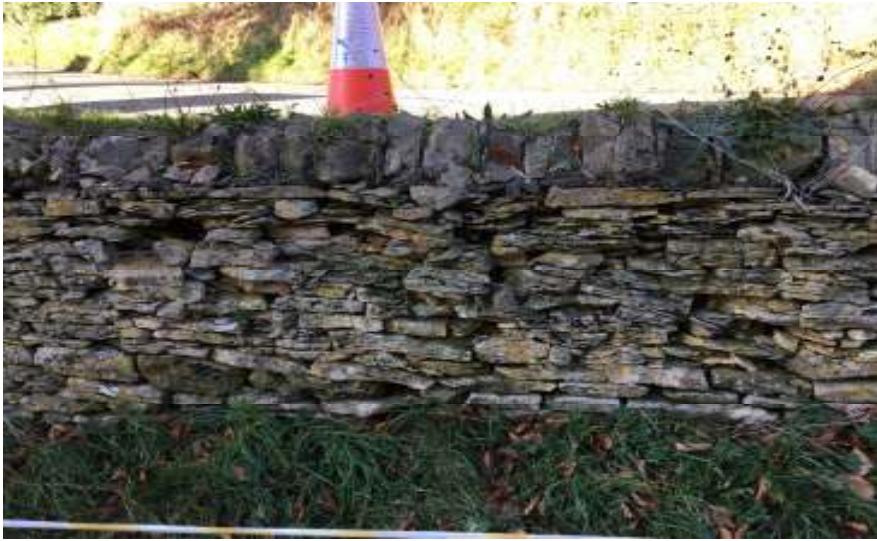
Photo 1

- ix) The Cotswold stone walls have several plants such as ivy and elderflower growing from the wall structure.
- x) Much of the stonework on the slip road side has been badly affected by damp and old age and plant roots and has delaminated and is crumbling and in some places has already collapsed.

"The retaining wall was generally in very poor condition with extensive cracking, particularly along the south wall which is a symptom of freeze-thaw weathering. This has likely been caused by damp conditions due to shading from the adjacent house. The east end of the south wall had partially collapsed with significant masonry loss, resulting in a road closure. The west wall exhibited similar cracking of the dry stones although to a lesser extent. There was significant vegetation obscuring the wall and small trees beginning to grow from the base and on top of the wall"

Appendix 1 - pics 1-> 3 Slip road side

Given the extensive degradation of the retaining wall and that a section has already partially collapsed, it is recommended that the entire wall is rebuilt, and a routine inspection programme implemented in the future. It is likely that the ivy is aiding the structural integrity of the wall, and it should therefore be removed with caution. The stones used to construct the new wall should be

tougher and less susceptible to damp conditions and freeze-thaw damage. To prevent a fall from height, a timber fence should be installed along the top of the wall.

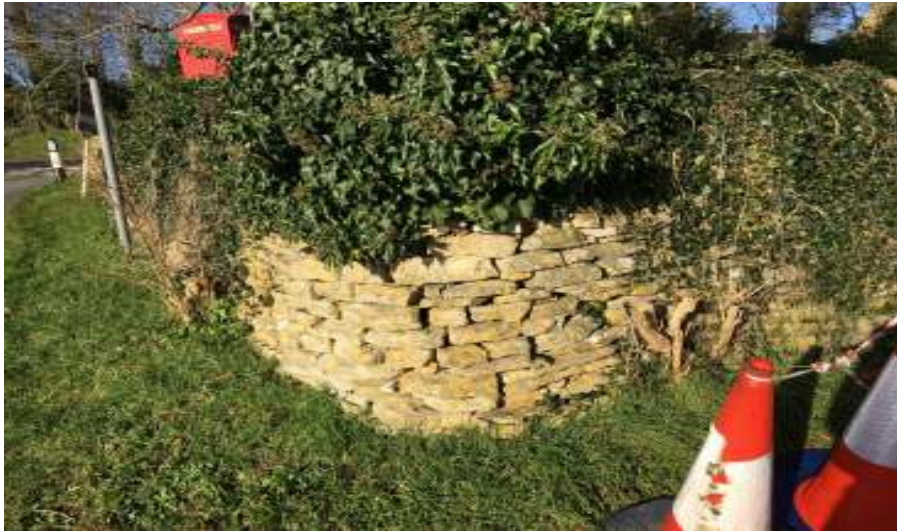
photo 4

Appendix 2 - pics 4 -> 6 Kilham Road side

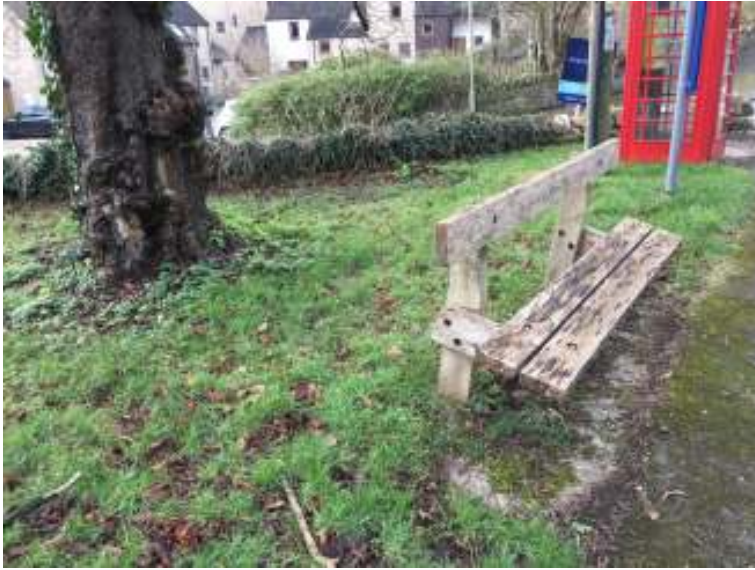
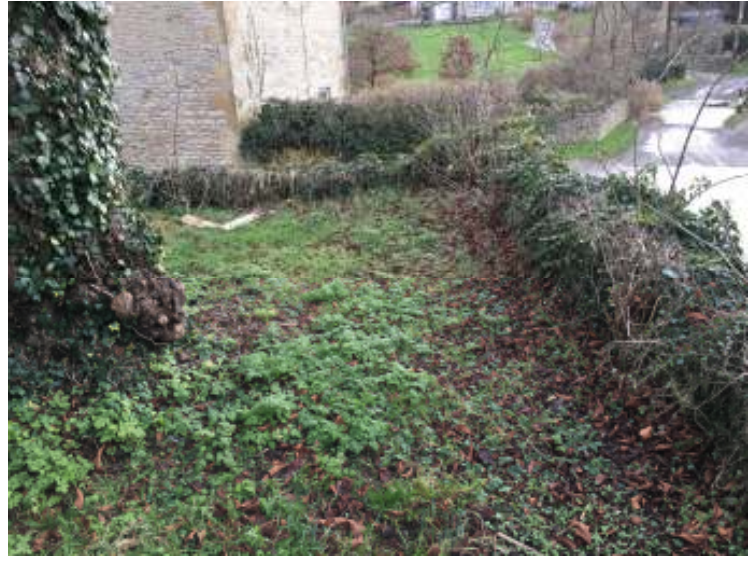
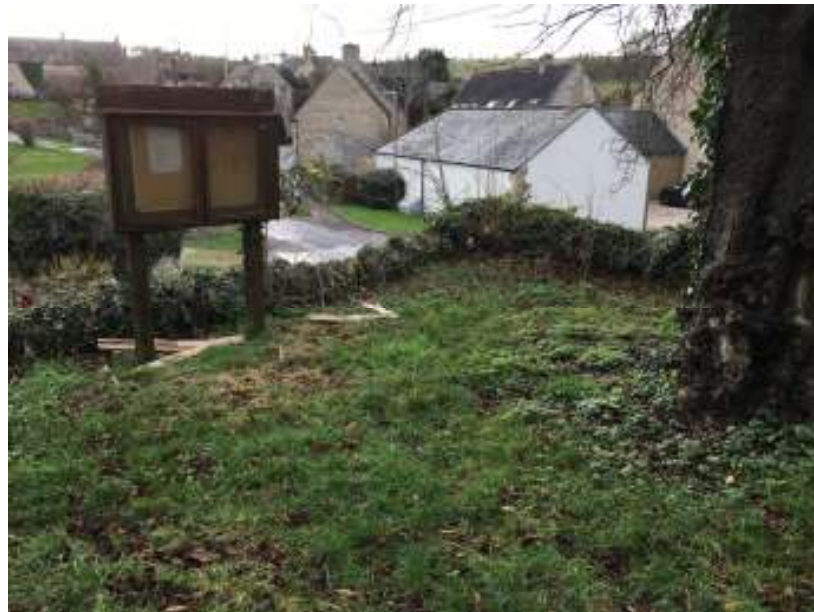
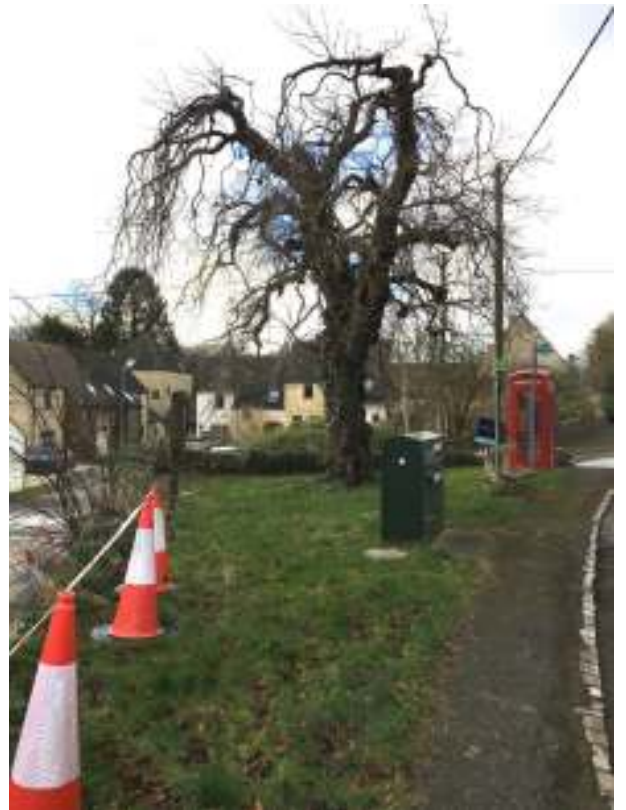
APPENDIX 3: The land surface & Utilities (1)

- v) Dry stone Cotswold walls are on 2 sides (Kilham Lane & The Slip Road)
- vi) The Cotswold stone walls average circa 1.5 meters in height.
- vii) The Cotswold stone walls operate as retaining walls for many tons of soil, that were back filled to enable the land to create a flat surface next to the high street to enable it to house various utilities:

- Telephone box with electrical supply - still in use as a defibrillator station.
 - BT Broad fibre broad band station current and in use.
 - Electric company wooden power pole currently in use

- Bus stop sign (redundant, but should remain)
 - Parish council notice board (redundant and not wanted)
 - Park bench, (collapsed rotten and not wanted)
