Safety Inspection Report

Annual Inspection

St Mary Bourne Play Area

22 May 2023

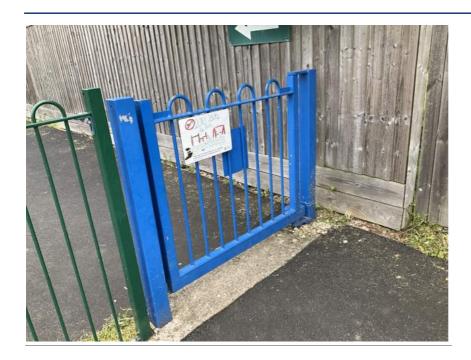
Gates

Shrinkage / separation of the surface. This may give a trip hazard.

Repair.

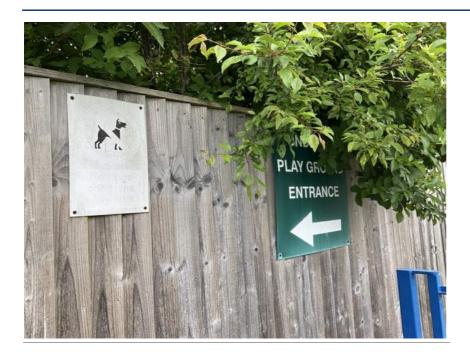
Signage

Vegetation obstructing sign or causing hazard.

Remove.

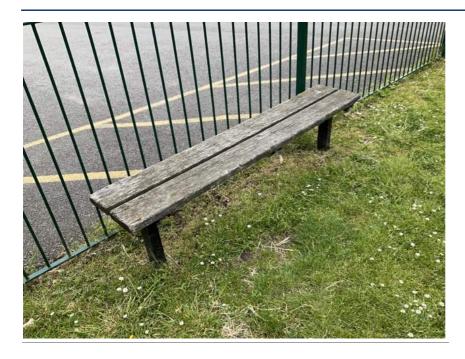
Seating - Bench

Item has corrosion.

Timber is splintered.

De-scale back to good metal and coat with lead free paint, using appropriate precautions. Repairs may be necessary where corrosion is severe.

Repair.

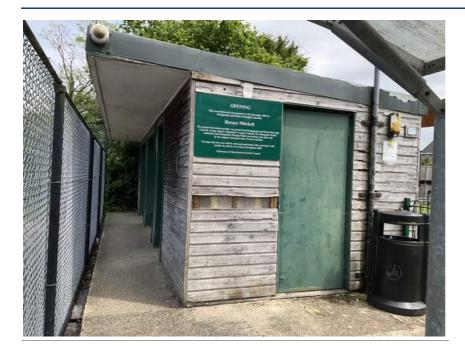
Shelter

Fixtures loose or missing.

Item is damaged.

Finger trap present as gap does not have a minimum dimension of 12 mm in every position between dimensions that change during use.

Replace.

Repair.

Modify bench lids or lock in closed position.

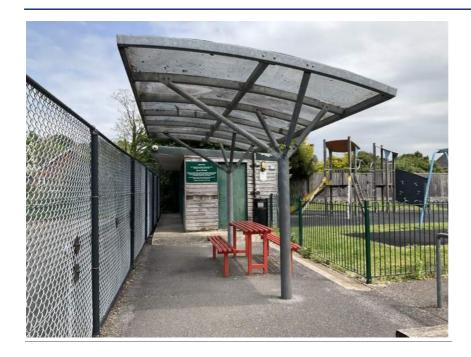
Shelter - Pergola

Item is cracked.

Repair.

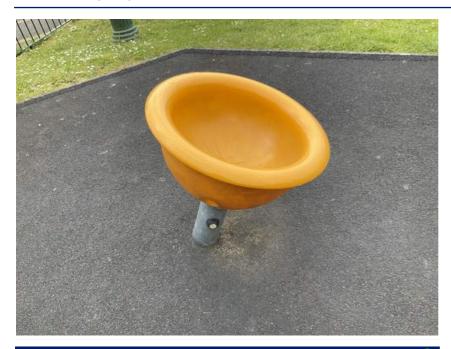
Carousel - Bowl

Trip points on the surface.

Make level.

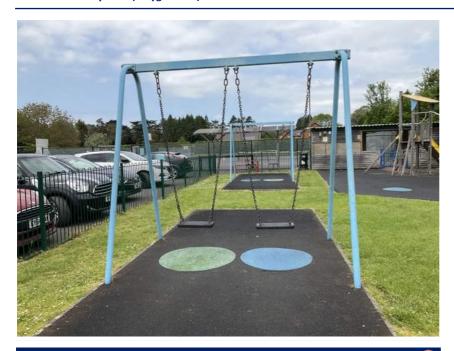
Swing - Junior - 1 Bay 2 Seat

The item is not compliant with the requirements of the relevant standards. The surfacing meets with the requirements of the relevant standards.

There is wear in the bushes.

Chain link connectors notched.

Loose swing seat eye-bolts.

The surface is cracking.

Trip points on the surface.

The dimension between adjacent swing seats is less than permitted.

Remove shackle bolt and check bush and shackle pin wear, replacing as necessary.

Monitor wear and replace as necessary.

Tighten connecting nuts.

Monitor.

Build up earth levels to remove trip hazard.

The unit was installed prior to the publication of the current standards. There is no requirement to make retrospective changes.

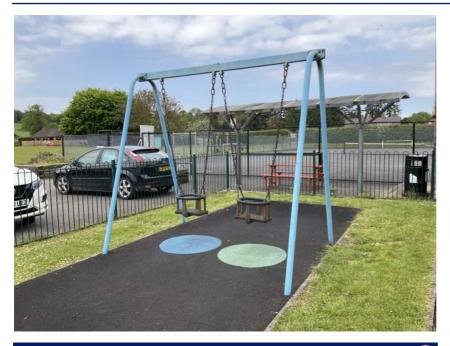
Swing - Toddler - 1 Bay 2 Seat

The item is not compliant with the requirements of the relevant standards. The surfacing meets with the requirements of the relevant standards.

Some chain wear.

Chain link connectors notched.

Trip points on the surface.

The dimension between adjacent swing seats is less than permitted.

Monitor for further deterioration and replace before 40% wear.

Monitor and replace as necessary.

Make level.

The unit was installed prior to the publication of the current standards. There is no requirement to make retrospective changes.

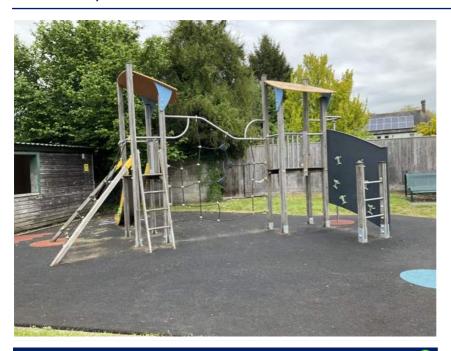
Multiplay - Junior

Delamination of wood.

Shrinkage / separation of the surface. This may give a trip hazard.

Fixtures loose or missing.

Item has some parts missing.

Laminate damaged.

Timber is decayed.

Significant decay to various posts.

The core of the wire is exposed.

Repair.

Tighten/replace.

Replace the missing parts.

Rub down and treat damaged edges.

Replace affected parts.

Wrap to extend life.

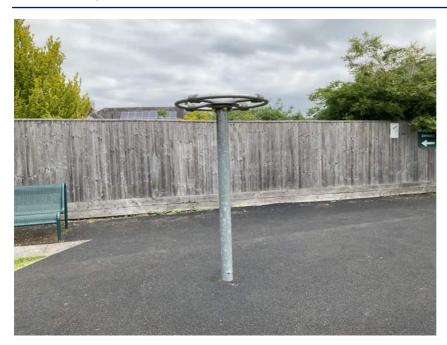
Carousel - Overhead

The supporting components should be dismantled and inspected according to the manufacturer's instructions. This will need doing on a regular basis. This can lead to a high risk if no action is taken.

Excessive movement from the bearings. Dismantle, investigate and repair as necessary.

Dismantle and inspect according to manufacturer's instructions.

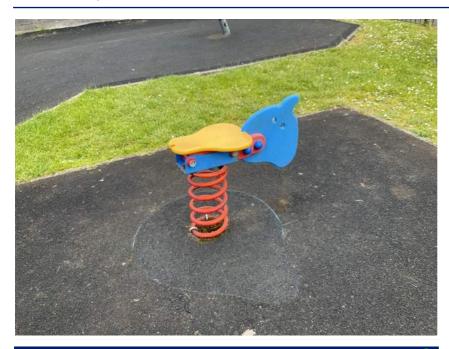
Rocker - Dog

Cap missing.

Item has corrosion.

Item is damaged.

Replace.

Treat and repair.

Repair.

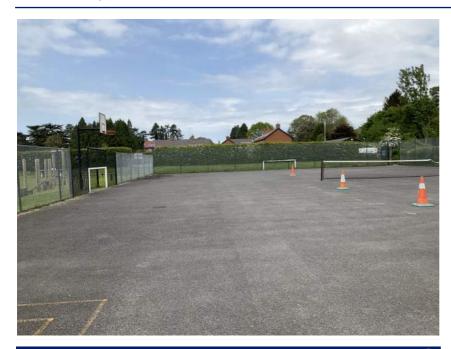
MUGA

The item is not compliant with the requirements of the relevant standards. The surfacing meets with the requirements of the relevant standards.

Item has corrosion.

Item is damaged.

Mechanism needs adjustment.

Timber preservation is in poor condition.

Minor repairs are needed.

Debris on surface.

A warning notice should be fitted to all sports related equipment with the words "do not climb on the framework or nets", "do not hang on the ring" (if provided) and "do not wear rings or other jewellery as these can get caught and cause injury".

Treat and repair.

Repair.

Adjust.

Stain with appropriate preservative. Most preservatives sold as child friendly by major DIY chains meet these standards (see advice in http://www.rospa.com/leisuresafety/adviceandinformation/playsafety/wooden-play-equipment.aspx).

Sweep away debris on a routine basis.

Fit warning notice.

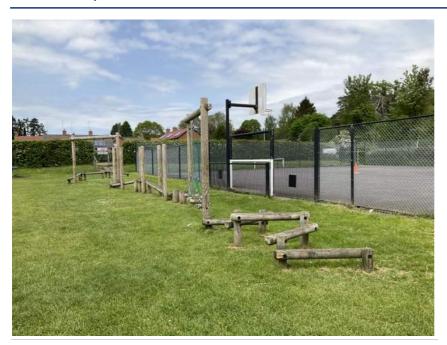
Agility Trail - Balance Beams, Stepping Logs, Suspended Log Walk & Rope Walk

Cap missing.

Item is damaged.

This equipment relies on one post for its stability. Special attention should be paid to maintenance (e.g. by monitoring degradation) and if necessary decommissioning the item before the end of its operating life.

There are natural splits / shakes in the timbers.

Timber is not in good condition.

Replace.

Sand splintered surfaces.

Consult with the manufacturer's guidance to determine suitable maintenance.

Monitor and sand back any splintered edges as required.

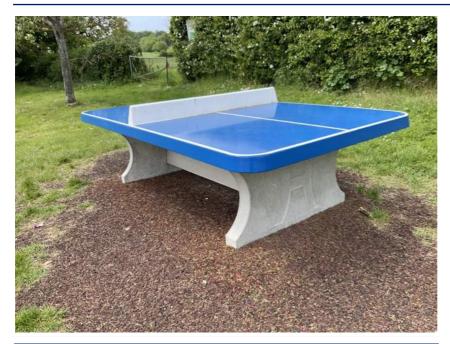
Table Tennis Table

Surface has unintended weeds.

Remove.

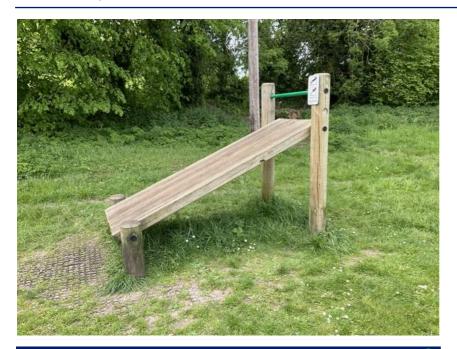
Adult Fitness - Inclined Leg Raise

There are natural splits / shakes in the timbers.

There are splinters or the potential for splinters.

Monitor.

Sand the timber down to remove the splinters and/or the places liable to give splinters.

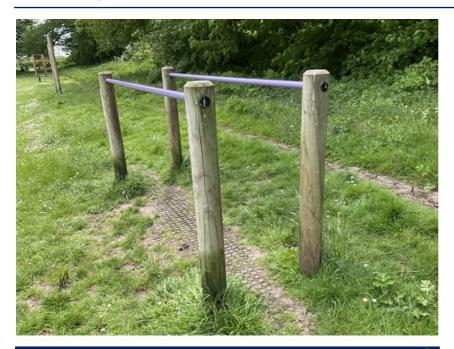
Adult Fitness - Parallel Bars

There are natural splits / shakes in the timbers.

Monitor.

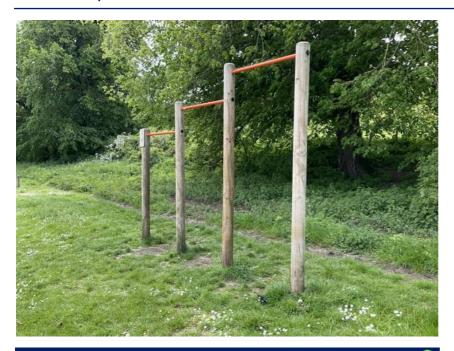
Adult Fitness - Pull Ups - 3 Heights

There are natural splits / shakes in the timbers.

Surface needs repair.

Monitor and sand back any splintered edges as required.

Repair.

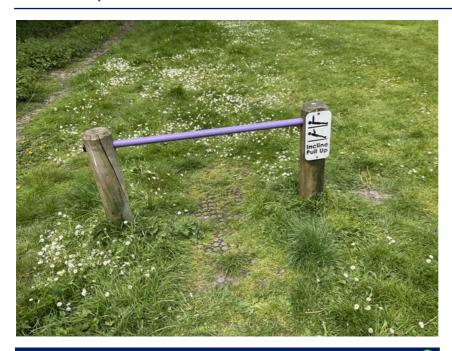
Adult Fitness - Inclined Pull Up

There are natural splits / shakes in the timbers.

Monitor.

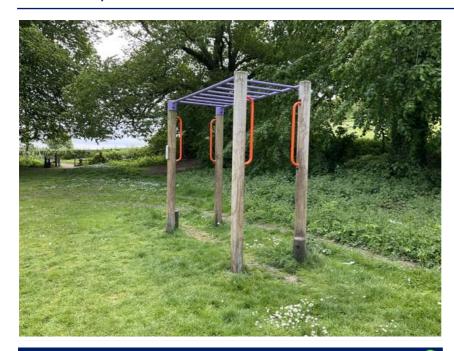
Adult Fitness - Monkey Bars

RoSPA is concerned by accidents on some types of overhead ladders and rings. However, there is a strong development value in these items.

There are natural splits / shakes in the timbers.

The protective surface under all bars and rings must be kept in good condition.

Monitor.
