CCTV – existing camera/hardware removal

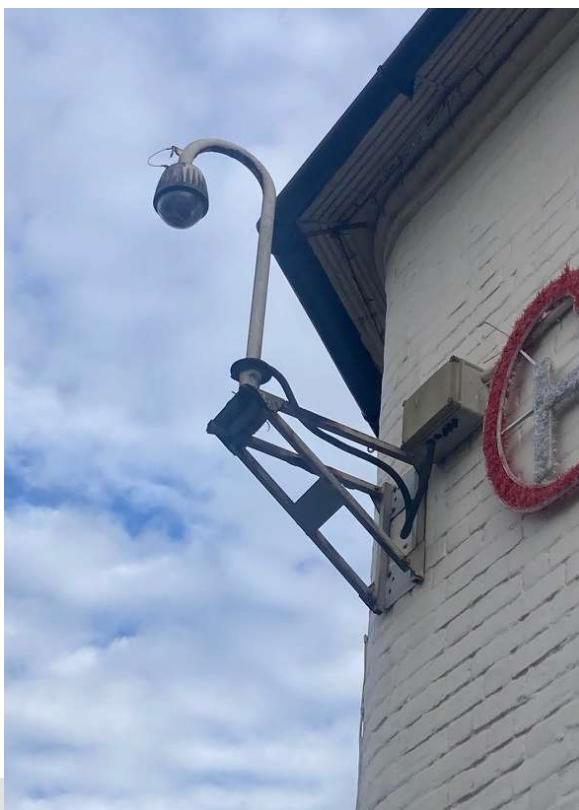
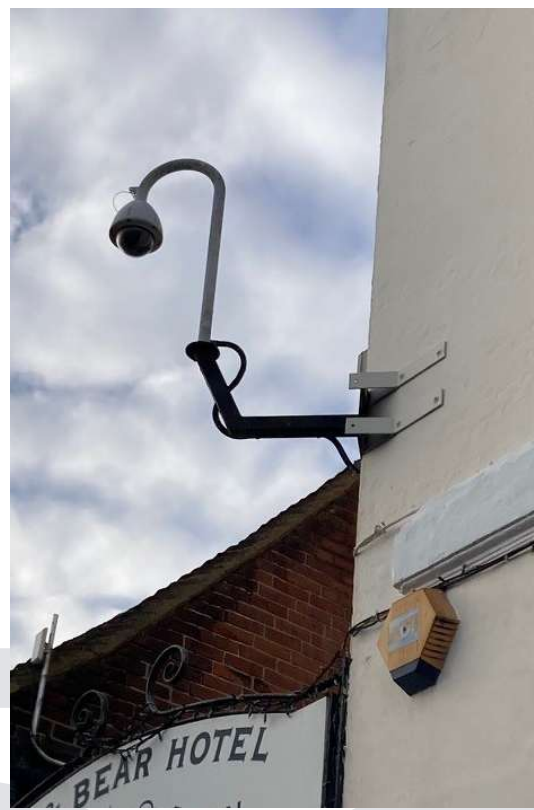
Post Office corner (left), RB Plant (right)

Within the conservation area there are at least three existing redundant cameras which are unsightly and should, in my opinion, be removed.

The following are the 4# obvious cameras that should be considered for removal:

Permission will be needed from the building owners and safe access to remove the cameras, brackets and associated 'boxes' – allowance should also be made to cut back and cap off any associated cables/wires etc.

High access platform will be needed for the two building mounted items, hi-ab crane is likely to be needed to remove the stand-alone poles.

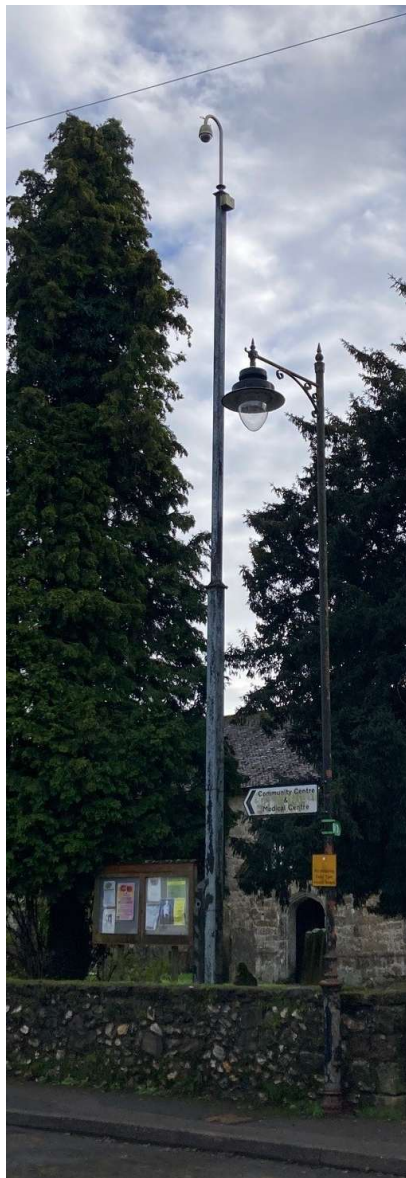
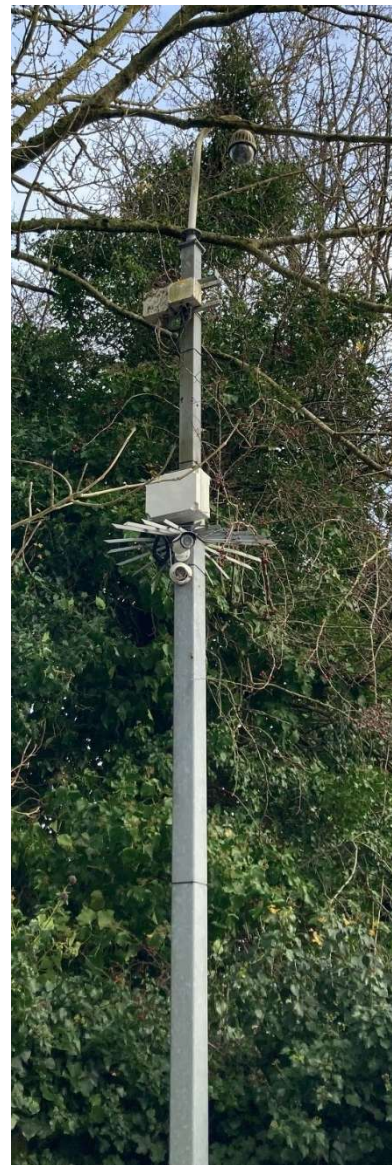
There are also two pole mounted cameras – one in the Maidstone Road car park and the other in the churchyard. The one in the churchyard is significant and unsightly. Removal will be a major task (and removal of the base?). It is unlikely that there is an alternative location where this pole can be reused.

The pole in the car park is shorter and could potentially be reused (behind the cricket pavilion) subject to the ability to gate the relevant lifting equipment necessary to re-erect it in the (yet to be) agreed location.

Note that the pole in the churchyard will 'fold' whereas the one in the car park does not.
