# Safety Inspection Report

## Widdrington Station Play Area

Widdrington Station and Stobswood Parish Council

22 June 2026

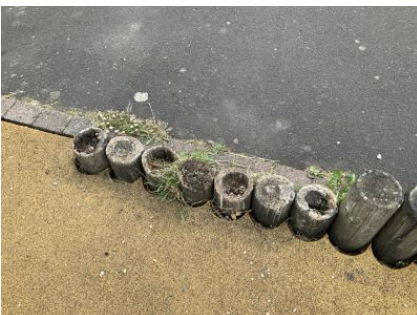
Timber is decayed.

Lots of timber broken and decayed. Recommend removing from site and filling in the holes.

Check on a routine basis., Replace affected parts.

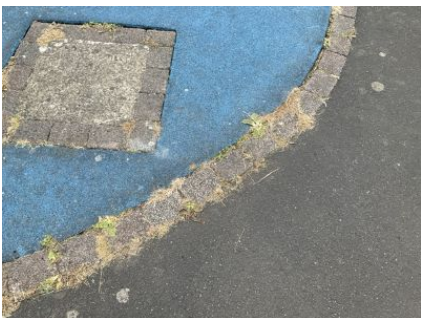
Shrinkage / separation of the surface. This may give a trip hazard.

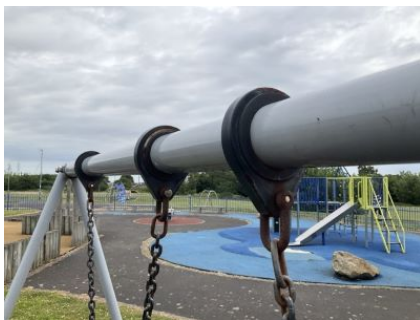
Item is rusting in places.

Repair.

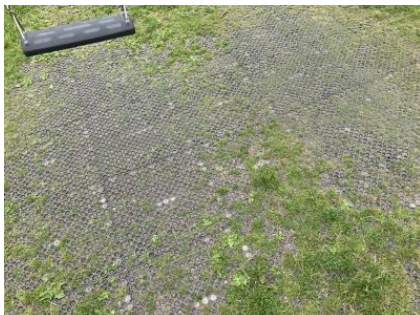
Surface needs repair.

## Repair.

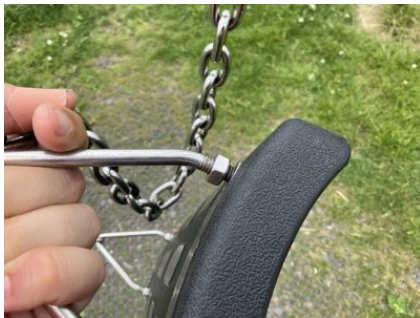
Loose swing seat eye-bolts.

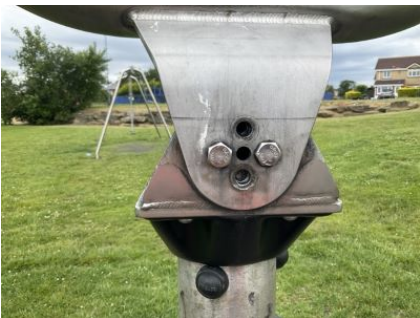
Bolt(s) missing.

Replace missing bolt(s).

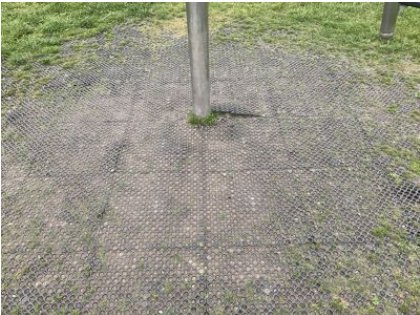
Surface needs repair.

Repair.

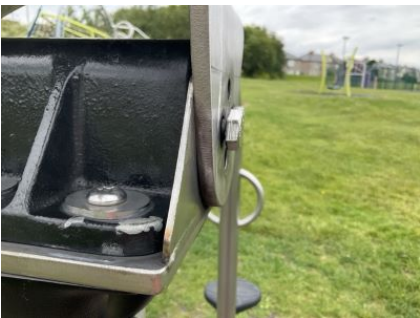
Bolt(s) loose.
